## ENVIRONMENTAL MONITORING DAILY SITE OBSERVATION FORM

**Report No. 1**

Project: Verizon Wireless Canterbury South CT Facility  
Address: 46 Cemetery Road, Canterbury, Connecticut

APT Project No: CT1418090

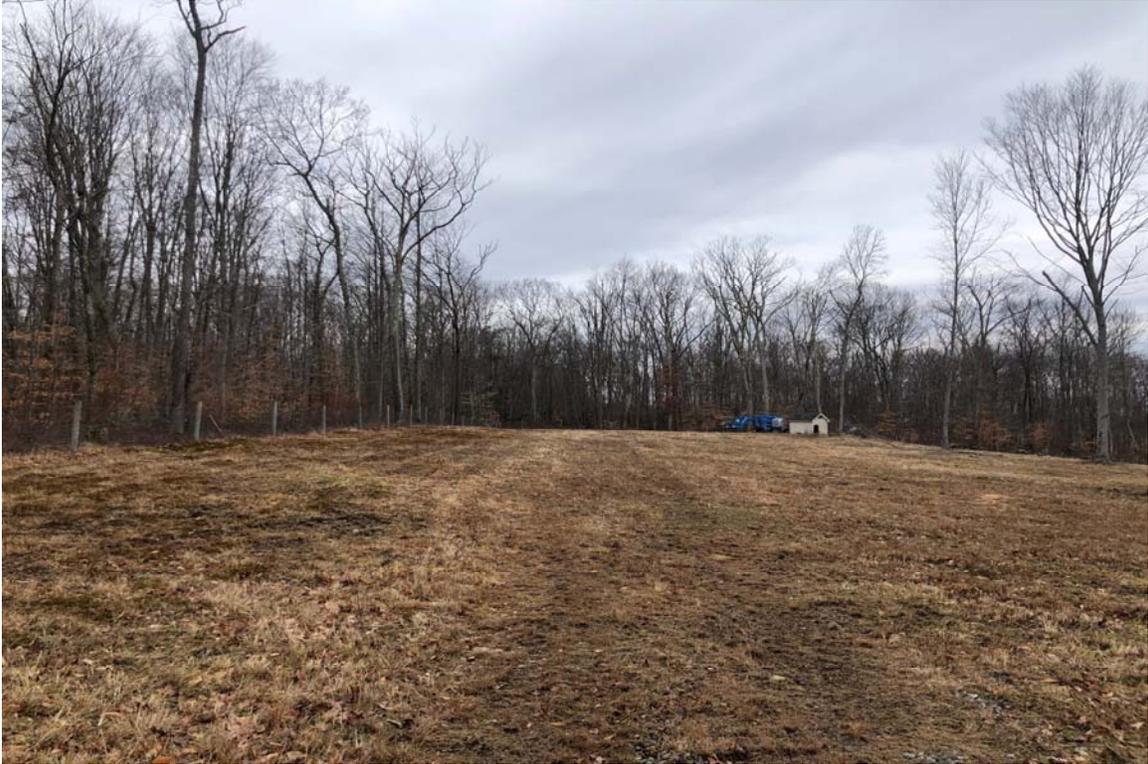
Photo 1: View of tower location at end of field.

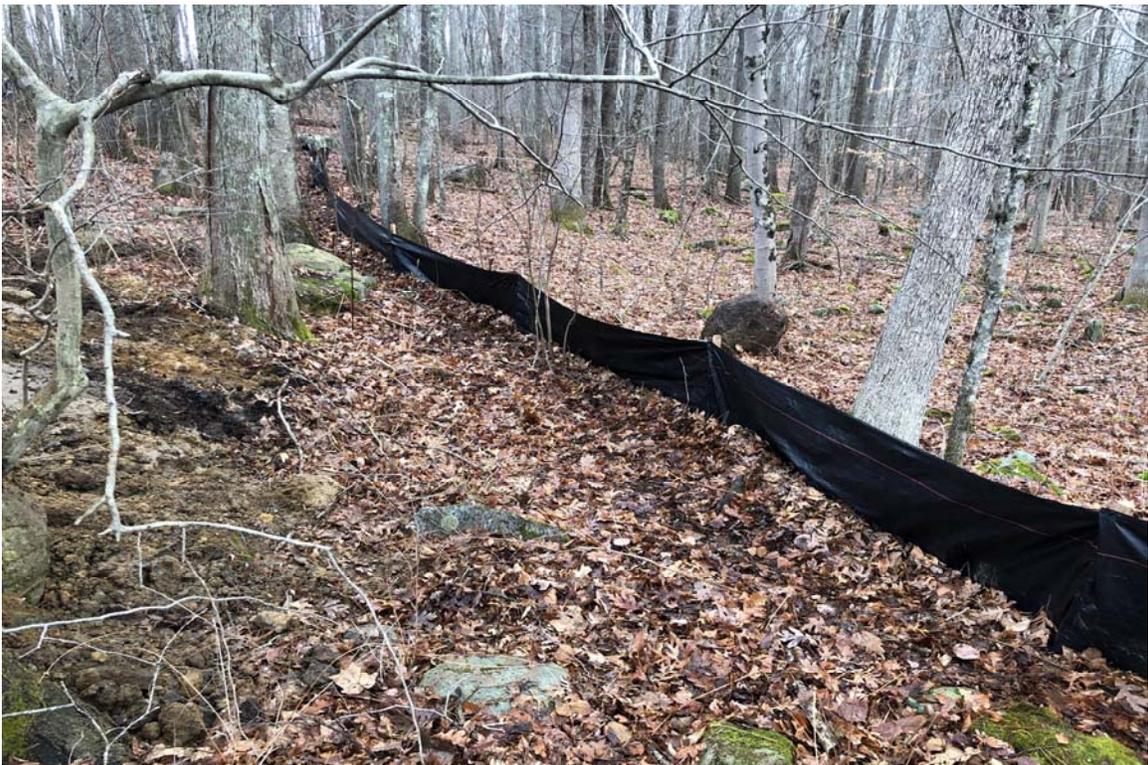
Photo 2: View of silt fence properly installed/maintained downslope of utility trenching work through Wetlands 4, 5 & 6.

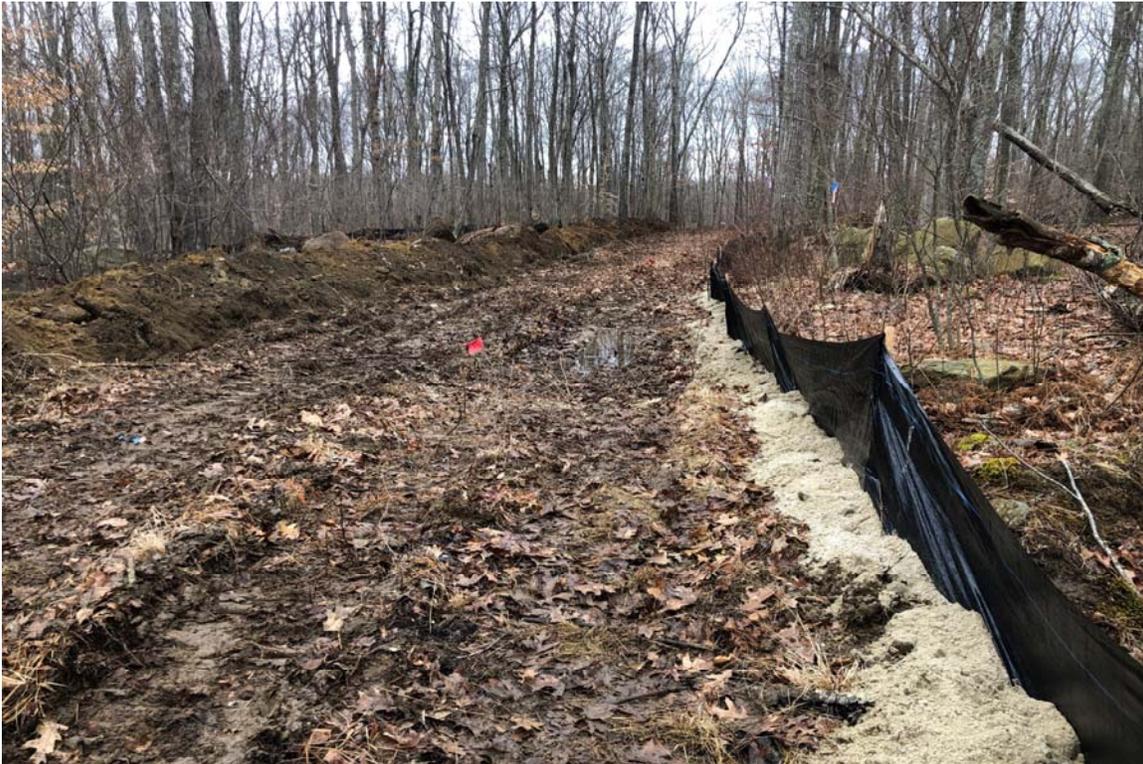
Photo 3: View of Wetland 6 utility crossing installation work with open trench located in left side of photo. Note minimal rutting through wetlands.

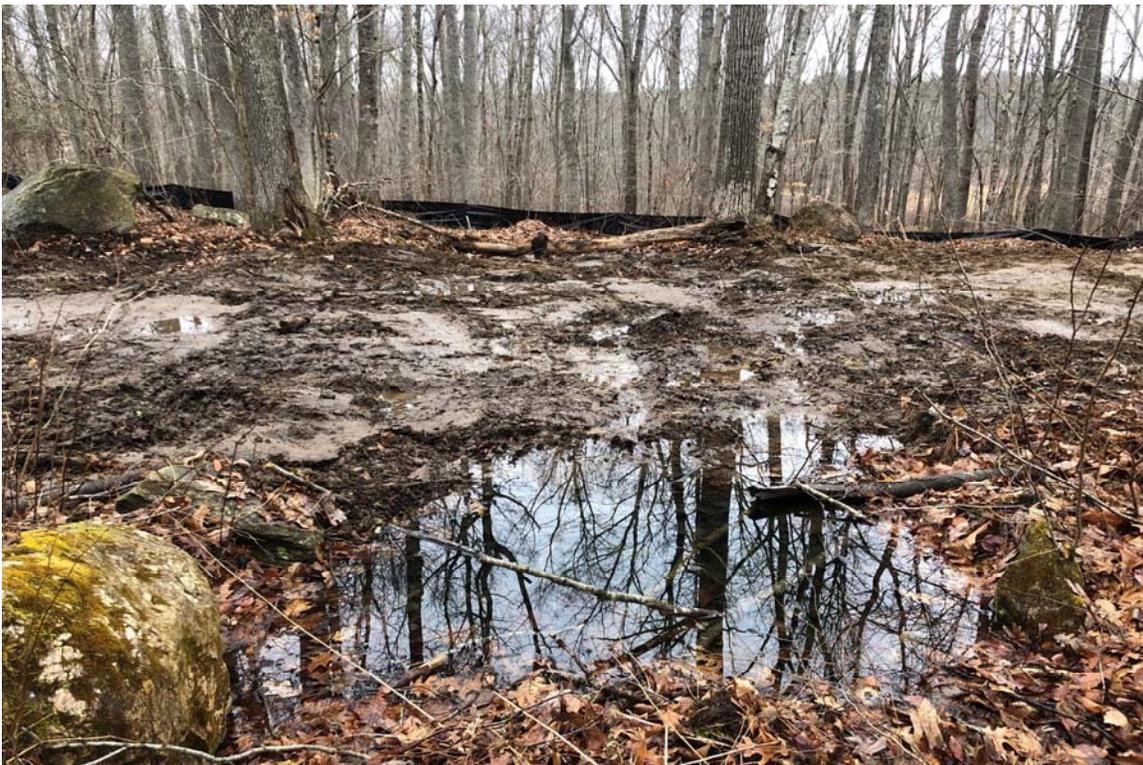
Photo 4: View of Wetland 5 utility crossing following completion of conduit installation and backfilling of trench. No significant erosion observed.

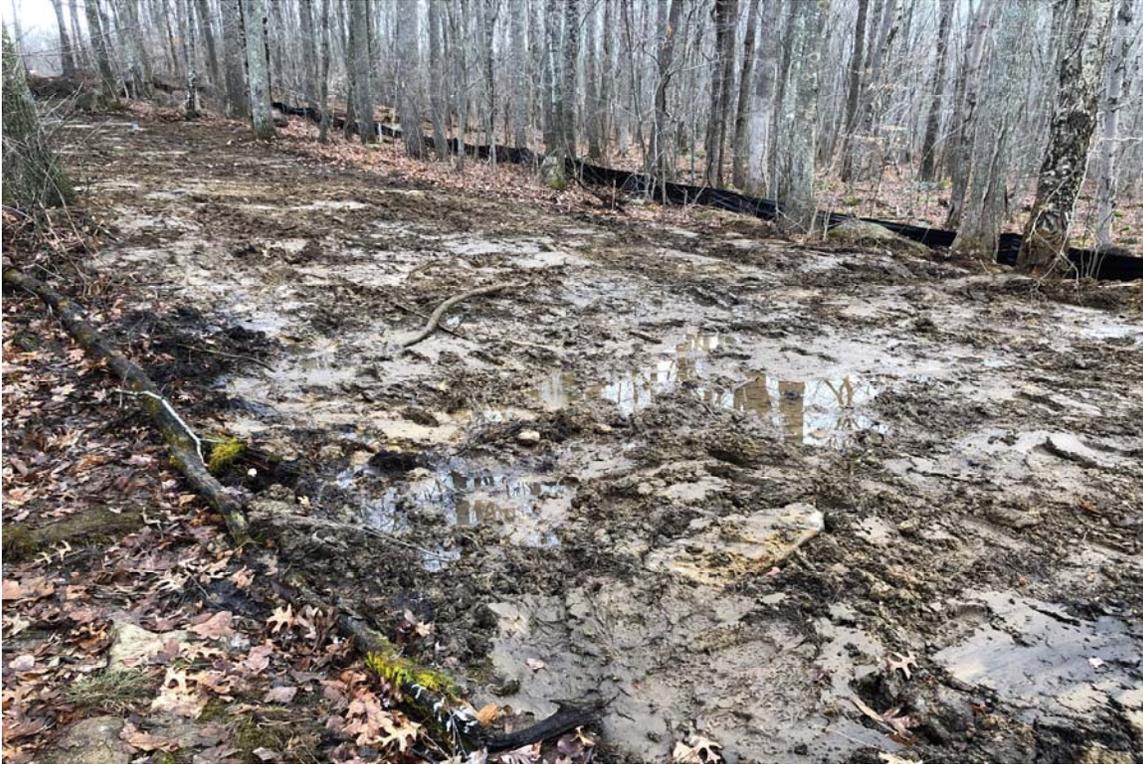
Photo 5: View of Wetland 4 utility crossing following completion of conduit installation and backfilling of trench. No significant erosion observed.

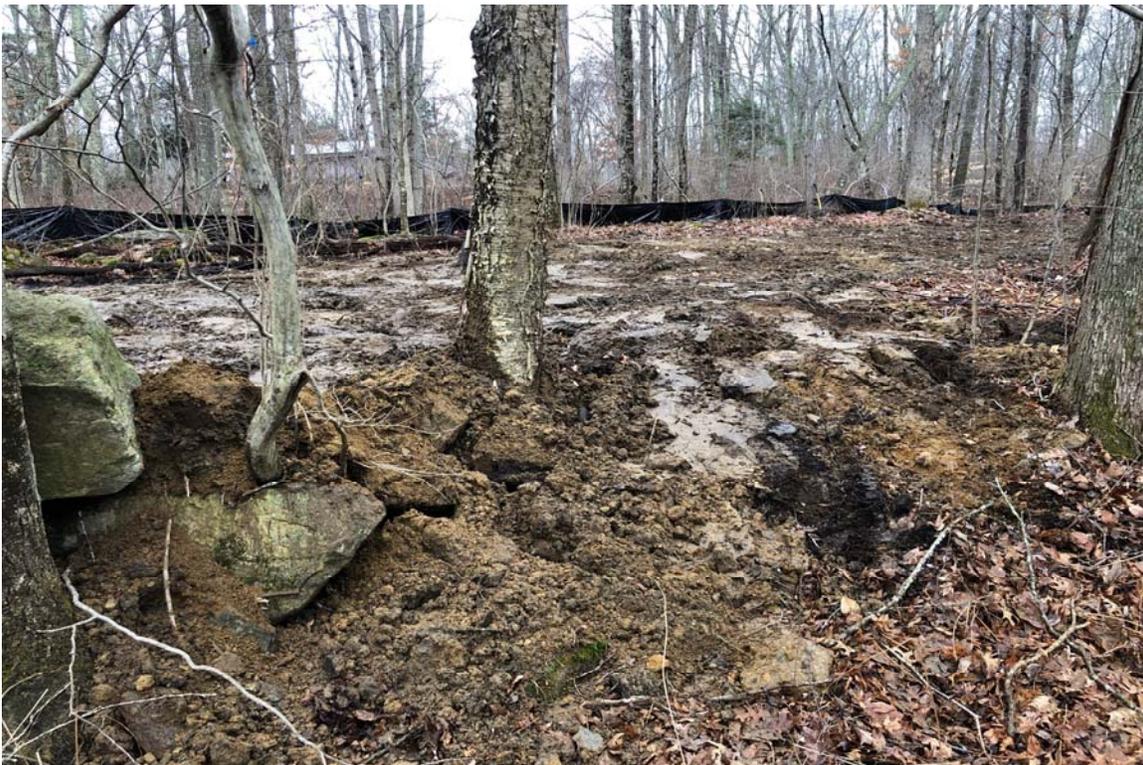
Photo 6: View of Wetland 5 utility crossing work area; downslope areas require restoration/smoothing of surface to ensure stabilization.

- Disturbed wetland areas shall have the surface area stabilized immediately with straw mulch to prevent soil erosion. This soil stabilization recommendation was completed on February 7<sup>th</sup> by the contractor.

- Wetland topsoil shall be amended with approved wetland topsoil material since native wetland topsoil was lost due to improper soil sorting procedures during utility trenching.

- Permanent vegetative stabilization/seeding shall occur once wetland topsoil placement has occurred, tentatively scheduled for the start of the 2020 growing season (late March/early April) per the permit-approved native wetland seed mix specification.

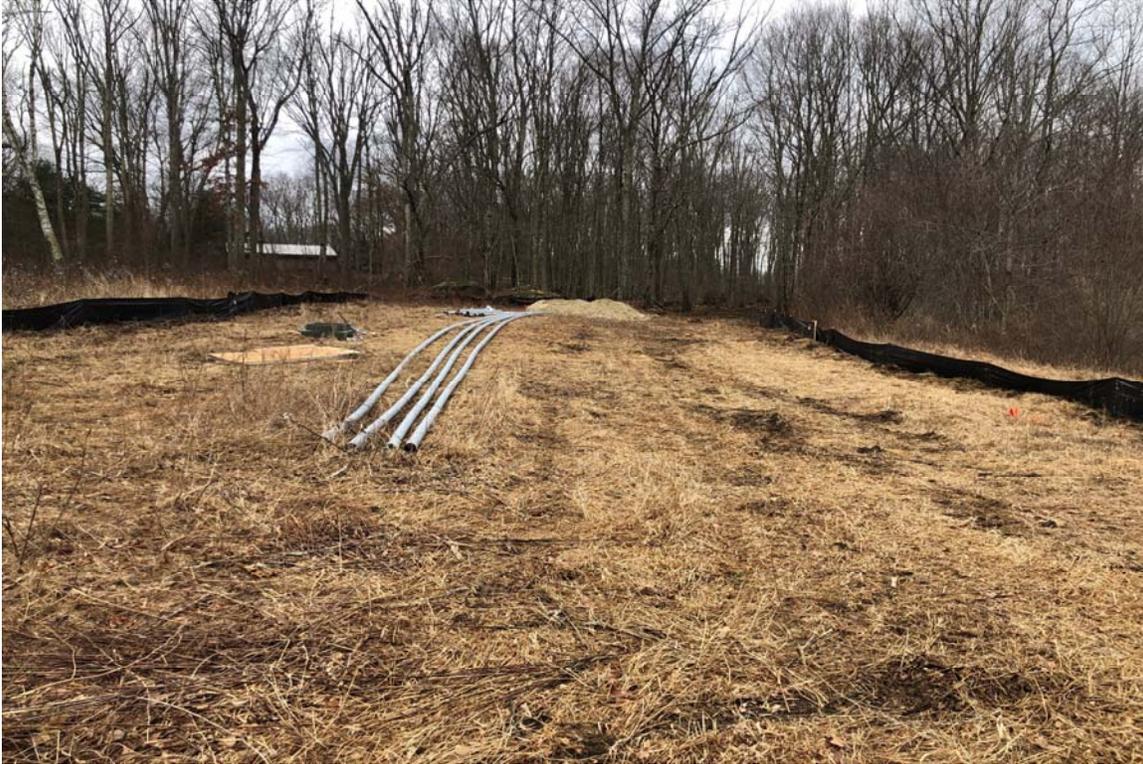
Photo 7: View of pending utility trenching work off Cemetery Road within upland field. Wetland crossing areas are located in the photo background within the forested area.

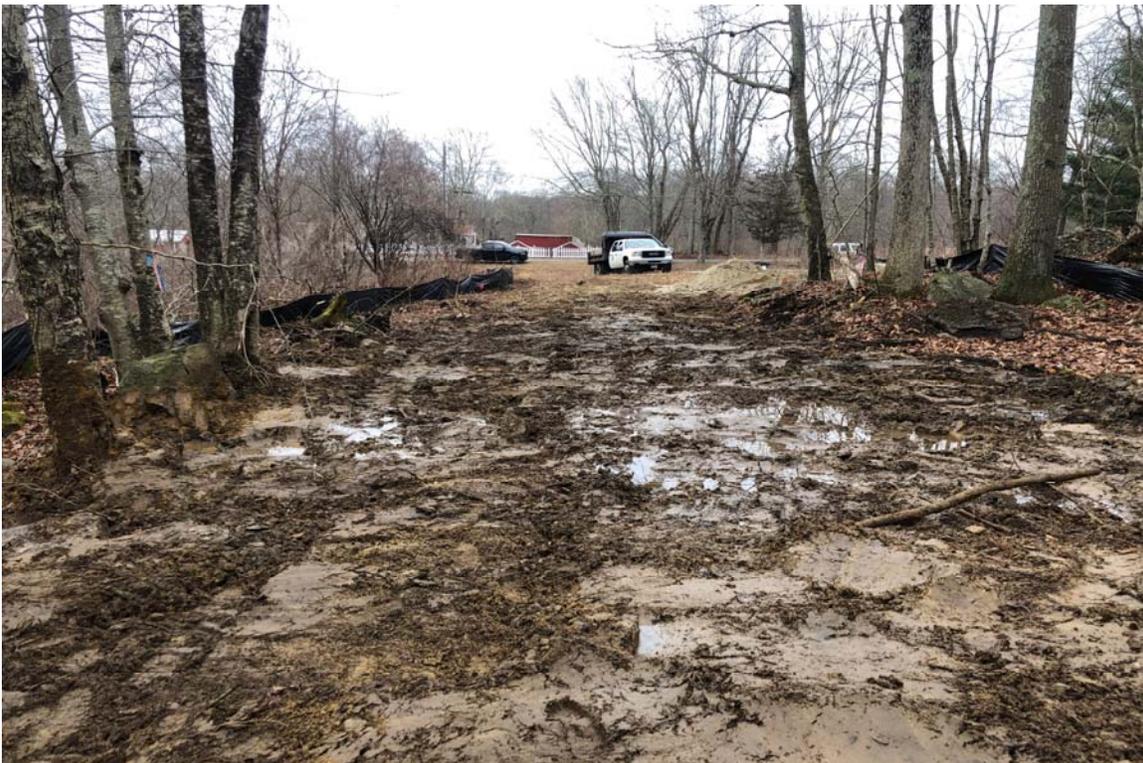
Photo 8: View of Wetland 4 utility crossing following completion of conduit installation and trench backfilling. No significant erosion observed. Cemetery Road in background beyond field.
