ENVIRONMENTAL MONITORING DAILY SITE OBSERVATION FORM

Report No. 7

Project: Verizon Wireless Lebanon Center CT Facility
Address: 917 Exeter Road, Lebanon, Connecticut

APT Project No: CT1417950

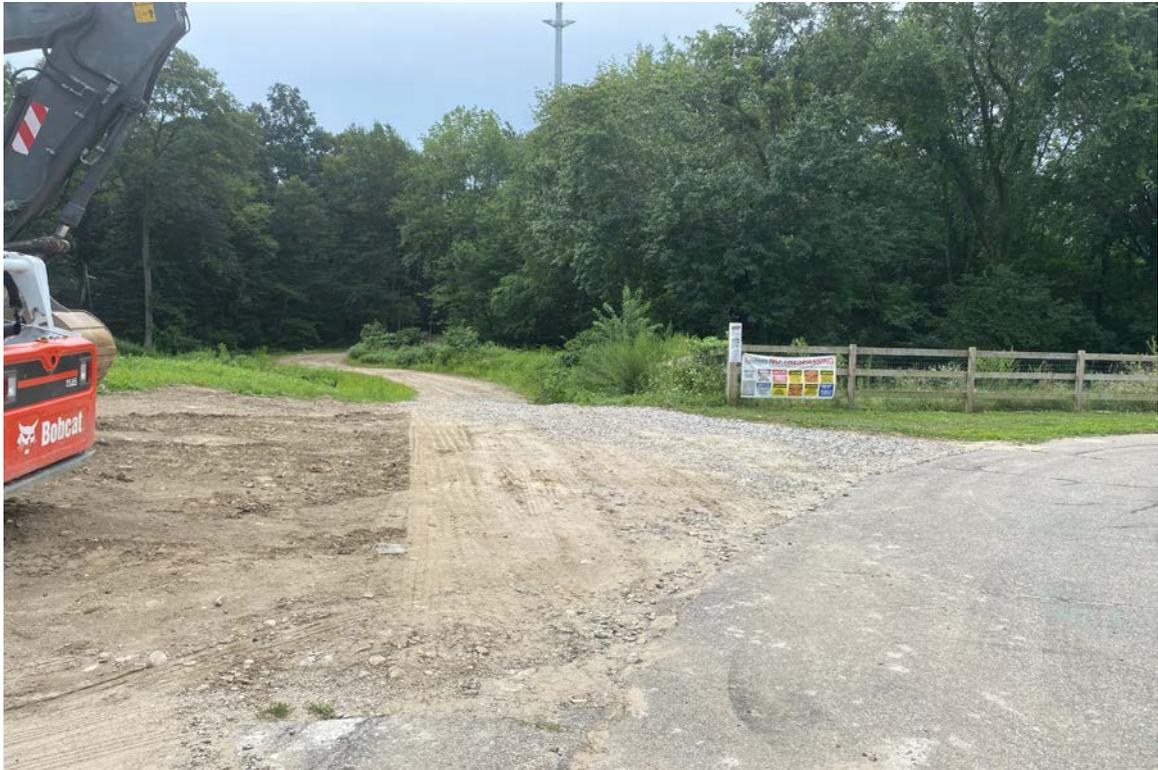
Photo 1: View of access road looking south from antitracking pad entrance.

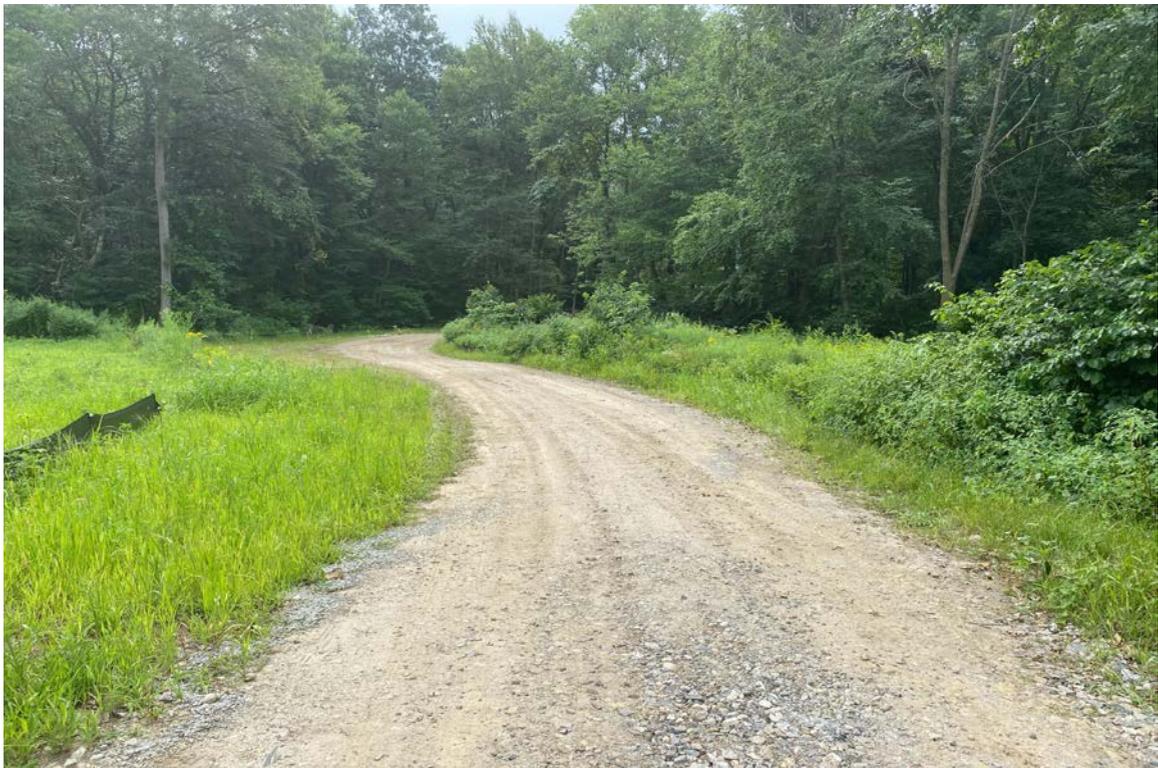
Photo 2: View of access road looking south showing shoulder stabilized with well established permanent vegetation.

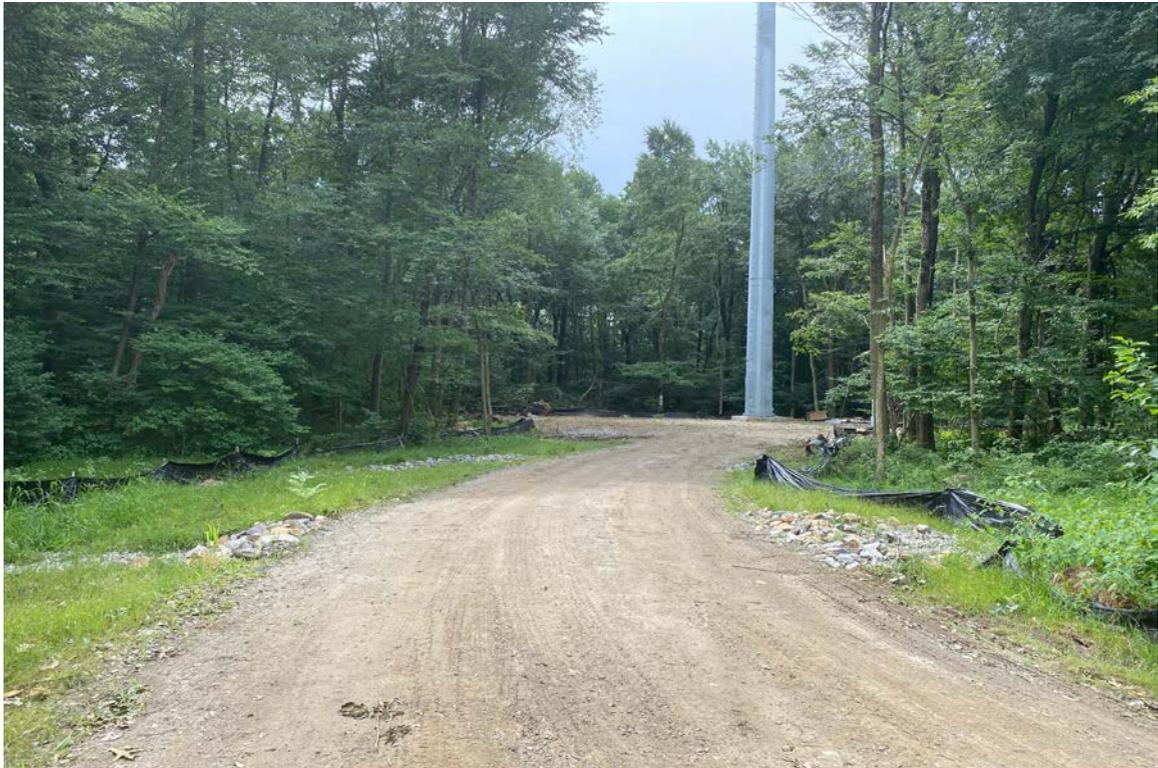
Photo 3: View of access road at French mattress and culverts crossing looking south with compound/tower in background. Road shoulder and side slopes stabilized with well established permanent vegetation.

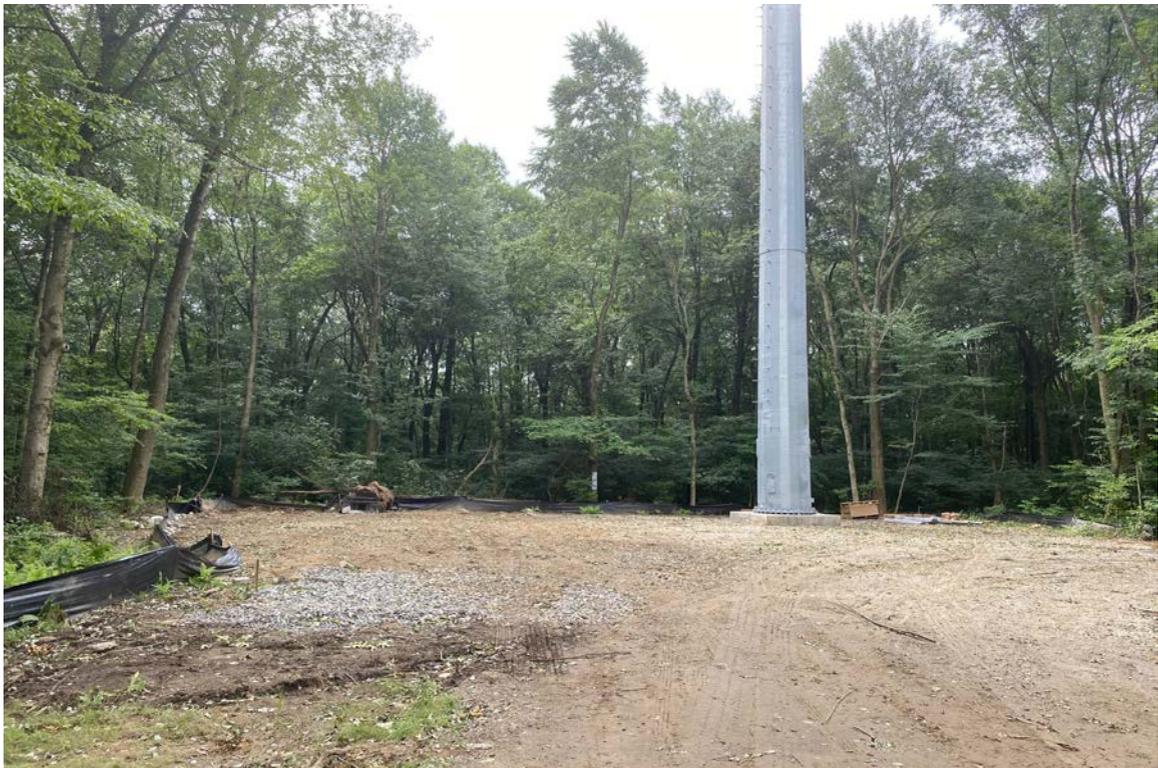
Photo 4: View of tower and compound area looking south.

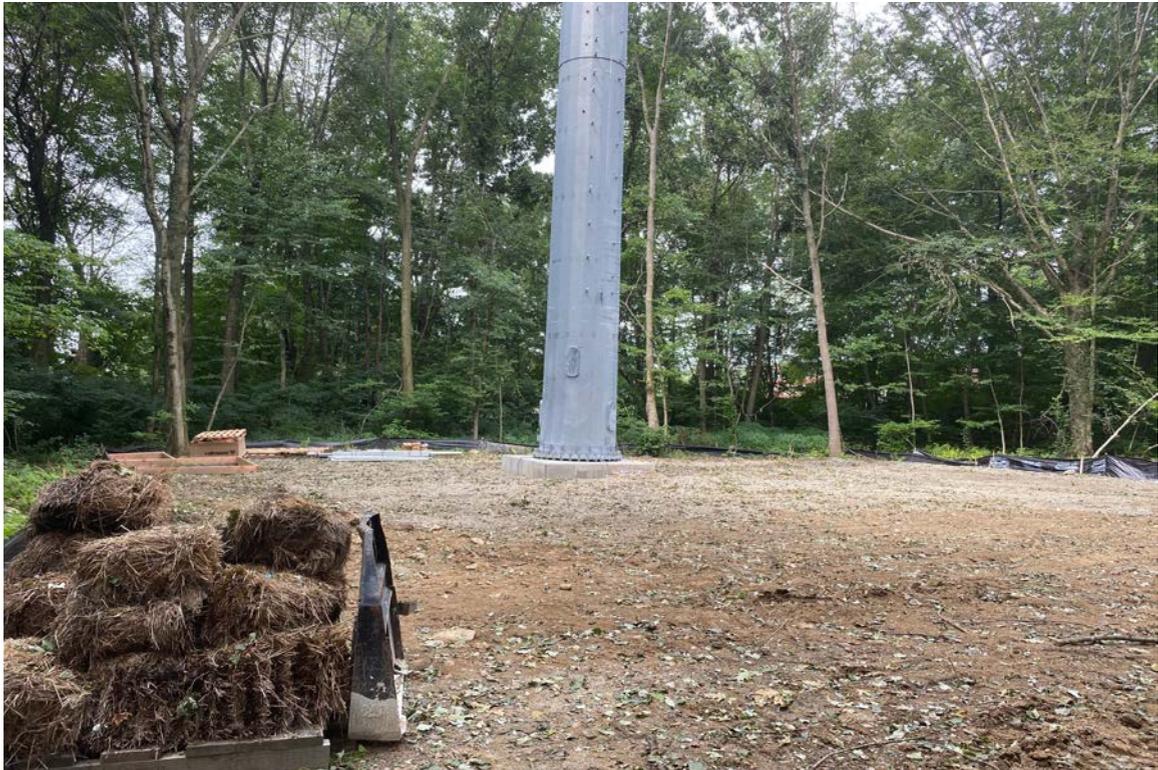
Photo 5: View of tower and compound area looking west.

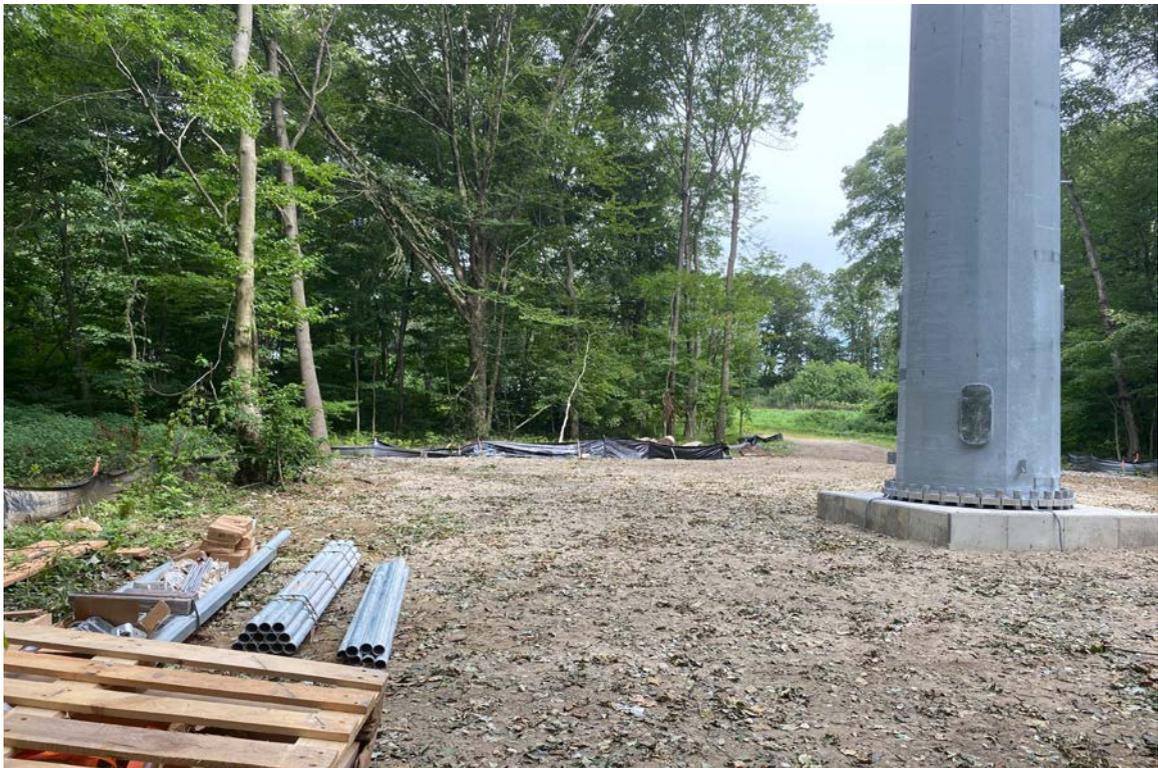
Photo 6: View of tower and compound area looking north.

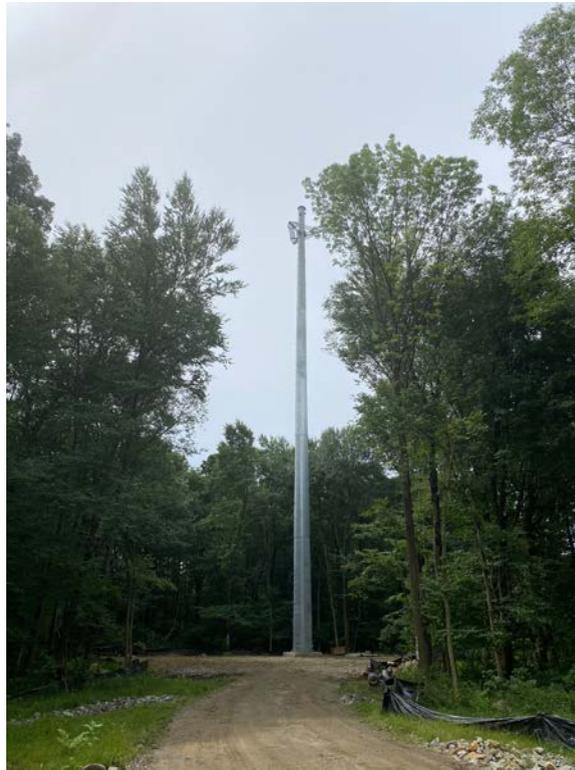
Photo 7: View of tower looking south.

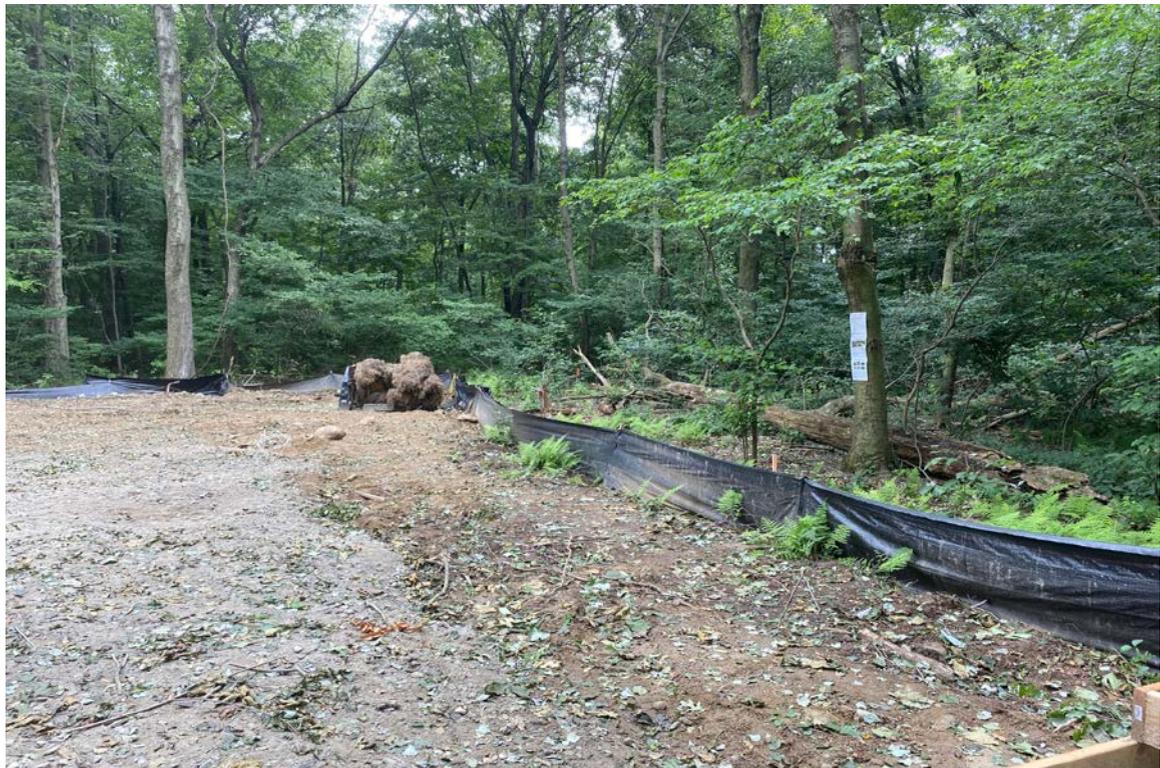
8/6/20 – All erosion controls and isolation barriers were found to be in relatively good condition with minor repairs to shore up some sections of silt fence; however, these areas did not impact the ability of the controls to treat any runoff or function from an isolation barrier standpoint. Vegetation along the shoulder and side slopes of the access road continues to remain healthy and put on additional growth to permanently stabilized those areas. Tower has been erected and rough grading of the compound has been completed.

Photo 8: View of erosion controls along south side of compound; all controls found in relatively good condition.
