**Summary Report  
Condition Reassessment and  
Post Tension Strand Evaluation  
25 Sigourney Street  
Hartford, Connecticut**

**DCS Project No. BI-2B-034A  
Architects Project No. 206063**

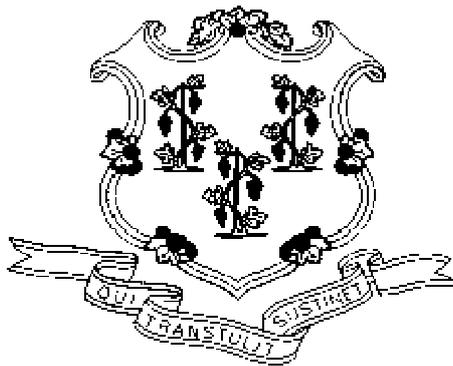
**State of Connecticut  
Department of Construction Services  
165 Capitol Avenue  
Hartford, CT 06106**

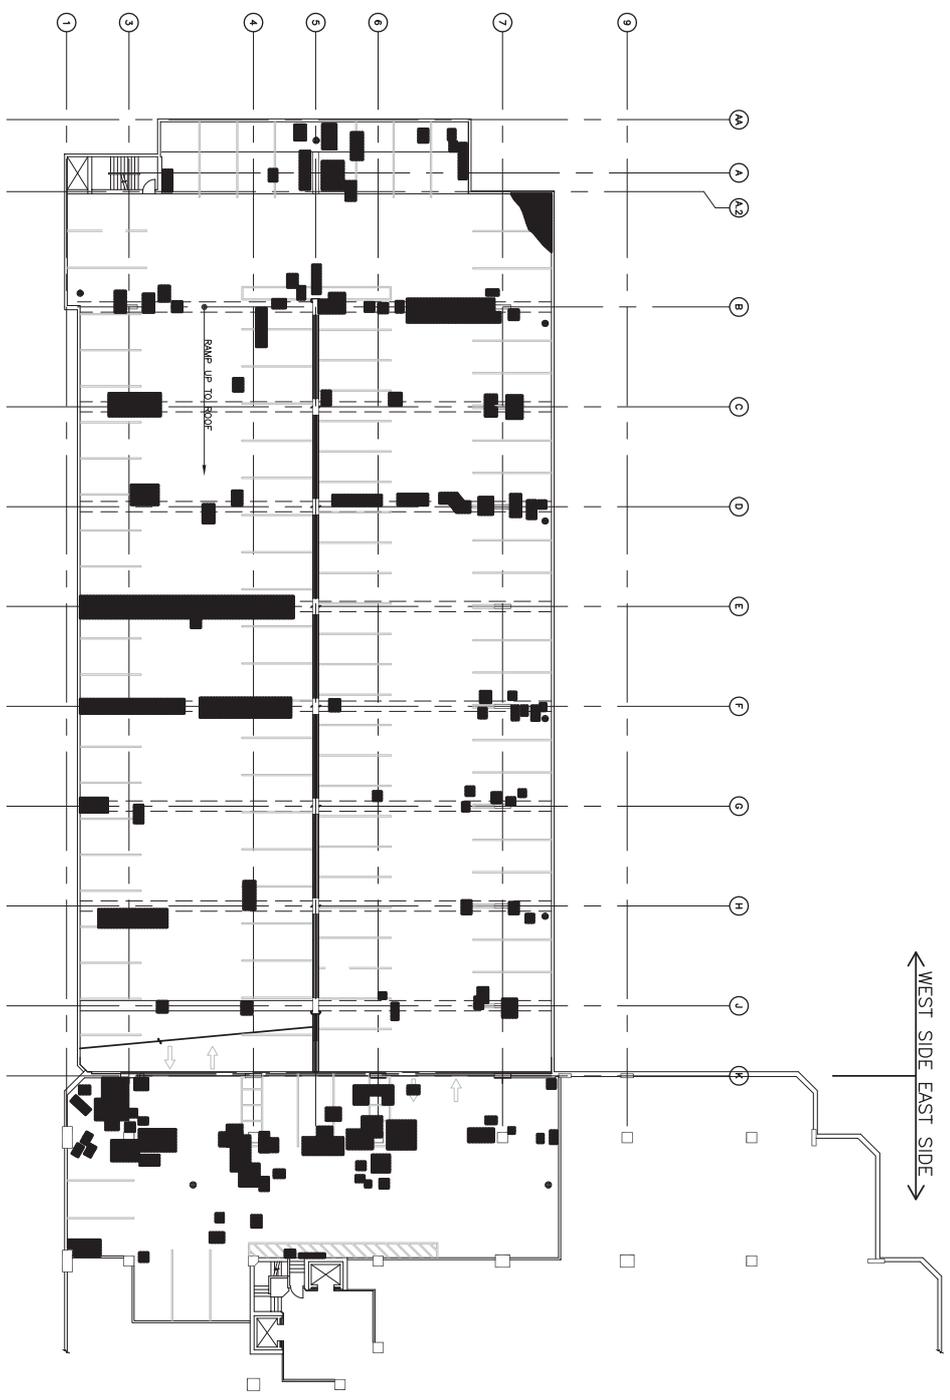
EXISTING CONCRETE DELAMINATION / SPALL AREA
---	---

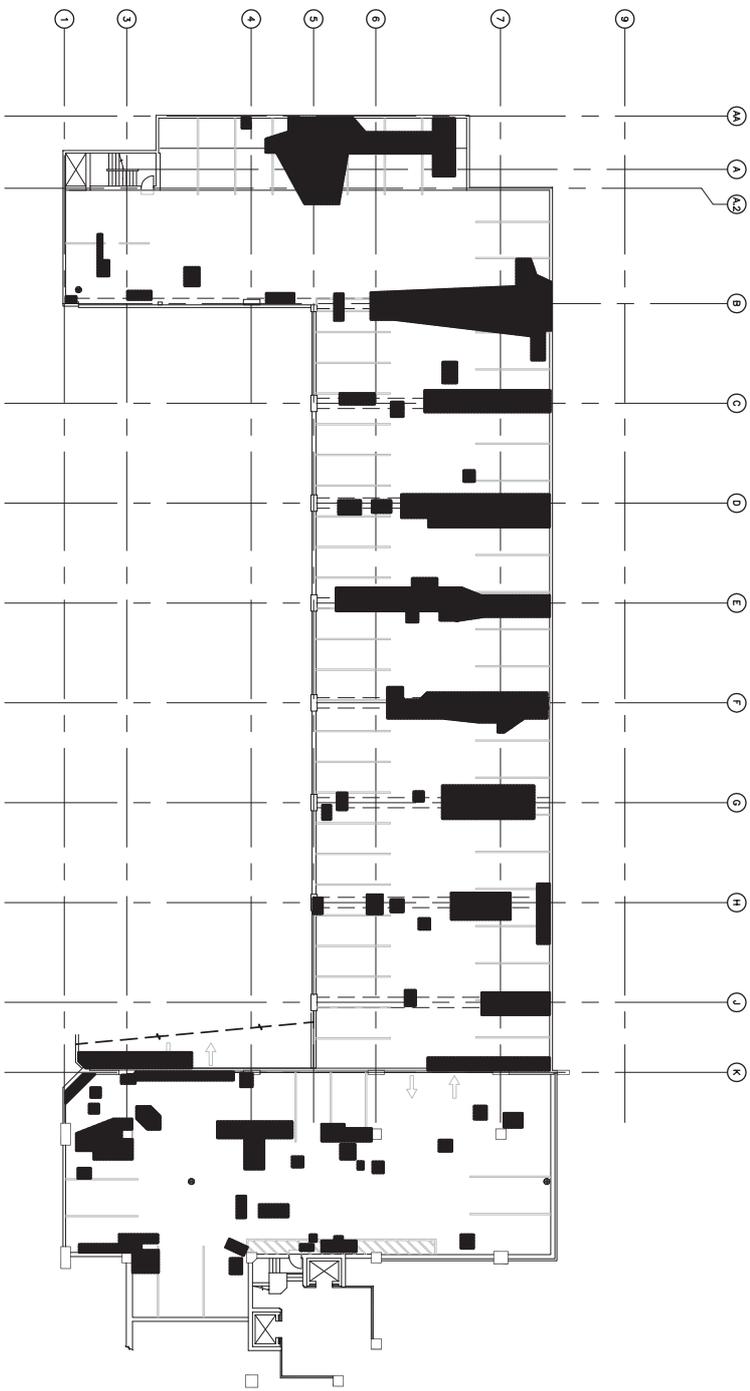
**6** EXISTING PARKING LEVEL P6 - 2011 DECK LAMINATION SURVEY  
SCALE: 1/32" = 1'-0"

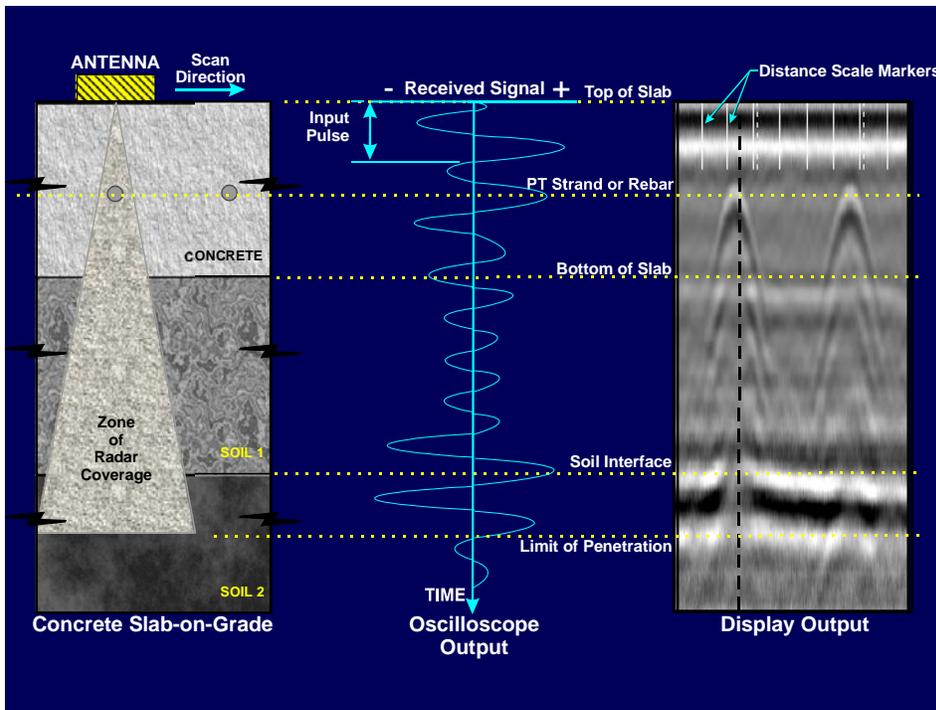
**Figure 2. Sample output from a SPR scan.**

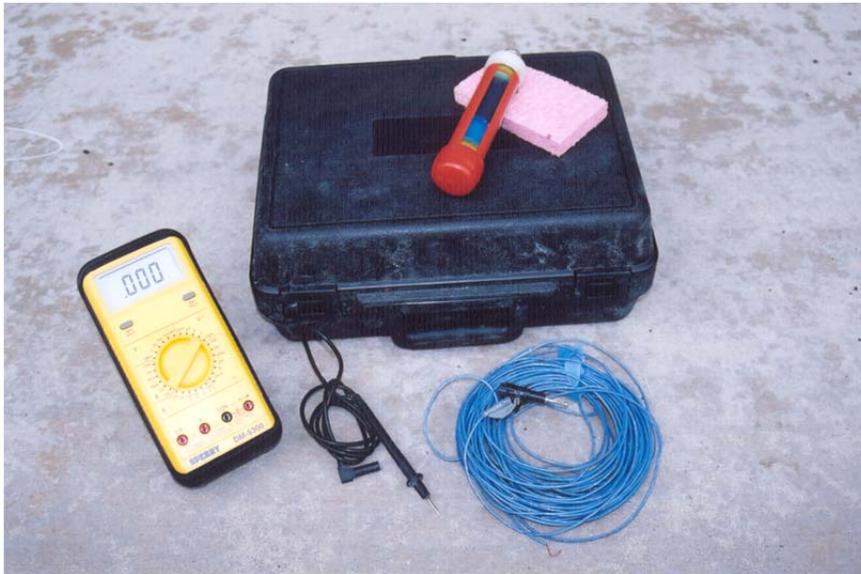
**Figure 3.** Half-cell corrosion equipment. Clockwise from top: copper- copper sulfate electrode and sponge, lead wires, and voltmeter.

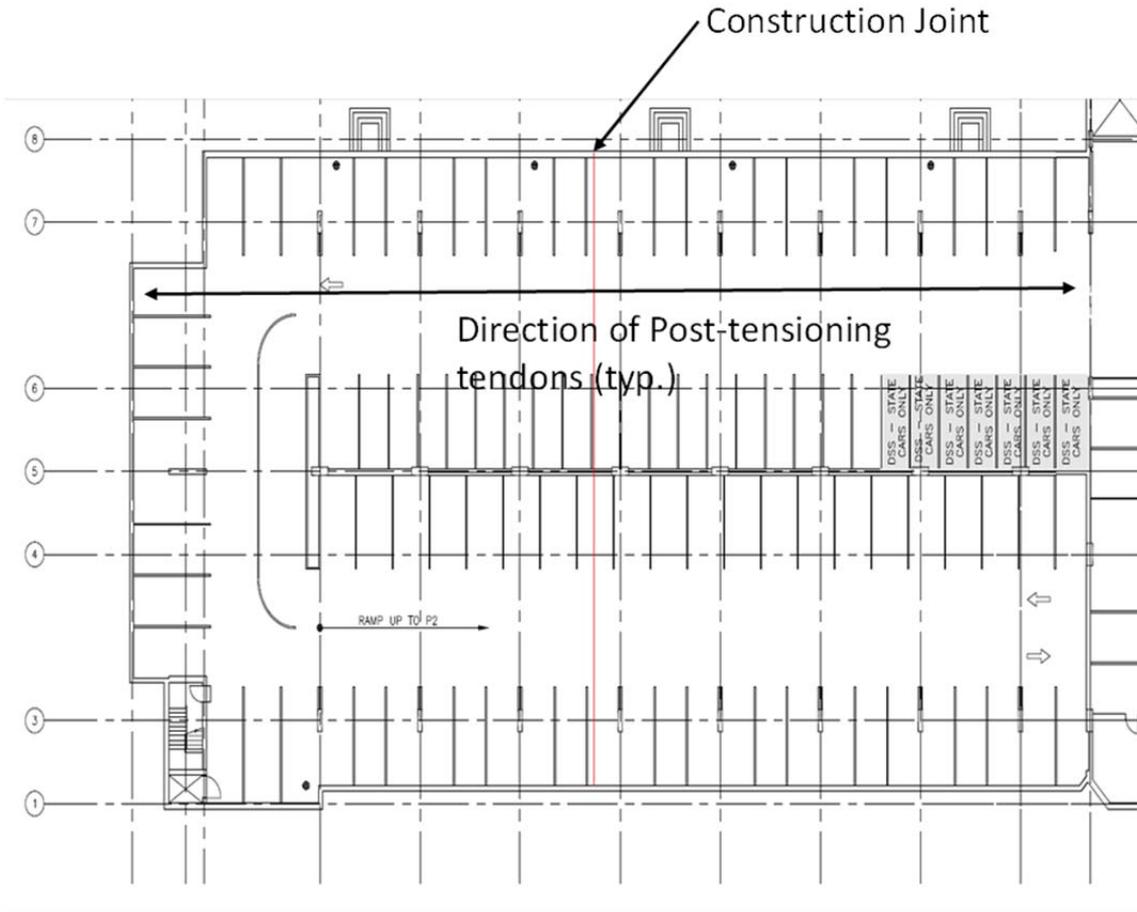
**Figure 4.** Typical layout of post-tensioning at 25 Sigourney St.

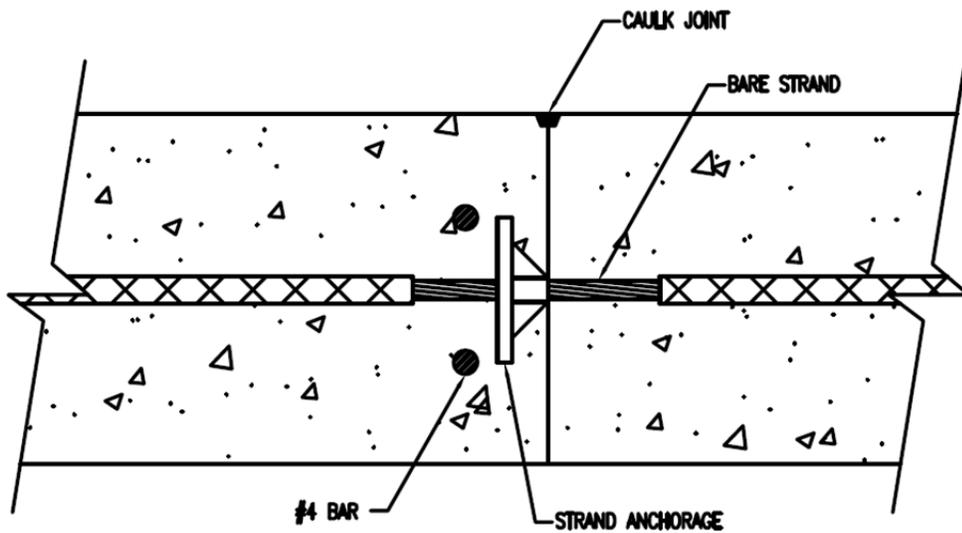
**Figure 8.** Strand conditions at construction joint. Note lack of positive corrosion protection as strand crosses joint.

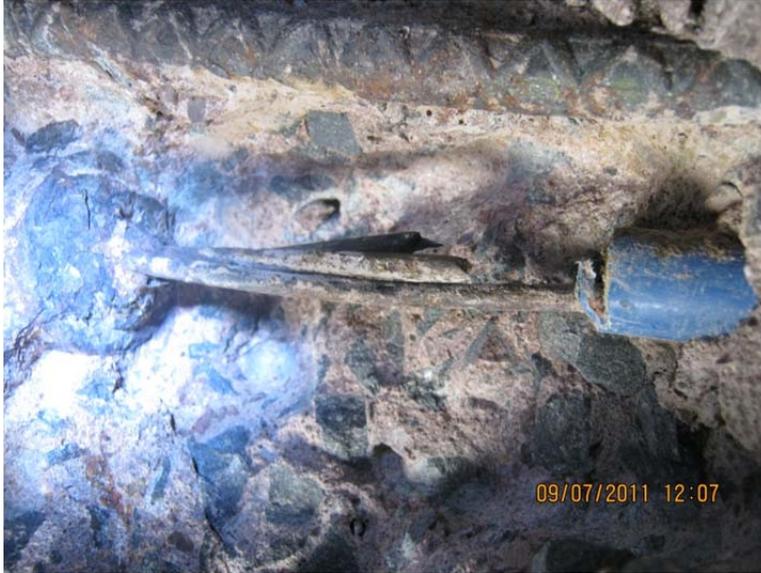
**Figure 10.** Failed strand at construction joint. Note corrosion on anchorage and failed wires.

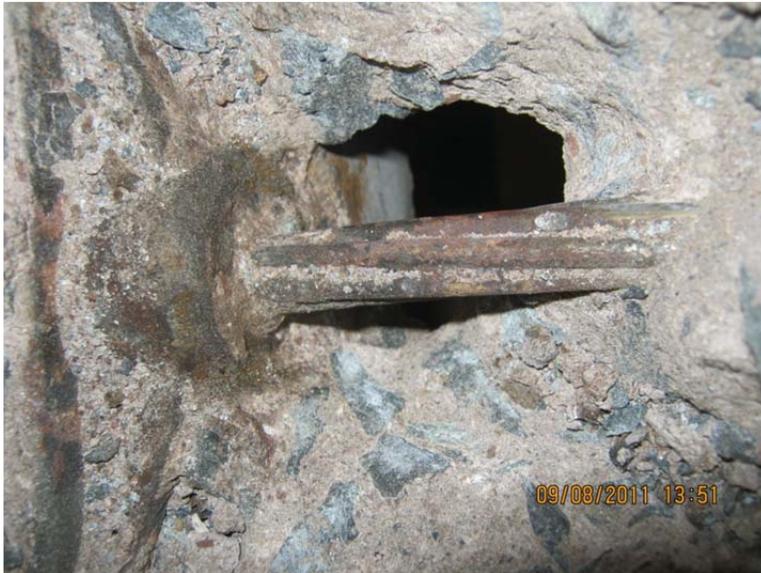
**Figure 11.** Corrosion damage on strand, without strand failure.

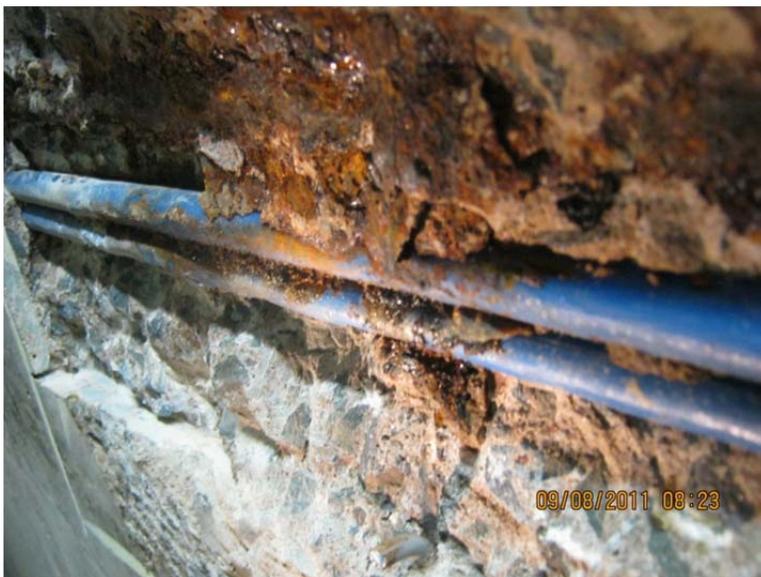
**Figure 15.** Corrosion damage to mild reinforcing steel and damage to sheathing on soffit.

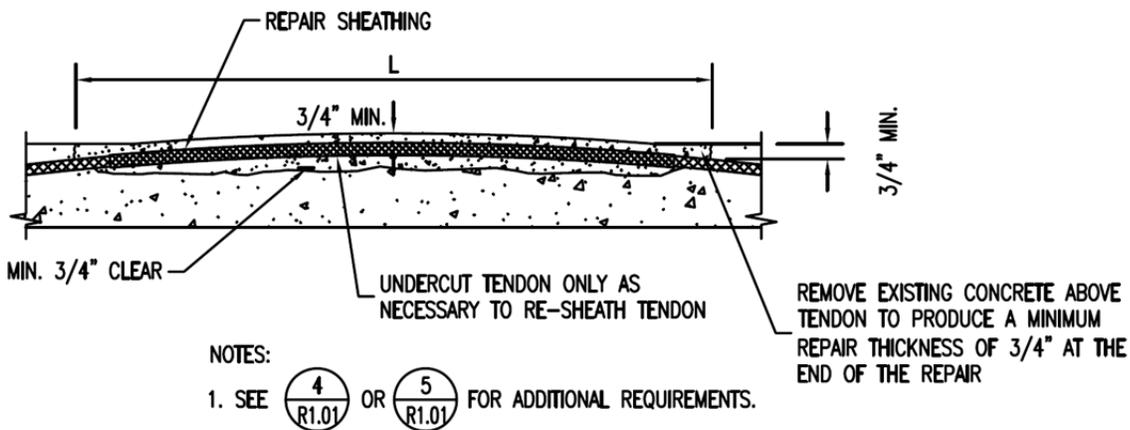
Figure 17. Strand corrosion protection repair.

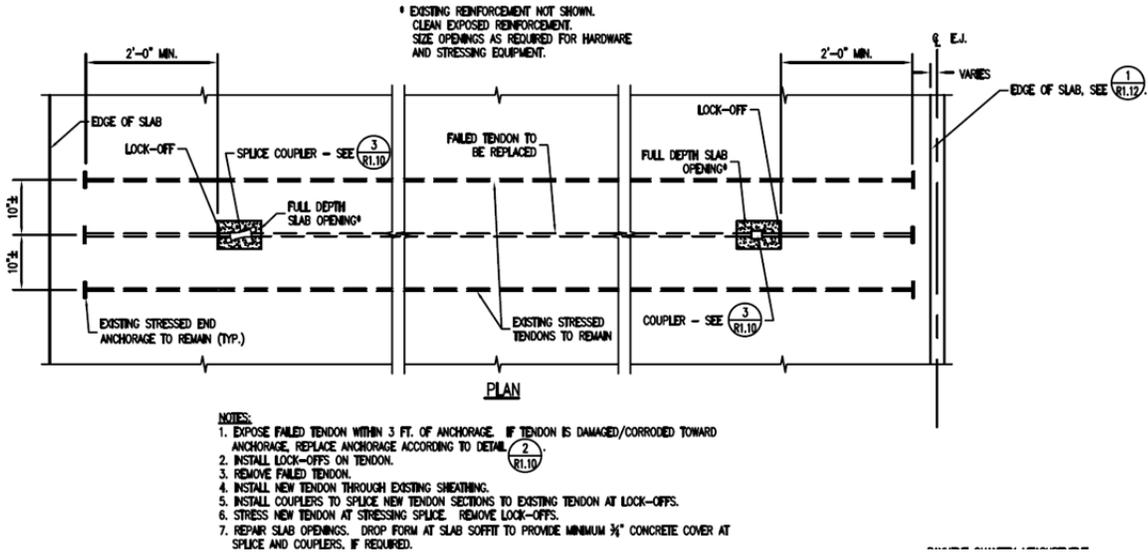
Figure 18. Strand replacement detail.

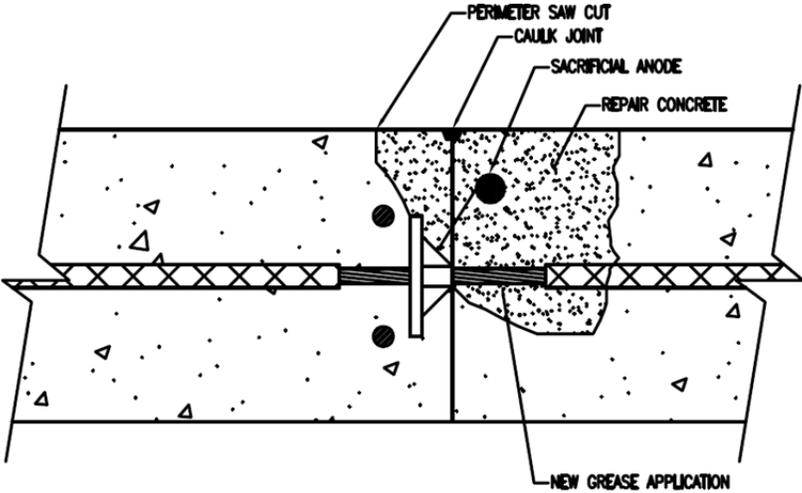
Figure 19. Corrosion protection repair at construction joint without strand / anchorage replacement.

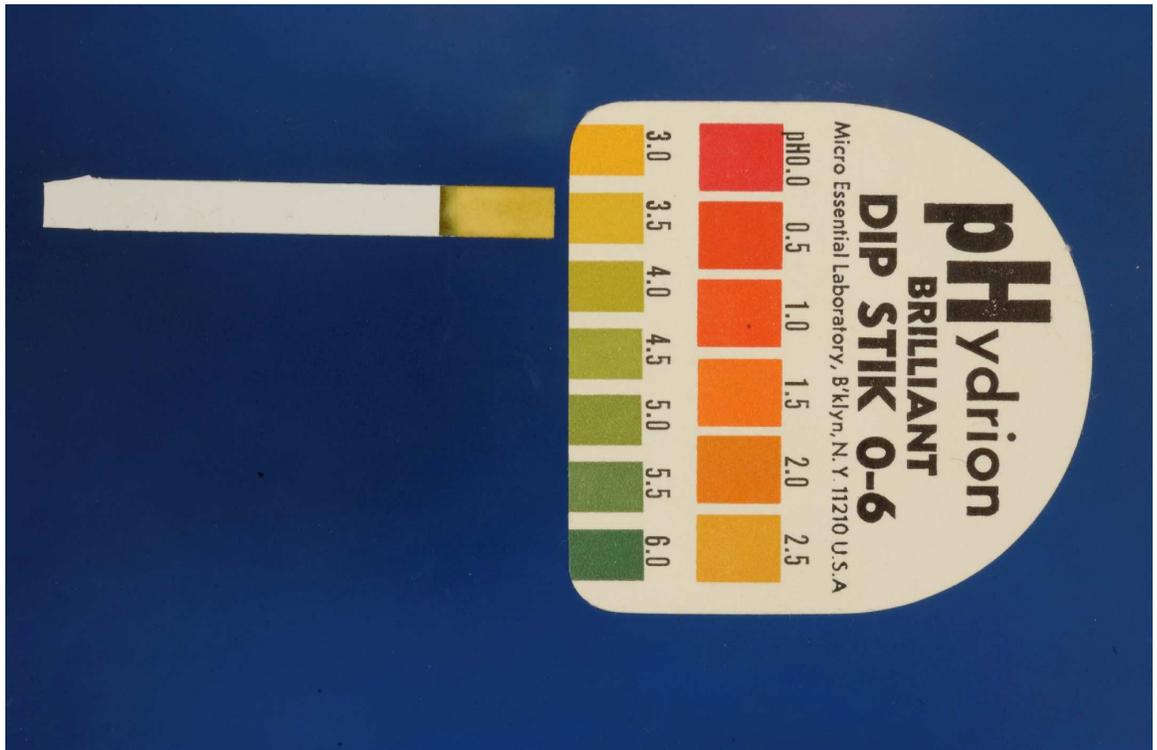
**Figure 7.** pH indication of 3.5 obtained on water sample prepared by mixing distilled water with finely ground corrosion products on strand #2. L3607 093011 07

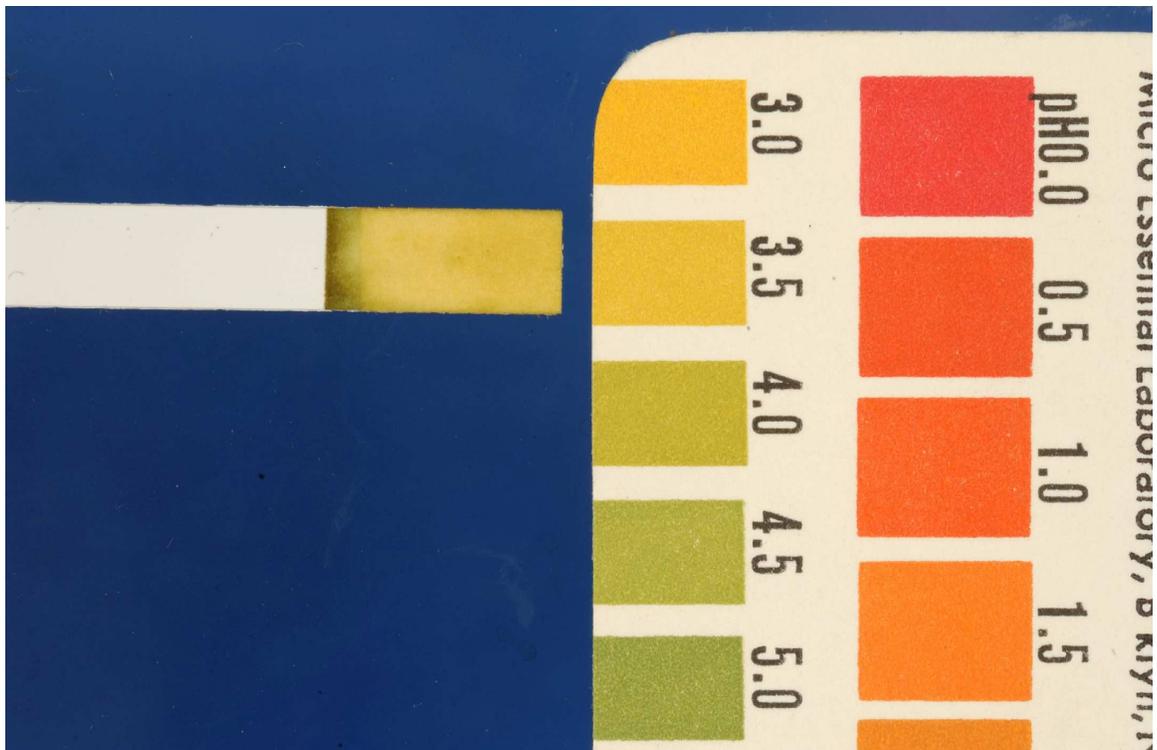
**Figure 8.** Close image of pH indicating paper and color scale shown in Figure 7.
