Mill Brook in Cornwall, Connecticut
Track Down Survey Report
November 2008

Prepared by:
Northwest Conservation District
1185 New Litchfield Street
Torrington CT 06790
Phone: (860)-626-7222 / Fax: (860)-626-8833
www.conservect.org/northwest

Mill Brook Track Down Survey Report
November, 2008

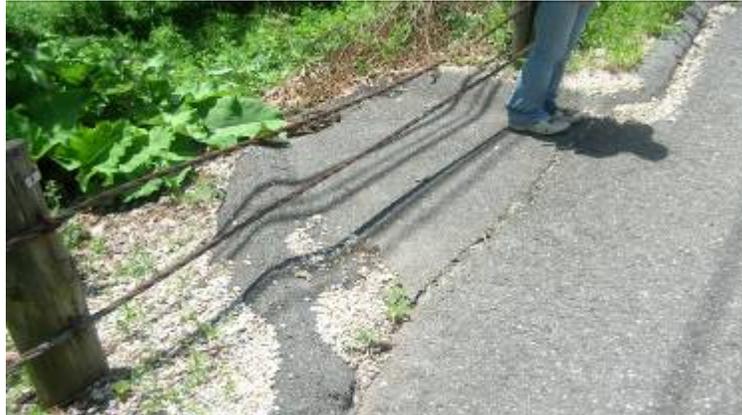
There were only a few catch basins located throughout the entire watershed and they always exited to a road side swale. A majority of road runoff sheet flows to the vegetated road sides, and the state highways had curb cut structures that diverted stormwater runoff

directly into road shoulder vegetation or rip rap slopes that carried water into the streams. (see photo below).

Curb Cut in Route 128 to Divert Stormwater Runoff Away from Travel Lanes

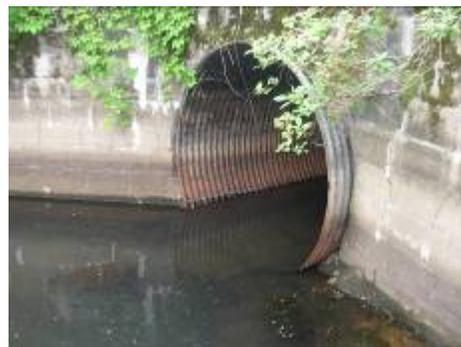
There are twenty seven locations where vehicles can cross the streams of the Mill Brook Watershed. All of the stream crossings were stable (see Rattlesnake Road Crossing at right). However, there is one stream crossing, on Scoville Road that is misaligned causing severe bank erosion just below the outfall. Continued erosion in this area may eventually destabilize the crossing (see photos below). Currently a tree and other shrub vegetation are helping to hold the headwall and the road grade together.

However, the tree in the right hand photo above has an exposed root system which will kill the tree causing further bank erosion. The two photos below are of an outfall where one of two tributaries to Mill Brook crosses underneath Scoville Road. (This problem is occurring on the eastern most tributary).

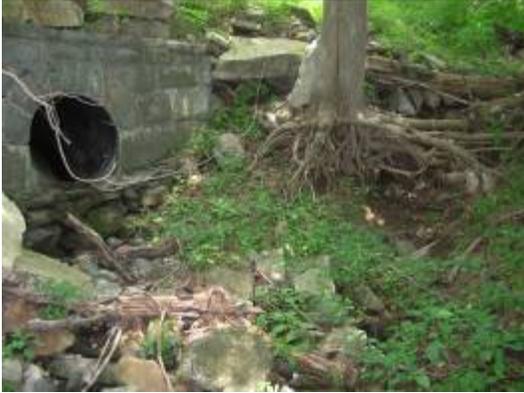
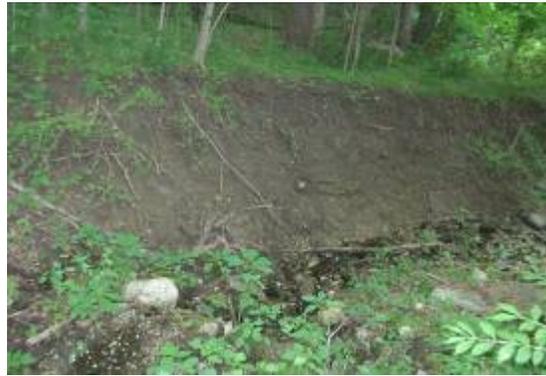
Because severe stream bank erosion is a problem here, it will be detailed in the Stream Bank Erosion Section below.

Stream Crossing at Scoville Road and the associated Bank Erosion

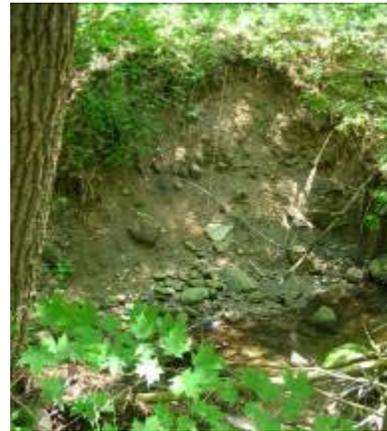
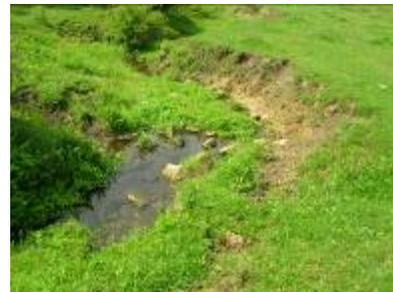
There were three locations of severe bank erosion totaling over 150 linear feet of erosion. One bank erosion site is pictured and described above, and the others are pictured below. The first photo pictured below is bank erosion located along State Route 128. This erosion site is occurring along a very straight section of stream and does not appear to be in danger of additional consecutive failures in the future. The second photo pictured below is located in a pasture adjacent to the intersection of Town and Scoville Roads. All the erosion sites likely contribute sediments to the stream intermittently during large runoff events, and do not represent a continuous source of sediments to the water column. The intermittent nature of bank erosion inputs along with the steep overall gradient of the Mill Brook Watershed does not allow sediments to remain in the watershed. They are quickly scoured and transported to the Housatonic River which also has a relatively steep gradient. Most of the Mill Brook sediments likely stay in suspension until the Housatonic River reaches Lake Lillanonah.

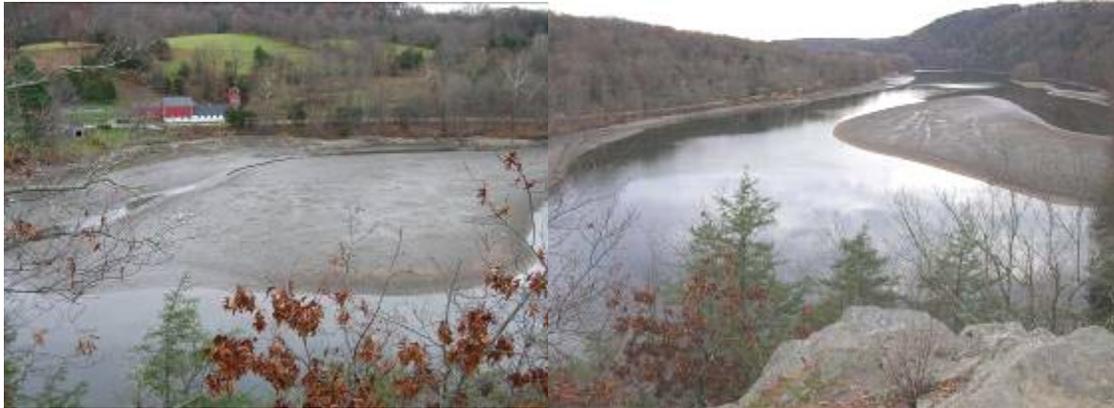
At the point where the Housatonic River empties into Lake Lillanonah, most of the sediments drop out of suspension and deposited at the top of the lake (see photo below). The picture below is taken from Lovers Leap Park in New Milford showing the hundreds of thousands of cubic yards of material that has been deposited at the top of Lake Lillanonah. The Mill Brook Watershed represents less than 1% of the entire Housatonic River Watershed and therefore has likely contributed less than 1% of the sediments deposited at the top of Lake Lillanonah. This sediment deposition is occurring

outside the Mill Brook watershed. However, it is important to understand how erosion in one part of the watershed can impact another part.

Lake Lillanonah looking south from Lover's Leap State Park in New Milford during a 10 foot lake draw down.

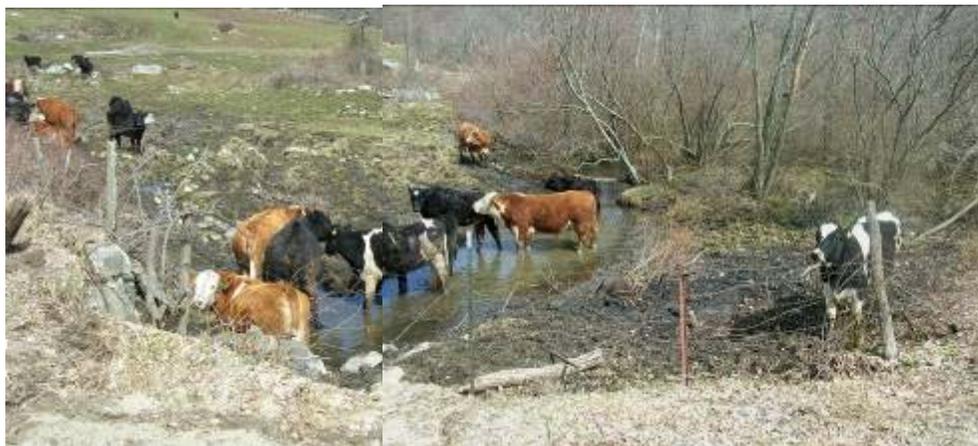
After completing a visual inspection of all the stream channels of the watershed, land use activities and high resolution aerial photos, it is likely agricultural activities are partially responsible for impairment in the watershed. The dominant issue uncovered using a visual assessment method was unfettered livestock access to approximately one mile out of the eight miles of stream channel inspected in the watershed.

Cattle Access to Stream Near Intersection of Town and Scoville Road

All of the problems listed in (a) through (f) above are occurring somewhere within the 1 mile of stream channel that livestock have access to, and all are likely causing water quality degradation. Livestock can access most of the stream channels in Sub Watershed #s 6008 (00-1, 01-1 and 00-2-R2). However, all these threats (a through f) to water quality can simply be eliminated by restricting and/or eliminating livestock access to the stream channels and the immediate riparian area buffering the stream channels. Creating exclusionary fencing along 1 mile of stream would be very expensive but is one of the actions that will need to occur in the effort to remove the Mill Brook from the US EPA's Impaired Waters of the United States list.

Both the CT Department of Environmental Protection and the US Department of Agriculture (USDA) - Natural Resources Conservation Service (NRCS) and the USDA - Farm Service Agency (FSA) commonly recommend that a 50 foot to 100 foot undisturbed buffer remain between agricultural activities and water resources. The reason the USDA and the CT DEP feel so strongly about this buffer setback is that research has proven time and again that the best way to protect soil, wetlands and water resources from agricultural impacts is to allow for an undisturbed buffer around wetlands and watercourses. In fact the USDA feels so strongly about keeping livestock and agricultural activities away from wetlands and open water that they have created programs to cost share (up to 75%) for the following:

- 1) Installation of exclusionary fencing around wetland and water courses.
- 2) Creation of watering troughs with solar pumps to fill them.
- 3) Installation of water wells and pipes to get drinking water to livestock
- 4) Design and construction of access points to streams for drinking, if conditions are suitable.
- 5) Rental payments of pasture acreage between any installed buffer fences.

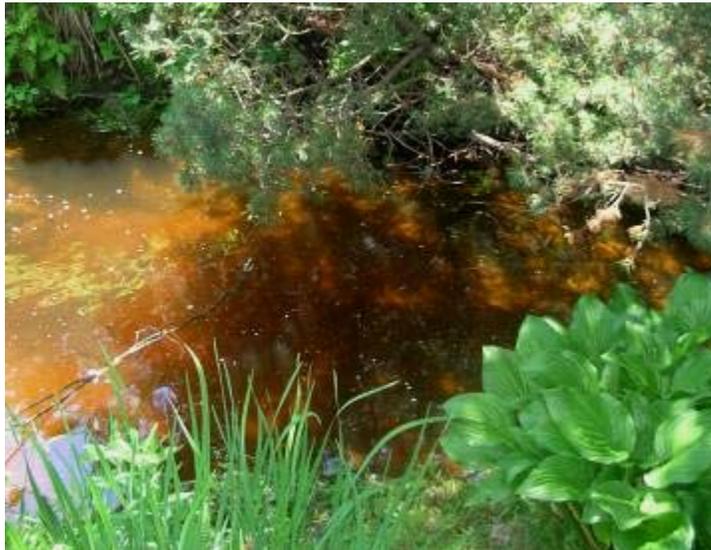
Both the US EPA and the Fisheries Division of the CT DEP accomplished aquatic organism sampling at many locations throughout the watershed since the early 1990s and noted a significant lack of expected populations and diversity of fish and macroinvertebrates in the upper half of the watershed. The track down survey only allowed for the visual inspection of stream waters, the stream channel condition and the condition of the riparian corridor. There was no water quality sampling accomplished during this assessment to investigate compounds of concern in the water column. However, there was some heavy water staining occurring in the upper part of the watershed. Because no water chemistry samples were taken the source or reason for the staining is unknown. Factors that cause staining (ex. high iron content) can affect both fish and macroinvertebrates. Therefore, a simple follow up to help assess why the stream is impaired in the upper watershed would be to perform some water chemistry sampling to assess if compounds of concern in the water column are causing problems. See photo below of stained waters in the upper watershed.

Stained Water Below Stream Crossing on Town Road
