# Watershed Field Assessment Report North Branch Park River Watershed

Connecticut Department of  
Environmental Protection

July 2010

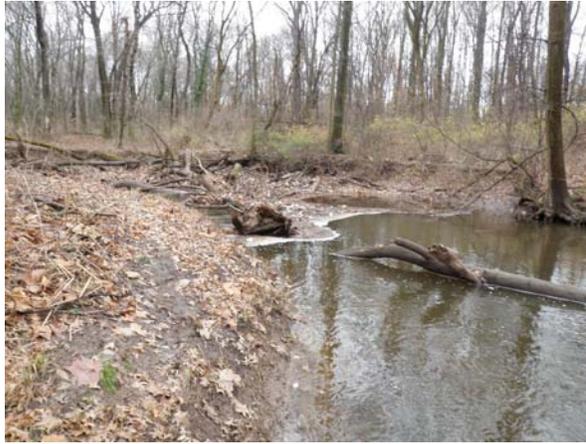
NBP-14: Excellent

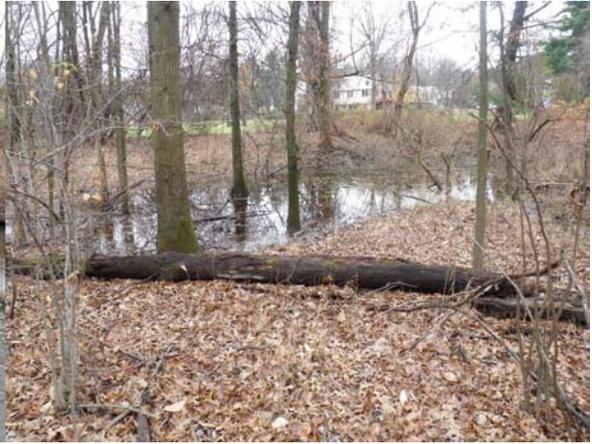
NBP-13: Good

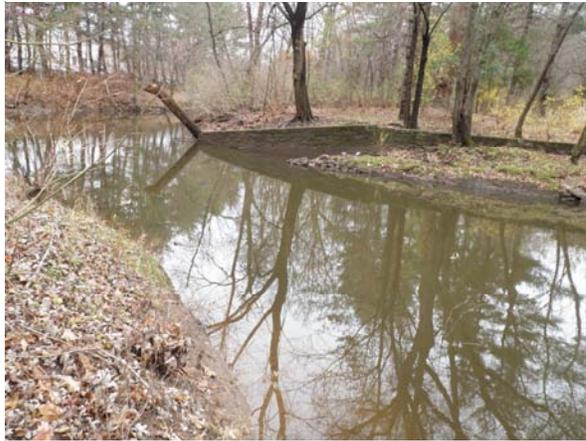
NBP-15: Fair

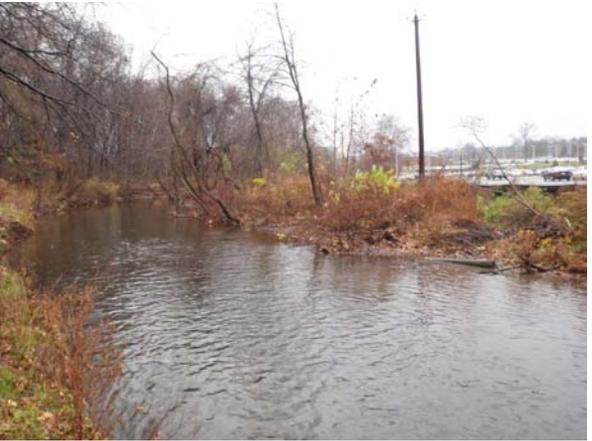
NBP-10: Marginal

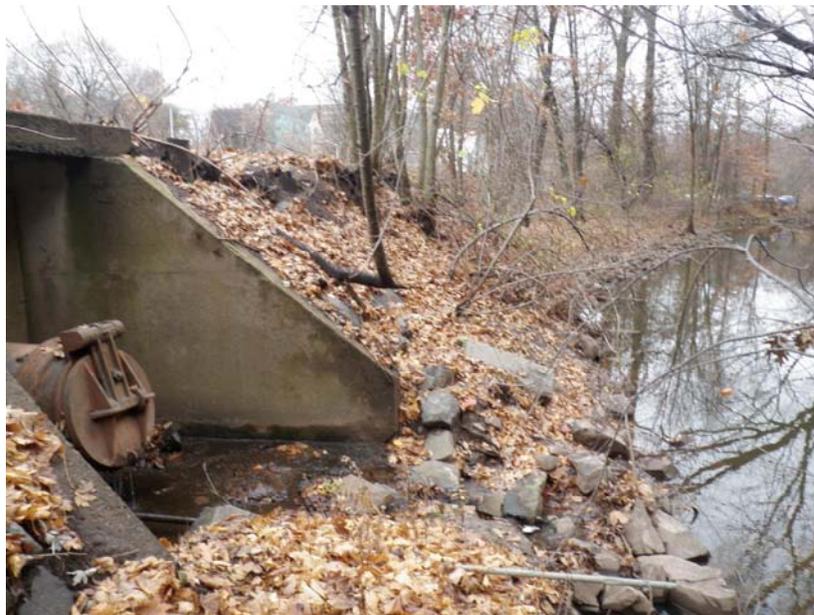
NBP-16: Poor overall condition, with little connectivity to the floodplain, modified bank habitat, and numerous outfalls

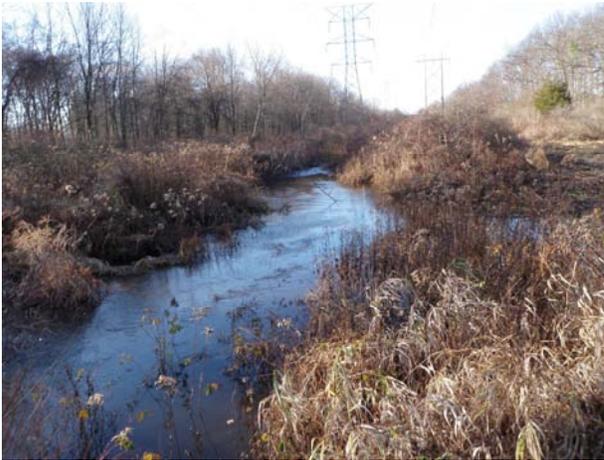
The buffer and floodplains of BBE-02 were well-vegetated; however, BBE-01 and part of the BBE-04 floodplain is actively managed to maintain clearance between the power lines and vegetation, such that the stream is poorly shaded. The riparian area of BBE-04 is also impacted by adjacent residential lawns.

BBE-01: Electric utility line vegetation maintenance in the riparian area.

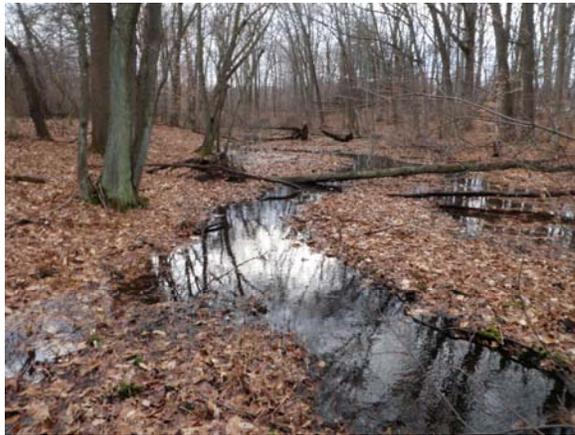
WBN-04: A high-quality, scenic portion of the reach.

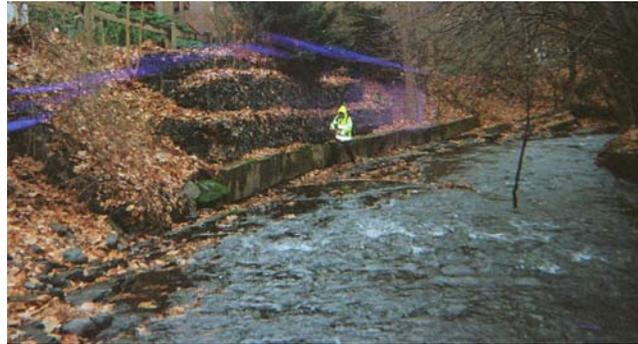
WBS-11 shows evidence of erosive instability throughout, but especially in the downstream portion, south of Cottage Grove Road. Some of this section runs over bedrock, and the adjacent bank and slopes have been reinforced by riprap and gabions, primarily on the left bank near a medical center and along the right bank where the brook flows close to Bloomfield Avenue. In spite of the armoring, slope failures are present between the stream and the road.

WBS-11: Steep bank reinforced with gabions.

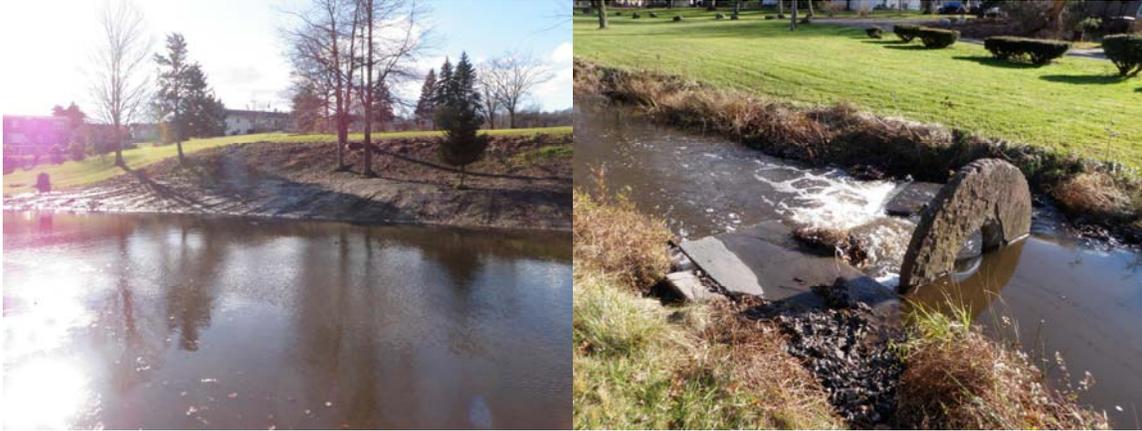
WBS-04: Bank and channel modification and evidence of recent pond dredging.

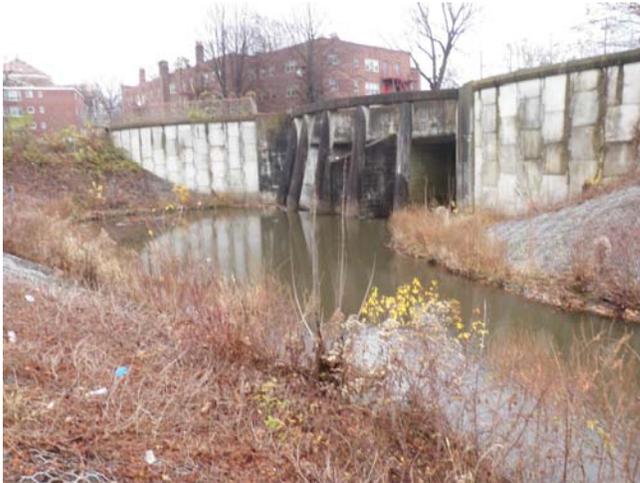
NBP-16: North Branch Park River at entrance to flood control conduit.

NBP-16 is the reach immediately upstream of the flood control conduit. This reach is highly altered, characterized by extensive attempts at channel and slope stabilization near the conduit entrance. This reach is rated as "Poor," and is the lowest-rated reach in the entire watershed. Numerous parking lots are located close to the river along the left bank. Where the bank is not armored, it is often eroding, and many large outfalls discharge to this reach. The buffer on the right bank is mostly wooded and less disturbed, except at the downstream end, where there is a steep armored slope, and slope failure where the armoring

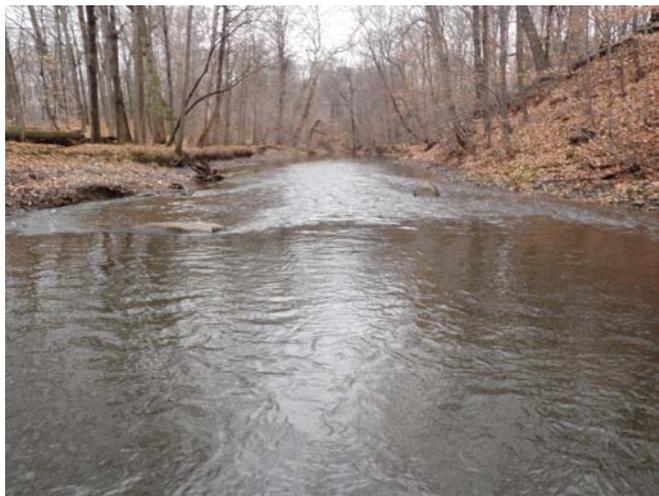
NBP-14 is rated as "Excellent," with the highest score of all the reaches assessed, due to the relatively stable stream channel (although erosive forces are still evident) and the extensive, mature forested riparian buffer. Some sizable stormwater pipes are located along the left bank. A sewer line also appears to cross the river near the middle of the reach.

NBP-14: High-quality reach of the North Branch Park River.

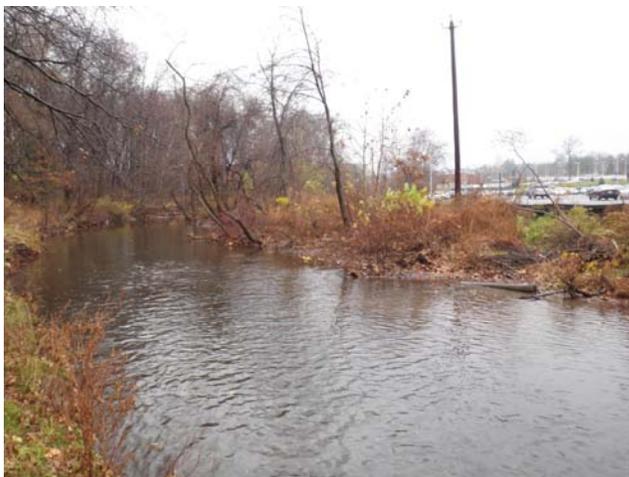
NBP-10: University of Hartford parking lots adjacent to the North Branch Park River.

Conditions in NBP-10 are slightly better; the stream reach was rated as “Marginal.”

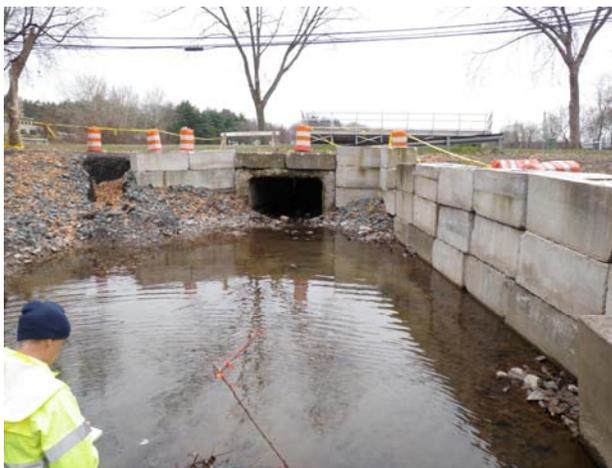
- The downstream end of Reach NBP-19 appears to have been recently modified through armoring the banks with riprap and concrete blocks and removing riparian vegetation. The work appears to have been performed to repair the entrance to a culvertized section of the stream. This site may be a good candidate for bank stabilization and riparian restoration.

NBP-19: Channel heavily and recently modified upstream of Burnham Street.

NBP-19 is a segment of a small tributary located northeast of the University of Hartford. Reach NBP-19 flows through a narrow wooded area east of Granby Street. The channel is somewhat disturbed, with broken outfall pipes and a toppled headwall, fallen trees, debris dams, and scoured banks. A major stormwater outfall pipe and eroded channel on the right bank are located near the upper end of the reach. The downstream end of the stream reach is highly altered and appeared to have been recently excavated, lined with riprap, and the channel modified with large concrete blocks on the right bank. The reach ends at a culvert under Burnham Street, which

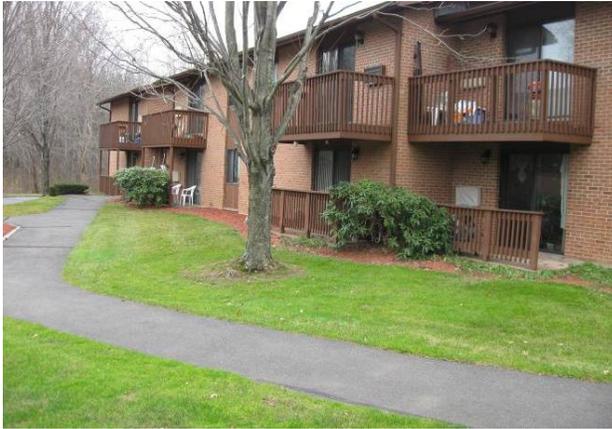
### **Woodside Village**

of Wash Brook. Stormwater runoff from the complex drains directly to Wash Brook without attenuation or treatment. The landscape maintenance intensity of the property was generally high, with managed turf areas and mulched gardens. Many roof leaders drain to turf areas. One roof leader was observed to drain to a turf area within 5 feet of yard drains, which is insufficient separation to effectively infiltrate runoff into the lawn.

Potential opportunities for improvements at this complex include stenciling the catch basins along the roadways and driveways, planting a wider buffer to Wash Brook along the roadside, installing rain gardens to receive stormwater from roof leaders that discharge to narrow vegetated strips, and implementing parking lot stormwater retrofits such as water quality swales or bioretention.

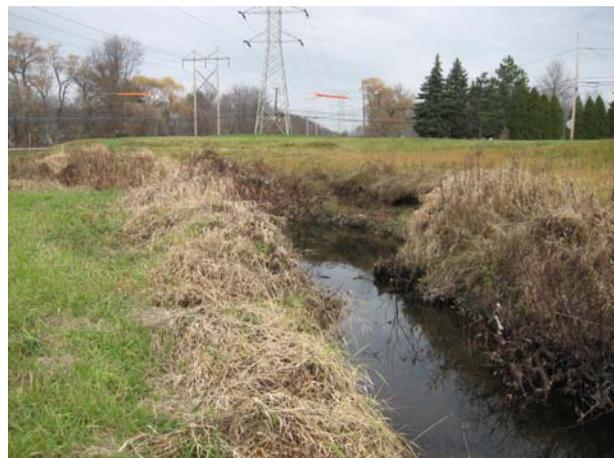
A nearby electrical utility corridor crosses Florence Road. Vegetation management activities in the utility corridor have impacted the vegetative buffer surrounding stream reaches BBW-04 and BBW-06 (the adjacent BBW-02 was assessed as part of the stream assessment portion of this project). The stream downstream of this area appeared to be down-cutting, with the banks severely eroding. The cause of the impacts may be a combination of impacted buffer and stormwater discharges. Opportunities exist to restore the riparian buffer to this segment of the stream by

planting low growing shrubs and native herbaceous vegetation that are compatible with the clearance requirements within the utility corridor right-of-way, combined with modified practices for maintaining the riparian buffer within the utility corridor.

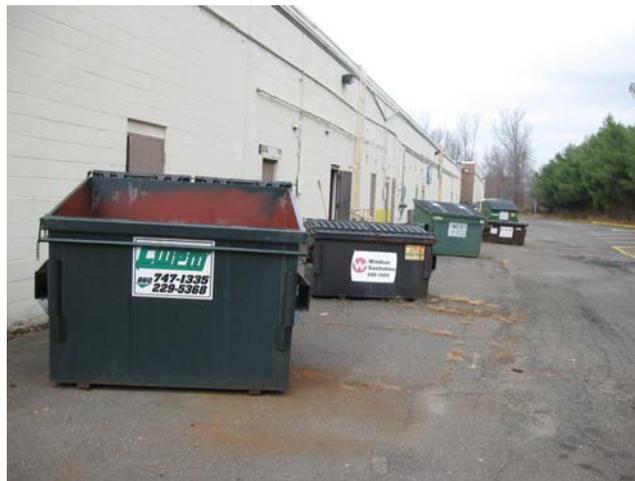
Runoff from garbage dumpster area drains to nearby catch basin

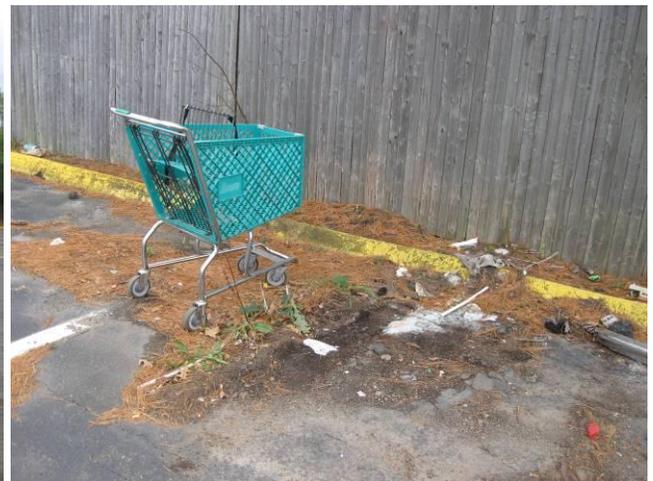
The parking lot pavement is breaking up and stained and sediment and debris have collected in some areas.

The shopping plaza parking lot is estimated to be approximately 15 years old. The pavement is in poor condition, with areas of broken pavement and significant oil staining. The storage of outdoors materials and loading operations could be improved to reduce the potential for stormwater pollution from the site. Each retail store appears to rent its own dumpster, and some dumpsters were not properly covered, many are located near a catch basin, and staining on the ground was observed around the dumpsters. Materials were stored outdoors without cover including bins, crates, packing materials, and various other items. The conditions and practices observed at this shopping plaza are typical of those at similar commercial shopping

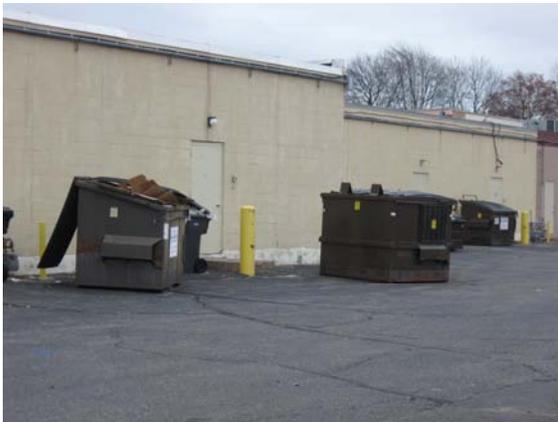
An uncovered dumpsters near a catch basin.

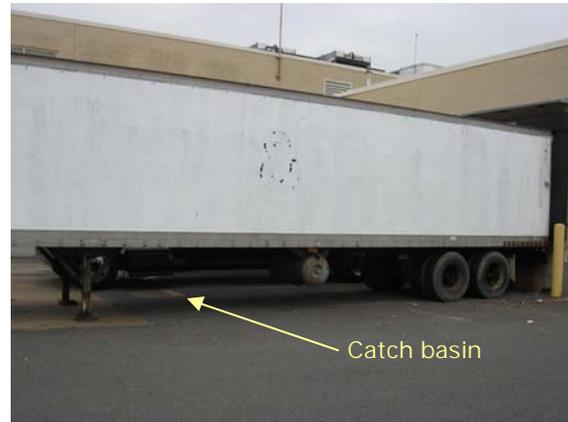
- Loading operations – Loading docks are positioned over drainage catch basins. Idling trucks may leak oil or other vehicle fluids that can discharge directly to the stormwater drainage system.
- Outdoor materials storage – The shopping center maintains outdoor sand and salt storage piles. The salt pile and one of the sand piles were covered, but a larger sand pile was not covered at the time of the evaluation. A catch basin is located nearby, although no evidence of material migration to the stormwater system was observed.
- Waste Management – Several dumpsters in the rear of the retail shops had no covers and were overflowing with garbage. The dumpsters are also located near catch basins.

Truck loading/unloading operations at this dock occur over a stormwater catch basin, increasing the potential for oil and spills to enter the system.
