# Northfield Brook in Thomaston and Northfield, Connecticut Track Down Survey Report

Prepared by  
Northwest Conservation District  
1185 New Litchfield Street  
Torrington CT 06790  
Phone: 860-626-7222 / Fax: 860-626-8833  
[www.conservect.org/northwest](http://www.conservect.org/northwest)

Northfield Brook Track Down Survey Report  
June, 2009

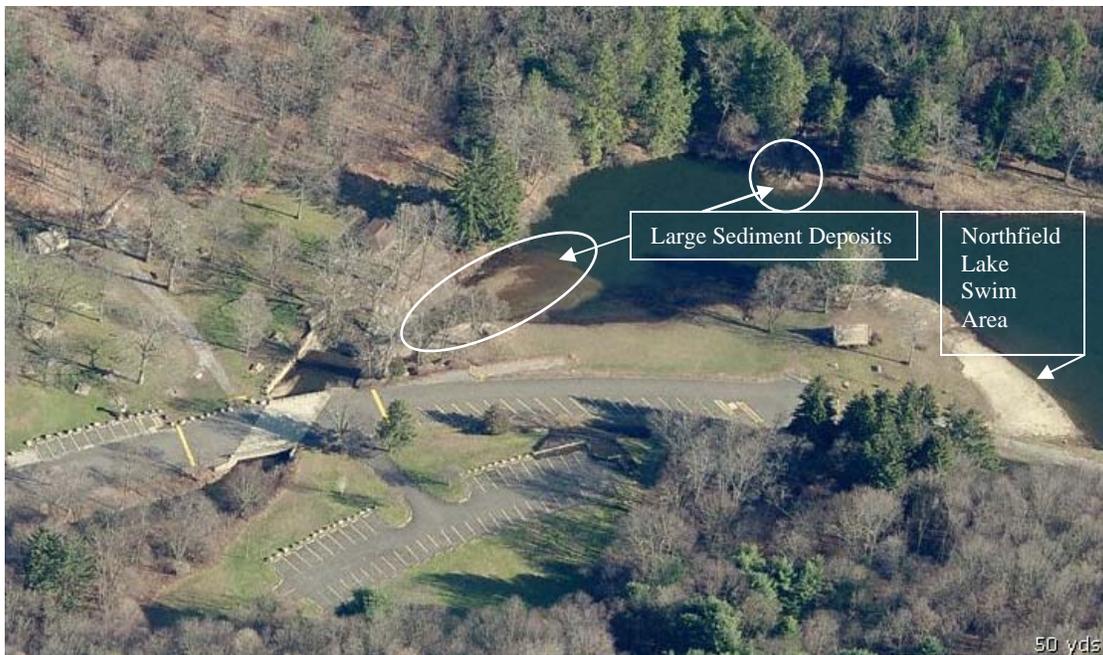
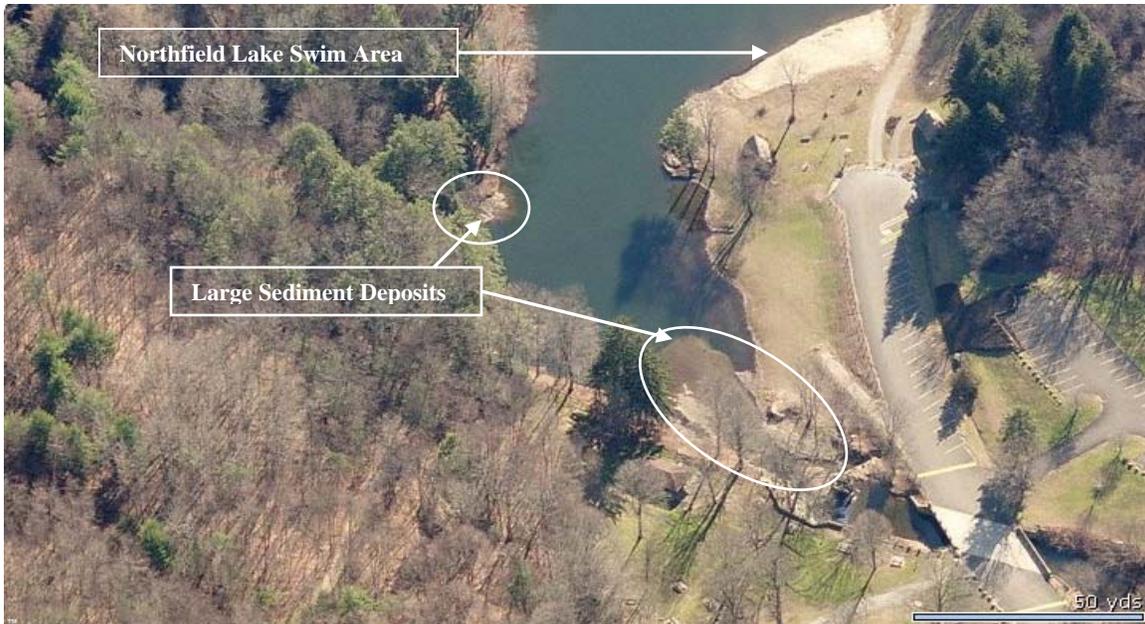
DOACE Northfield Brook Lake Swimming and Recreation Area (note two large sediment deposits)

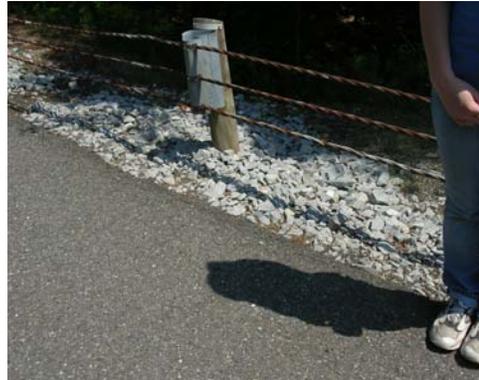
A majority of road runoff sheet flows to the vegetated road sides swales or rock lined ditch that diverts stormwater runoff directly to a tributary or main stem of Northfield Brook. (see photo below).

Route 254 Stormwater Runoff Away from Travel Lanes

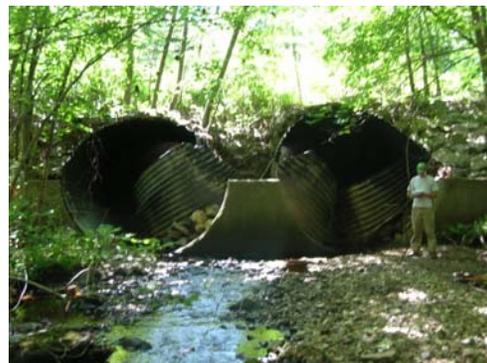
There are twenty seven locations where vehicles can cross streams in the Northfield Brook Watershed. Most of the stream crossings were stable. However there is one that is in dire need of repair and currently eroding into the brook. If left in disrepair the crossing will collapse and send hundreds of cubic yards of sediment into Northfield Lake (see Knife Shop Road Crossing photo at right).

During the Track Down Survey field work in 2007, NCD notified both the Town of Thomaston and the CT Department of Transportation that the Stream Crossing at Knife Shop Road was in eminent danger of failing which would deposit hundreds of cubic yards of sediments and construction debris into Northfield Lake. Shortly after the NCD notification the collapsing culverts were removed, a bridge was installed and the road reopened.

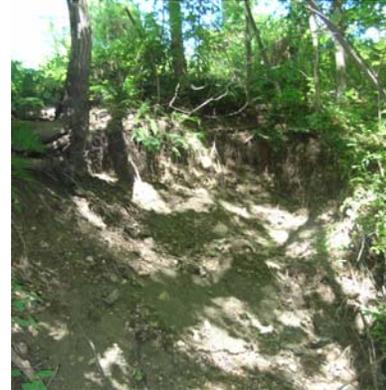
There was only one area with severe bank erosion totaling 25 linear feet of erosion. The severe bank erosion is located just below Atwood Road in Thomaston and is pictured at right. This erosion site is occurring just below a medium density neighborhood with no stormwater volume management structures. This erosion site likely contributes sediments to the stream intermittently during large runoff events and is not a continuous source of sediments.

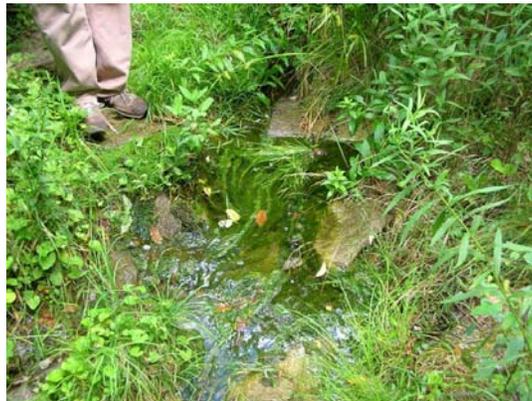
There are a number of medium density (1/2 to 1 acre lots) neighborhoods in the watershed. Examples include Highwood Farm in Thomaston and the Borough of Northfield in Litchfield. Both these neighborhoods had tributaries to the Northfield Brook that were choked with filamentous algae growth (see photo below). Heavy lawn fertilizer application, pet waste and failing septic systems are all potential nutrient enrichment sources that are feeding into the algae problems in both tributary streams and Northfield Lake.

*Tributary Exiting Highwood Farms Subdivision Choked with Filamentous Algae*

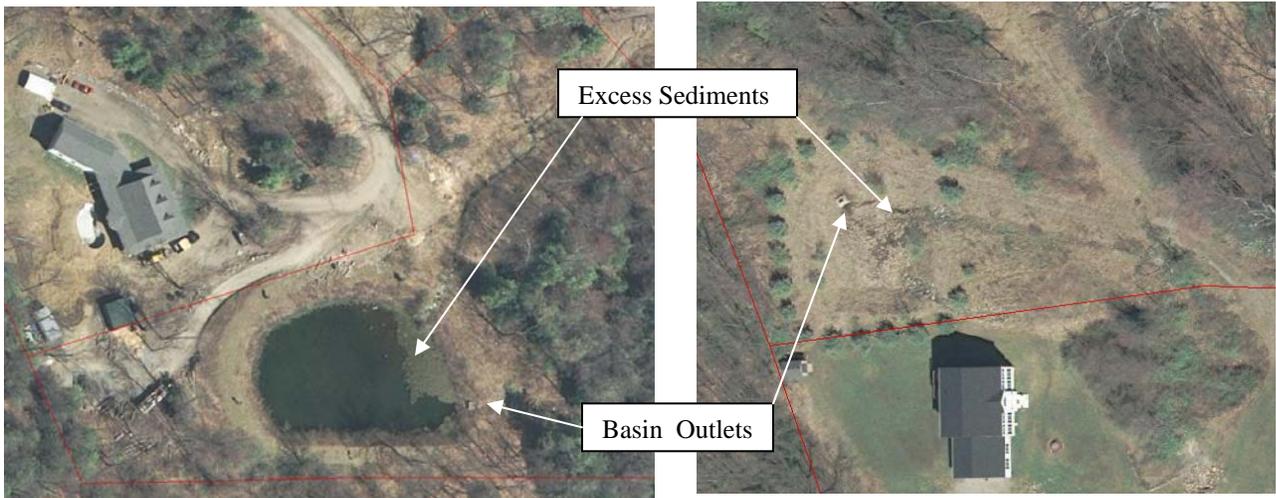
The Highwood Farm Subdivision in Thomaston has two stormwater basin structures that are entirely failing. Both basins are completely full of sediments and invasive vegetation, and the outlet structures do not allow water to be detained or metered out slowly (see basin photos below). Therefore, these basins have no capacity to detain stormwater and they are providing no water quality renovation.

The failing stormwater structures on the Highwood Farms Subdivision in Thomaston are currently the biggest single contributor of sediments to Northfield Brook Lake. Because the sediments are being carried by stormwater runoff from over 15 acres of impervious surface, it is certainly carrying a heavy load of nutrients. The best way to resolve the sediment and nutrient problems created by the failing stormwater structures is to retro fit a stormwater wetland into the existing basins. The town of Thomaston owns the basins and over 13 acres around them. Therefore, there is plenty of space to accomplish a stormwater wetland retrofits. Installing stormwater retrofits would remove all sediment and most of the nutrients from stormwater runoff and prevent any down gradient erosion and water quality degradation.

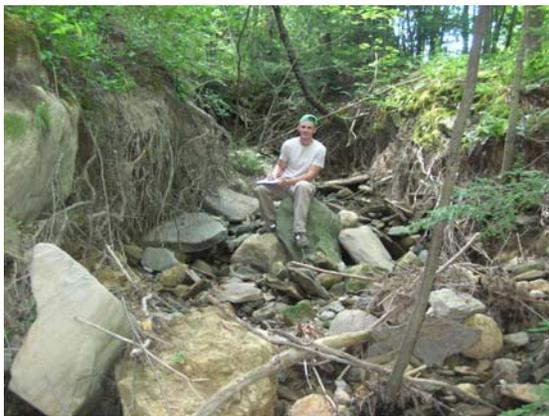
Because these basins are completely full of sediments and the outlet structures have no flow control, a very large gully has eroded in the hillside above Northfield Lake and deposited over 1000 cubic yards of sediments and debris into Northfield Lake (see photos below).

*Gully Erosion from Failing Basins*

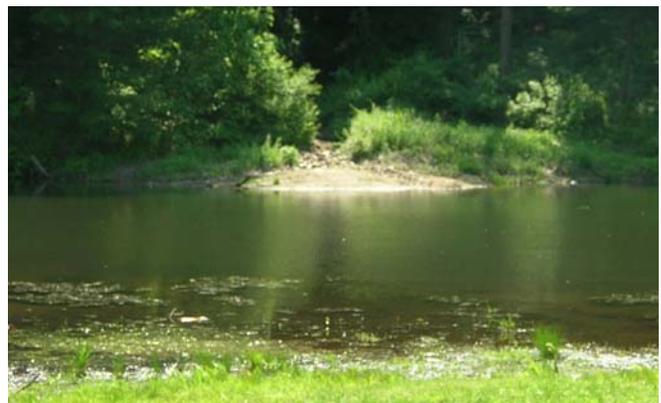
*Sediment Deposition in Lake from Failing Basins*

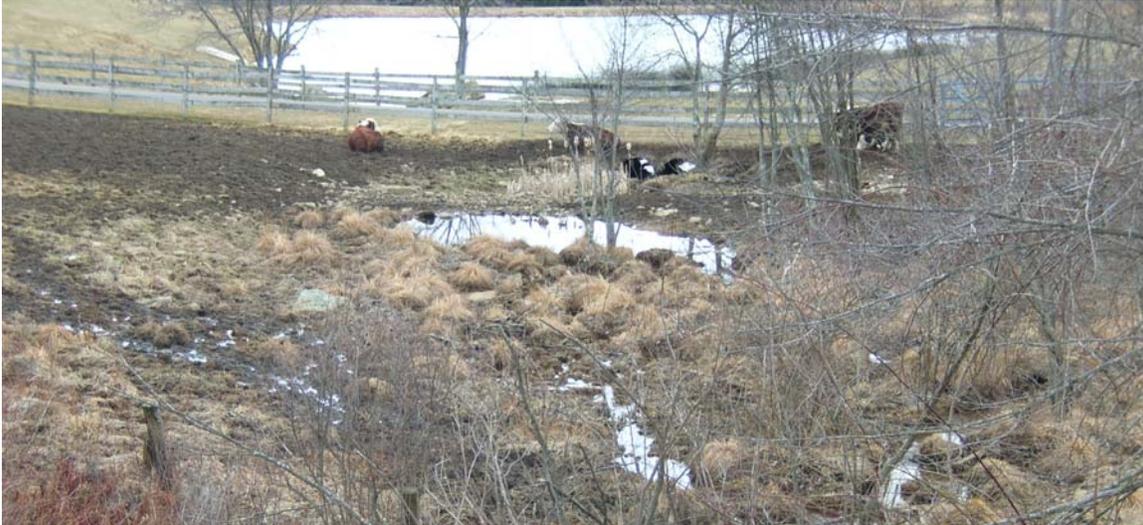
After completing a visual inspection of all the stream channels of the watershed, land use activities and high resolution aerial photos, it is likely agriculture activities are partially responsible for impairments in the watershed. A water quality problem uncovered using a visual assessment method was unfettered livestock to stream and riparian areas (see photo below).

*Cattle Access Stream Near Intersection of Route 254 and McBride Road*

All of the problems listed above are occurring in the upper watershed of the Northfield Brook, and all are likely causing water quality degradation. Livestock can access most of the stream channels in Sub Watershed #s 6909 (Local Basin 6909-02). However, all these threats to water quality can simply be eliminated by restricting and/or eliminating livestock access to the stream channels and the immediate riparian area buffering the stream channels. Creating exclusionary fencing along the tributary stream that drains Local Basin # 6909-02. could be accomplished at relatively low cost to the farm operator. This is a necessary action to remove the Northfield from the US EPA's Impaired Waters of the United States list.

Exclude livestock from stream and riparian areas. The CT Department of Environmental Protection and the US Department of Agriculture (USDA) - Natural Resources Conservation Service (NRCS) and the USDA – Farm Service Agency (FSA) commonly recommend a 50 foot to 100 foot undisturbed buffer remain between agricultural activities and water resources. The reason the USDA and the CT DEP feel so strongly about this buffer setback is that research has proven time and again that the best way to protect soil, wetlands and water resources from agricultural impacts is to allow for an undisturbed buffer around wetlands and watercourses. In fact the USDA feels so strongly about keeping livestock and agricultural activities away from wetlands and open water that they have created programs to cost share (up to 75%) for the following:
