Watershed Field Assessment Report Pequonnock River Watershed

City of Bridgeport

February 2011

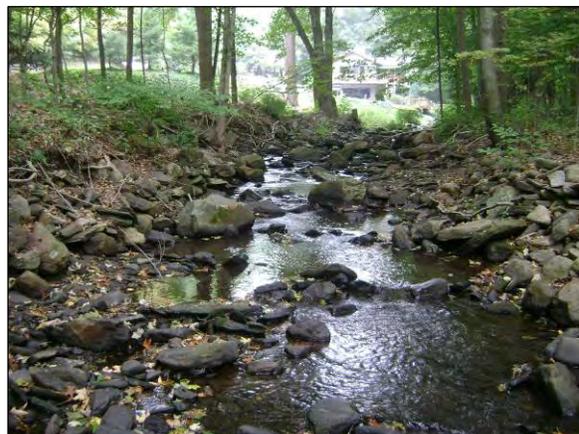
UPR-05: Excellent

The Pequonnock River subwatershed has a high degree of variability in stream conditions along the main stem of the Pequonnock River. As indicated in *Table 2-4*, Upper Pequonnock River (UPR-05) is the highest rated stream reach (“Excellent”) due to mature floodplain forest along a wide riparian corridor and generally optimal floodplain, buffer, and in-stream habitat conditions. The Lower Pequonnock River reaches LPR-04 is rated “poor” due to a lack of buffer and floodplain in the urbanized section of Bridgeport. LPR-05/06 received a score of “zero” since the reach is a culverted section of stream that is routed underneath Route 8 and a shopping center. The photographs in *Figure 2-3* illustrate the sharp contrast in conditions within this subwatershed.

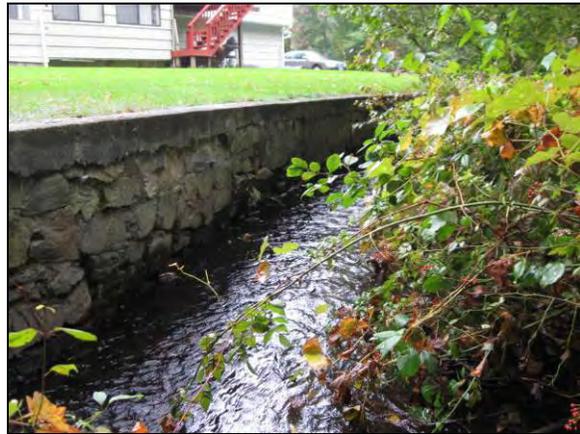
These deficiencies include rip-rap along the banks, turf planted to the stream bank, and retaining walls replacing the natural bank (one was constructed from milk crates). One residential property that abuts the stream constructed a driveway bridge over the stream for access across the property.

Concrete retaining wall along UWB-03.

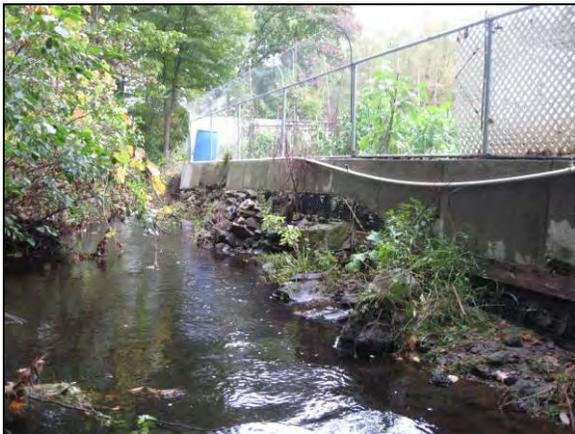
Concrete retaining wall along UWB-03.

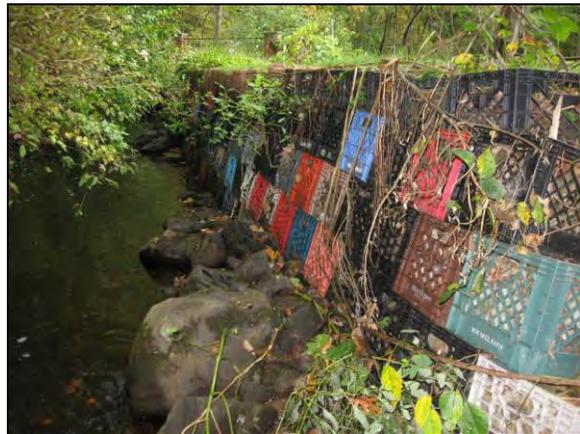
Retaining wall constructed of milk-crates filled with rocks and cement along UWB-03.

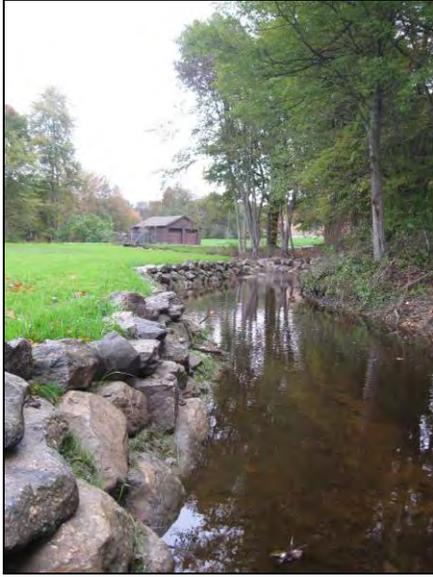
Recently constructed rip-rap channel downstream of the Northbrook Townhouses.

The land-owner at the downstream end of this reach expressed concern over the recent flooding on his property, which prompted the rip-rap channel shown in the photograph above and expressed willingness to cooperate in restoration efforts. There is ample space along the lower half of the reach for stream restoration if property owners are cooperative. The overall stream condition rating for this reach is “Fair”.

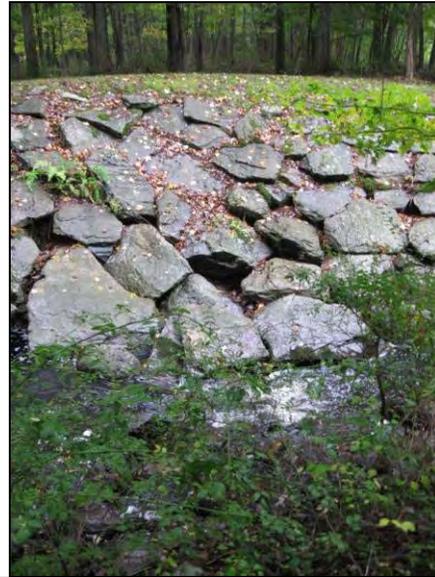
There are many concrete or rip-rap lined channels and banks throughout the watershed. One example is the rip-rap armored bank upstream of the entrance into Wolfe Park. The majority of the channel modification is believed to have been constructed to prevent bank erosion and flooding due to upstream development. Some of these channels have the potential to be restored to a more natural condition by removing the armoring, restoring a floodplain, and implementing bioengineering techniques to provide a measure of stability for the channel.

The bank is armored with rip-rap upstream of the entrance into Wolfe Park.

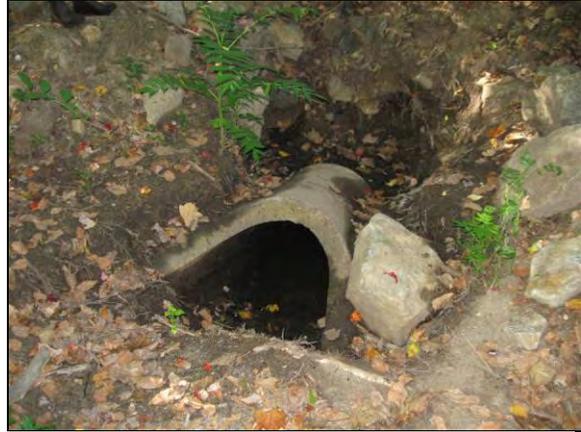
There are a high density of outfalls along this reach which drain areas of the subdivision and a commercial building. Scour is present along the bank and in the stream near outfalls OT-02 and OT-04 that appears to have resulted for the outfalls. Stream crossing SC-01 serves as grade control for upstream pond and prevents any fish passage from the pond to the stream. There is a moderate amount of trash and debris along the entire reach, including a small metal barrel in the wetland area, various bottles and toys, a small bicycle, golf balls, chairs, a broken PVC pipe, yard waste and potted plants.

The concrete flared end segment of outfall OT-04 has collapsed and is no longer connected to the storm system.

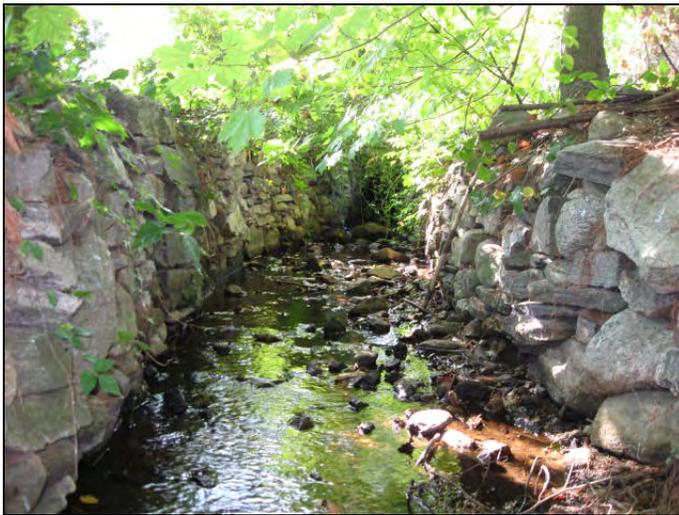
MPT-19 is rated “marginal” due to the numerous stream crossings and significant channelization with the stone channel and the underground segment beneath the parking lot. There would be high potential for stream restoration along this reach if the property were not privately owned.

CM-01 downstream of Route 25 stream crossing.

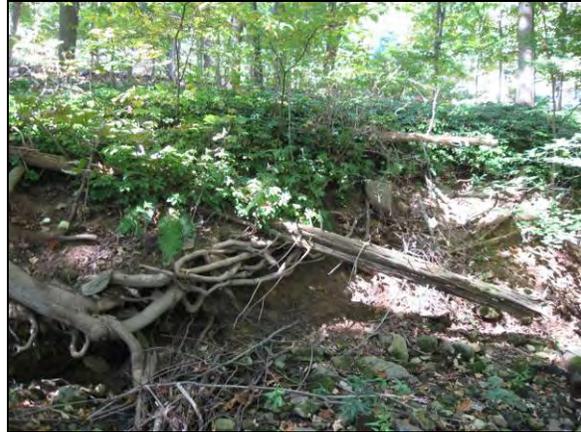
Both upstream and downstream of the bank channelization severe bank erosion is evident with undercut banks. It appears that residential land owners have attempted to secure the areas of the bank that are eroding with the addition of more stone wall, although the efforts do not appear successful. The reach is crossed by Spring Hill Road, a footbridge, and two driveways. Stream crossing SC-02 and SC-03 associated with the footbridge and the residential driveway are candidates for restoration to remove the fish barrier and stabilize the bank erosion. The overall stream conditions for reach MPT-25 is “Excellent” due to good buffer distance, canopy cover, in-stream habitat, and floodplain connection.

An example of the bank erosion downstream of the channelized banks.

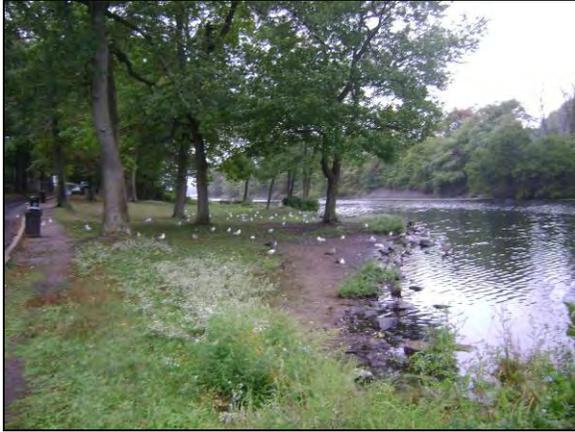
There were 14 outfalls observed along the reach located around the pond, many conveying runoff from Route 25/Route 8 into Bunnell's Pond ranging in size from 8-inch to 5-foot in diameter.

Bunnell's Pond has impaired buffer along the eastern side.

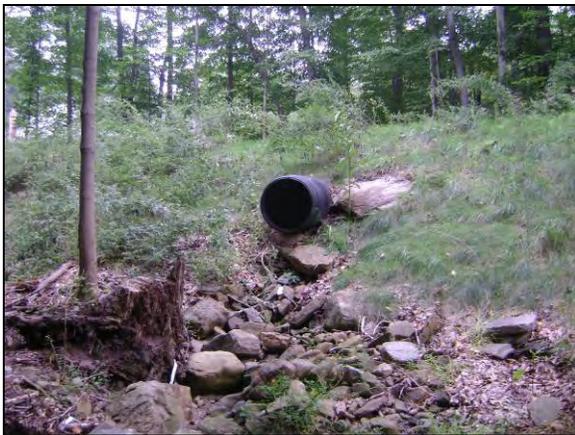
Reach UBH-02 is rated suboptimal for in-stream habitat, vegetative protection, bank erosion and floodplain connection since the reach has some buffer between the nearby homes. The floodplain habitat is rated optimal, with a good mix of wetland and non-wetland plants. The overall stream rating for UBH-02 is “Good”. The biggest problem in this reach is scour and erosion around outfalls.

Tributary outfall OT-01 has an approximately 3-foot drop to the channel which is causing erosion and scour around the outfall.

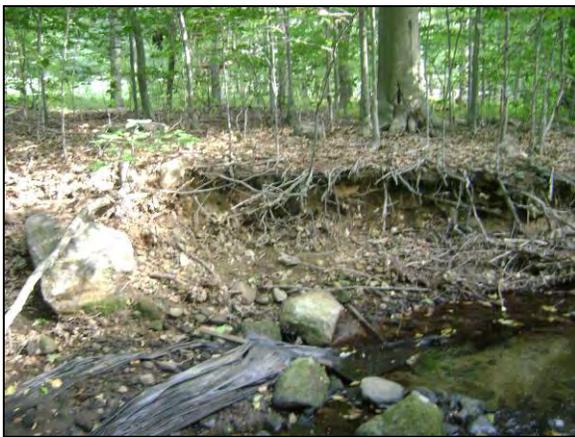
An example of an undercut bank caused by an outfall located upstream of this bank.

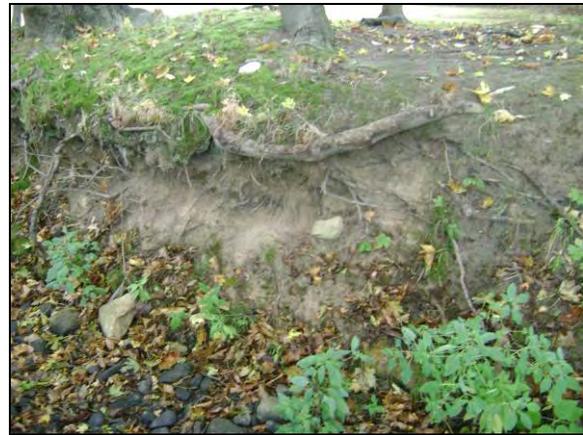
Severe bank erosion in the form of undercut banks are prevalent along this reach.

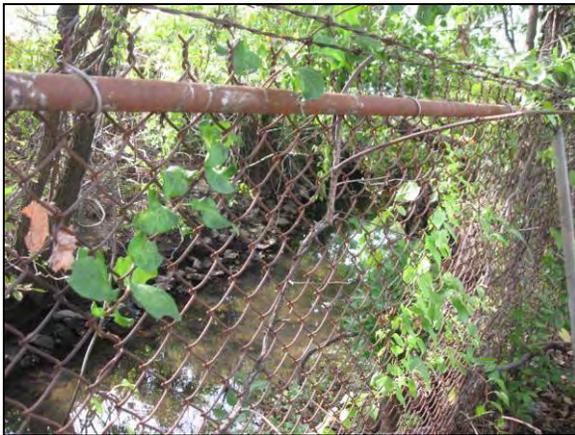
ISL-01 is highly encroached and inaccessible to the public.

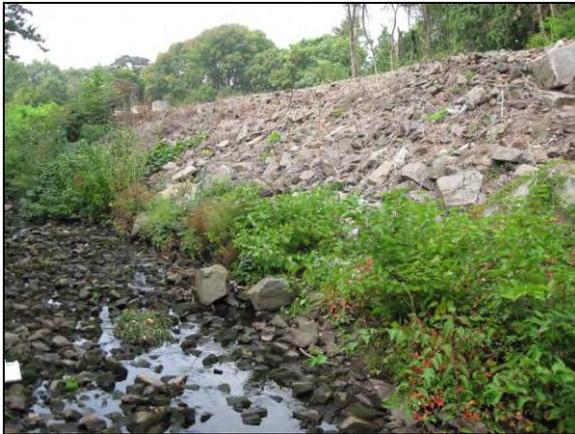
ISL-03B is a short, approximately 550 foot segment that flows from an arched culvert stream crossing at Olmstead Street (the entrance driveway to Park Cemetery), through a channelized section between the cemetery and the Aquarion Water Company building parking lot, to the double-box culvert at Capital Avenue. The biggest problems with this stream reach are the lack of canopy cover, lack of floodplain connection, and invasive species growing in the stream and on the banks. The reach is rated “Poor”.

ISL-03B is channelized with rip-rap and placed stone in the stream channel.

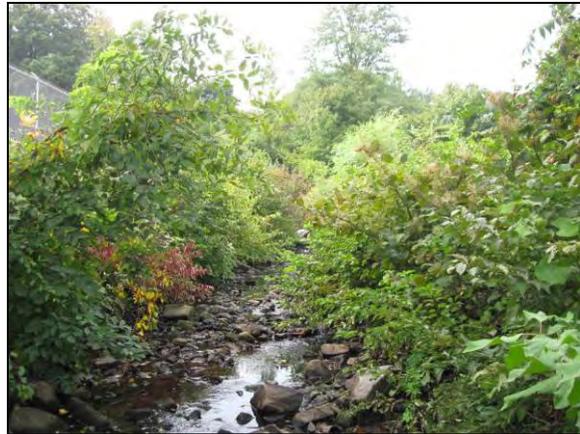
Invasive species thrive along this reach due to the lack of canopy cover which provides full sun.

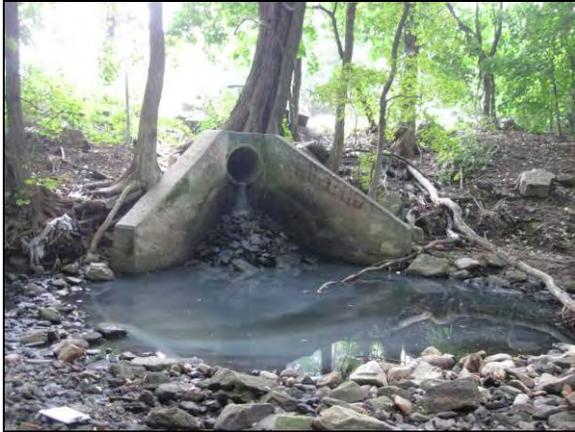
discharge at the time of the field assessments. The water was a milky white color and was investigated by Save the Sound and determined to be coming from illegal connections of residential homes. OT-03 discharges stormwater from behind the Read Elementary School. There was a large scour hole and pool with standing water downstream of the outfall. Tires and various trash items were also present in this area. The biggest problem in reach ISL-03 is illegal dumping of waste in the stream channel. Some of the items found in the stream are shopping carts, approximately 50-100 tires, car parts, various plastic pieces, PVC piping, tennis rackets, and crates. This stream reach is an excellent opportunity for volunteer stream cleanup.

Dry-weather discharge at OT-02 was determined to be illegal connections of residential discharge.

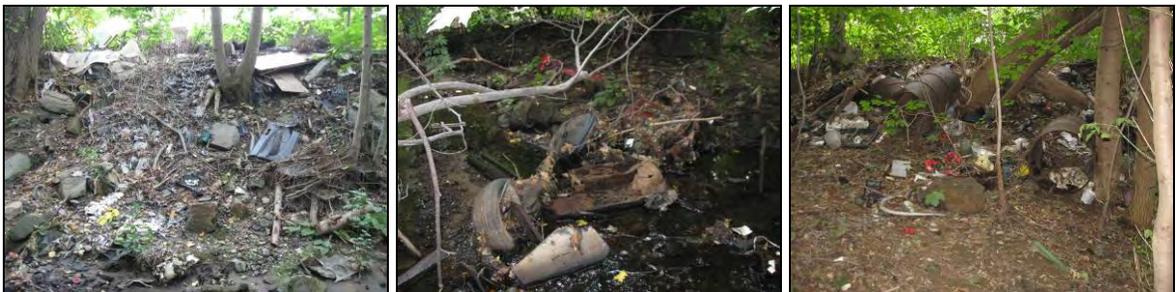
Illegal dumping of waste in the stream channel in RCH-03.

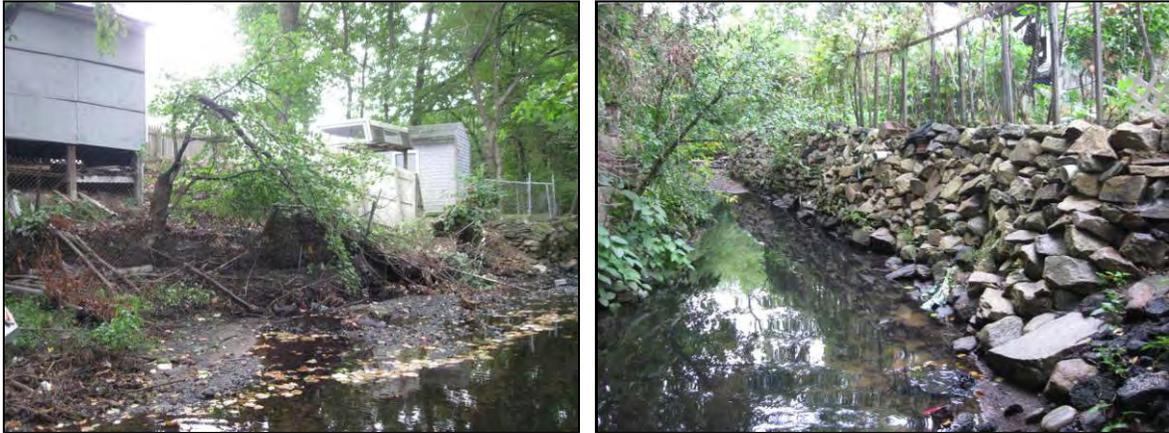
The biggest problem along reach ISL-04 is impacted buffers on residential properties. Many structures are built close to the stream bank (left) and a stone wall was constructed as a retaining wall to the river (river). Buffer encroachment prevents adequate connection to the floodplain.

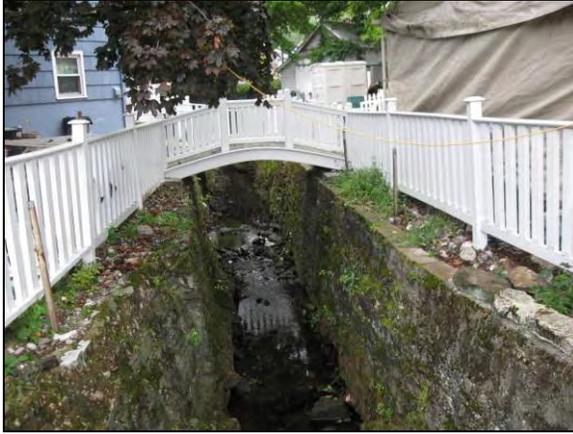
This stream reach is rated “Poor” overall due to marginal in-stream habitat, severe bank erosion and little to no floodplain connection.

Stream channelization near the Chopsey Hill Road stream crossing disconnects the stream from the floodplain, increasing peak flow velocity.

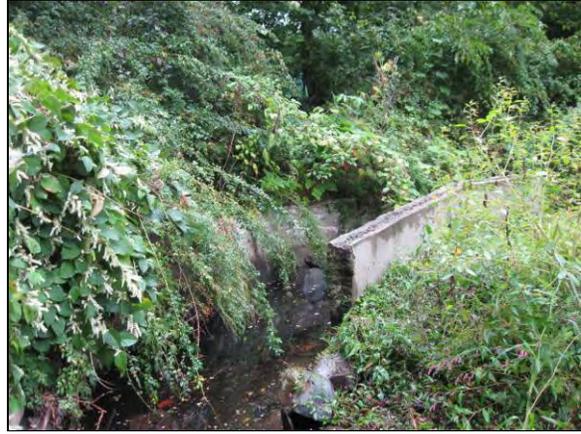
Retaining walls in this section of the reach are being actively undercut due to upstream development and lack of floodplain connection. Japanese Knotweed and other invasive species are prevalent in this area.

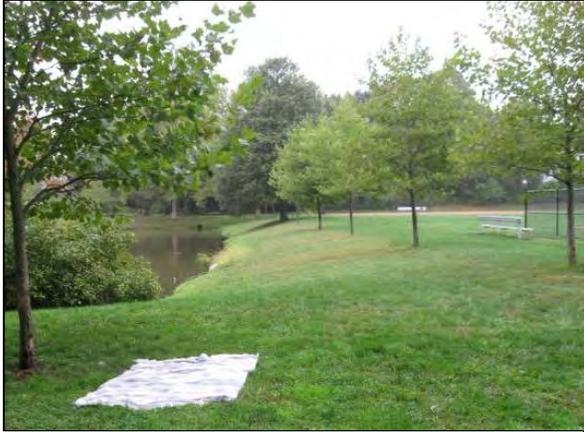
The buffer of the large stormwater pond inside Island Brook Park is mostly turf, although there is adequate space for plantings to improve the buffer.

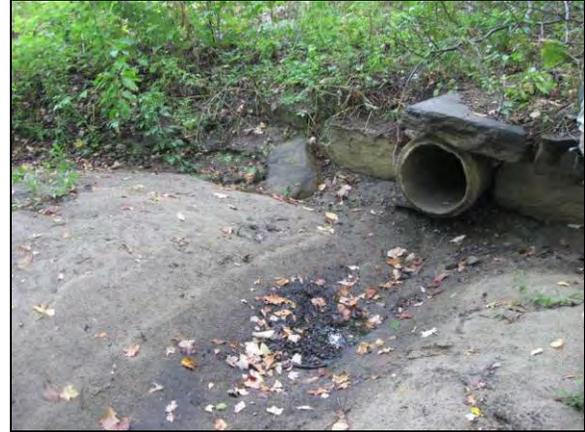
The sand substrate near OT-04 has eroded and is a good restoration candidate.

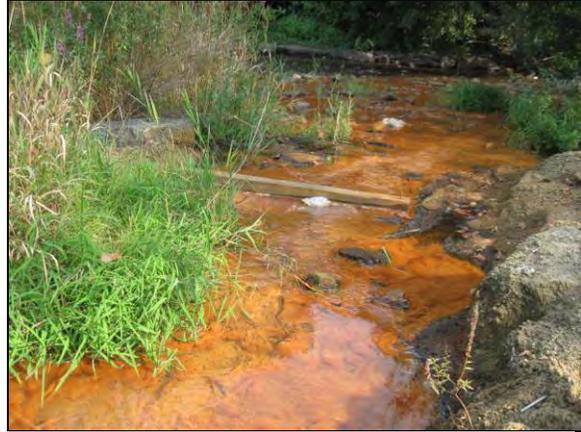
Iron bacteria is present downstream of discharge from iron outfall pipes along this reach. Although the orange bacteria are unsightly, it is not toxic.

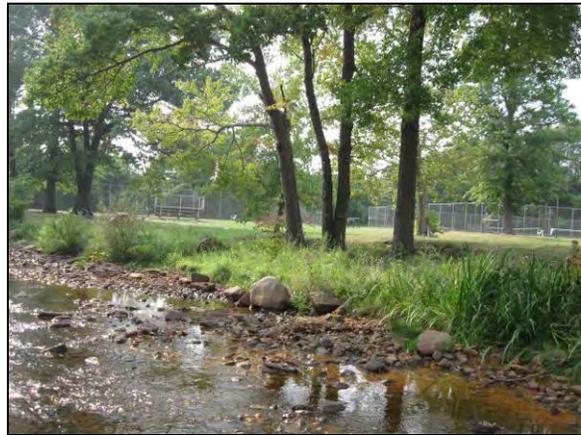
The vegetated buffer along LPR-07 is mostly turf; however, there is plenty of space for more tree plantings.

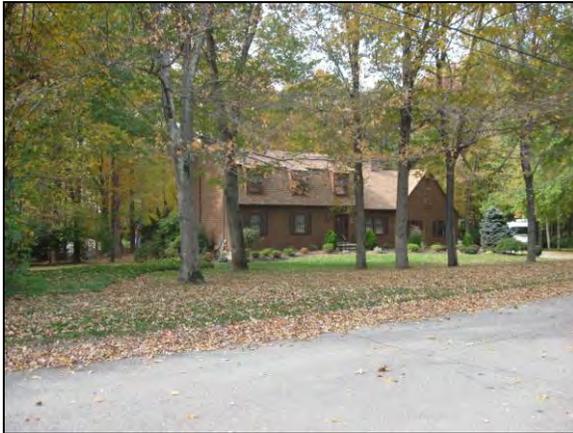
The mature trees in this neighborhood cause leaves to fill the curb and gutter system in the fall.

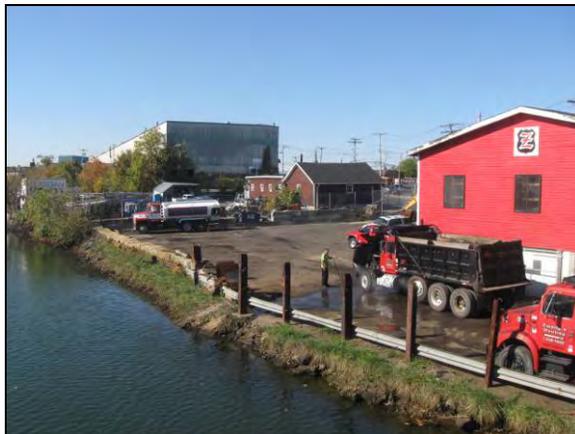
Truck wash water from Zwally's Hauling drains directly to the Pequonnock River.

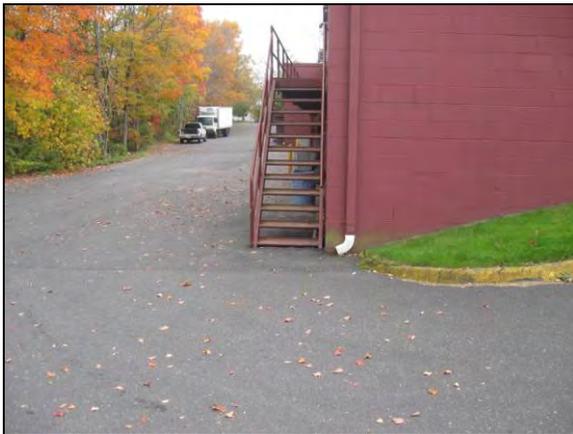
Downspouts discharge to impervious surfaces at Chuck's Corner Shopping Center.

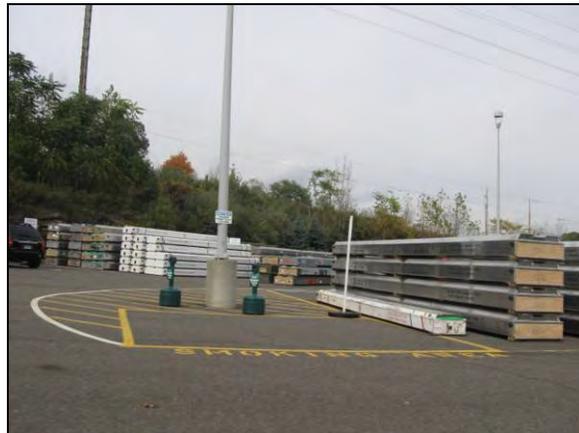
The outdoor material storage area is uncovered.

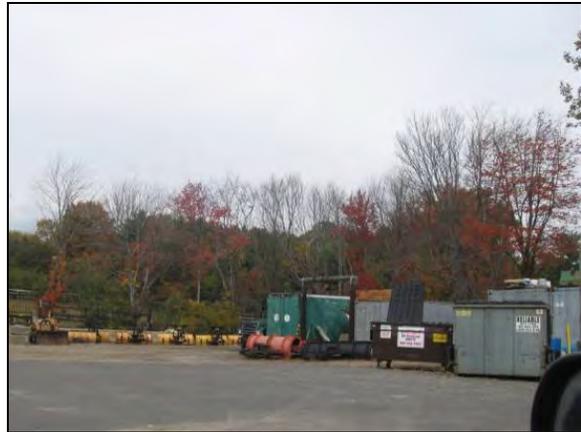
Uncovered outdoor storage at the Agriscience and Biotechnology school.

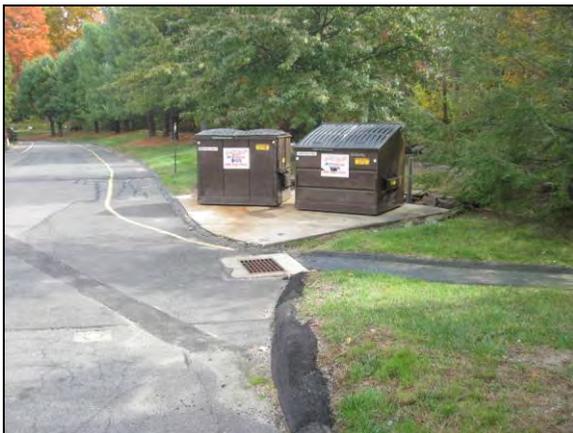
Runoff or leaking from these dumpsters would drain to the stormwater drainage system.

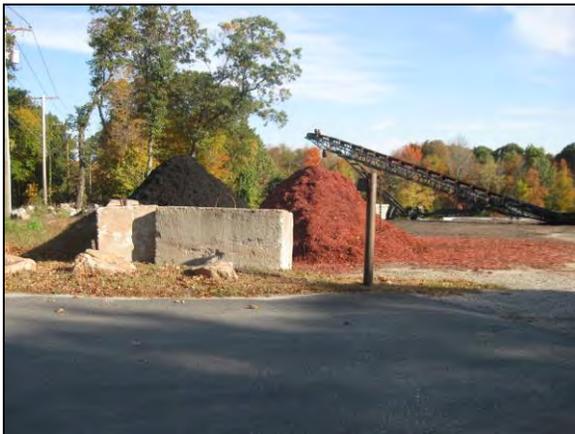
Mulch and topsoil are stored outside without cover.

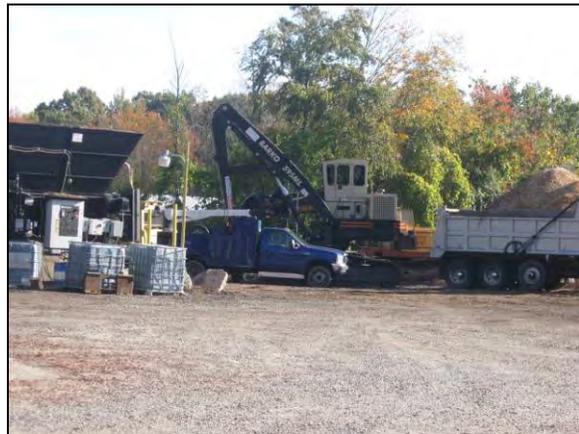
Loading and unloading equipment is stored outside, including excavators, dump trucks, and conveyor belts. Three chemical totes are stored on-site without cover.

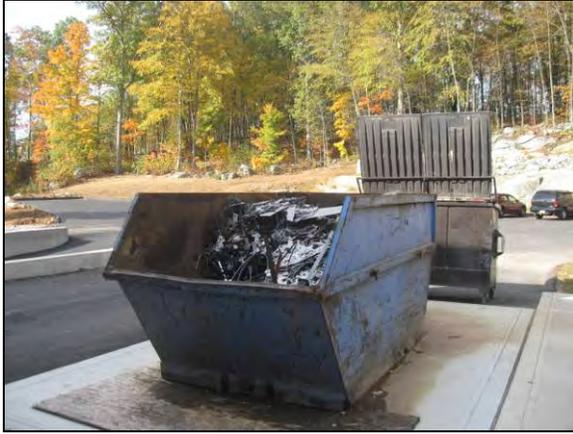
Uncovered dumpsters are near a storm drain and appear to be leaking.
