DESIGN FLOOD MEMORANDUM

RE: Design Flood Memorandum
Mill River District Shoreline Analysis
City of New Haven
CNH Project No. 15-195-21
RTG Project No. 15103.00

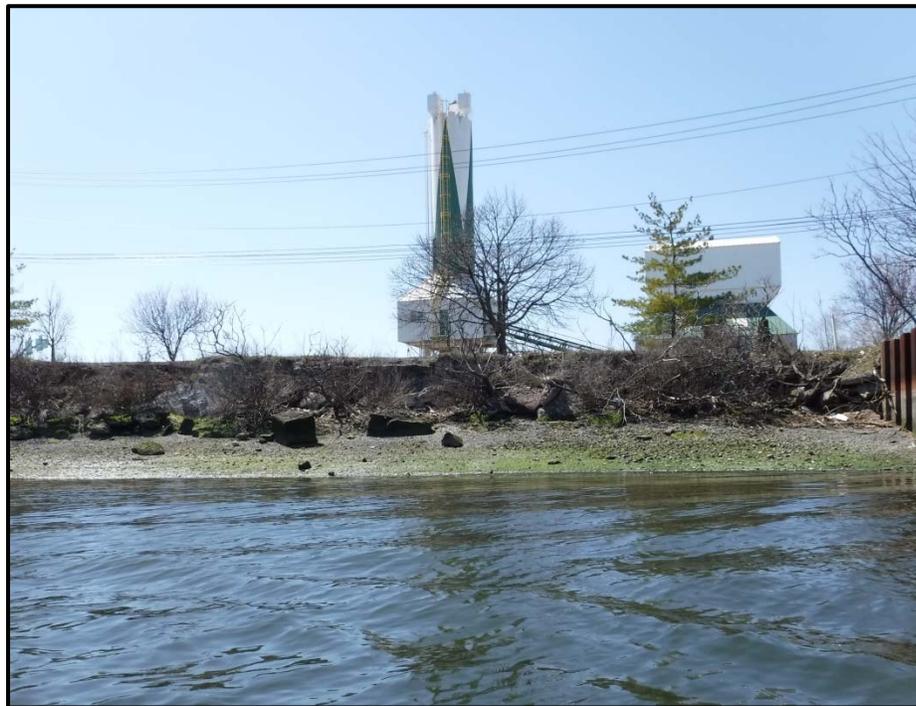
Photo No. 2:
Natural shoreline along York Hill Trap Quarry Co.,
looking west, photo taken on April 14, 2016.

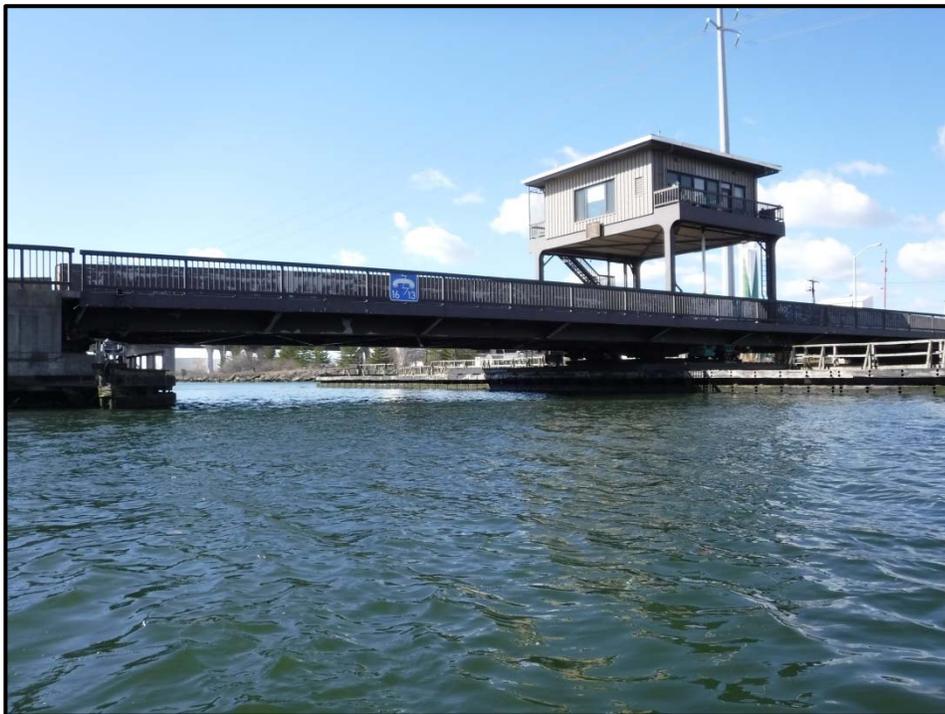
Photo No. 4:
Chapel Street Bridge, looking south,
photo taken March 18, 2016.

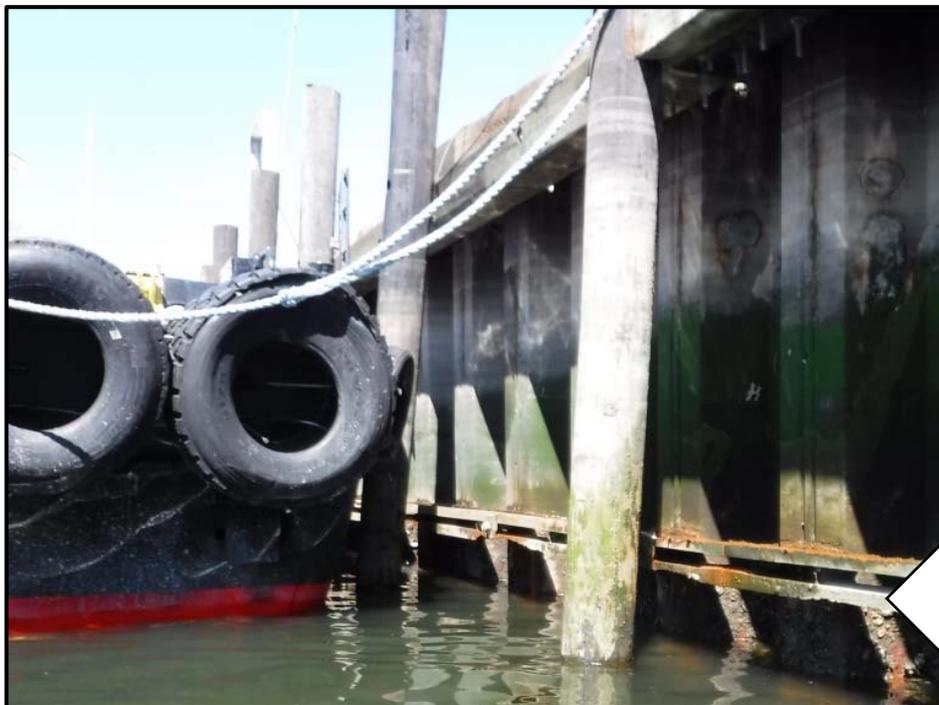
Saltonstall Ave (NA)	13+10 - 13+65 (55 lf)	Failed Stone/ Concrete Masonry Seawall	0.0 - 1.0	<ul style="list-style-type: none"> •20-foot-long section has collapsed into the river (Photo No. 7). •Remainder of seawall exhibits some signs of settlement. •Small fixed timber pier exists approx. 10 feet offshore from seawall.
	Hillard Bloom Shellfish, Inc. (174, 717, 1)	13+65 - E15+44 (179 lf)	Stone Masonry Seawall	0.0 - 4.0	<ul style="list-style-type: none"> •Southern end of seawall has collapsed with a sloping natural shoreline behind (Photo No. 8). •Remainder of seawall appears to be in satisfactory condition (Photo No. 9).
	New NRB #3 Corp. (174, 717, 8)	E15+44 - E17+56 (212 lf)	Steel Sheet Pile Bulkhead	4.5	<ul style="list-style-type: none"> •Timber fender and floating dock exist seaward of bulkhead along most of its length. •Lateral support of bulkhead provided by seaward mounted steel double channel wale and tie-backs. •Up to 25% section loss in wale and bulkhead around MLW (Photo No. 10).

Photo No. 10:
Steel sheet pile bulkhead along New NRB #3 Corp., looking northeast,
photo taken April 14, 2016.

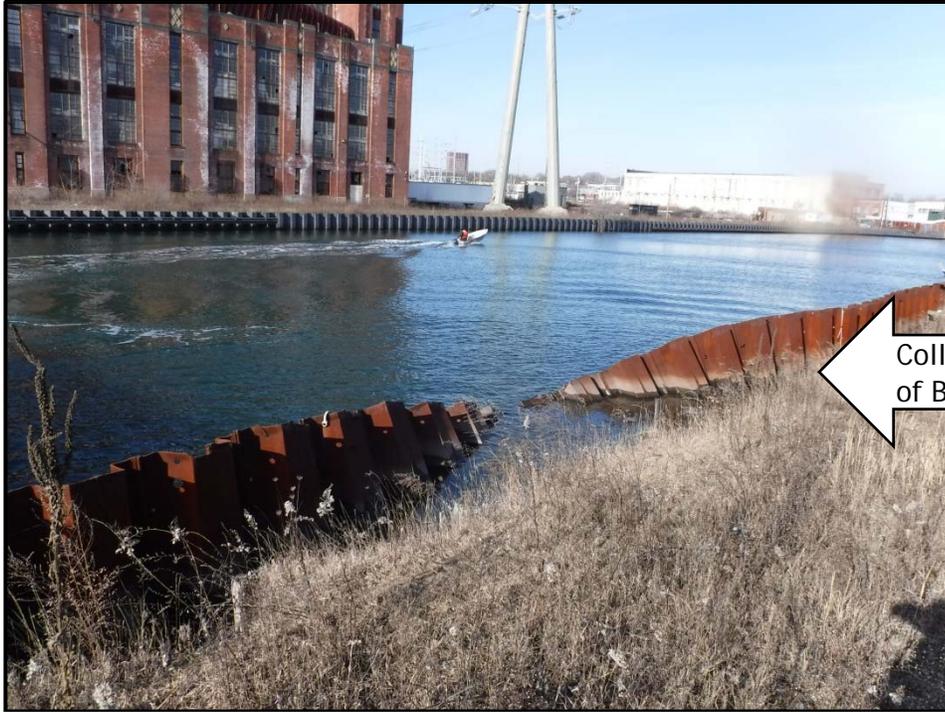
Collapsed Section
of Bulkhead

Photo No. 13:
Steel sheet pile bulkhead along Gateway Terminal,
looking northwest, photo taken January 8, 2016.

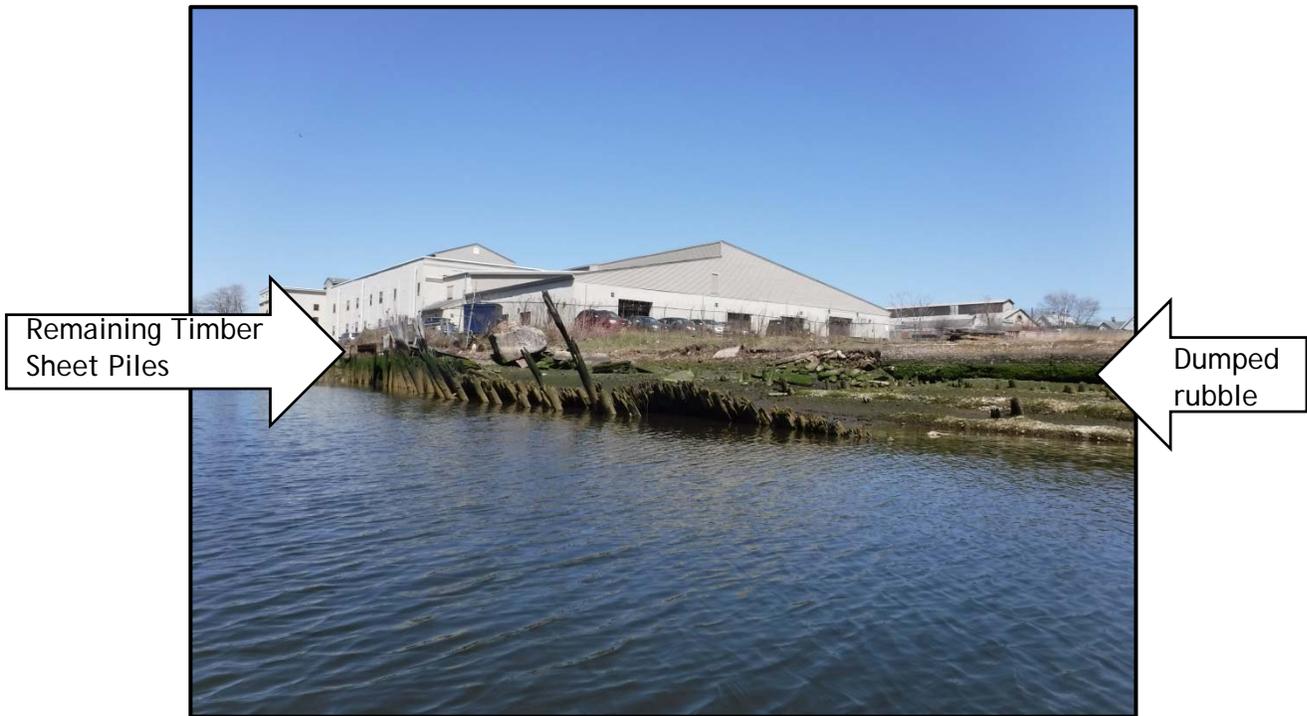
Remaining Timber
Sheet Piles

Dumped
rubble

Photo No. 14:
Failed timber sheet pile bulkhead along Gateway Terminal,
looking northeast, photo taken April 14, 2016.

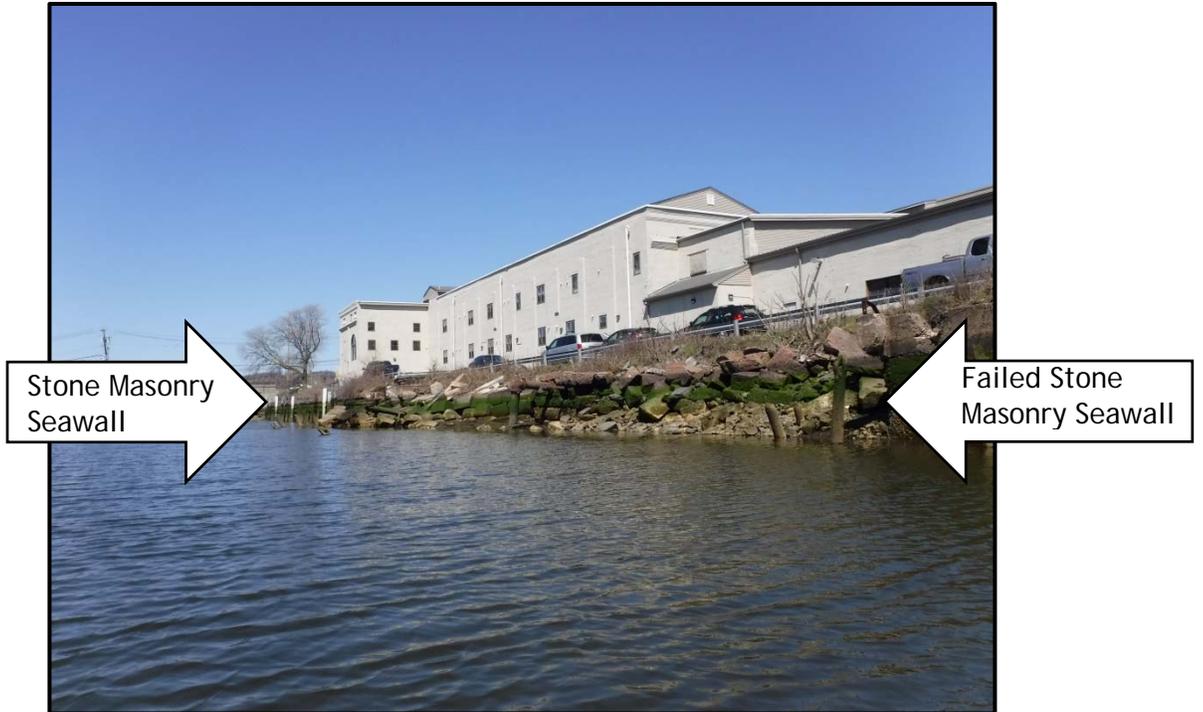
Gateway Terminal & O&G South (174, 729, 1)	E17+56 - E22+19 (463 lf)	Steel Sheet Pile Bulkhead	0.0 - 3.0	<ul style="list-style-type: none"> •Lateral support of bulkhead provided by landward mounted steel double channel wale and tie-backs. •50% and greater section loss in wale and bulkhead around MLW with exposed retained soil (Photo No. 11). •Pockets of settlement behind the bulkhead (Photo No. 12). •Approx. 50-foot-long section of bulkhead has collapsed seaward into the river (Photo No. 13).
	Gateway Terminal & O&G North (174, 729, 1)	E22+19 - E23+88 (169 lf)	Failed Timber Sheet Pile Bulkhead	0.0	<ul style="list-style-type: none"> •Bulkhead has collapsed seaward into the river (Photo No. 14). •Retained soil has been completely eroded and natural shoreline has developed with some dumped riprap observed at its top.
	Powerhouse Building South (174, 736, 1)	E23+88 - E25+83 (195 lf)	Failed Concrete/ Stone Masonry Seawall	0.0	<ul style="list-style-type: none"> •Seawall has collapsed seaward into the river (Photo No. 15). •Retained soil has been eroded and natural shoreline slope has developed.

Photo No. 15:
Stone masonry seawall along the Powerhouse Building,
looking northeast, photo taken April 14, 2016.

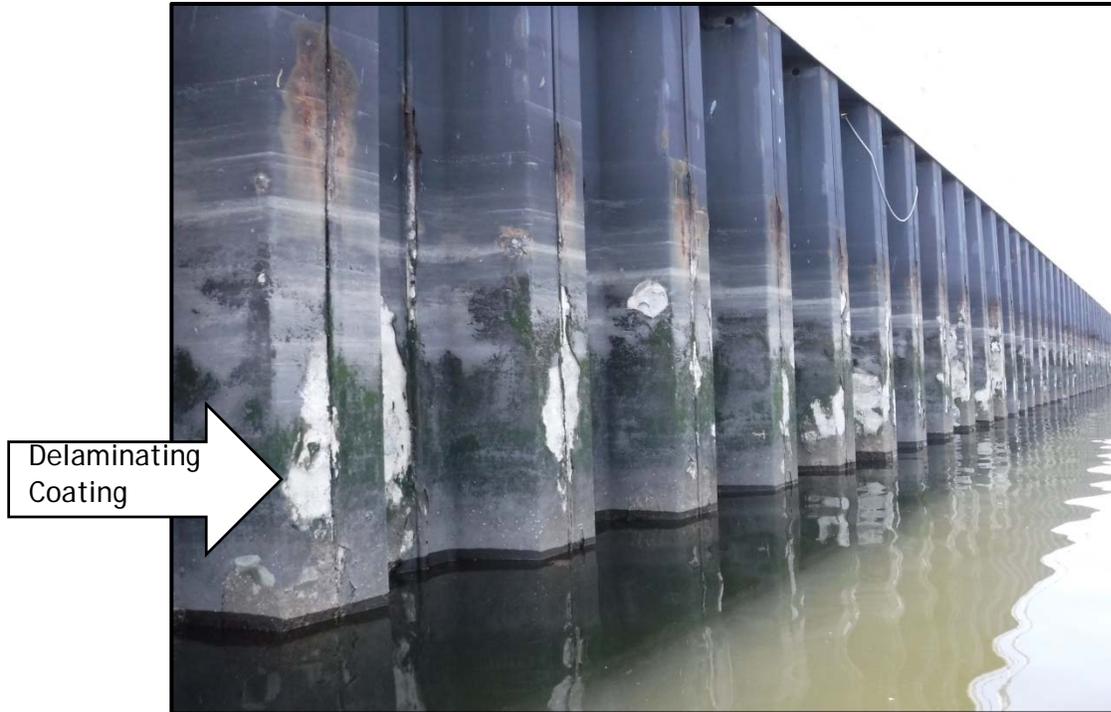
Delaminating
Coating

Photo No. 21:
Steel sheet pile bulkhead along UL Grand Avenue Substation,
looking northwest, photo taken April 14, 2016.

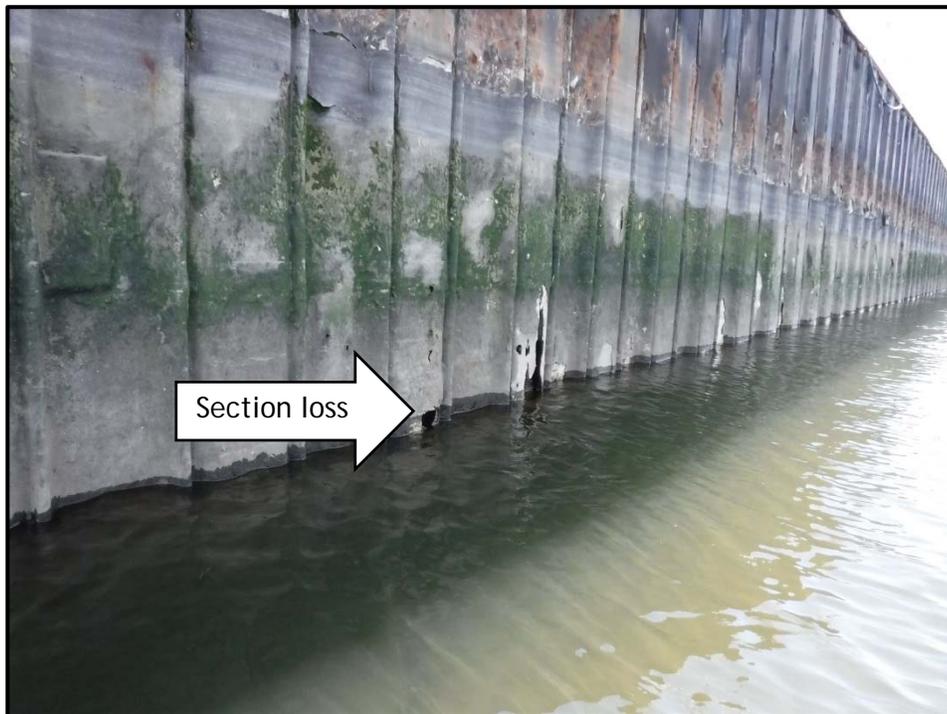
Property (Map, Block, Lot) ¹	Approximate Shoreline Stationing Limits (Approx. Length) ^{1,2}	Existing Shoreline Description	General Condition Rating ³	Notes
West Shore	Gateway Terminal (178, 557, 1)	10+63 - W21+80 (1,050 lf)	Stone Masonry Seawall	0.0 - 6.0	<ul style="list-style-type: none"> Remnants of what appears to have been a fixed timber pier exist immediately seaward of seawall (Photo No. 18). Seawall appears to be bearing on pile supported timber decking at about MLW (Photo No. 19). Some steel sheet piles exist along the outside corner of the lot immediately seaward of a section of collapsed seawall.
	Former Simkins (179, 567, 1.1)	W21+80 - W26+36 (495 lf)	Natural Shoreline & some Dumped Riprap	5.0	<ul style="list-style-type: none"> Dumped riprap located at the top of natural shoreline slope (Photo No. 20). Remnants of a timber bulkhead exist in some areas.
	UL Grand Avenue Substation (179, 567, 8)	W26+36 - W32+43 (6+28 lf)	Steel Sheet Pile Bulkhead	5.0 - 6.0	<ul style="list-style-type: none"> Steel channel cap located along entire length of bulkhead. Bulkhead is comprised of Z- and flat-sheet piles (Photo Nos. 21 & 22). Lateral support anchor system was not observed (assumed interior). Delaminating protective coating and heavy section loss in discrete locations around MLW (Photo No. 22).

Section loss

Photo No. 22:
Section loss in steel sheet pile bulkhead along UL Grand Avenue Substation,
looking northwest, photo taken April 14, 2016.

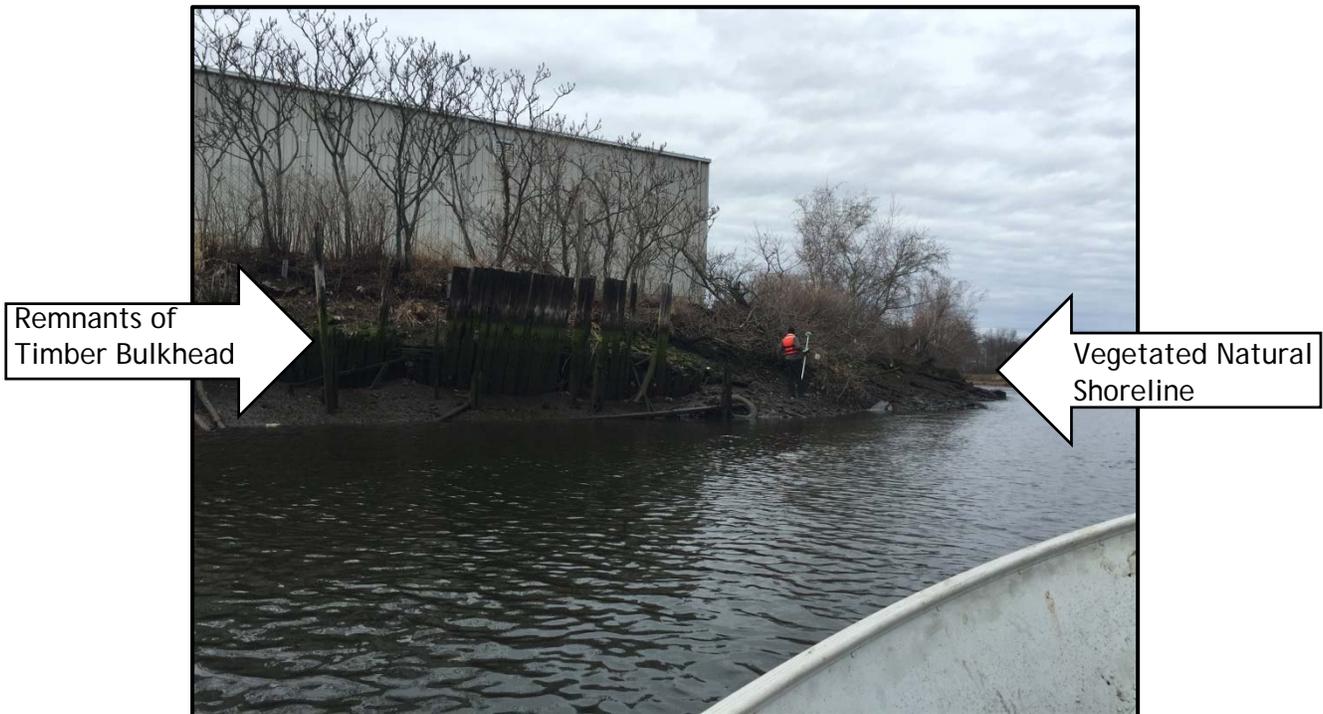
Ball Island	McVac East (180, 585, 1-2)	E28+85 - E36+91 (738 lf)	Natural Shoreline	NA	<ul style="list-style-type: none"> Shoreline is vegetated along MHW (Photo No. 28). Remnants of what appears to have been a timber sheet pile wall exist in one area. Large boulders exist in one small length of the shoreline. Evidence of erosion (e.g., exposed roots, downed vegetation) was observed along the northern shoreline of the island.
	McVac West (180, 585, 2)	W33+06 - W38+10 (505 lf)	Natural Shoreline	NA	<ul style="list-style-type: none"> Shoreline is vegetated along MHW (Photo No. 29). Remnants of what appears to have been a stone masonry seawall exist in one area. Dumped rubble (e.g., brick) exists along a portion of the shoreline. Evidence of erosion (e.g., exposed fence post foundations, exposed roots, downed vegetation) was observed along the entire length of the shoreline.
West Shore	Former St. Gobain South (180, 585, 3)	W33+06 - W35+43 (187 lf)	Timber Sheet Pile Bulkhead	4.5	<ul style="list-style-type: none"> Dumped riprap exists along the toe of the bulkhead (Photo No. 30). A timber fender system exists immediately seaward of bulkhead. Some gaps observed between the timber sheet piles.

Photo No. 28:
Shoreline along east side of Ball Island and north of Grand Avenue,
looking west, photo taken February 4, 2016.

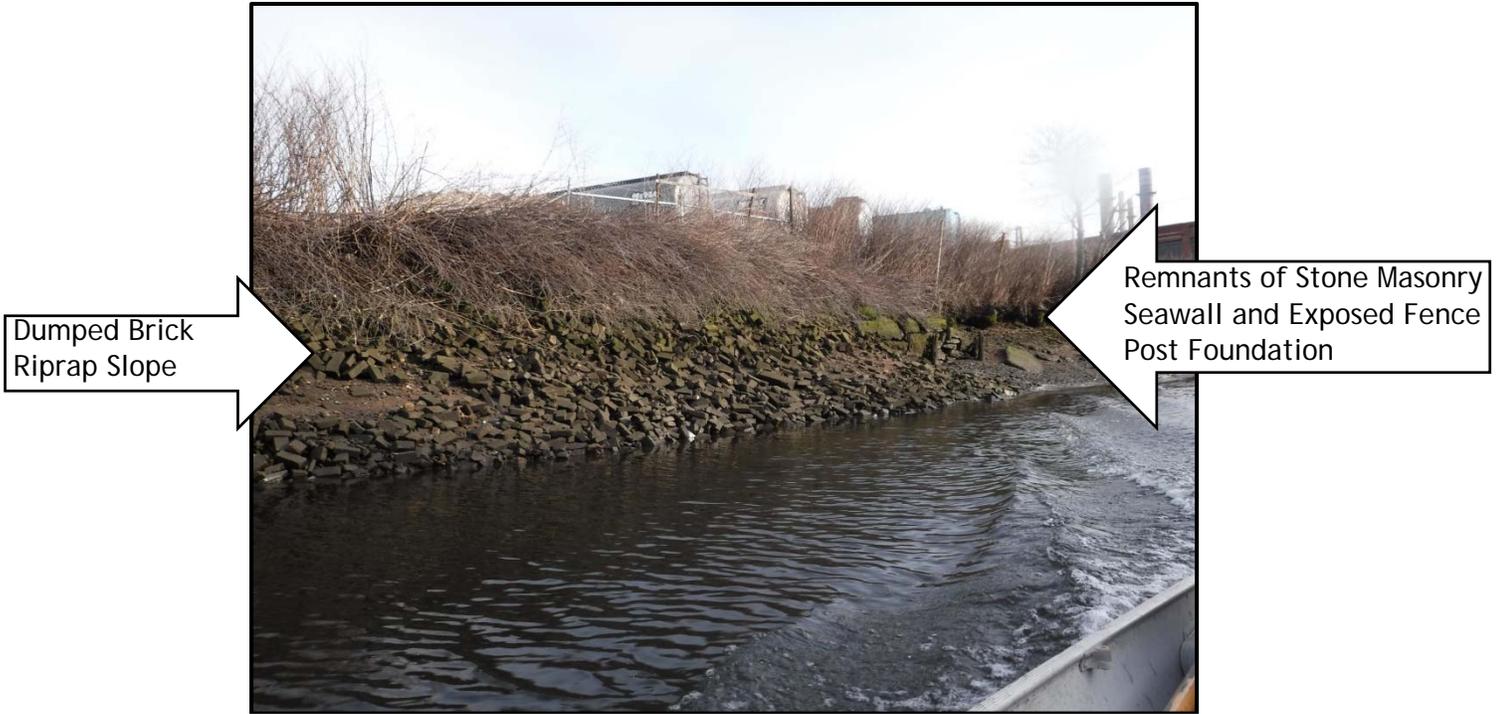
Dumped Brick
Riprap Slope

Remnants of Stone Masonry
Seawall and Exposed Fence
Post Foundation

Photo No. 29:
Shoreline along west side of Ball Island and north of Grand Avenue,
looking southeast, photo taken February 19, 2016.

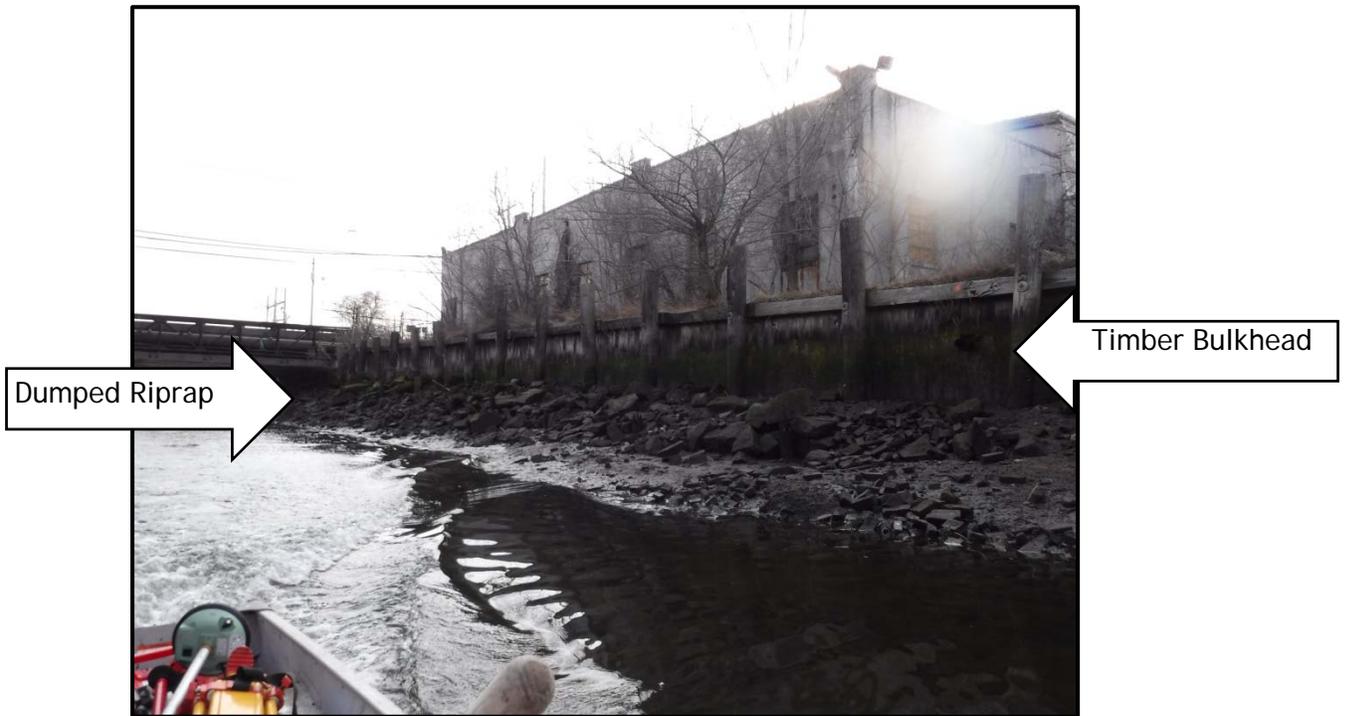
Dumped Riprap

Timber Bulkhead

Photo No. 30:
Timber bulkhead with riprap at toe along former St. Gobain, looking southwest,
photo taken February 19, 2016.

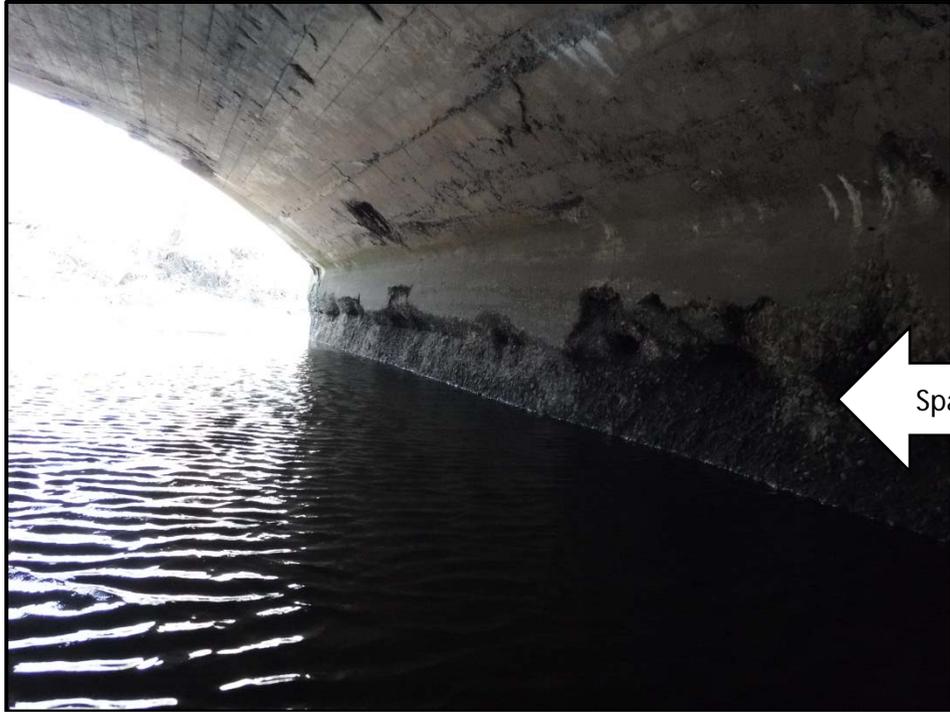
Spalling Along Abutment

Photo No. 35:
West abutment of the active rail crossing over the Mill River, looking south,
photo taken April 14, 2016.

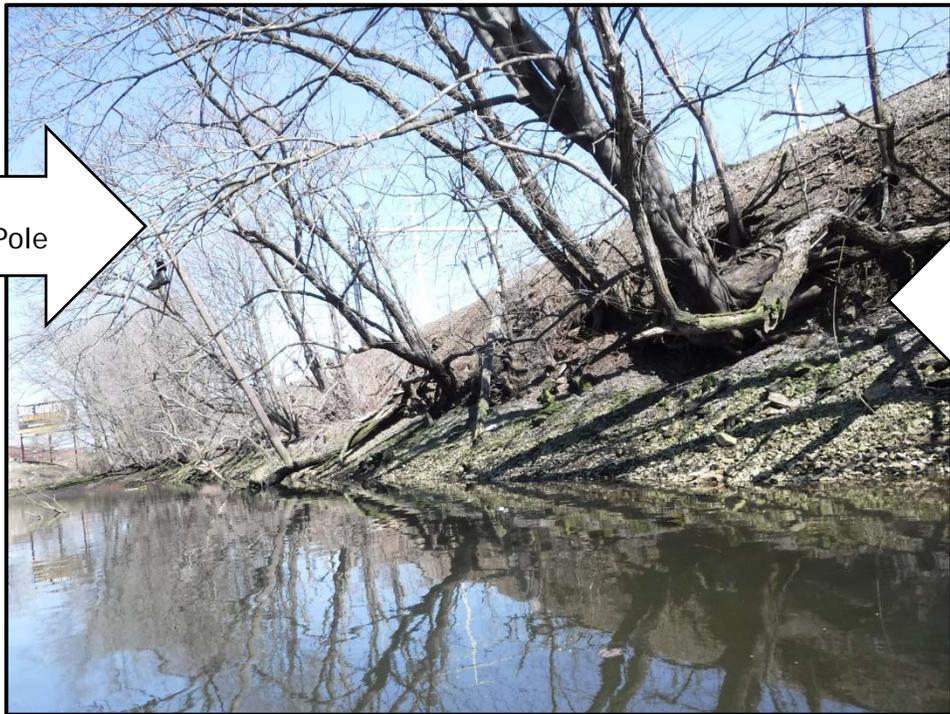
Leaning
Telephone Pole

Exposed Roots/
Downed Trees

Photo No. 36:
Earthen embankment along rail corridor, looking northeast,
photo taken April 14, 2016.

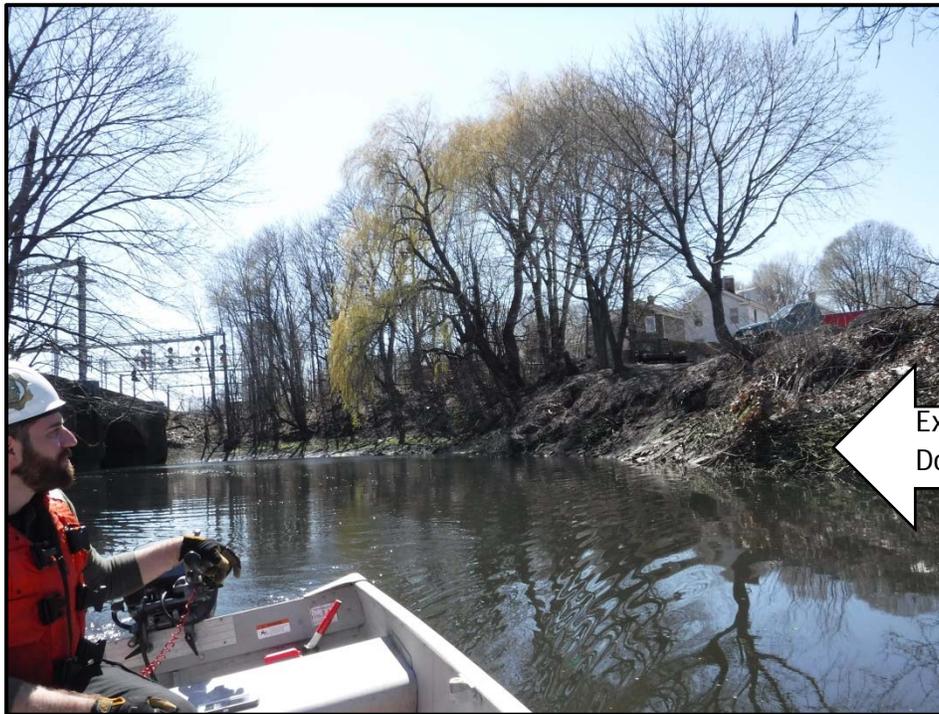
West Shore	Elizabeth Browning (181, 589, 2-4)	46+52 - 47+52 (159 lf)	Natural Shoreline	NA	<ul style="list-style-type: none"> •The shoreline was observed to be relatively steep (i.e., about 1V:1H) (Photo No. 38). •Evidence of erosion along the base of the slope was observed (e.g., exposed roots, downed vegetation).
	Hillcrest Properties, LLC (181, 589, 1)	47+52 - 50+20 (246 lf)	Natural Shoreline	NA	<ul style="list-style-type: none"> •The shoreline was observed to be relatively steep (i.e., about 1V:1H) (Photo No. 38). •Evidence of erosion along the base of the slope was observed (e.g., exposed roots, downed vegetation).
	Multiple Properties (181, 603, 1-6)	50+84 - 53+93 (332 lf)	Natural Shoreline	NA	<ul style="list-style-type: none"> •Evidence of erosion along the base of the slope was observed (e.g., exposed roots, downed vegetation).
	Interstate 91 (NA)	53+93 - 57+62 (283 lf)	Dumped Riprap	6.0	<ul style="list-style-type: none"> •Some vegetation observed. •Riprap is relatively consistent with little to no bare areas observed (Photo No. 39).

Exposed Roots/
Downed Trees

Photo No. 38:
Shoreline along Elizabeth Browning and Hillcrest Properties, LLC,
looking southwest, photo taken April 14, 2016.

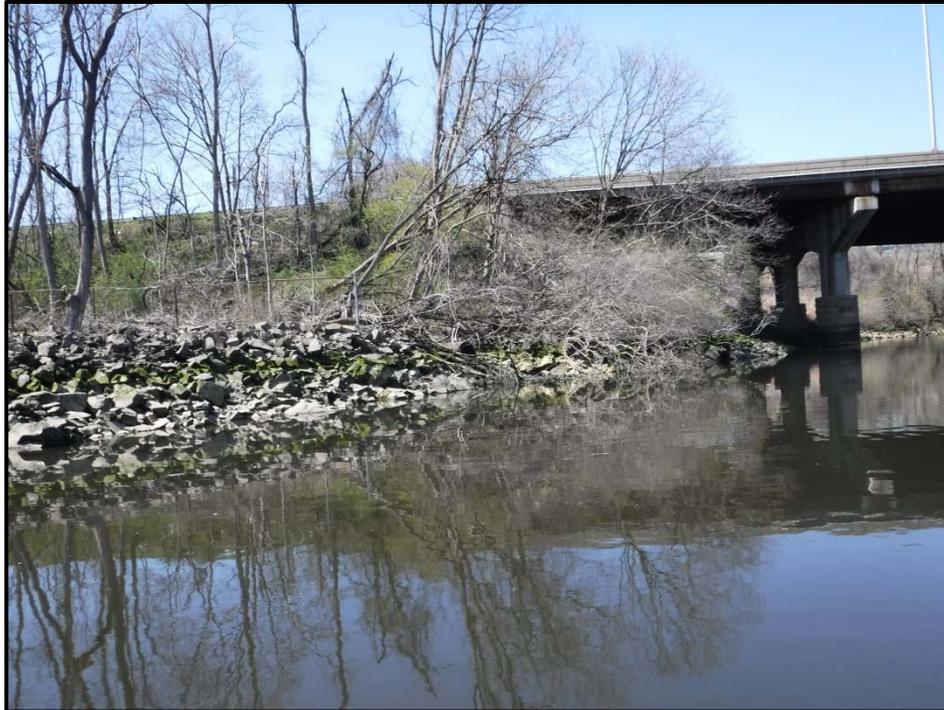
Photo No. 39:
Dumped riprap along Interstate 91, looking northwest,
photo taken April 14, 2016.
