Investigate Reported Areas of Water Infiltration

For
25 Sigourney Street
Hartford, CT 06106
DPW Project Number B1-2B-033L

Prepared For
STATE OF CONNECTICUT
Department of Public Works

November 7, 2008

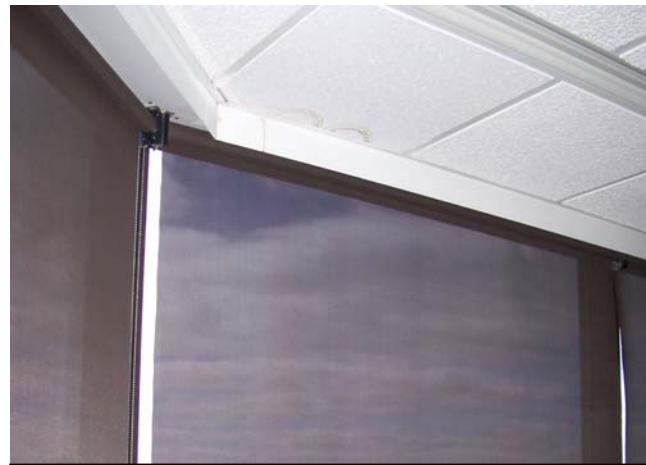
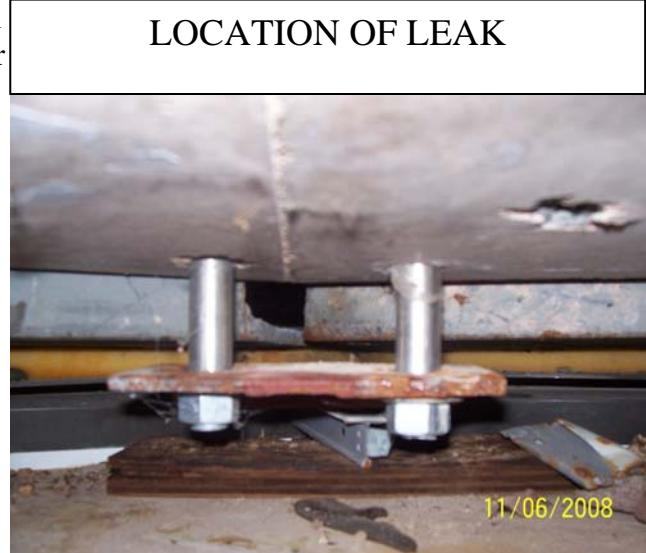
At the request of Connecticut Department of Public Works, Silver Petrucci & Associates, Architects and Engineers was retained to conduct a water infiltration study at 25 Sigourney Street Hartford, Connecticut. Field work was conducted on November 6th 2008, by Silver Petrucci & Associates, Architects and Engineers, to exam an active leak on the 18th floor of the office building at 25 Sigourney Street. The leak was reported in the northwest corner office on the 18th floor around 3pm. When Silver Petrucci & Associates arrived at the building to examine the leak, approximately 1 hour later, there was no active water movement down the window. However, further examination into the ceiling cavity exposed a small pool of water in the middle of the window in the identical location of previous leaks. The water was pooling on top of the metal flashing and spilling over the back of the flashing and dripping through the weld of the flashing at the bend of the window. We were able to see the location of the water in the building, but were unable to track where the leak was entering the building. The current leaks in the building are all occurring in the corner offices on the 18th floor located directly below corner balconies of the 19th floor. We have a few theories about where these remain few leaks are entering the building. We recommend to further examination the balconies on the 19th to determine if the water is gaining access to the building through either the floor of the balconies or through the parapet wall around the balconies. Further testing is recommended to determine the exact locations of water infiltration.
