March 8, 2013

RE: Norwalk Pump Station and Tower Tank
34 Grandview Avenue, Norwalk, Connecticut
Pre-Demolition Asbestos, Lead-Based Paint and Paint Chip Survey

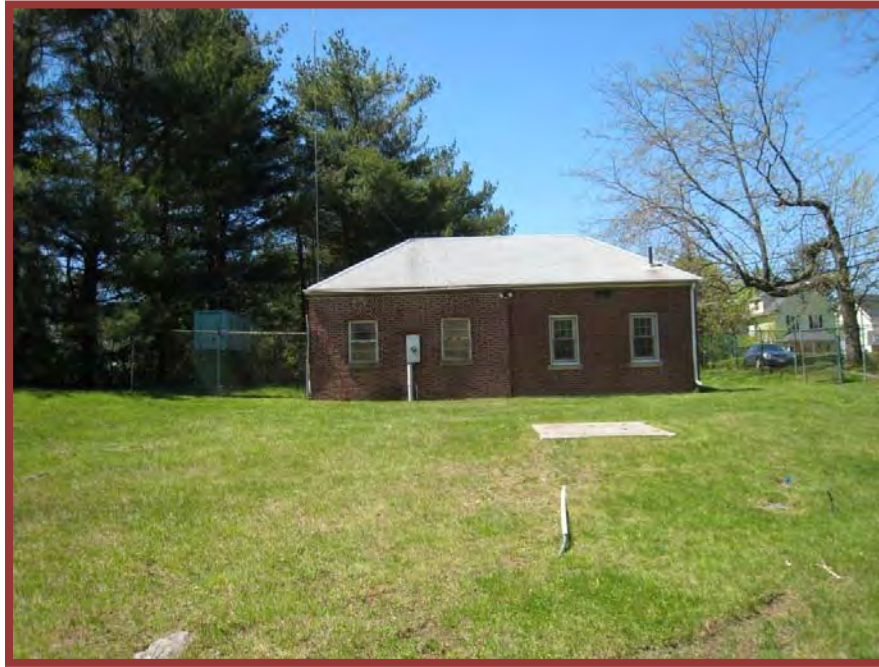
Photo 1 – View of Pump Station facing west.

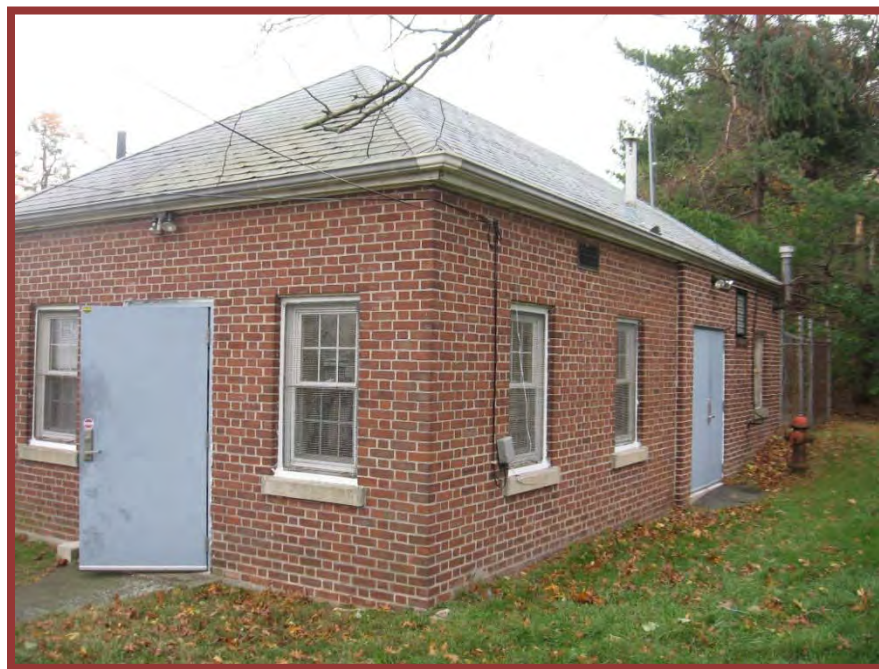
Photo 2 - View Pump Station facing south.

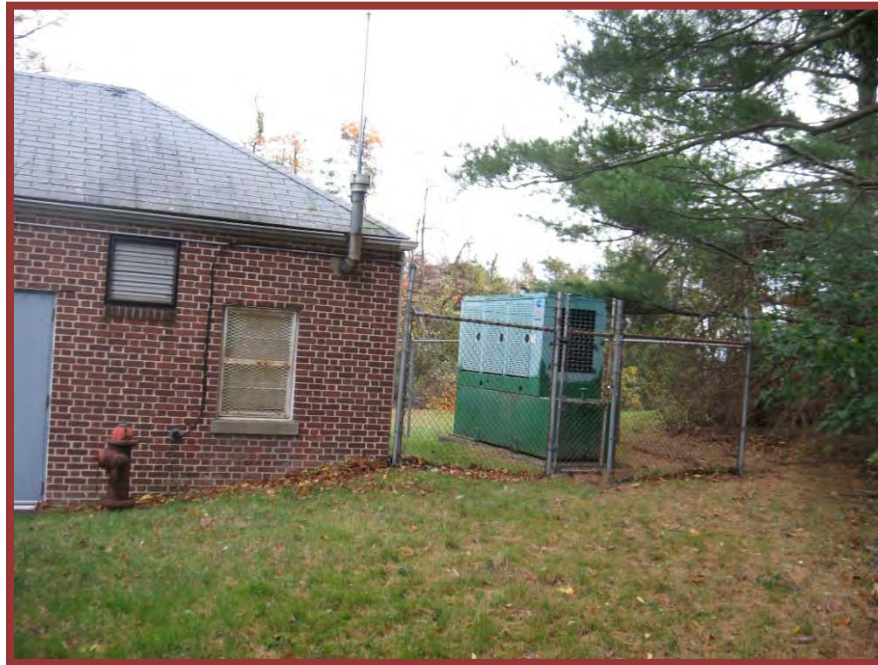
Photo 3 - View of fenced area where generator is located, facing southeast.

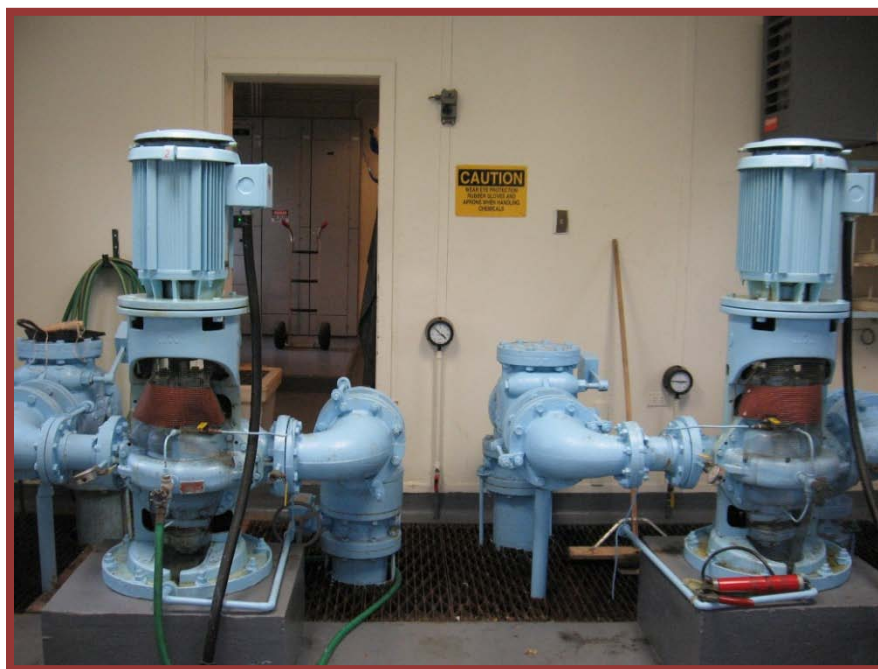
Sample ID	Sample Location	Component	PCB Result (mg/kg) (ppm)	Estimated Affected Area
RM1 Pump Unit	Room 1	Blue Painted Pump Unit	2.4/0.71*	35 ft ²
RM2/1 Floor	Room 2/1	Grey Painted Concrete Floor	0.61	N/A
RM2 Wall	Room 2	White Painted Brick Wall	ND<0.50	N/A
Cntrl Water Tnk Pipe	Elevated Water Tank	Painted Water Tank Pipe	0.66	N/A
Water Tnk Supp. Col.	Elevated Water Tank	Painted Water Tank Support Columns	89	2,500 ft ²

Photo 4 - View of pump units in Room 1 of Pump Station.

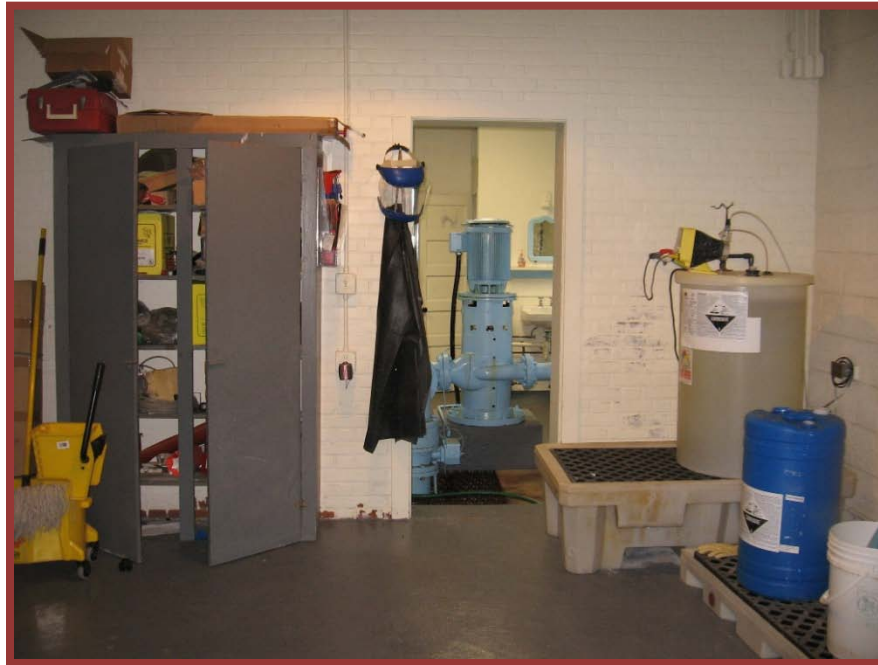
Photo 5 - View of Room 2 of Pump Station, facing north.

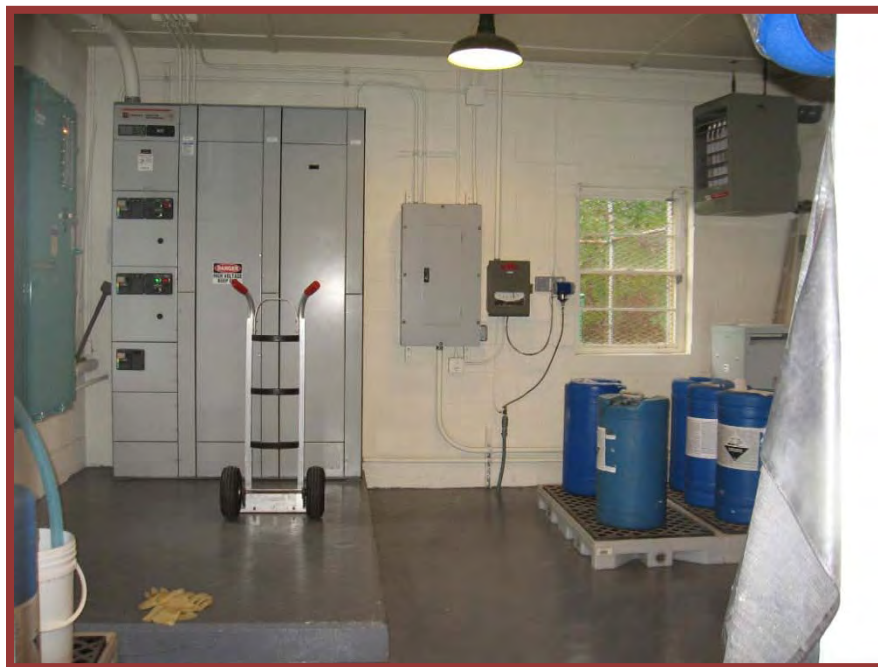
Photo 6 - View of Room 2 of Pump Station, facing south.

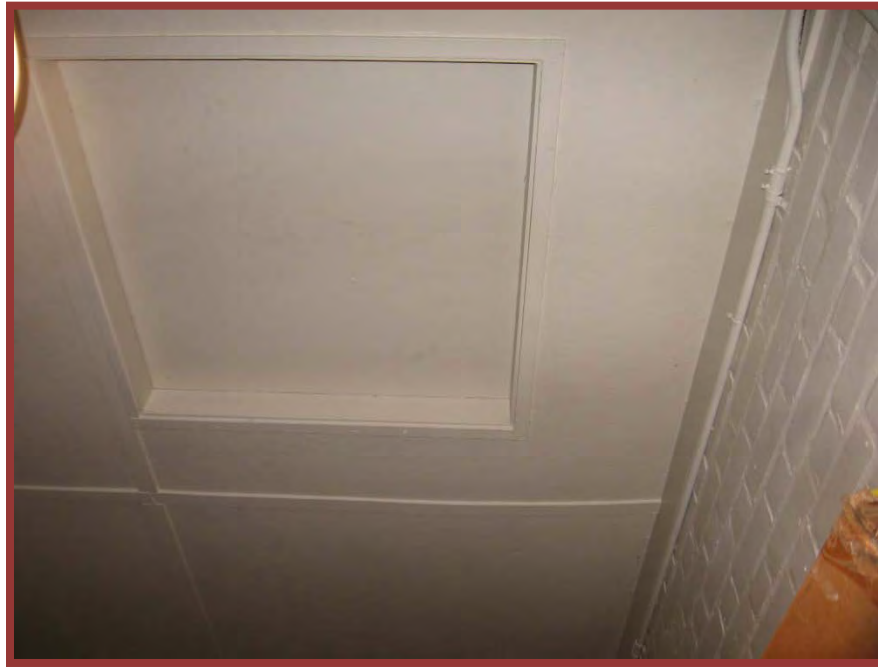
Photo 7 - View of ceiling hatch in Room 2 used to access crawl space.

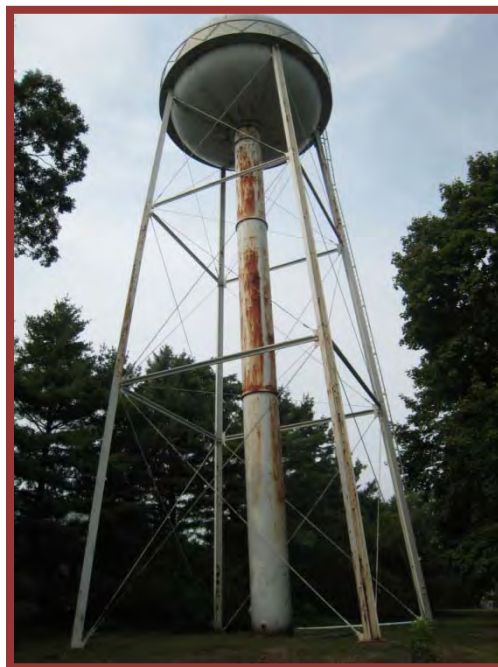
The soffit that runs along the north, east and west sides of building's Room 1 has LBP. The soffit observed along the east, west and south sides of the building where Room 2 is located does not have LBP. In addition, the tank tower support legs and horizontal bracings have LBP. The top of the tower tank was not accessed during the inspection. The ladder was equipped with no safety cage and no safety climb rail.

Per Client's request, the painted surface of the elevated tank was not evaluated for PCBs as part of this survey. **Therefore, the paint on the tank is assumed to contain PCBs.**

Photo 8 - View of elevated Water Tank facing north.
