RE: Docket No. 508: Milvon to West River Railroad Transmission Line 115kV Rebuild Project
Quarterly Construction Status Report – Q1 2024

CSC DOCKET #508 MILVON TO WEST RIVER RAILROAD TRANSMISSION LINE 115 KV REBUILD

Quarter: Q1 2024

Report #3

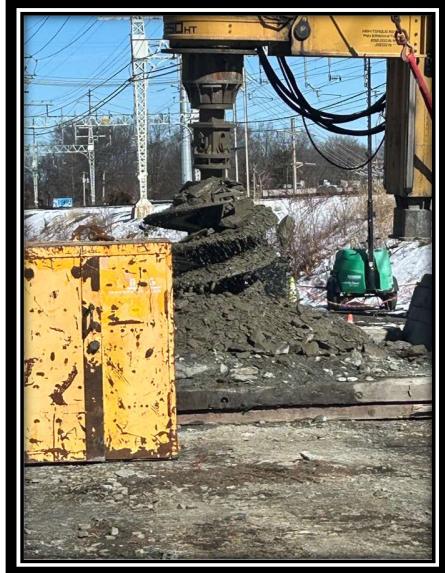
Photo 1: Typical drilling process, with spin-off bin for soils.

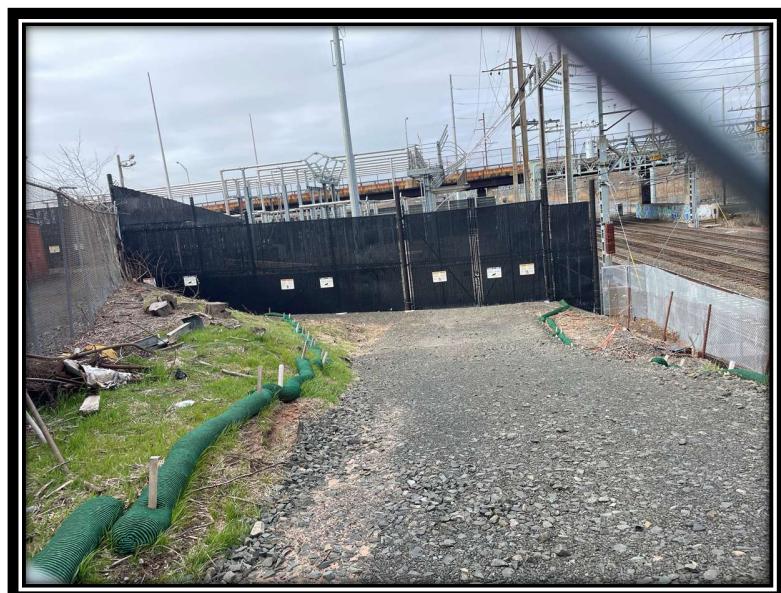
Photo 2: Permanent road installation off Grant Street and into the West River Substation. Completed with erosion controls, mulching, and seeding.

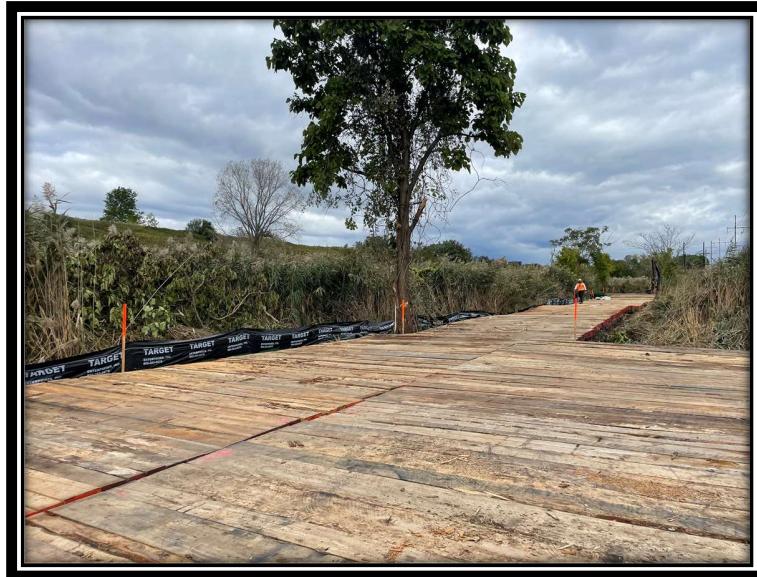
Photo 3: Matting through wetland area, located on western side of the West River.

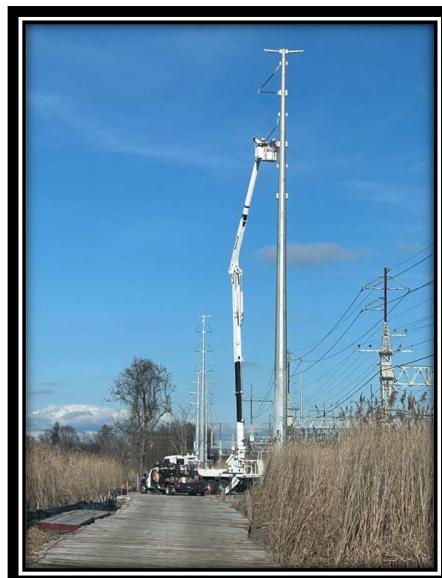
Photo 4 : Overhead work along temporary access road, west side of the West River.

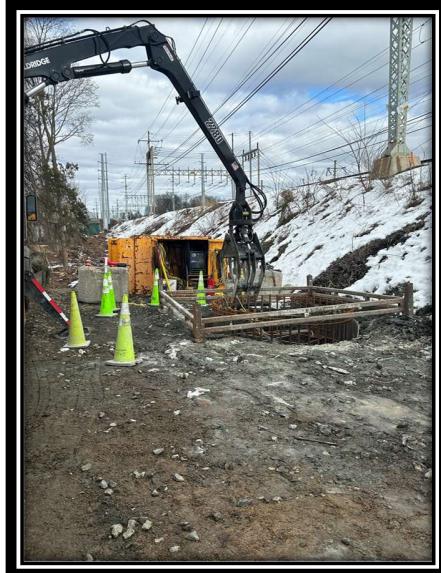
Photo 5: Typical cage setting for foundation concrete pour.

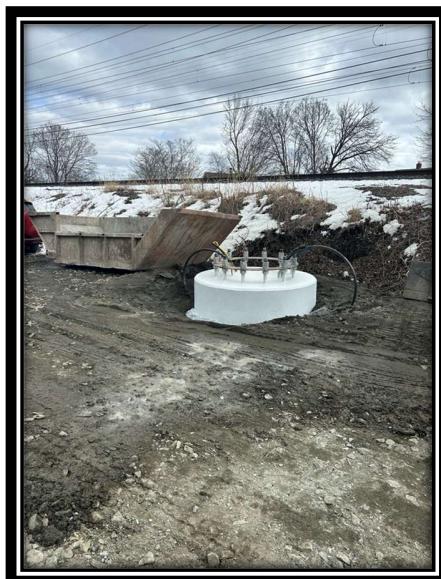
Photo 6: Typical completed foundation.

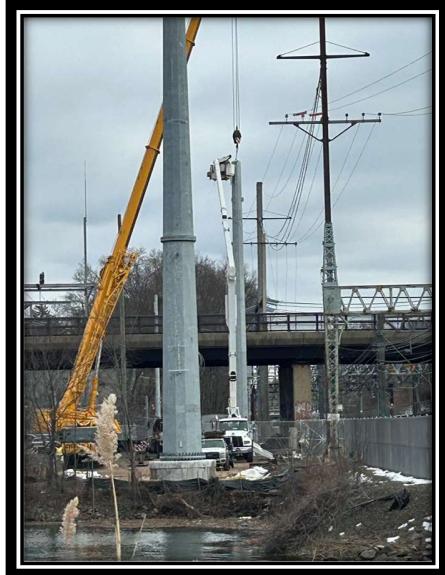
Photo 6: P1049N and P1049EN setting, located on east side of the West River.

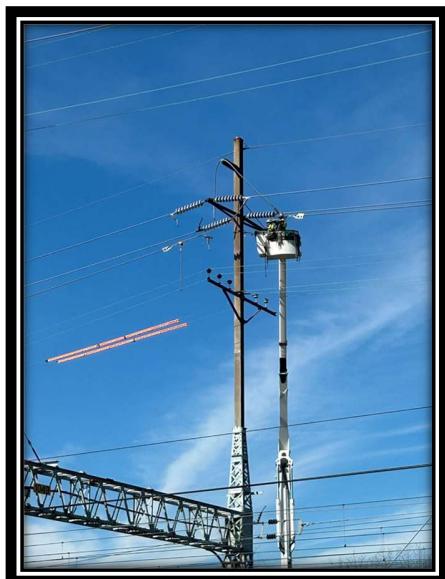
Photo 7: Typical bonnet removal.

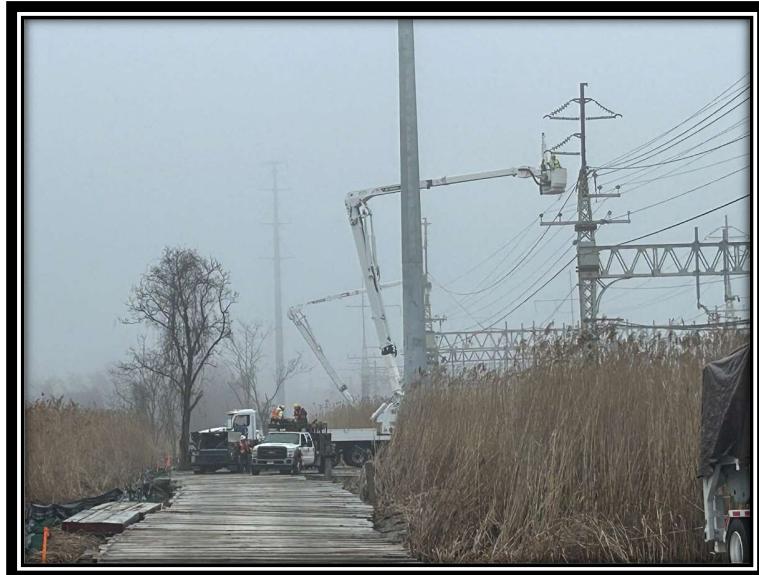
Photo 8: Typical bonnet removal.

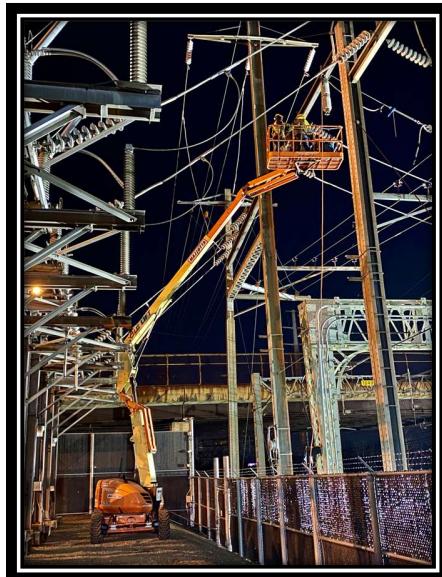
Photo 9: Pulling of phases into the West River South Substation.

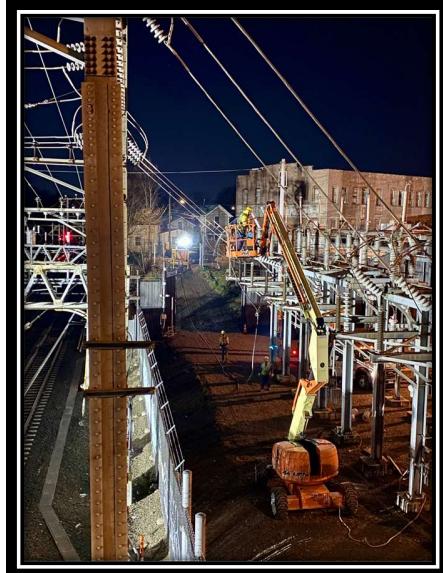
Photo 10: Pulling of phases into the West River South Substation.

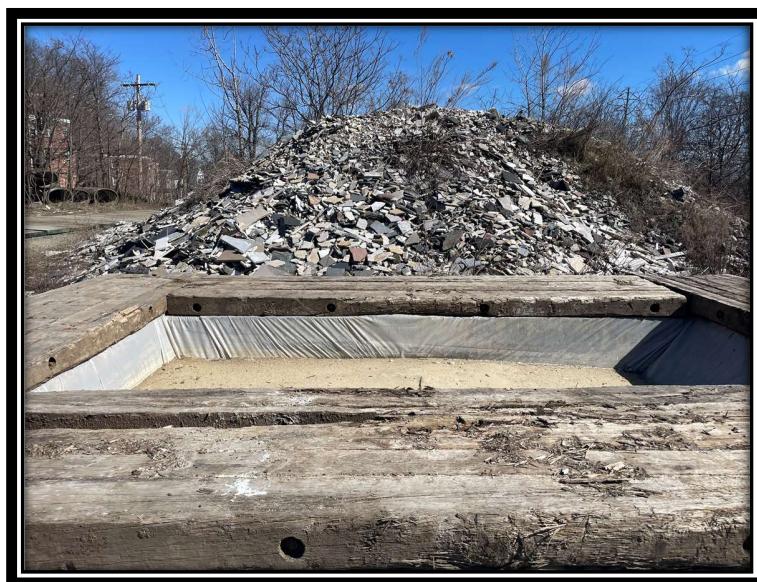
Photo 11: Concrete washout bin. Adjacent stockpile from property owner.

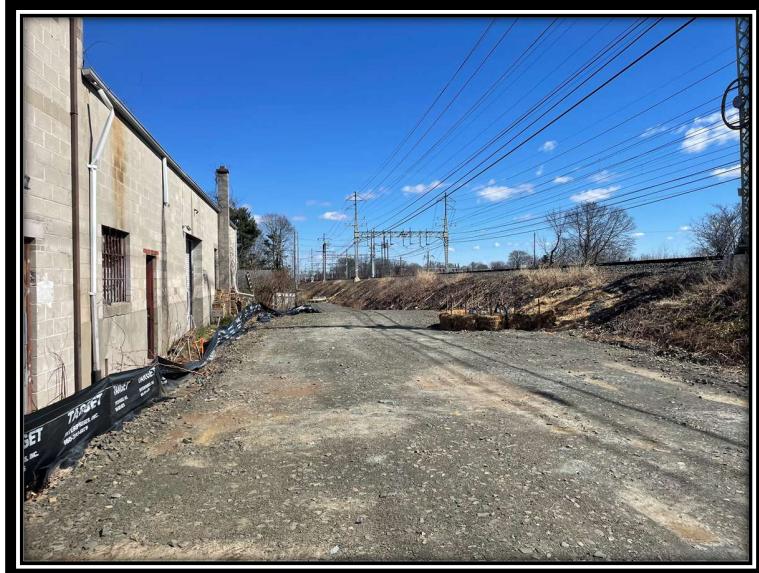
- The elimination of temporary construction matting along most of the permanent access road for Structures P1027N and P1028N, the reduction of grubbing in certain areas in the vicinity of the access road, the use of temporary gravel with geotextile fabric in lieu of temporary matting around the access drive between and around Structures P1027N and P1028N, and the use of temporary construction matting along the northwestern side of the access road turnaround at Structure 1028N was implemented. The deviation was requested February 13, 2024, and approved by the CSC February 16, 2024.

- A rock construction entrance was implemented where the access road to Structures 1027N, 1028N, and 1026N meets Clark Street due to wet field conditions and concerns for sediment migration and erosion. This rock construction entrance has mitigated this concern.

Photo 12: Temporary/permanent gravel access road to P1028N and P1027N.

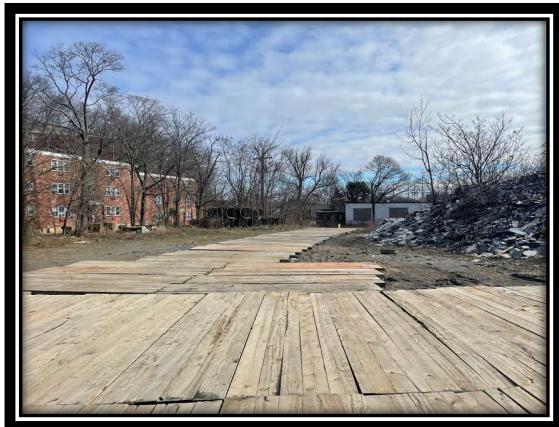
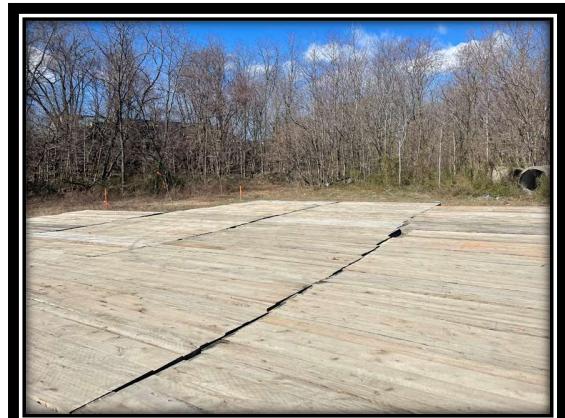
- Due to inclement weather conditions, the work pad area and access road associated with P1026N was observed to need additional erosion and sediment controls. To prevent the migration of sediment and erosion in this area, the temporary matting associated with the work pad at P1026N was expanded and extended to encompass the temporary access road. The temporary matting was utilized only on the same property and within the same general project work area. This has prevented the migration of sediments and soils. Due to the nature of matting and relatively level area, additional disturbance was not implemented. As needed and following the removal of the temporary matting, the area will be reseeded.

Photo 13: Temporary matted access road and work pad associated with P1026N. Accumulated stockpile associated with property owner's activities.

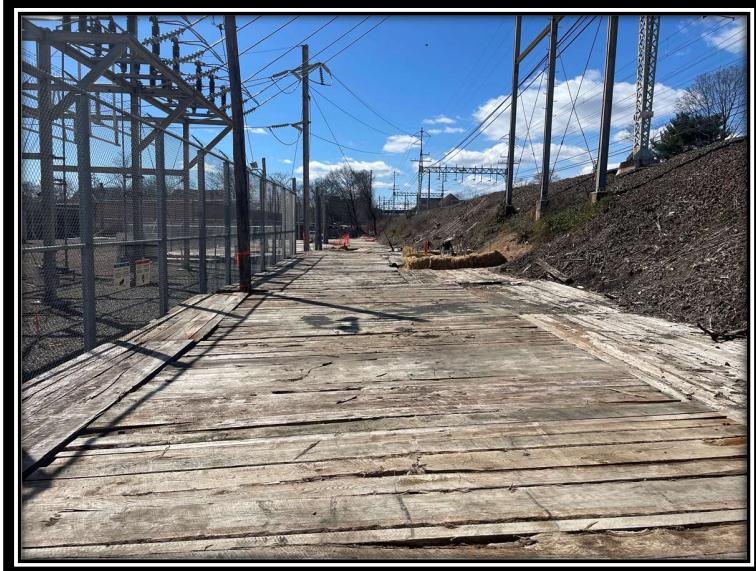
Photo 14: Work pad associated with P1029ES, P1029WNS, P1029SS, and P1028S, facing southwest.

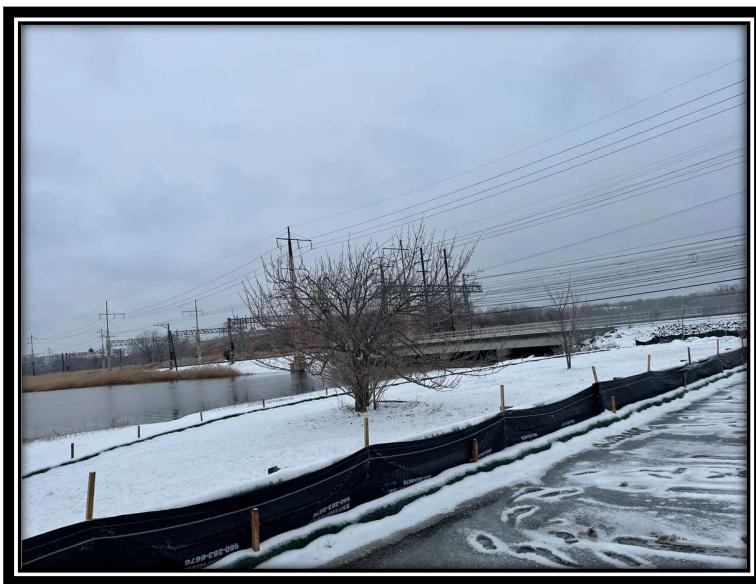
Photo 15: Exclusionary fencing associated with P1049S and P1049ES work pad.

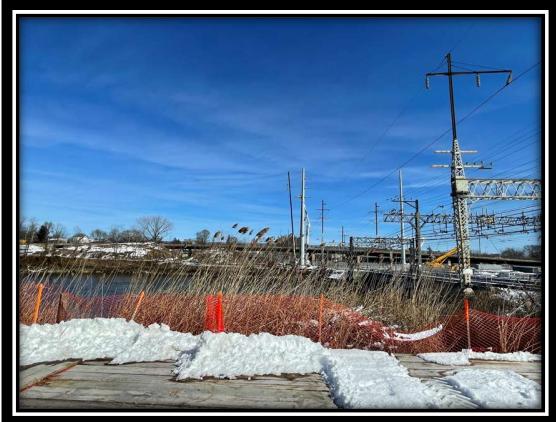
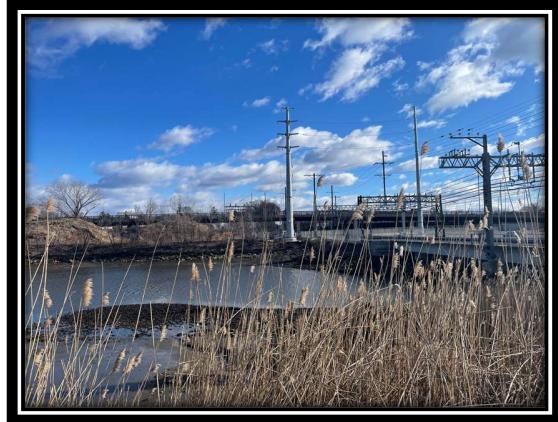
- Removal of the H-Frame on the west side of the West River was conducted. Previously, UI requested and received approval to modify work pads within the freshwater and tidal wetlands for this work from the CSC and CTDEEP. The construction contractor identified alternative means and methods involving equipment, rather than implementing the requested reconfiguration of timber matting in the wetland areas. By utilizing alternative means and methods, timber matting in the wetland areas was reduced by approximately 1,202 sq.ft. in inland wetlands and 628 sq.ft. in tidal wetlands, totaling a reduction of 5,472 sq.ft. of temporary wetland impacts.

Photo 16: Current unobstructed view of the West River, facing north-northeast, following removal of the H-Frame.
