CONNECTICUT SITING COUNCIL

Post-Construction Report

Date: August 11, 2010

RE: **DOCKET NO. 380** - SBA Infrastructure LLC Certificate of Environmental Compatibility and Public Need for the construction, maintenance and operation of a wireless telecommunications facility at 47 Garrett Ridge Drive, New Hartford, Connecticut.

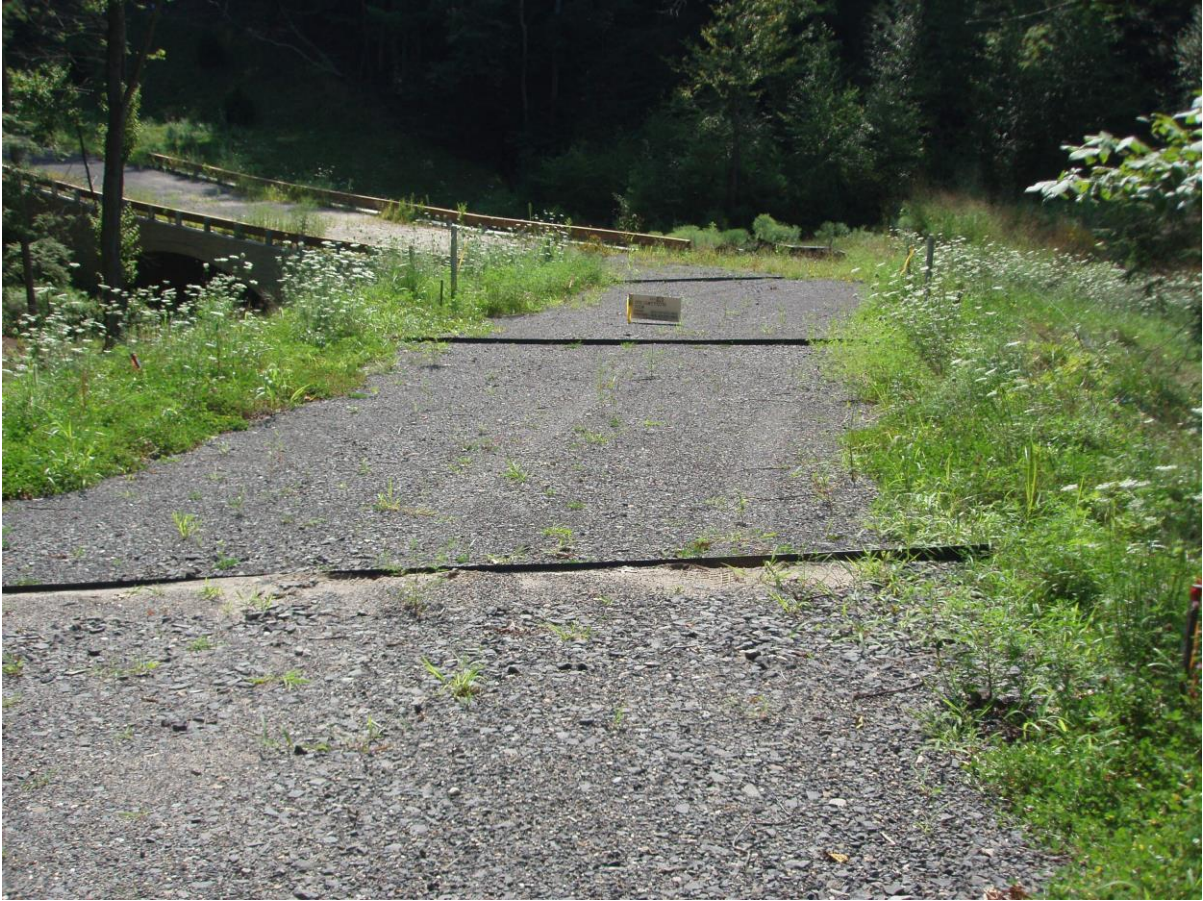
Rubber deflectors in the access road. Note re-vegetated side slopes.

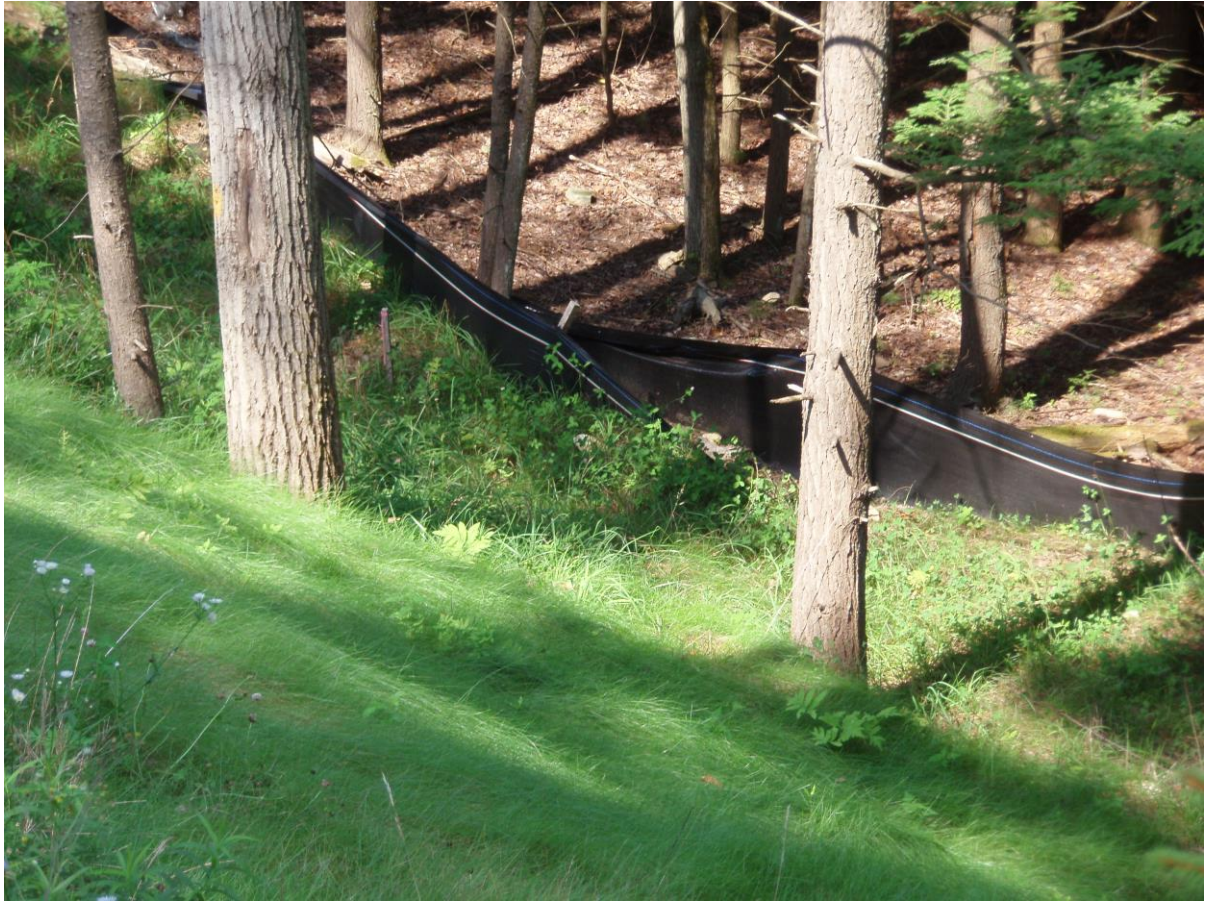
No erosion issues were evident at the site and the fabric soil erosion control fencing should be removed to enable movement of small animals around the site and adjacent wetland area. A storm water collection basin associated with a subdivision adjacent to the site is filling with sand with sandy discharge flowing into the wetland north of the bridge. This detention basin is not associated with this project. During construction of the site and at the request of the Metropolitan District Commission, the Certificate Holder installed several rows of soil control measures (silt fence and hay bales) in the wetland to control flow from this detention basin. The hay bale measures are disintegrating and pose no impediment to wetland functions.

Erosion control fence at base of re-vegetated embankment.

A letter will be drafted to the Certificate Holder for proper removal of the fabric soil erosion control fencing adjacent to the access road and the wetland north of the bridge.

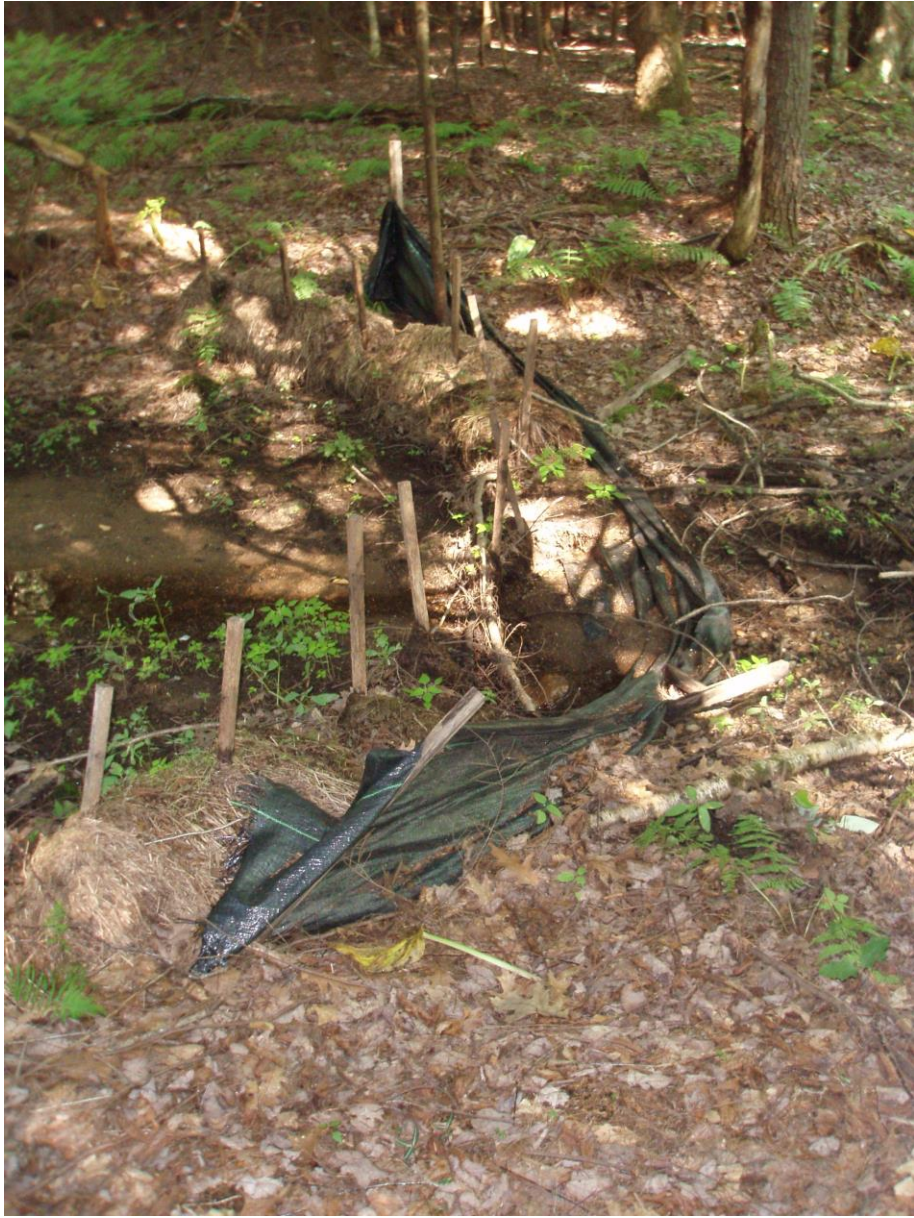
Erosion control fence in wetland area north of bridge.
