Final Summary Report

Project: Bay Communications Site CT0007 Facility Address: Moose Hill Road, Guilford, Connecticut Date: February 5, 2016

Report No._1_

PHOTO DOCUMENTATION Bay Communication Environmental Monitoring Inspection Moose Hill Road, Guilford, CT Photos taken on June 10, 2015

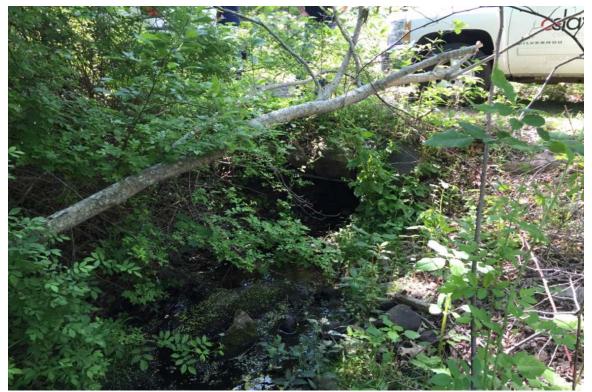
Photo 2: View of existing stream culvert crossing north side looking south.

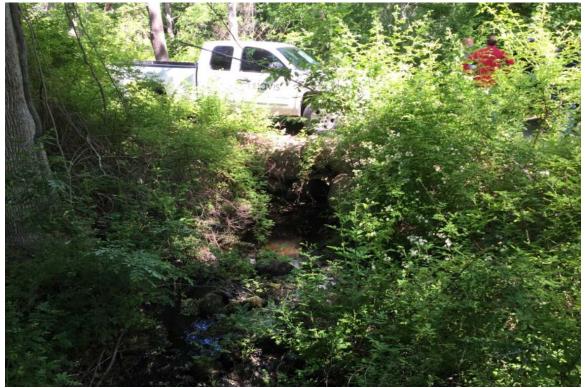
Photo 3: View of existing stream culvert crossing south side looking north.

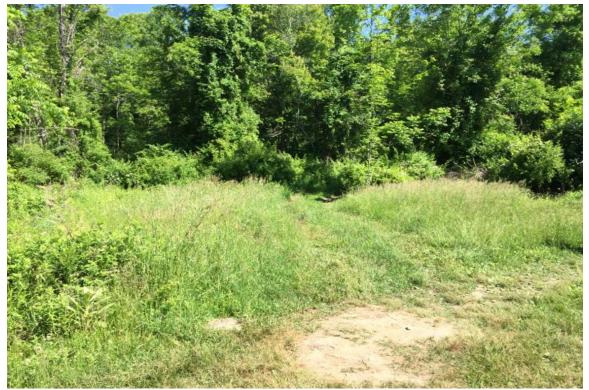
Photo 4: View of proposed additional laydown area looking north.

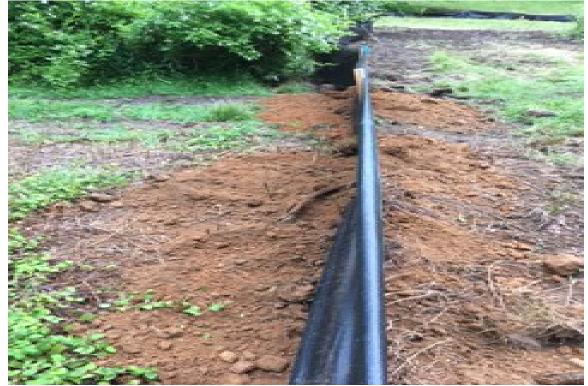
Photo 1: View of properly buries silt fence flap (typ.), looking east.

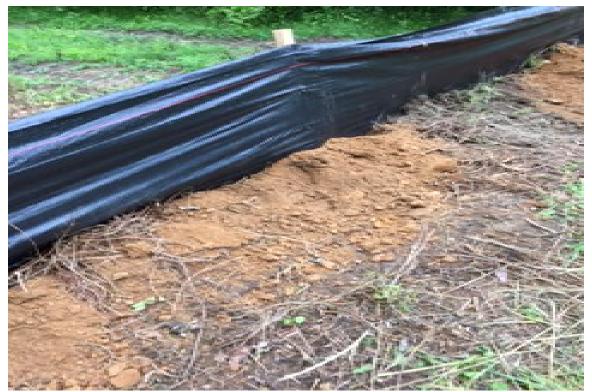
Photo 2: View of properly buried silt fence flap (typ.), looking north.

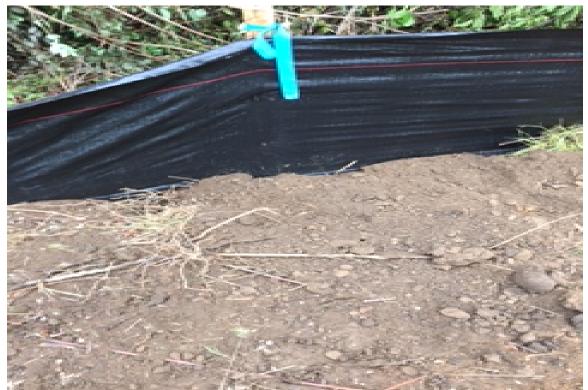
Photo 3: View of properly buried silt fence flap (typ.), looking north.

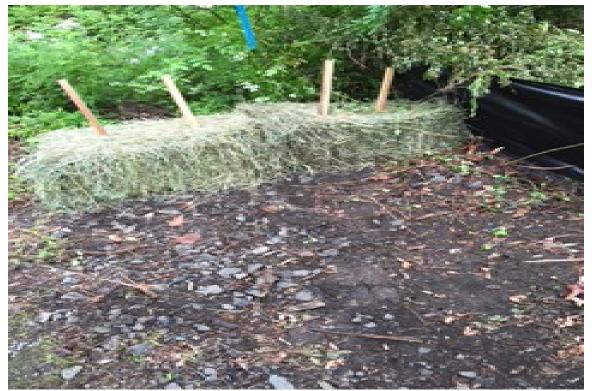
Photo 4: View of straw bales check dam near stream crossing, looking east.

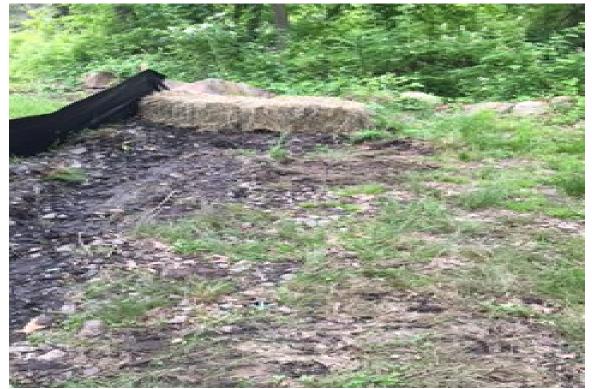
Photo 5: View of straw bales check dam near stream crossing, looking west.

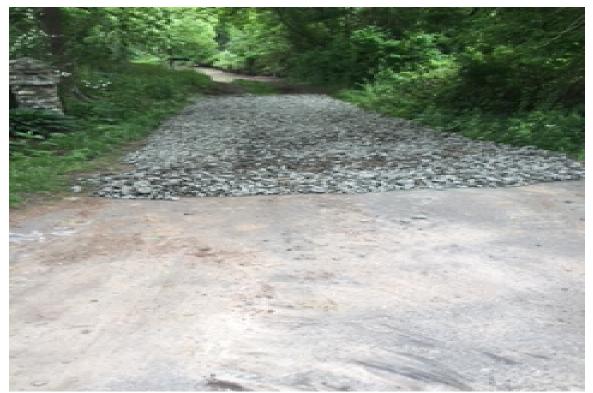
Photo 6: View of anti-tracking pad at construction entrance looking east from Moose Hill Road.

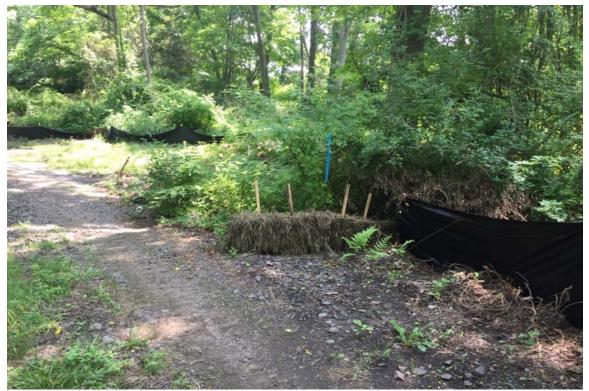
Photo 2: View of southwest side of culvert looking southeast at staked check dam.

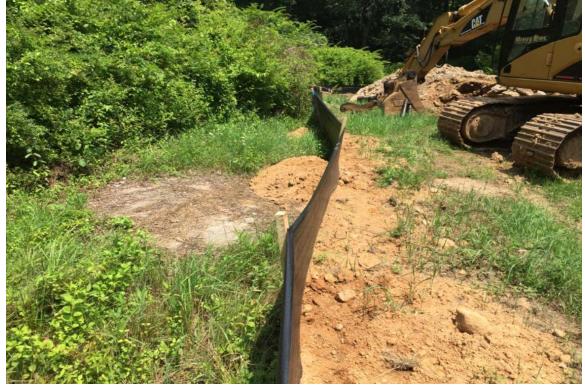
Photo 3: View of silt fence properly buried in exposed bedrock area looking northeast.

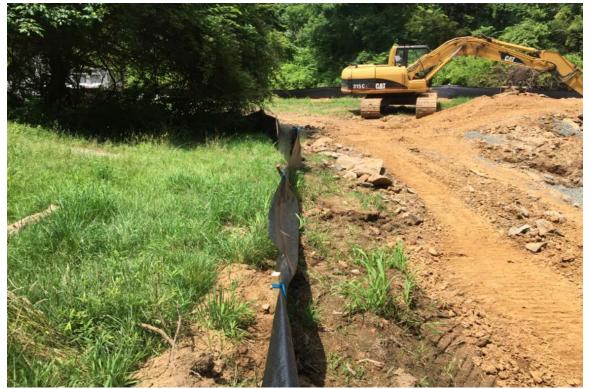
Photo 4: View of silt fence properly buried looking west.

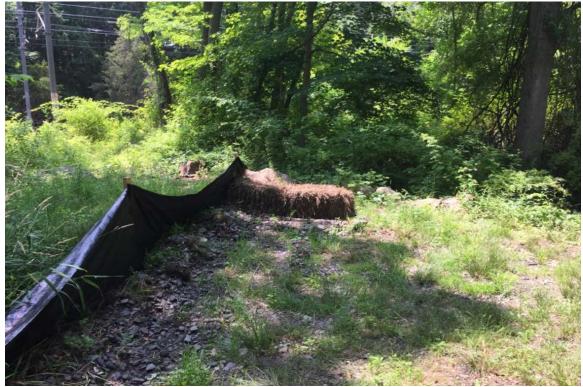
Photo 5: View of southeast side of culvert looking southwest correction area #1 bales need to be staked down.

Minor Correction Area #1 – stake straw bales check dam	to be corrected							
Minor Correction Area #2 – stake straw bales check dam	to be corrected							
Project Modification Requested:								
Extra Work Space Requested								
Change to Work Area								
Description of Modification:

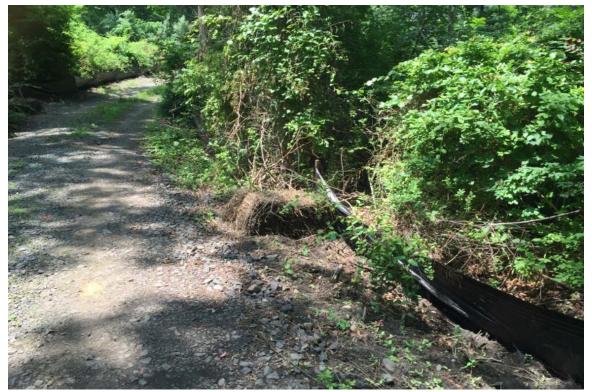
Photo 6: View of northeast side of culvert looking west correction area #2 stake bale needs to be staked down.

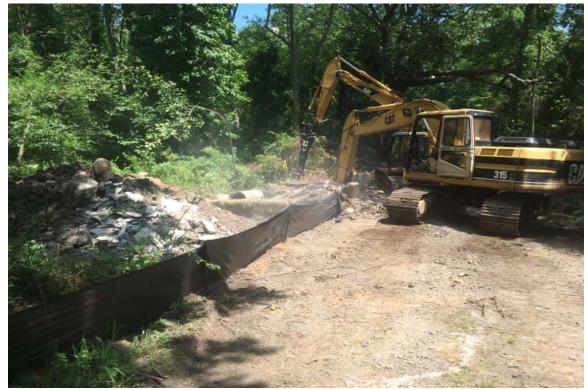
Photo 1: View of new stream crossing culvert in mid construction looking east.

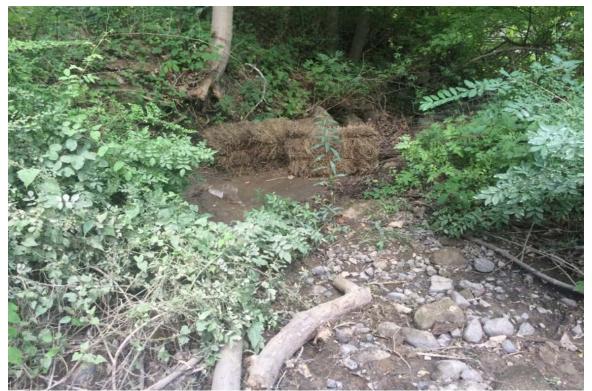
Photo 2: View of hay bale check dam in streambed south side (dry streambed, no flows) looking south.

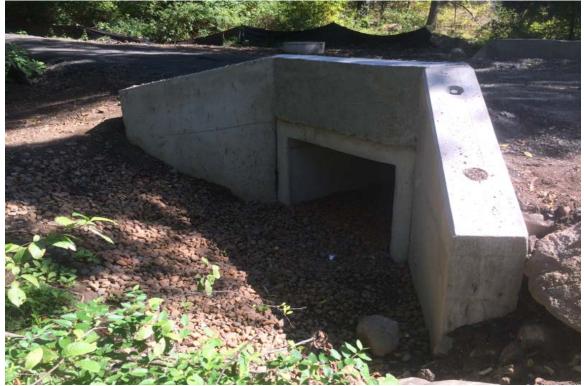
Photo 1: View of stream crossing new culvert inlet looking southeast, culvert set a proper elevation and backfilled with 1 foot of streambed material.

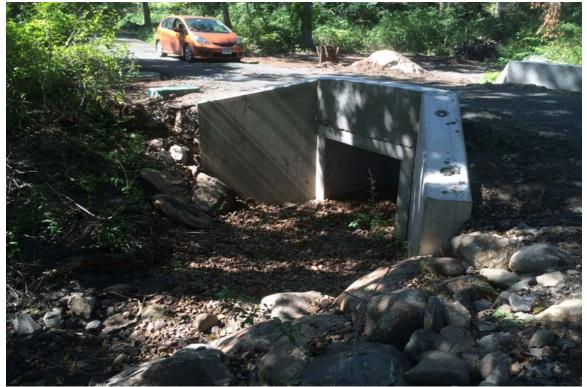
Photo 2: View of culvert outlet looking northwest, culvert set a proper elevation and backfilled with 1 foot of streambed material.

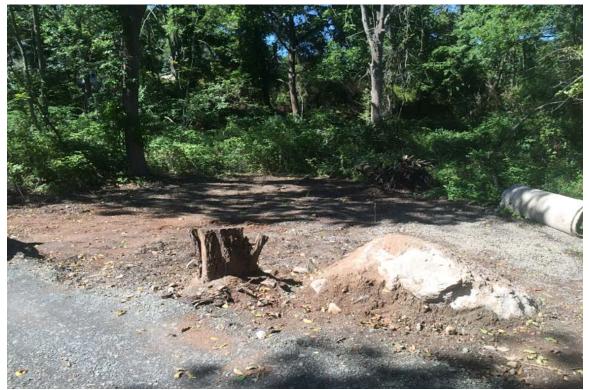
Photo 3: View of new stream crossing staging area partially restored looking north, area requires additional restoration.

07/24/15 – None	N/A		
Silt Fence needs to be reestablished around compound	to be completed		
Small silt fence breaks along access road need repair	to be completed		
Stream crossing side slopes need to be stabilized & check dams installed	to be completed		
Stream crossing staging area need to be stabilized	to be completed		
Project Modification Requested:			
Extra Work Space Requested			
Change to Work Area			
Description of Modification:

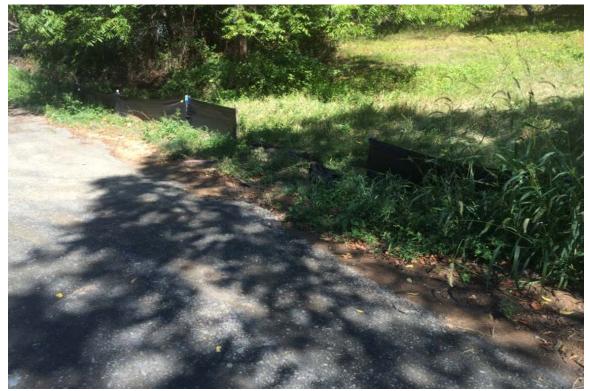
Photo 5: View of small break in silt fencing (typ.) that needs to be corrected, looking east.

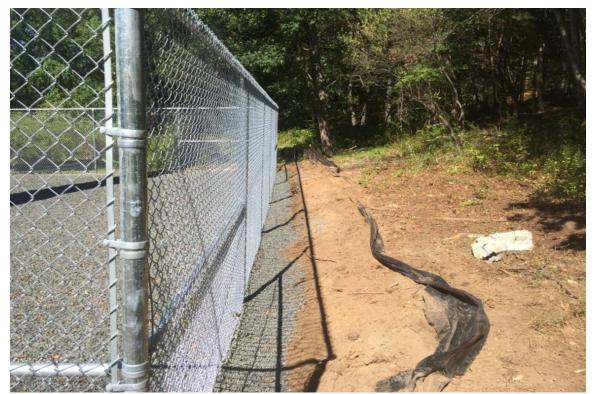
Photo 6: View of west side of compound looking north, silt fence needs to be reestablished around compound.

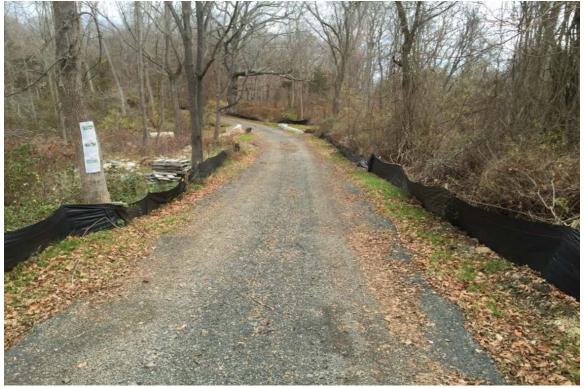
Photo 2: View of stabilized access road looking east.

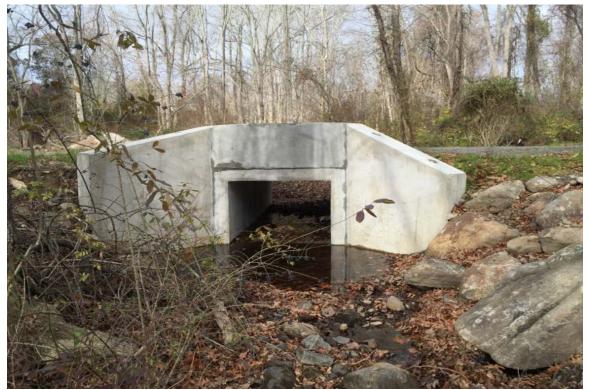
Photo 3: View of south side of stabilized culvert looking northwest.

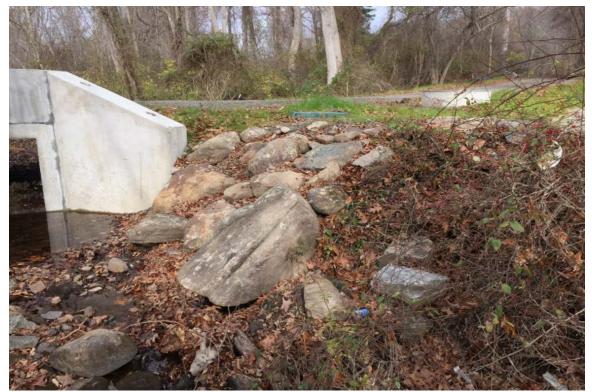
Photo 4: View of permanently stabilized southeast bank.

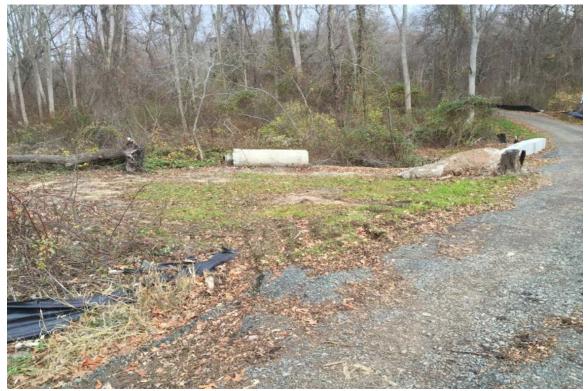
Photo 5: View of stream crossing staging area permanently stabilized looking northeast.

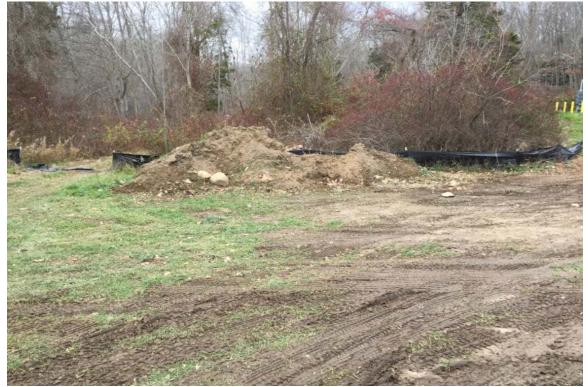
Photo 7: View of construction staging area and topsoil pile looking north. Area needs to be stabilized with seed and mulch.

Stream crossing staging area need to be stabilized - completed	11/30/15		
Loam stockpile – spread, seed and mulch	To Be Completed		
Construction Staging Area – loam, seed and mulch	To Be Completed		
Remove silt fence from all areas	To Be Completed		
Project Modification Requested:			
Extra Work Space RequestedIChange to Work AreaIDescription of Modification:

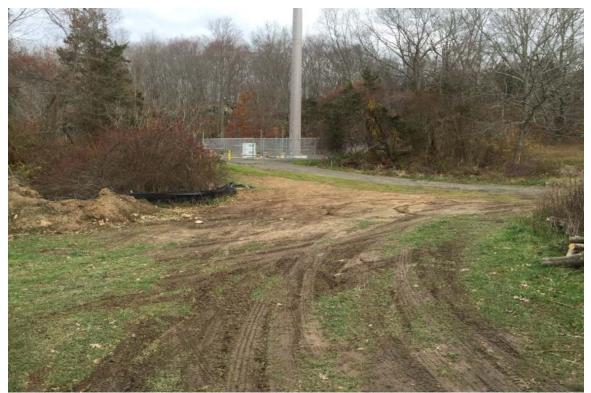
Photo 8: View of construction staging area and topsoil pile looking northeast. Area needs to be stabilized with seed and mulch.

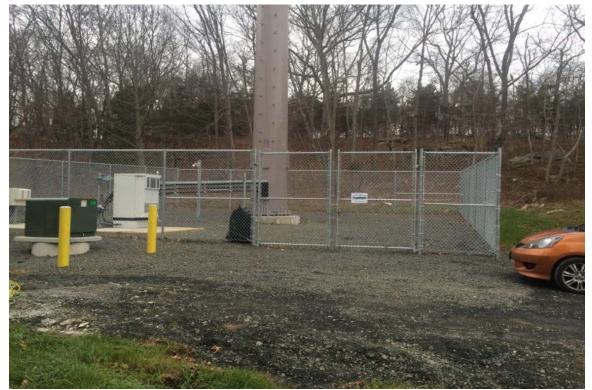
Photo 1: View of stabilized compound looking east.

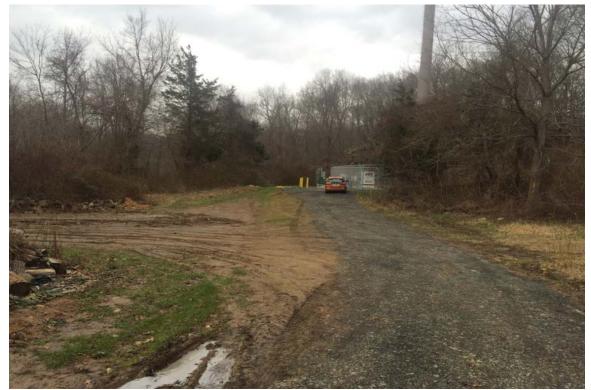
Photo 3: View of stabilized access road looking north.

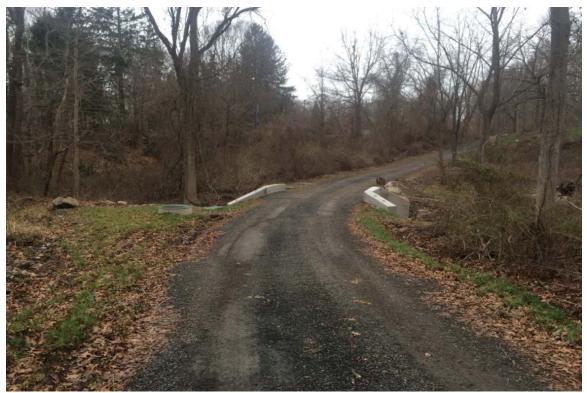
Photo 4: View of stabilized culvert crossing looking west.

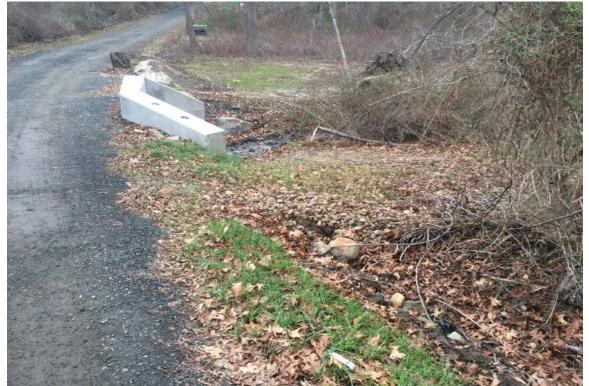
Photo 5: View of stabilized culvert crossing inlet looking west.

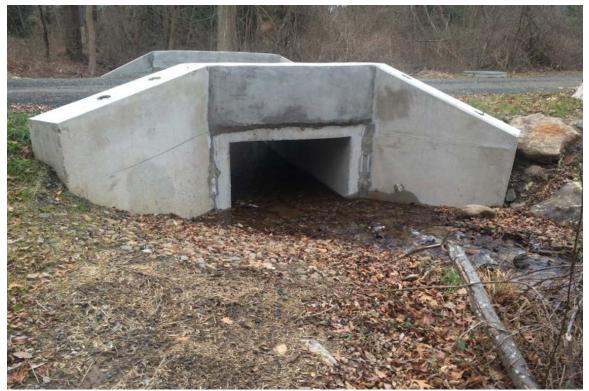
Photo 6: View of stabilized culvert crossing inlet looking north.

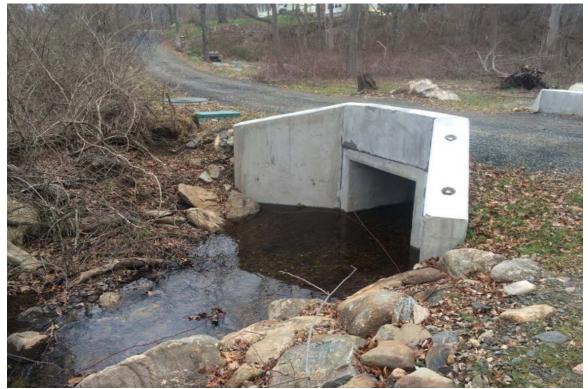
Photo 7: View of stabilized culvert crossing outlet looking west.

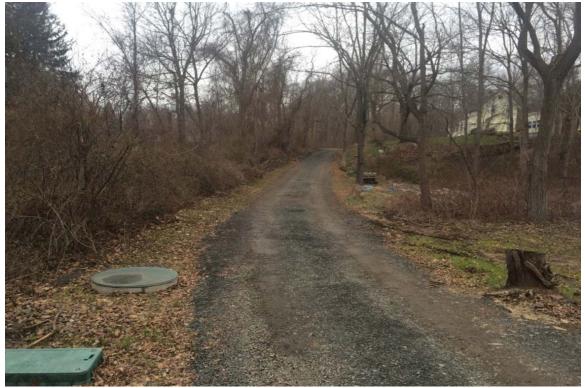
Photo 8: View of stabilized access road looking west.

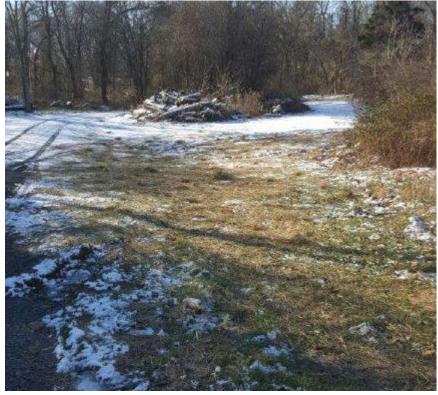
Photo 9: View of seeded and mulched construction staging area looking southwest.

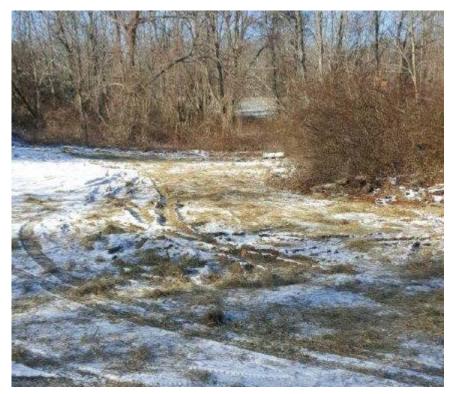
Photo 10: View of seeded and mulched construction staging area looking west.
