Docket No. 424 – Development and Management Plan Inspection

The Connecticut Light and Power Company Certificate of Environmental Compatibility and Public Need for the Connecticut portion of the Interstate Reliability Project.

**Card Street Substation  
 Interim Week Inspection:**

**Card Street Substation  
 Bi-Week Submission Inspection:**

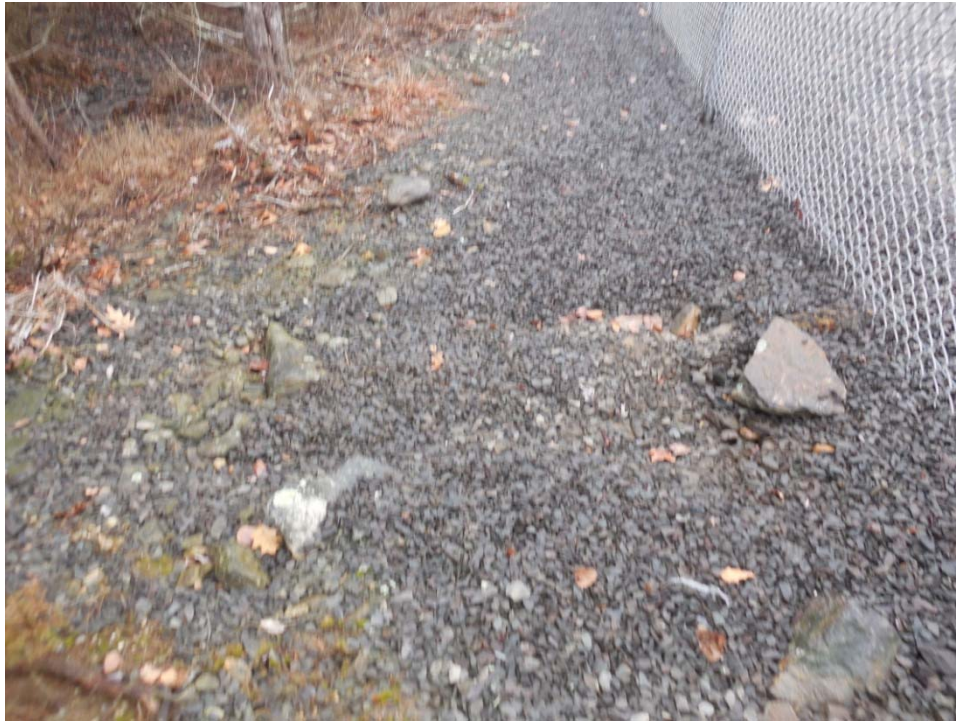
Photo #1: View (facing west) of runoff outlet at southwestern edge of substation with no apparent sedimentation.

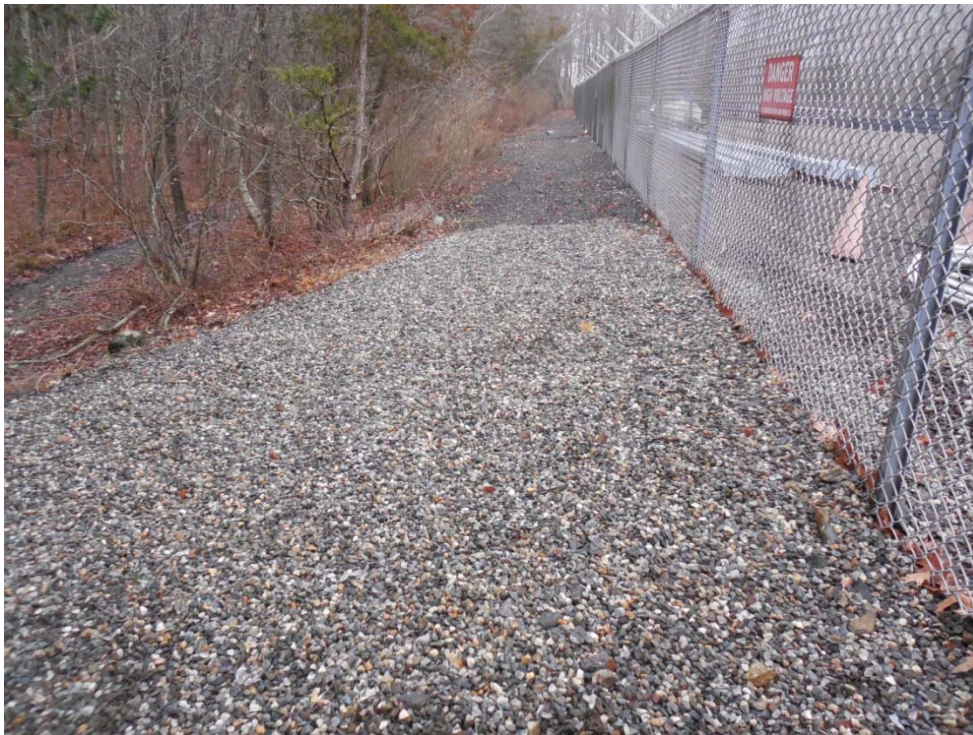
Photo #2: View (facing west) of third (main) runoff outlet at southwestern edge of substation with no apparent sedimentation.

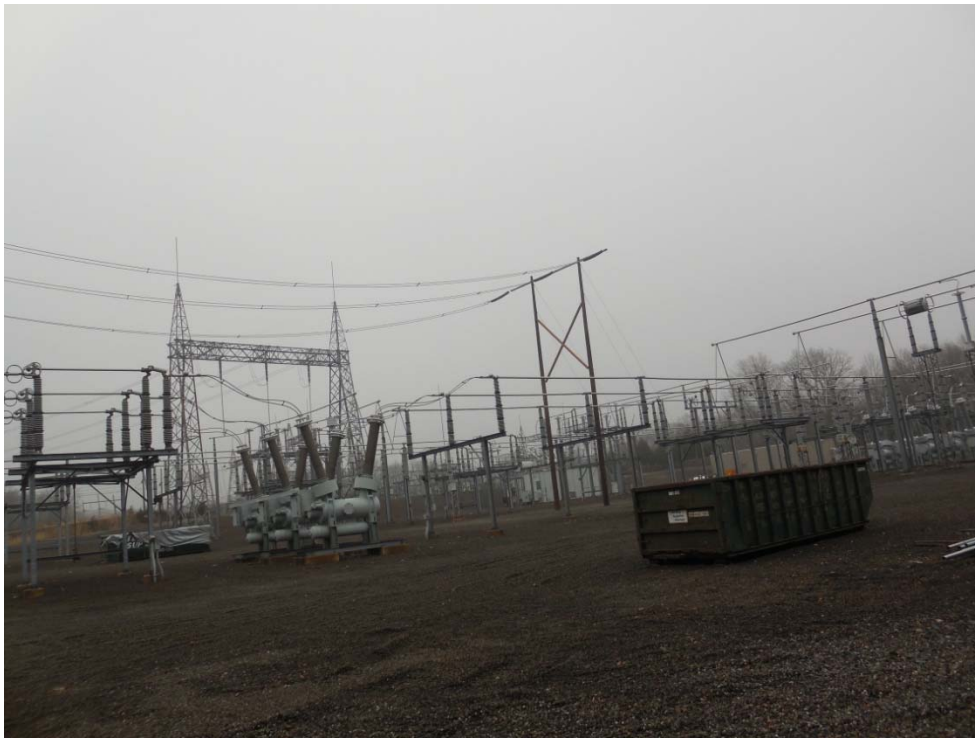
Photo #3: View (facing northeast) of first of two new Wood Pole H-frame Structures and contained, covered stockpile dumpster (left background of photo).

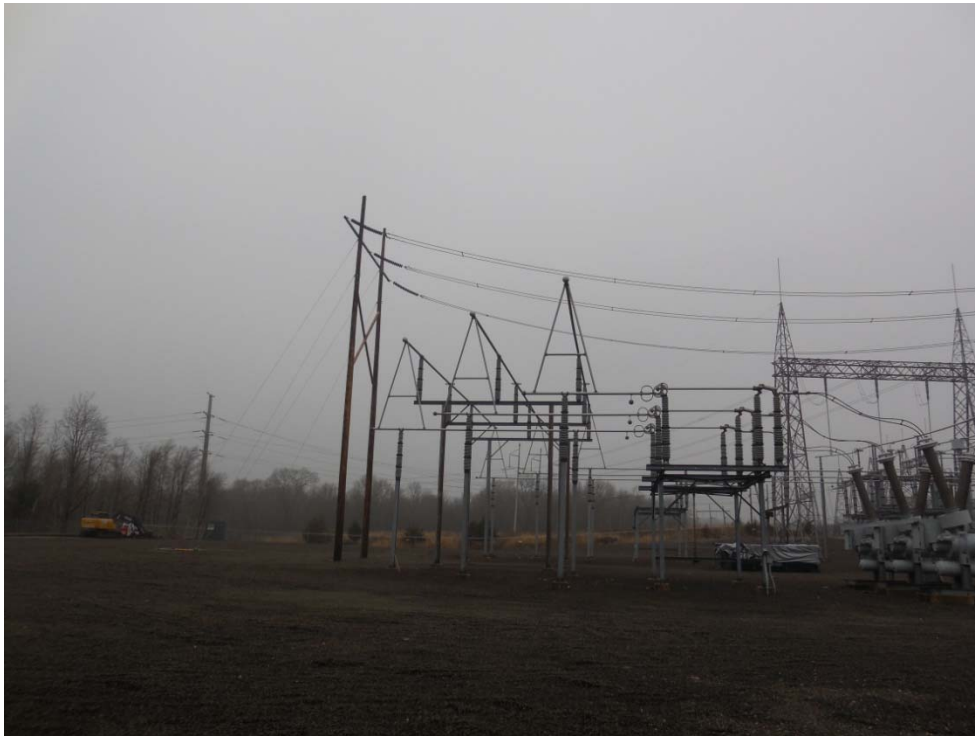
Photo #4: View (facing northwest) of second of two new Wood Pole H-frame Structures.

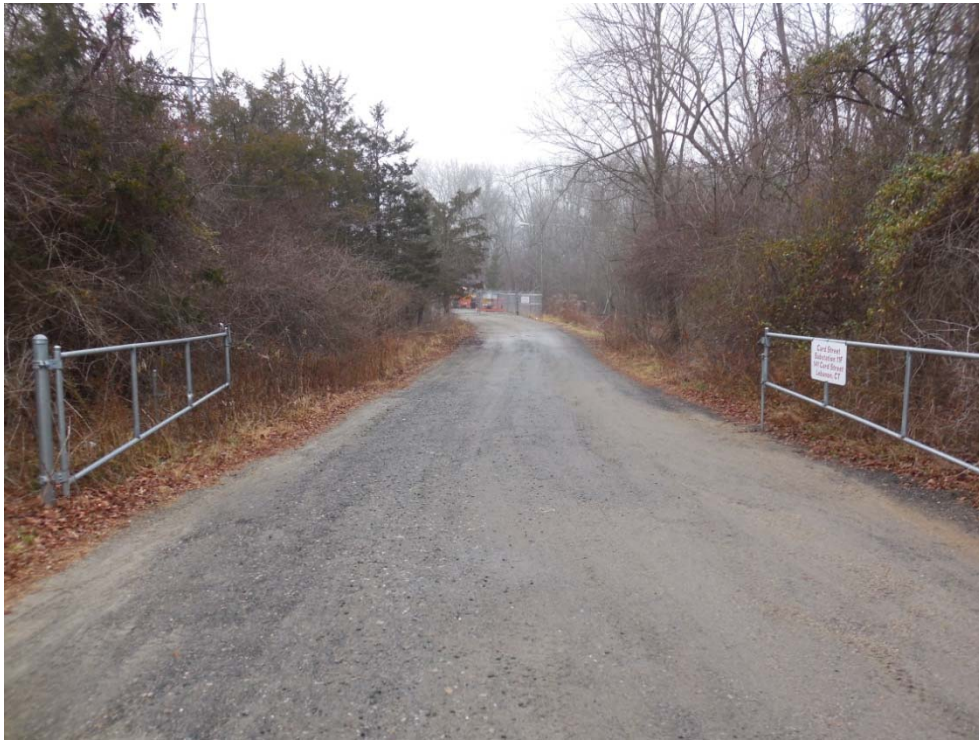
Photo #5: View (facing north) of heavily tracked and compacted entrance pad to substation.

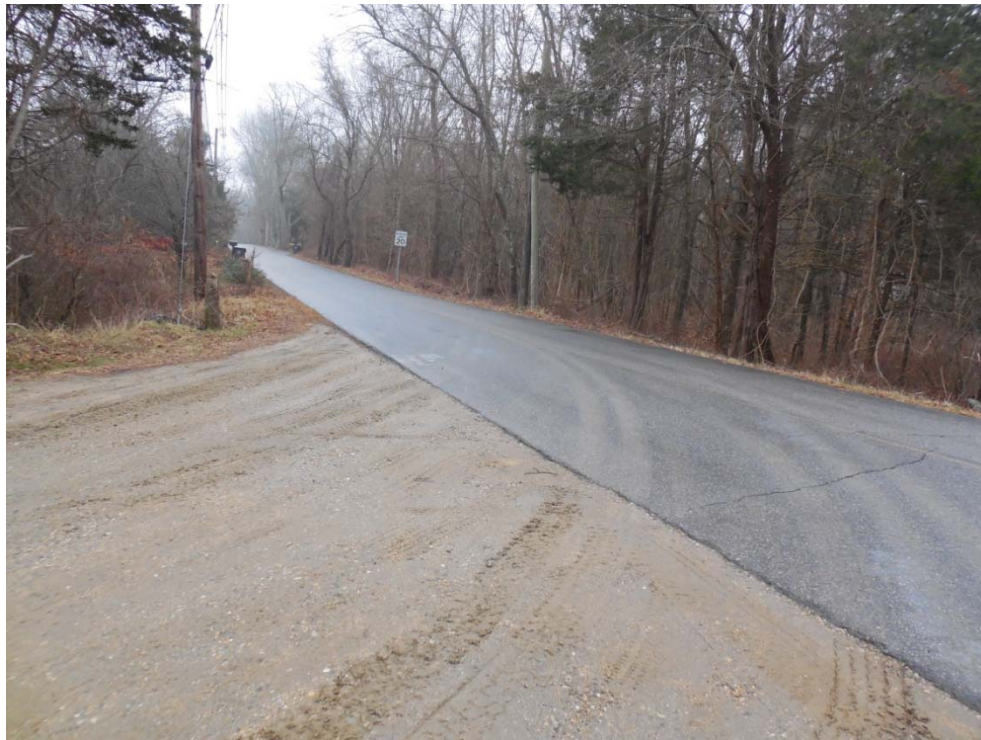
Photo #6: View (facing east) of Card Street, free of significant sediment from access.

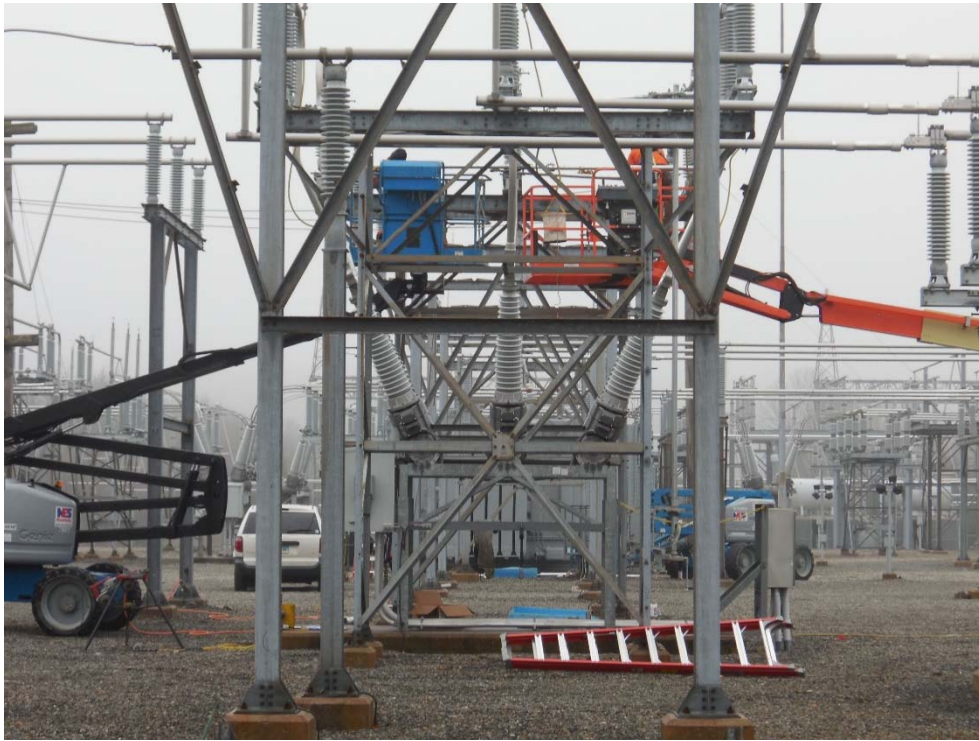
ES Boulos electrical contractors working on aerial bus-way in the northern section of the substation (away from the newly installed wood pole structures. According to representatives from Burns & McDonnell, this work is not related to the Interstate project).

Photo #7: View (facing south) of electrical contractors working on aerial bus-way on north side of substation.

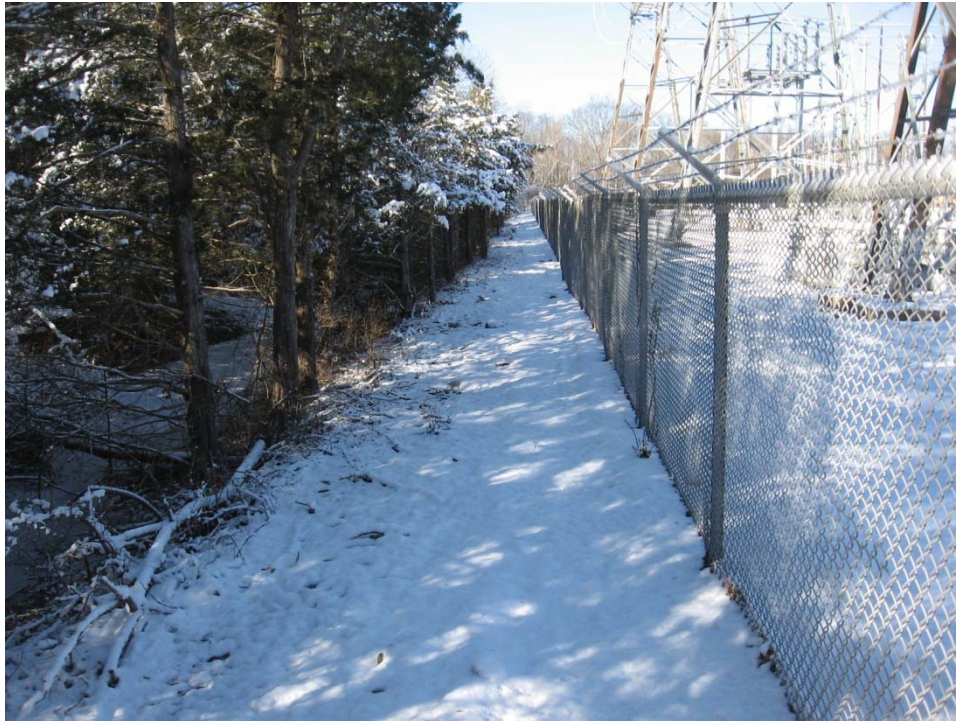
Photo #1: View (facing west) of southwestern edge of substation.

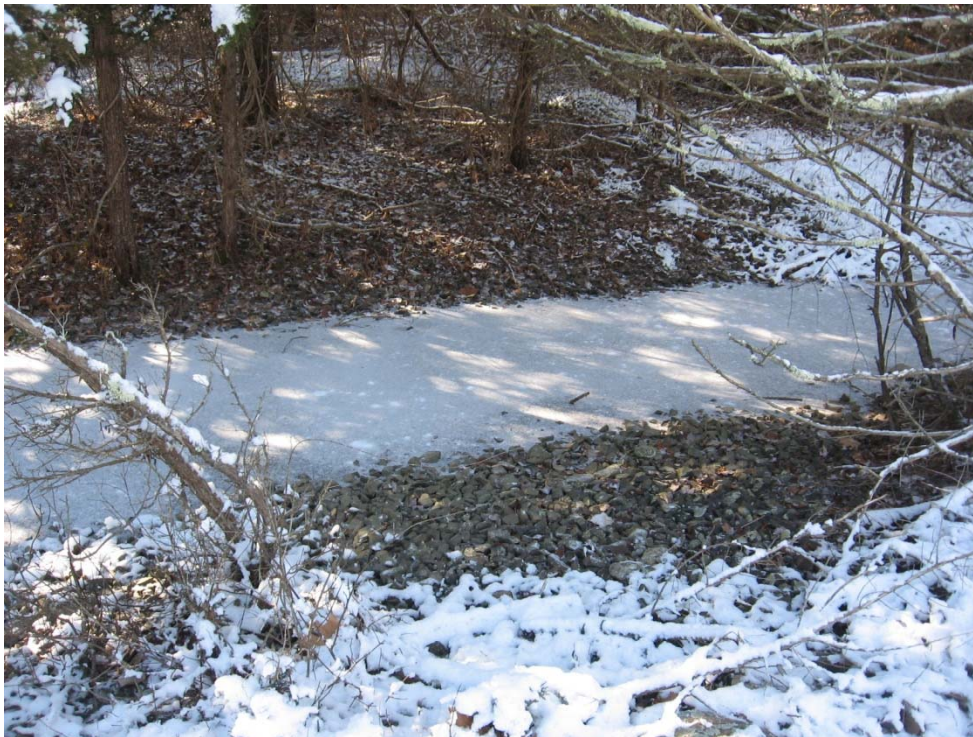
Photo #2: View (facing southwest) of frozen wetland swale at southwestern edge of substation with no apparent sedimentation.

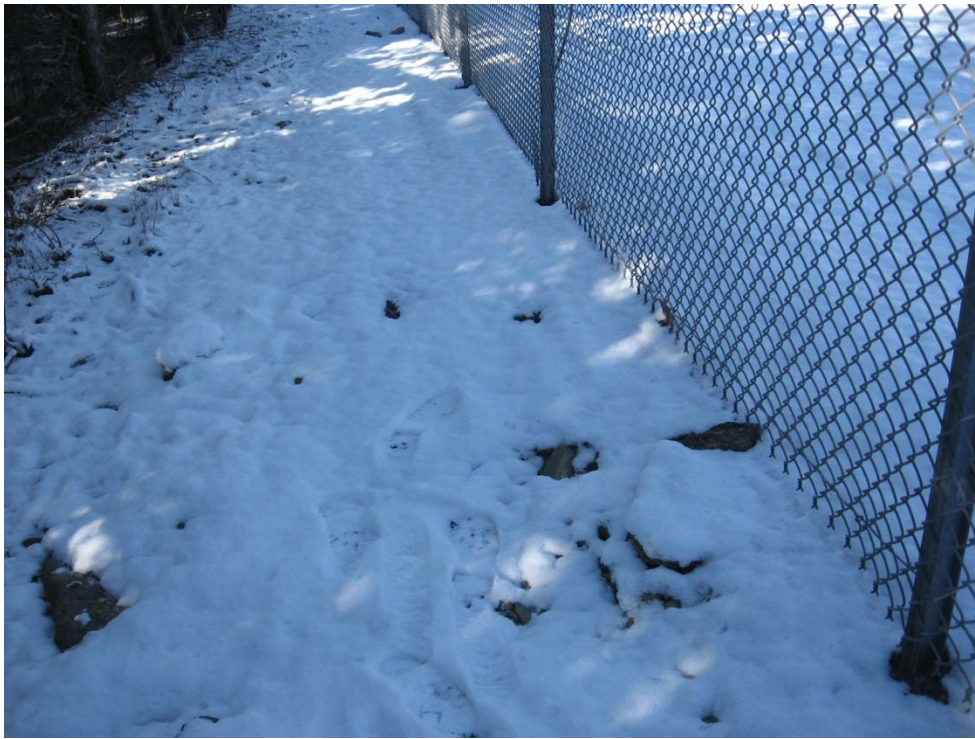
Photo #3: View (facing west) of runoff outlet at southwestern edge of substation.

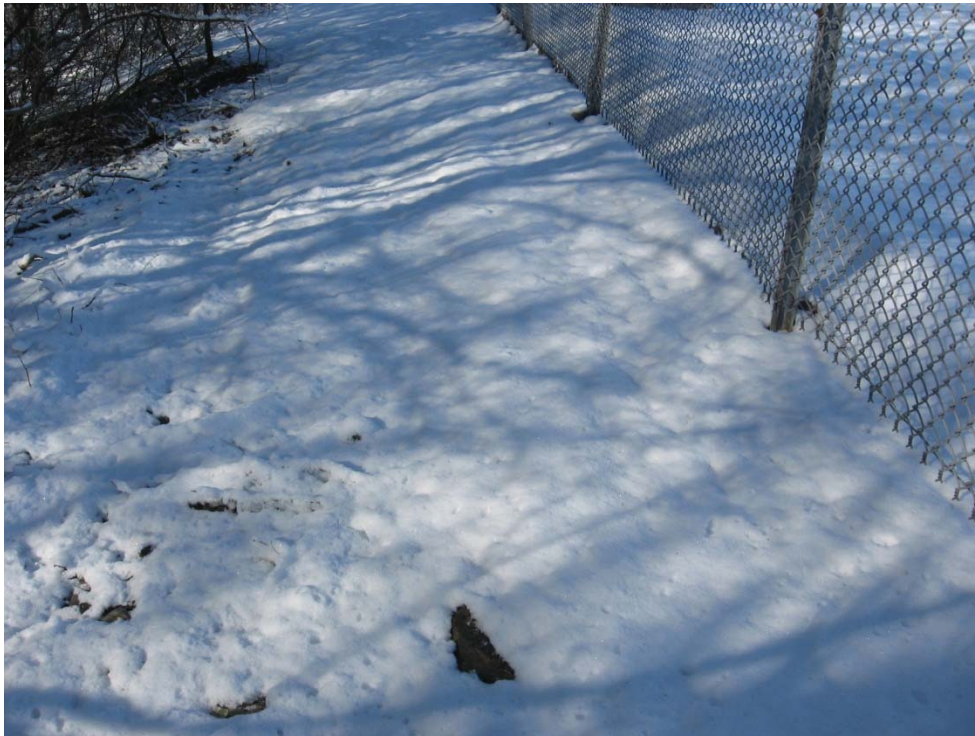
Photo #4: View (facing west) of third (main) runoff outlet at southwestern edge of substation with no apparent sedimentation.

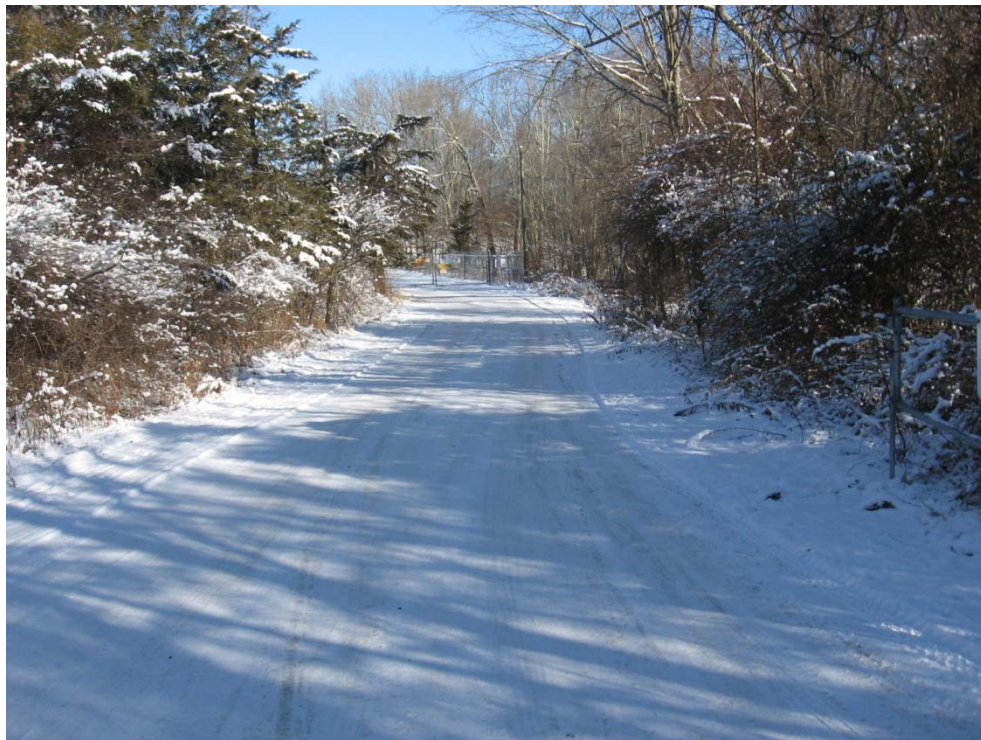
Photo #5: View (facing north) of frozen and stable entrance to substation.

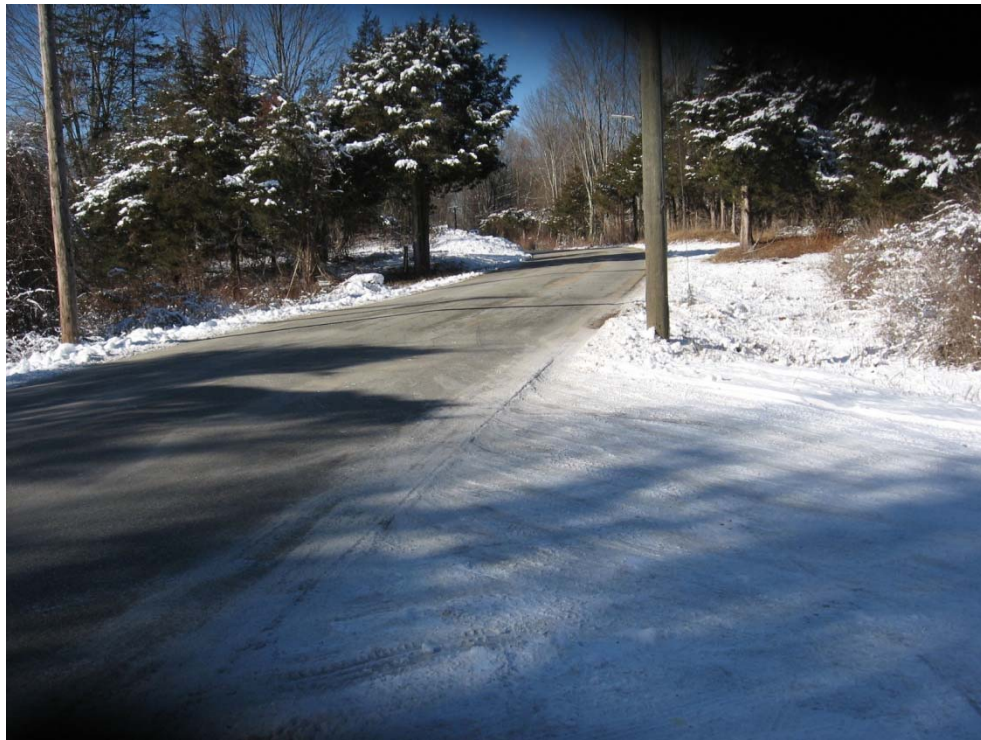
Photo #6: View (facing west) of Card Street, free of significant sediment from access.

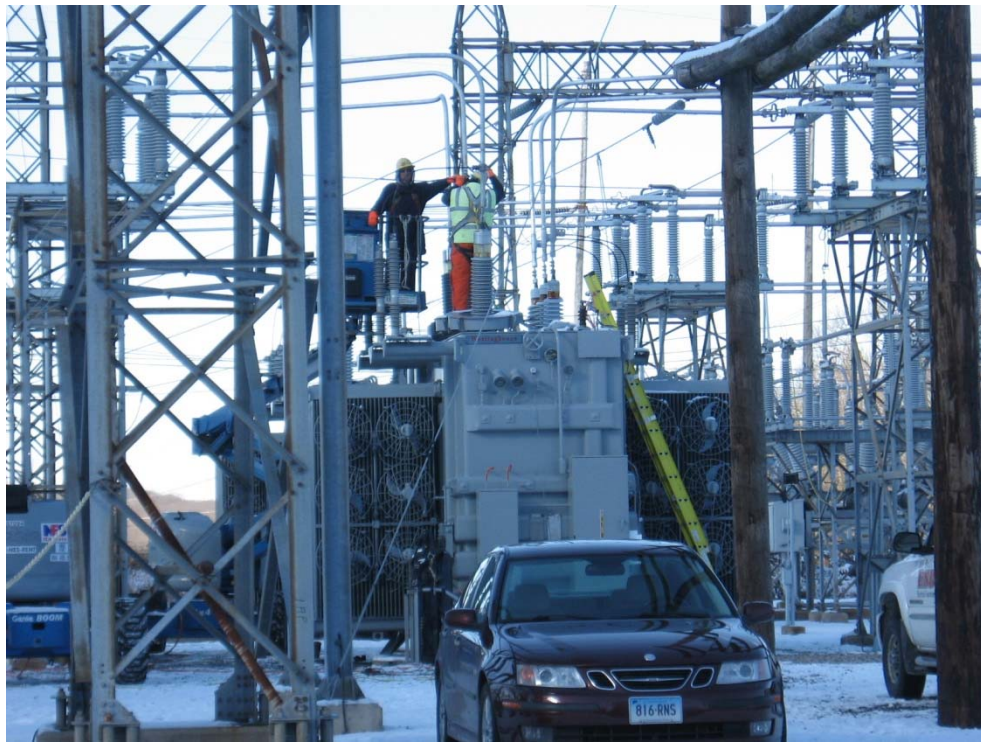
Electrical contractors working on aerial bus-way in the northern section of the substation (away from the newly installed wood pole structures. According to representatives from Burns & McDonnell, this work is not related to the Interstate project).

Photo #7: View (facing northwest) of contractors working on aerial bus-way on north side of substation. (not project related)
