### Docket No. 424 - Development and Management Plan Inspection

The Connecticut Light and Power Company Certificate of Environmental Compatibility and Public Need for the Connecticut portion of the Interstate Reliability Project.

## IRP Overhead ROW Interim Week Inspection:

**Date:** March 5, 2014

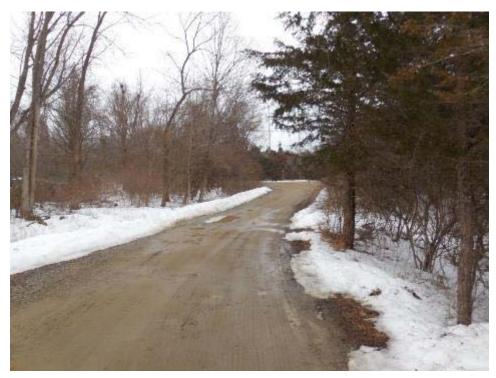
Photo #1: Condition of access road to Card Street Substation.

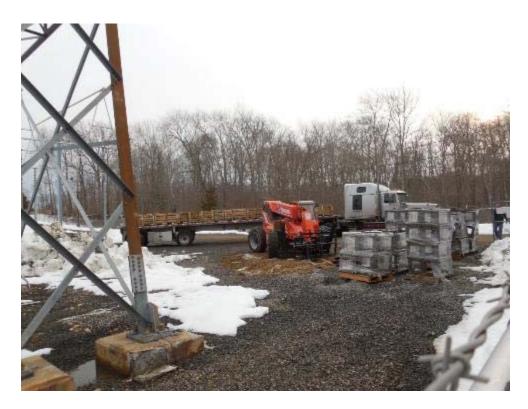
Photo #2: Delivery of Materials for future Construction.

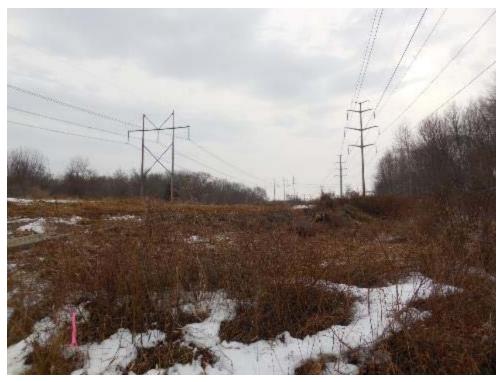
Photo #3: View facing Pads 1 and 2 from access road.

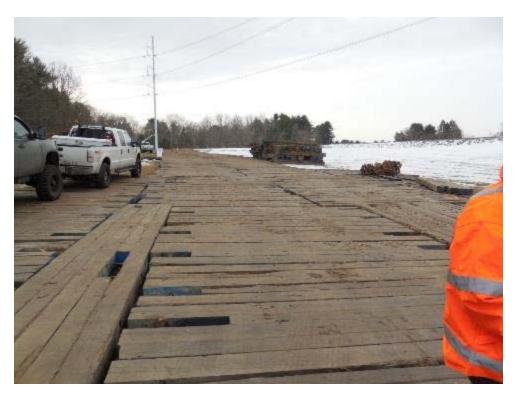
Photo #4: View of wetland Mats up-line of Bassett's Bridge Rd. installed in the l00-yr flood plain.

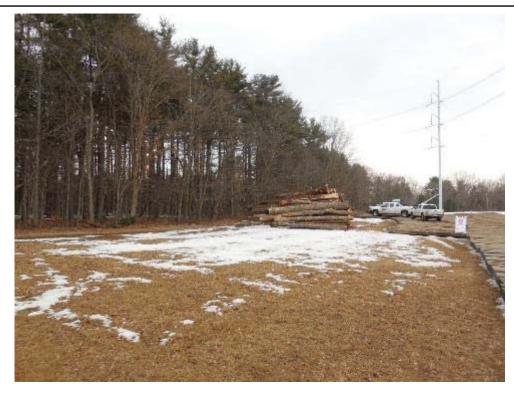
• Burns and McDonnell project forester Tom Degnan indicated that the USACE and CT DEEP requested all timber cut in the vicinity of structures 82-85 to be placed to the northeast of the wetland mats down-line from structure 82, just outside the ROW.

Photo #5: Timber stacked per the request of USACE and CT DEEP.

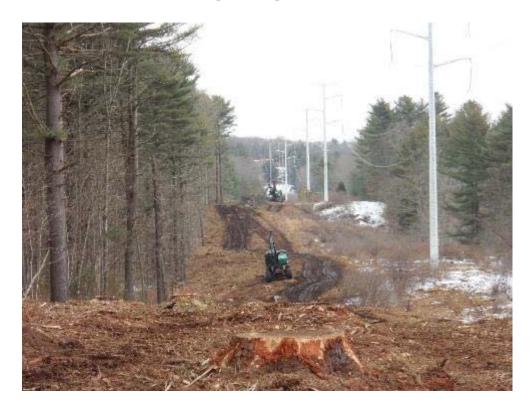
Photo #6: View up-line toward Str 84 showing wetland mat removal and mowing activities.

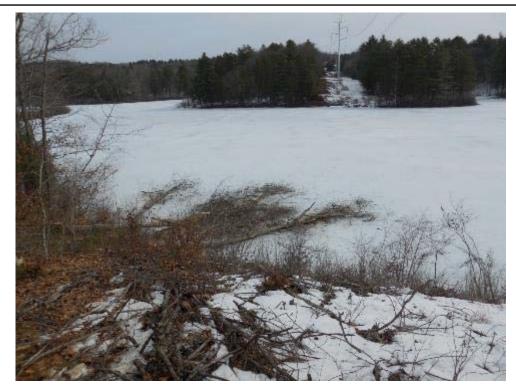
• At the request of CT DEEP, select trees adjacent to Mansfield Hollow Lake were dropped into the lake to create Bass habitat. P. Lockwood indicated there are a few trees on the opposite side of the lake crossing that will also be dropped to create habitat. See photo.

Photo #7: View up-line of tree drops in Mansfield Hollow Lake at the request of CT DEEP. (There will be additional drops on the opposite side of the Lake).

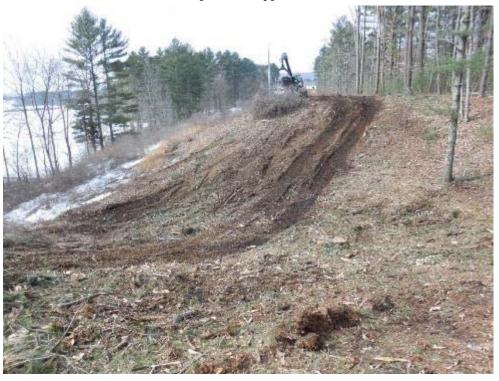
Photo #8: View down-line of disturbed area of concern prior to forecast rain event.

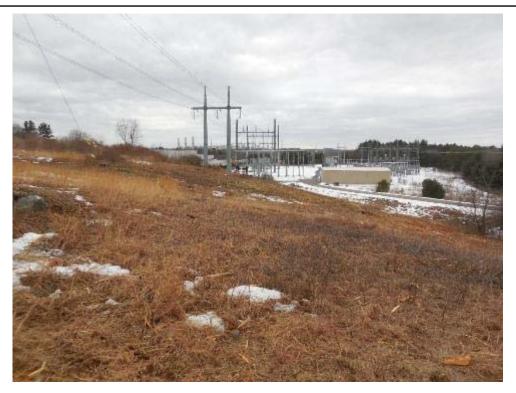
Photo #9: View down-line of mowed area in the vicinity of Str 272. Killingly Substation visible in background.

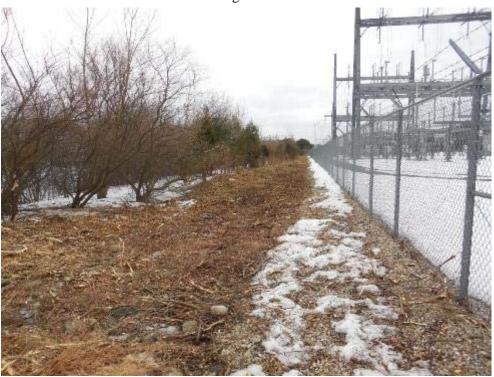
Photo #10: View down-line of mowed area for access road along the side of Killingly Substation.

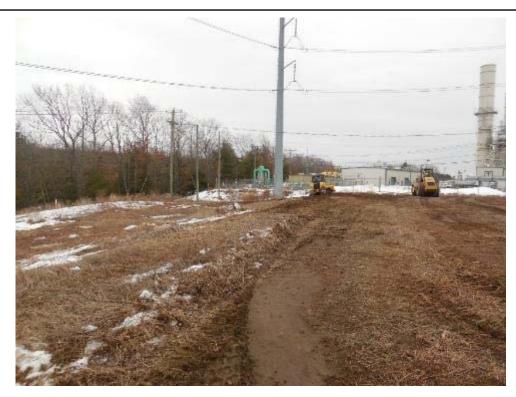
Photo #11: View of grading for construction pad for Str 266 and Str 267.

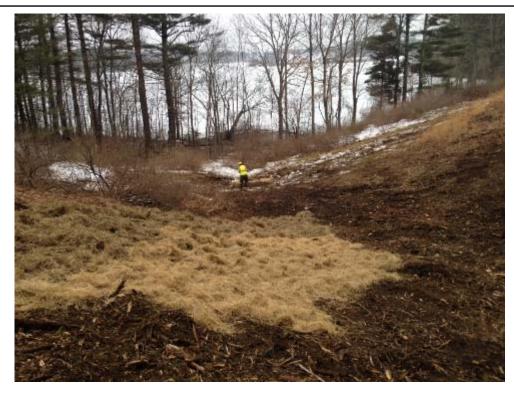
Photo #13: View of disturbed area of concern between Str 83 and Str 84, stabilized prior to rain event. (Photo received from P. Lockwood.)
