Docket No. 424 – Development and Management Plan Inspection

The Connecticut Light and Power Company Certificate of Environmental Compatibility and Public Need for the Connecticut portion of the Interstate Reliability Project.

IRP Overhead ROW

Date: April 10, 2014

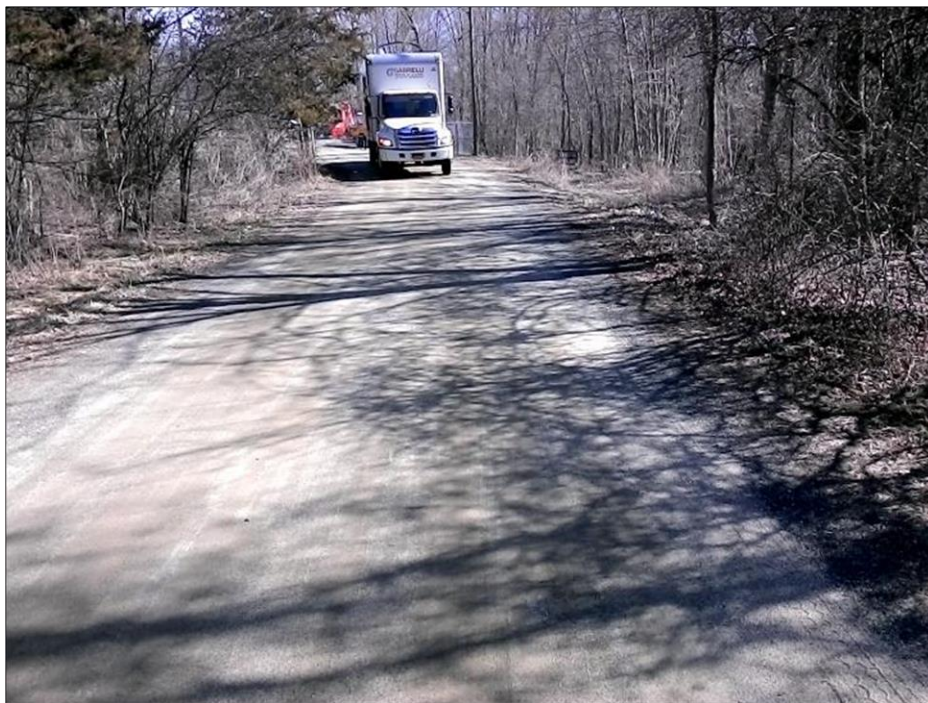
Areas of Inspection	Observation:	Recommended Action:	Corrected Action:
Access Roads and Adjacent Roadways	<p>Interim Week (4/2)</p> <p>CSSS: Tracking pad is not installed.</p> <p>Adjacent roadways clear and free of sediment at all other visited sites</p>	<p>Install tracking pad as soon as possible.</p> <p>Continue to follow this procedure.</p>	<p>NA</p> <p>NA</p>
	<p>Bi-Week (4/10)</p> <p>CSSS: Tracking pad is not installed.</p> <p>Roadway construction in accordance with BMP Manual and D &M Plans</p> <p>Adjacent roadways clear and free of sediment at all other visited sites</p> <p>There appears to be a significant amount of fines in the access road material. (see photo #2)</p> <p>Contractors taking care to not damage paved roadways while loading and unloading equipment.</p>	<p>Install tracking pad as soon as possible.</p> <p>Continue to follow this procedure.</p> <p>NA</p> <p>E.I. should monitor condition of access roads, especially after heavy rains and/or significant vehicular usage to ensure surface of road does not significantly rut, cause undue tracking on adjacent paved roads, or begin to migrate off the access road as sedimentation.</p> <p>Continue to follow this procedure.</p>	<p>NA</p> <p>NA</p> <p>NA</p>

Photo #1: Entrance at Card Street Substation. Tracking Pad should be installed as soon as possible.

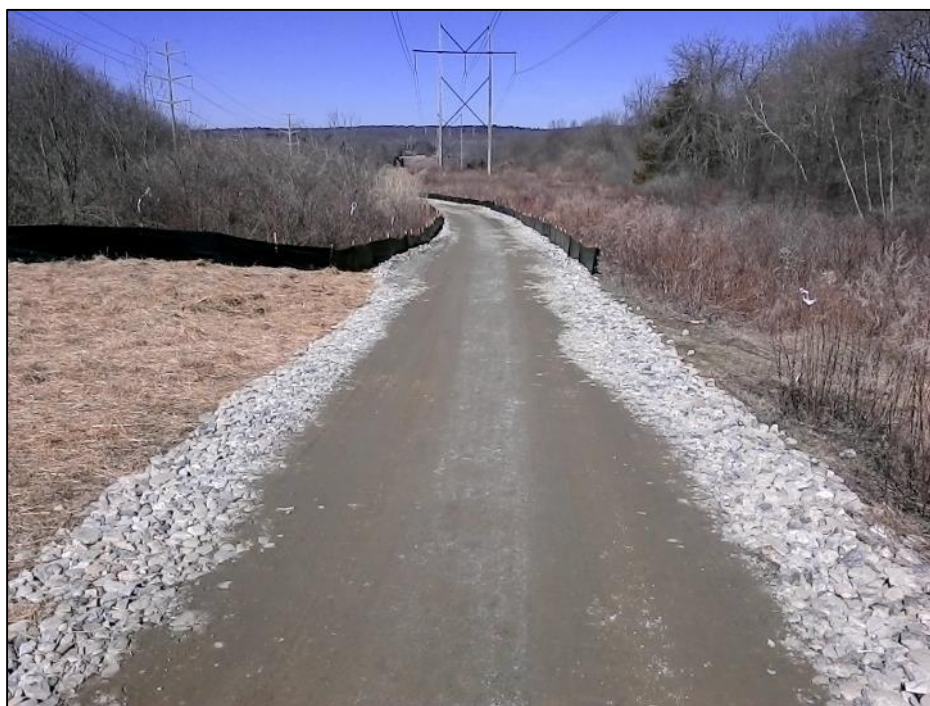
Photo #2: View (up-line toward str 3) of fine material along the top surface of the access road.

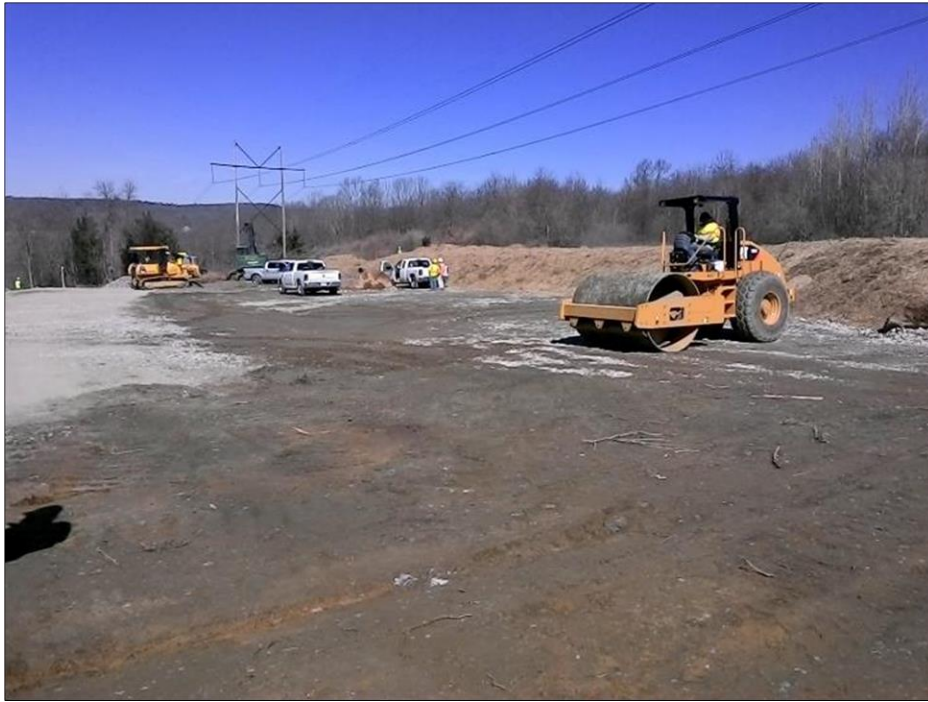
Photo #3: (Up-line) Construction of Pad 3.

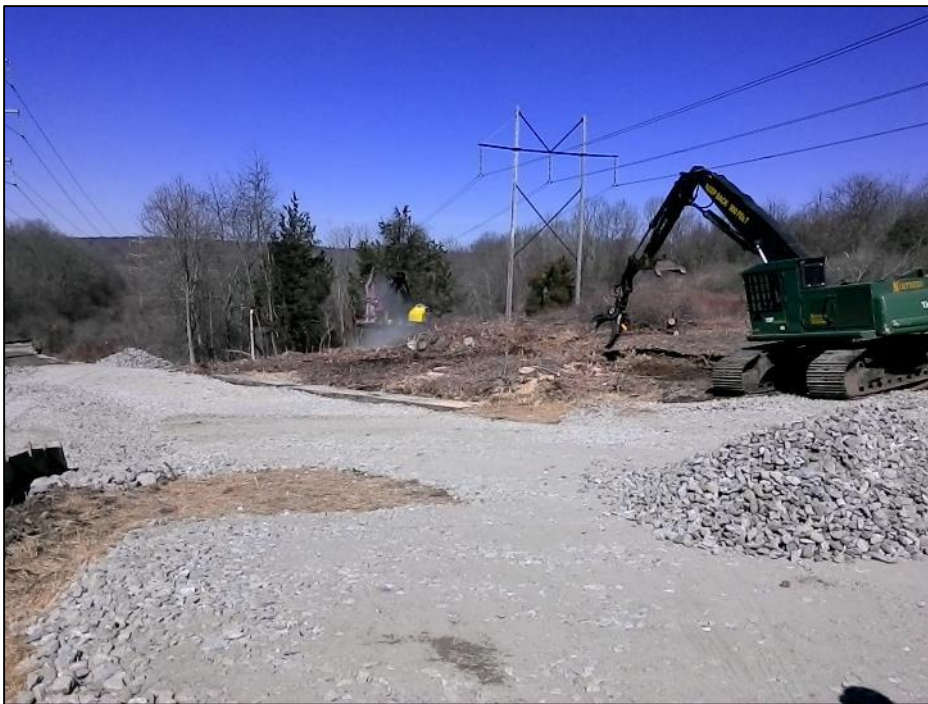
Photo #4: (Up-line) of tree clearing activities.

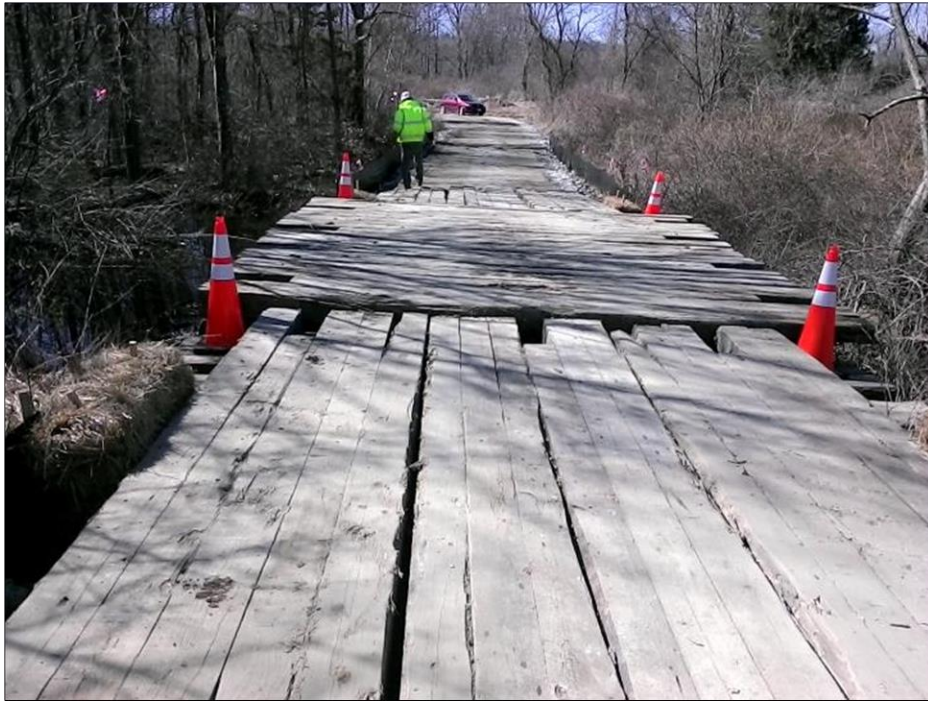
Photo #5: (South of ROW on access from Card Street) View of temporary wetland crossing.

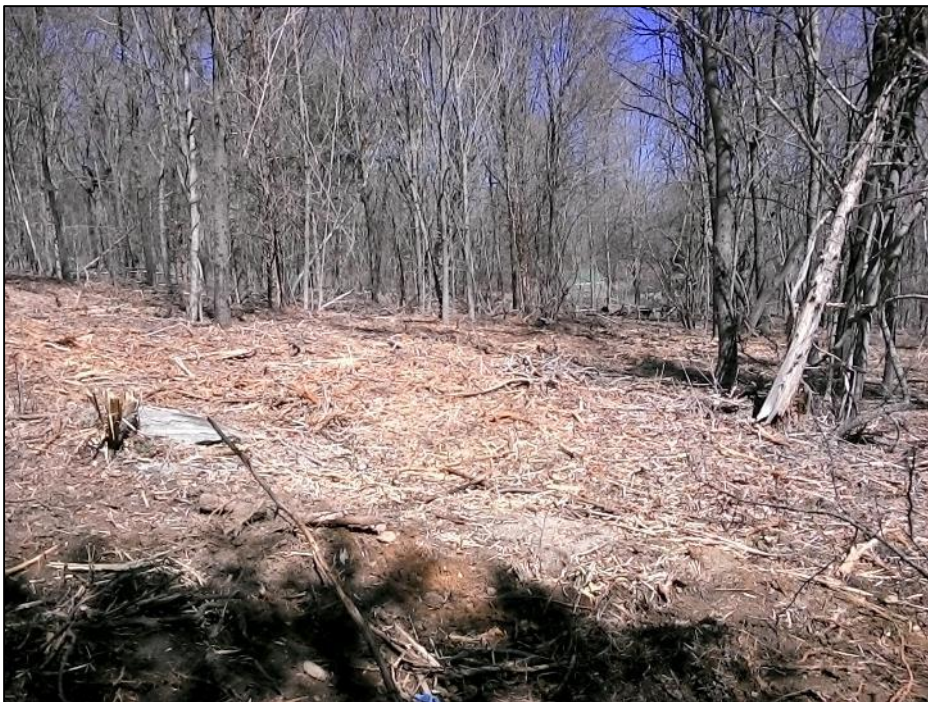
Photo #6: (down-line , right) View into mown area for pad 72.

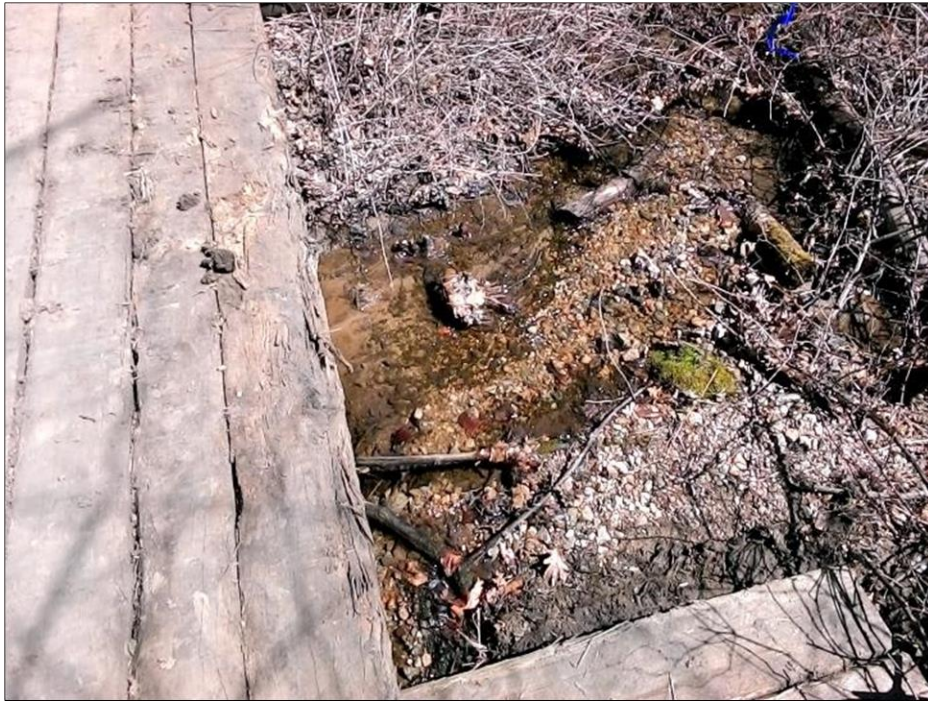
Photo #7: (Up-line) of temporary crossing over existing culvert set to be replaced during project.

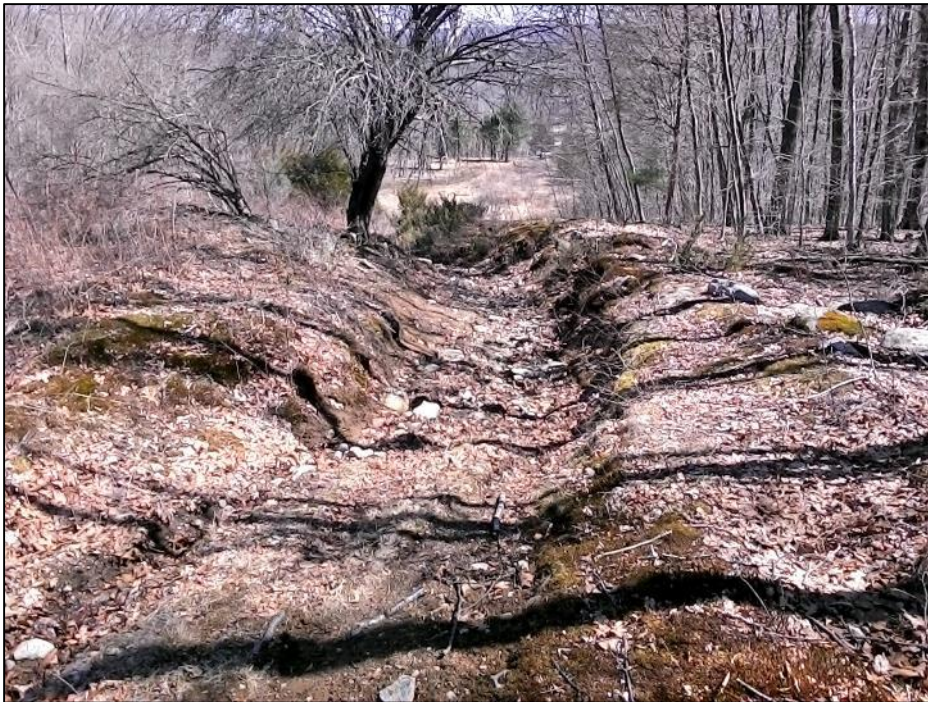
Photo #8: (up-line, right of str 71) View of existing ROW access road set to be replaced due to multiple years of erosion.

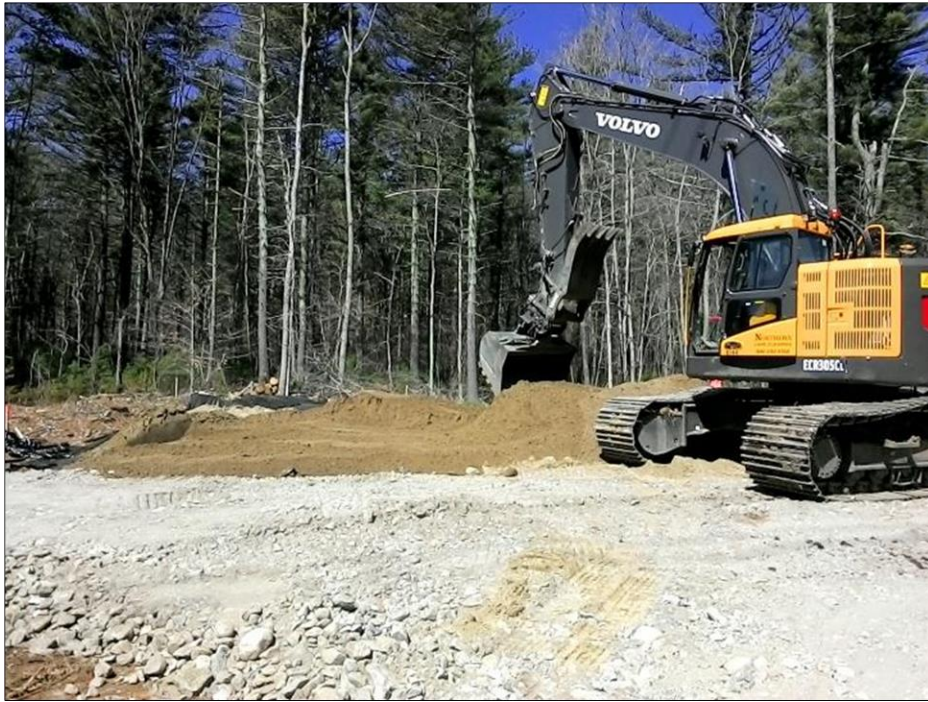
Bi-Week (4/10)	Str 85: Contractors taking care installing filter fabric and buffer sand over area of cultural significance.	Continue to follow this procedure.	NA
Rare, Threatened, and Endangered Species	Interim Week (4/2)	Exclusion fence down/damaged in two (2) areas at Boston Post Road Laydown area.	Repair fence	NA
	Bi-Week (4/10)	NA	NA	NA
Additional Documentation Comments: Notes for 4/10/2014: <ul style="list-style-type: none"> Drill crews are preparing to commence drilling for structure 272 up-line of killingly substation. 				
Open Items: <ol style="list-style-type: none"> Card Street sub-station anti-tracking pad 				
Closed Items:

Photo #9: View of installation of filter fabric and buffer sand at pad 85 over area of cultural significance.

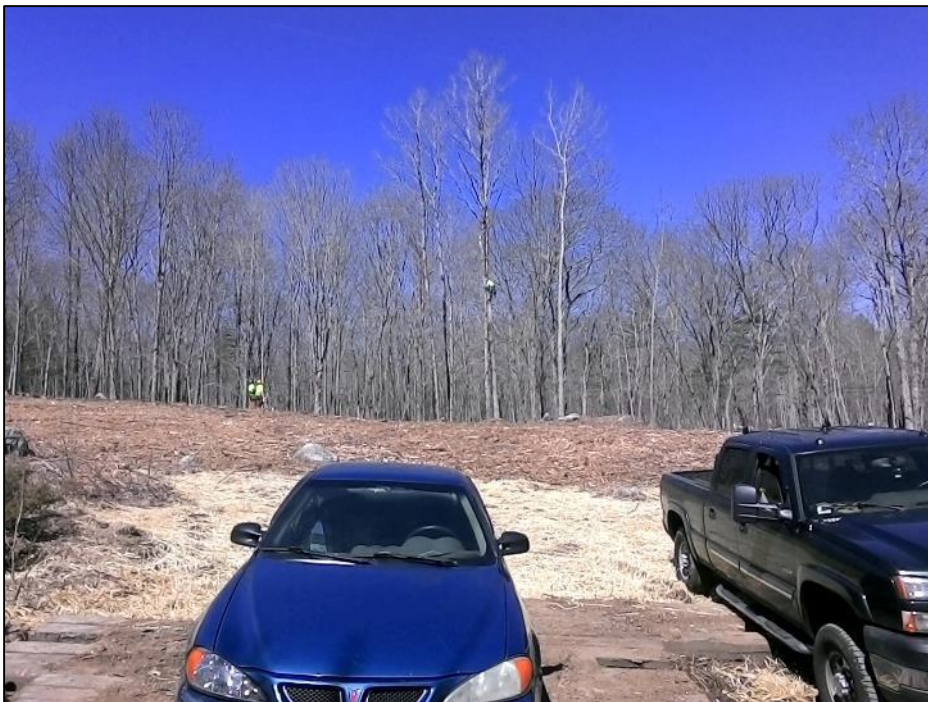
Photo #10: (up-line, left of str 90) View of tree pruning activities.

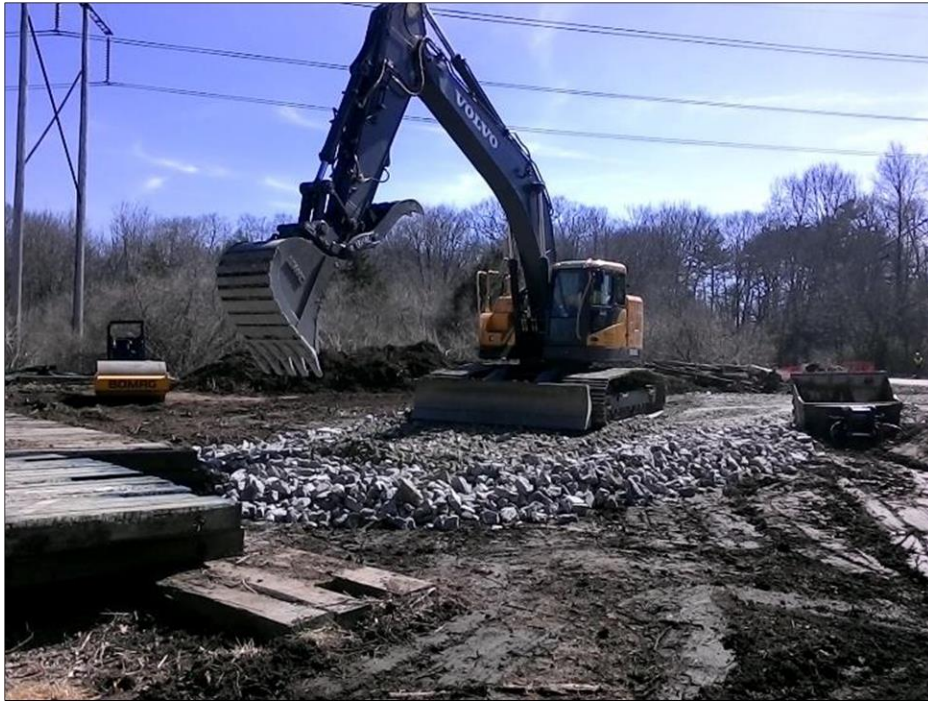
Photo #11: View of Str 91pad under construction.

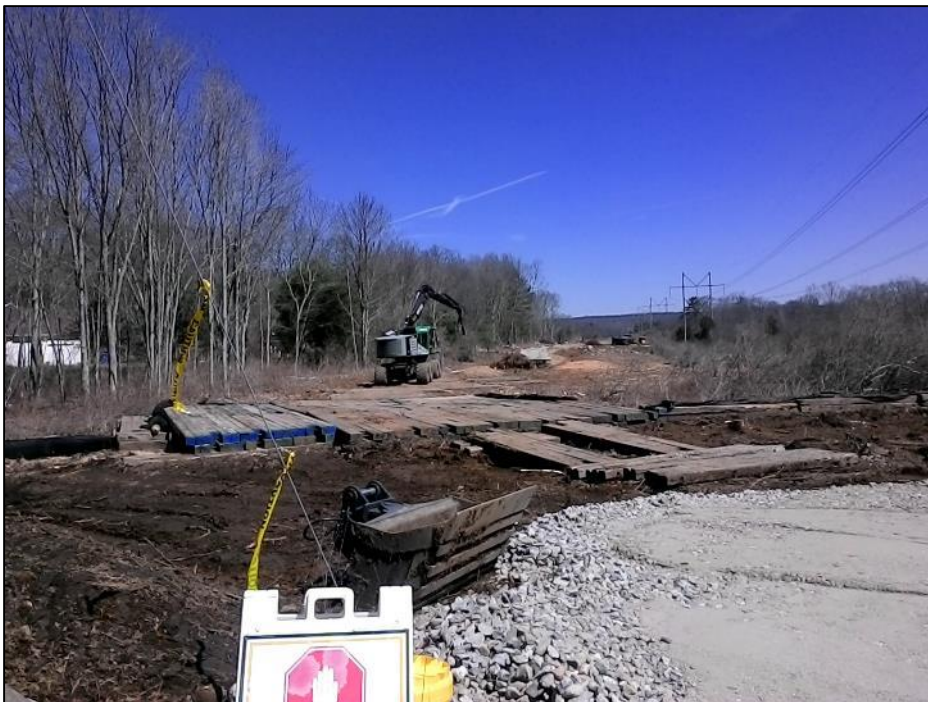
Photo #12: (up-line of str 91) Temporary mat crossing over S20-20

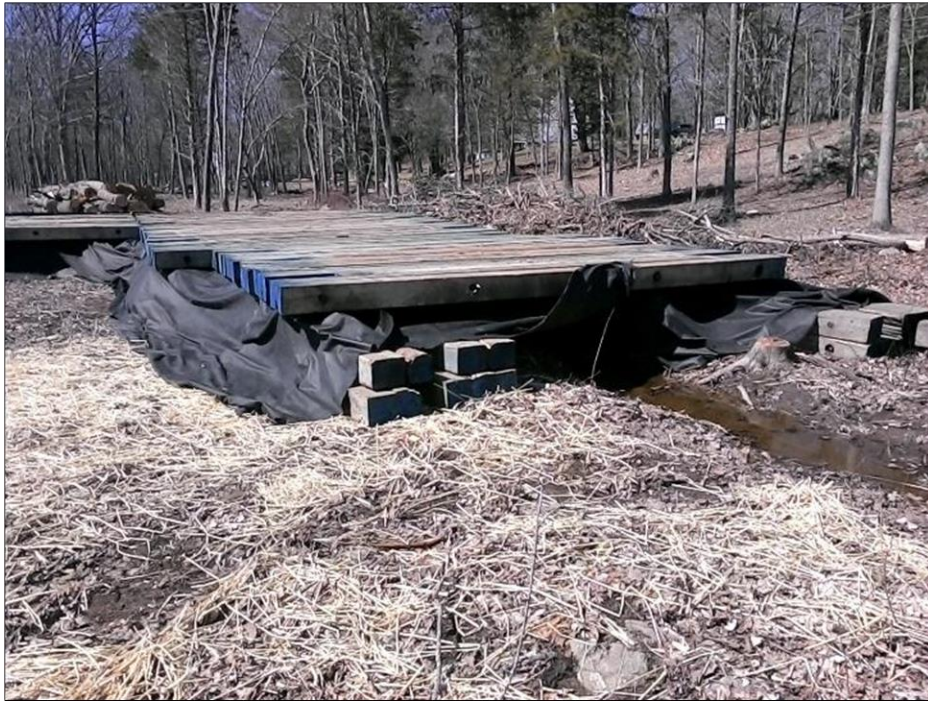
Photo #13: (down-line) temporary mat crossing over S20-21

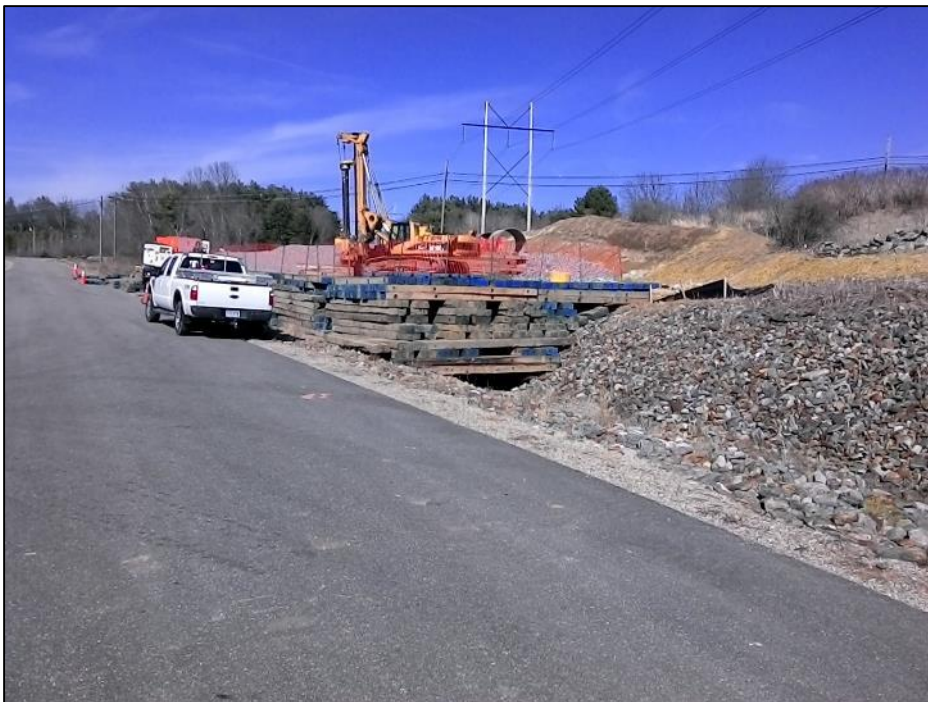
Photo #14: (up-line of 272) preparation of commencement of drilling operations.

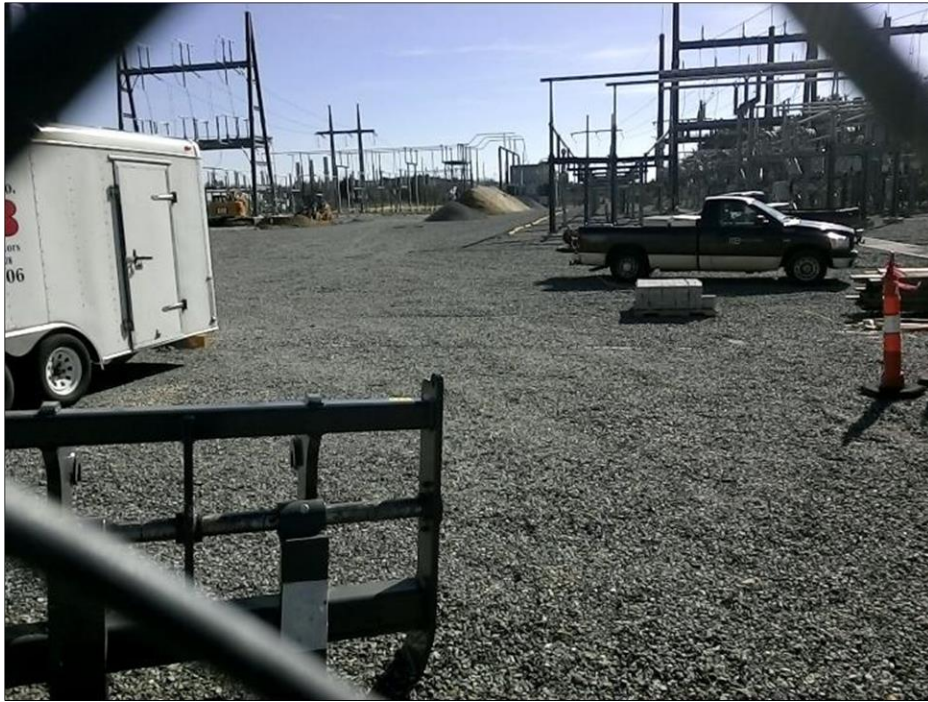
Bi-Week (4/10)	All stabilization measures appear in accordance with the BMP Manual and the D&M Plans. KS: Straw wattles have been installed adjacent to the excavation work within the substation.	Continue to follow this procedure. NA	NA NA
Inland Wetland and Watercourse encroachment and mitigation	Interim Week (4/2)	All wetland crossings appear in accordance with BMP Manual and D&M Plans.	NA	NA
	Bi-Week (4/10)	All wetland crossings appear in accordance with BMP Manual and D&M Plans.		
Spills and Material Storage.	Interim Week (4/2)	Spill kits noted on all visited Sites.	Continue to follow this procedure.	NA
	Bi-Week (4/10)	Spill kits noted on all visited Sites.	Continue to follow this procedure.	NA
Cultural Resources	Interim Week (4/2)	Areas of Cultural significance were cleared in accordance with D&M requirements.	Continue to follow this procedure.	NA

Photo #15: View facing down-line into KS of excavation activities. Straw wattles installed at edge of excavation visible at back center of photo.
