### **Docket No. 424 - Development and Management Plan Inspection**

The Connecticut Light and Power Company Certificate of Environmental Compatibility and Public Need for the Connecticut portion of the Interstate Reliability Project.

# **Interim Week Inspection:**

## **Bi-Weekly Inspection:**

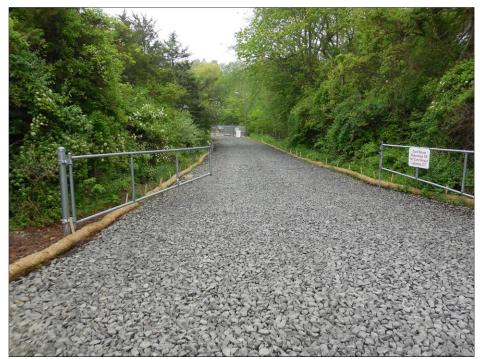
Photo #1: View of entrance pad at CSSS.

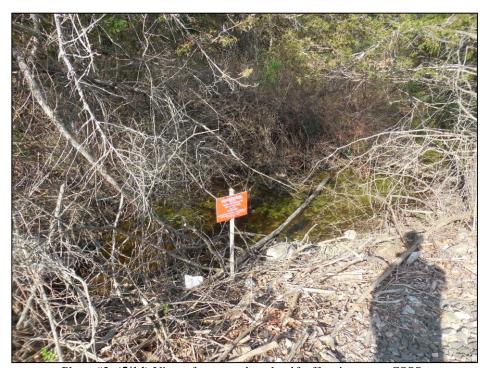
- CSSS: Observed protected wetland or buffer area signage being installed.(Photo 2)
- Drilling operations ongoing at Str 265, 267, 269, and 270.

Photo #2: (5/14) View of protected wetland/buffer signage at CSSS.

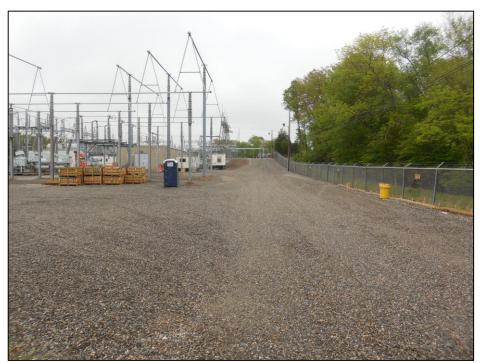
- CSSS: P. Lockwood indicated that new stone was placed inside the substation at the southwest corner. (Photo 3)
- Drilling operations ongoing at Str 1.
- Access roadway in the vicinity of Str 53 and 54 in agricultural farmland area being installed with filter fabric barrier in accordance with D & M detail sheets. (Photo 6)

Photo #3: Area where new stone that was placed at CSSS.

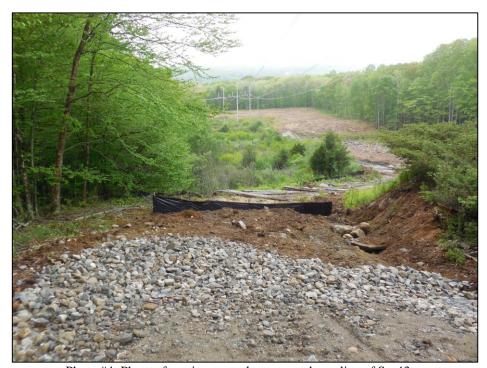
Photo #4: Photo of erosion control measures down-line of Str 43.

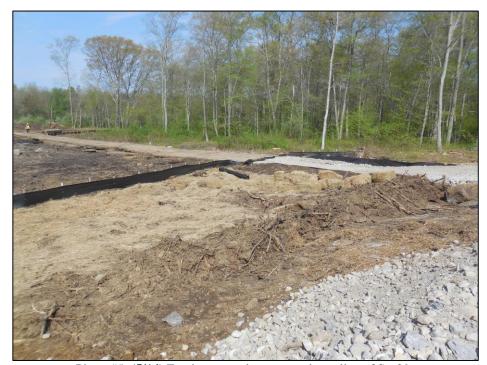
Photo #5: (5/14) Erosion control measures down-line of Str 29.

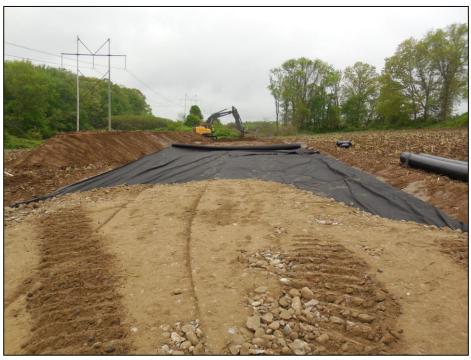
Photo #6: Access road in agricultural farmland area being installed with filter fabric barrier up-line of Str 53.

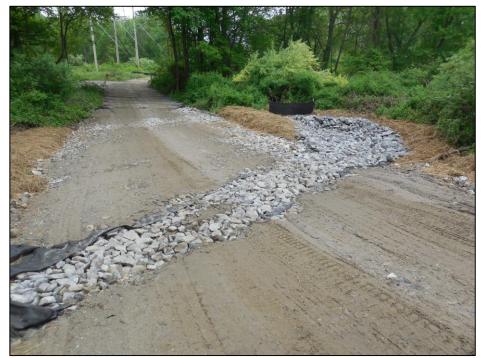
Inland Wetland and Waterco and mitigati	Bi-Week (5/23)	Mat installations in wetland areas are in accordance with the BMP Manual. (Photo 7)	Continue to follow this procedure.	NA

Photo #7: Erosion control measures on access road up-line of Str 55. Wetland mat installation visible in the background.

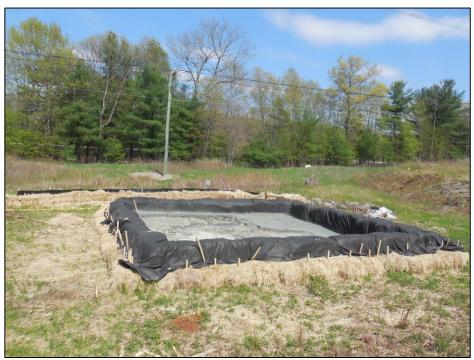
T		1
Interim Week (5/14)	Spill kits noted on all visited sites.  Contractor implementing concrete wash out areas down-line from Killingly Substation and adjacent to the Lake Road Switching Station for foundation concrete pours. (Photo 8)	Continue to follow this procedure.  Continue to follow this procedure.	NA
Bi-Week (5/23)	Spill kits noted on all visited sites.	Continue to follow this procedure.	NA
Interim Week (5/14)	Pads in cultural areas are being installed with a geotextile separation fabric and sand buffer layer prior to the installation of the pad material.	NA	NA
Bi-Week (5/23)	Pads in cultural areas are being installed with a geotextile separation fabric and sand buffer layer prior to the installation of the pad material.	NA	NA
Interim Week (5/14)	NA	NA	NA
Bi-Week (5/23)	NA	NA	NA
	Interim Week (5/14)	Spill kits noted on all visited sites.  Pads in cultural areas are being installed with a geotextile separation fabric and sand buffer layer prior to the installation of the pad material.  Pads in cultural areas are being installed with a geotextile separation fabric and sand buffer layer prior to the installation of the pad material.  NA  NA  NA	Contractor implementing concrete wash out areas down-line from Killingly Substation and adjacent to the Lake Road Switching Station for foundation concrete pours. (Photo 8)    Spill kits noted on all visited sites.   Continue to follow this procedure.

Photo #8: (5/14) Concrete wash out area up-line of Str 265.
