Docket No. 424 – Development and Management Plan Inspection

The Connecticut Light and Power Company Certificate of Environmental Compatibility and Public Need for the Connecticut portion of the Interstate Reliability Project.

IRP Overhead ROW

Interim Week Inspection:

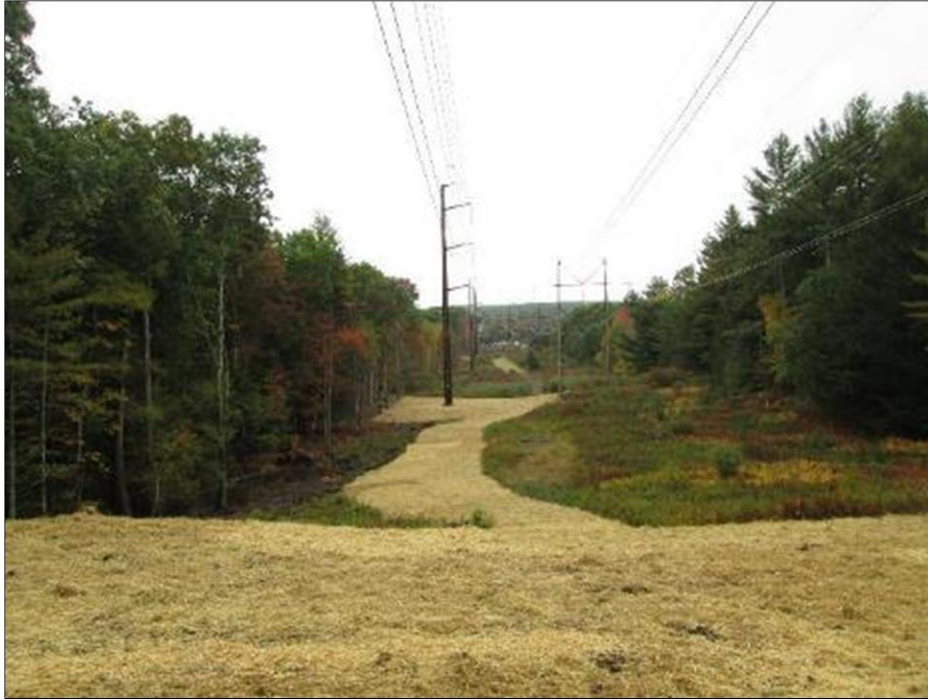
MS19, Str 97-100: Stripping gravel and fill from pad, restoration and reclamation of Str pad 100, seeding and spreading of hay on exposed soil. (Photo 1 & 2)

- Non-project related work between Str 59 & 60: Storm Hardening.
- Str 97-100: Construction pad 100 and down-line access road and pads have been removed, restored and stabilized with straw mulch to their original, pre-construction grades and slopes. (Photo 1 & 2)
- Str pads restored to their original grades and slopes: Str 84-87, 97-100, and 269-270.

Photo #1: Hay spread over restored topsoil up-line of Str 97. (10/1)

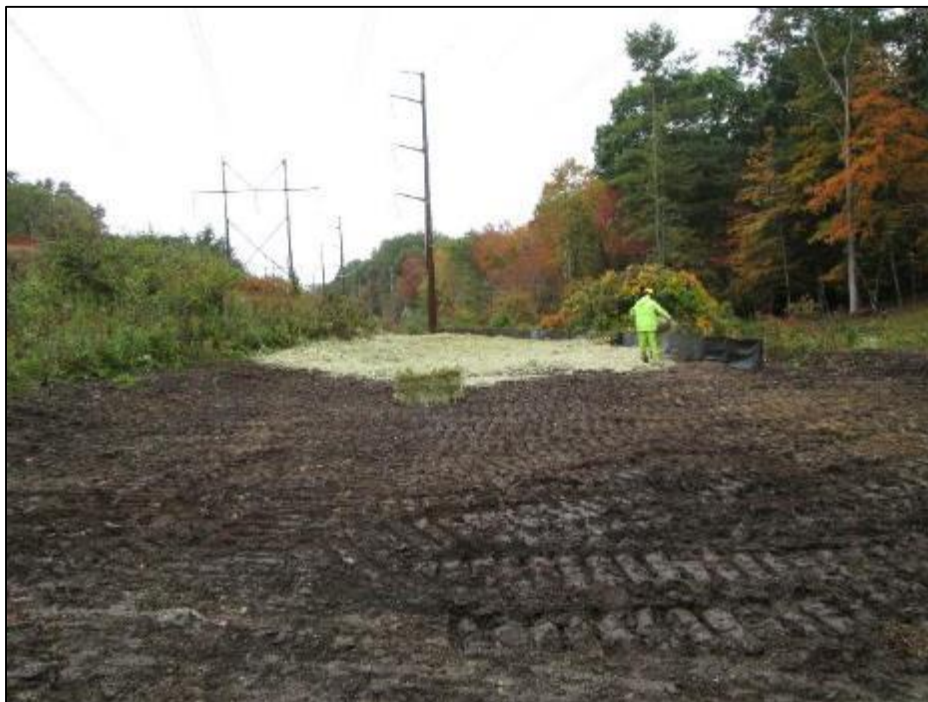
Photo #2: Spreading of hay and seed on exposed topsoil up-line of Str 99. (10/1)

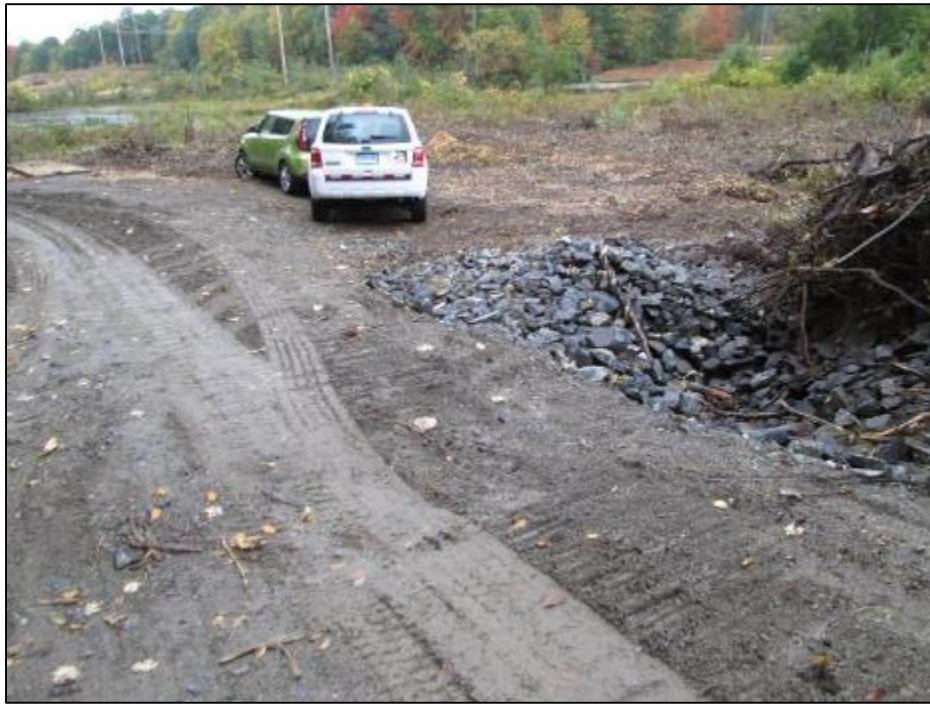
Photo #3: Plunge pool on edge of access road up-line of Str 202. (10/1)

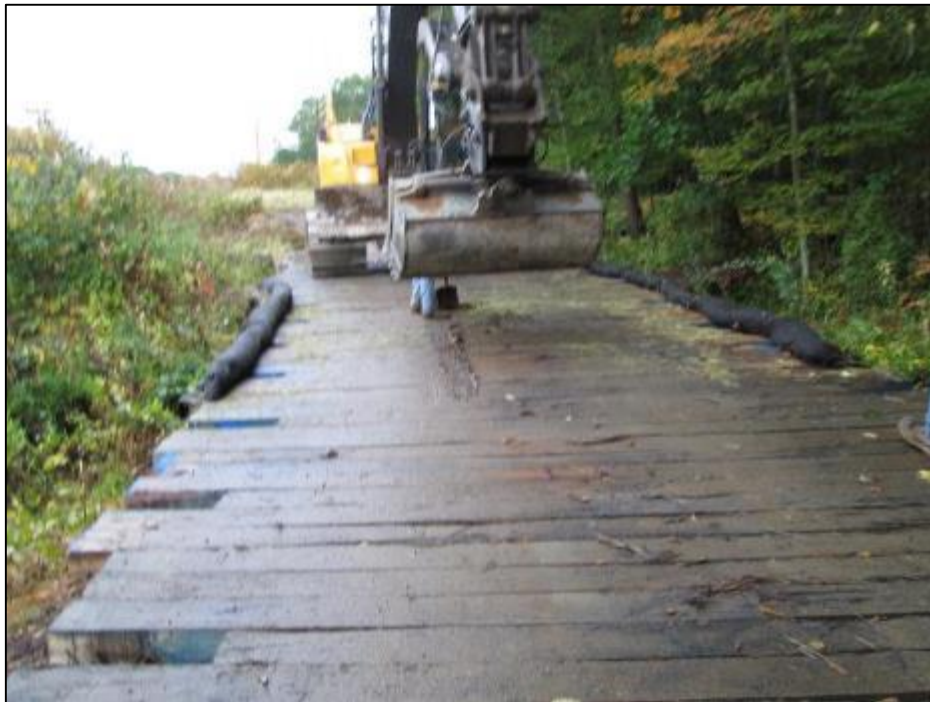
MS39, Str 203-204: Grading of Str pad 203, delivery of construction materials, cleaning of wetland mats up-line of Str 203. (Photo 4)

Photo #4: Cleaning of wetland mats up-line of Str 203. (10/1)

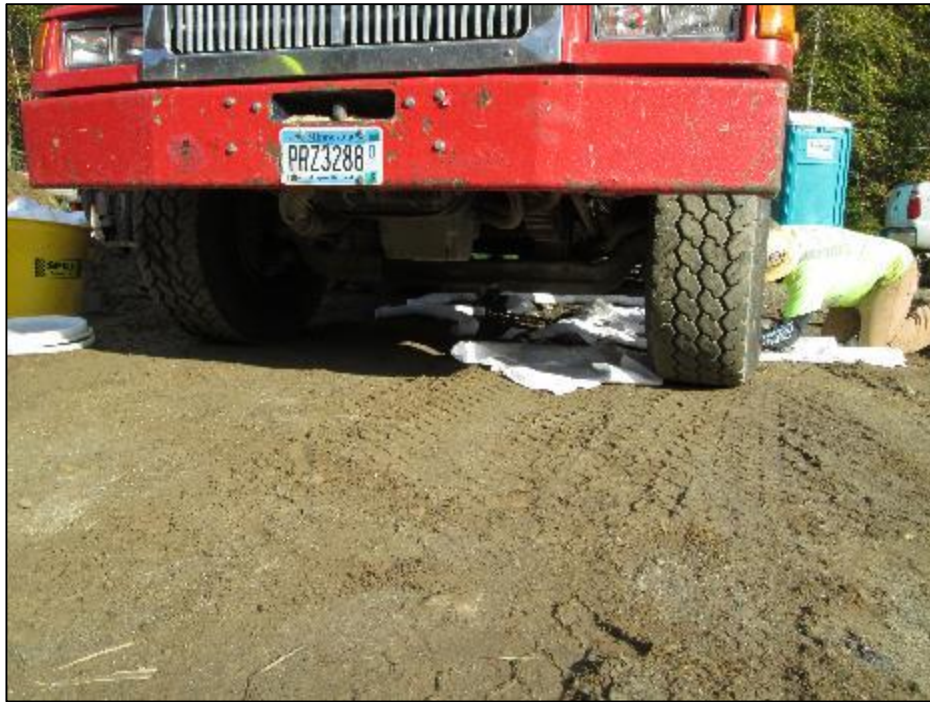
Spills and Material Storage.	Interim Week (10/1)	Spill kits noted on all visited sites.	Continue to follow this procedure.	NA
	Bi-Week (10/8)	Spill kits noted on all visited sites. Str 49: Observed Hydraulic fluid spill (less than a gallon) on an upland area. (Photos 5 & 6)	Continue to follow this procedure. NA	NA Tri-state crew immediately contained spill with spill kit materials.
Cultural Resources	Interim Week (10/1)	Pads in cultural areas are being installed with a geotextile separation fabric and sand buffer layer prior to the installation of the pad material.	NA	NA
	Bi-Week (10/8)	Pads in cultural areas are being installed with a geotextile separation fabric and sand buffer layer prior to the installation of the pad material.	NA	NA
Rare, Threatened, and Endangered Species	Interim Week (10/1)	NA	NA	NA
	Bi-Week (10/8)	NA	NA	NA
Additional Documentation Comments: Notes for 10/1/2014: <ul style="list-style-type: none"> • CSSS: Non-project related work inside station. • Drilling operations ongoing at Str 59.

Photo #5: Tri-state crew containing hydraulic fluid spill at Str 49.

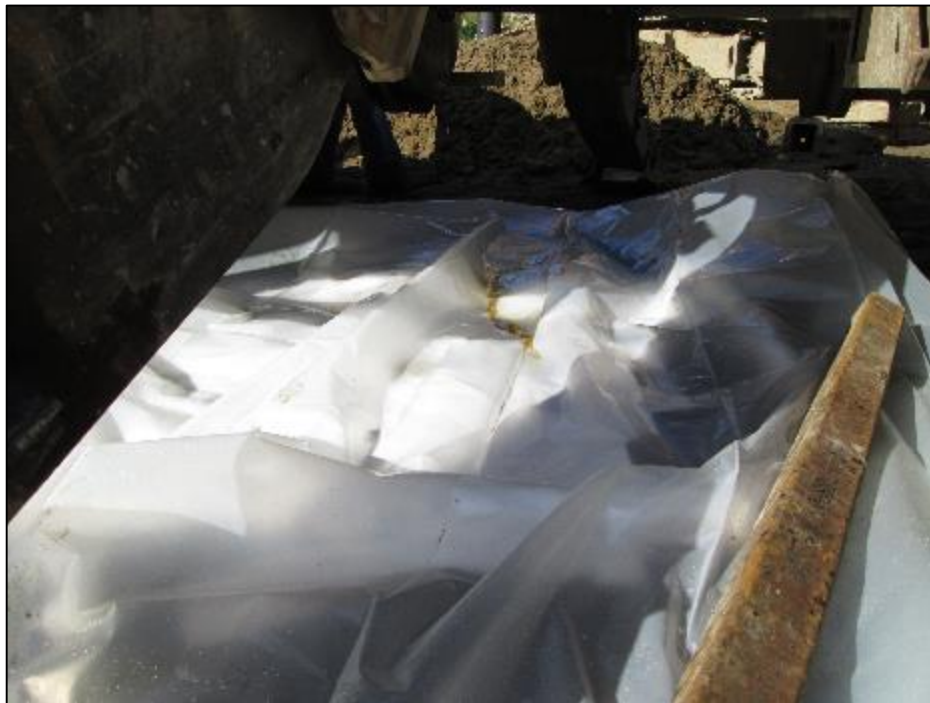
Photo #6: Hydraulic fluid spill contained with plastic and diaper dams at Str 49.

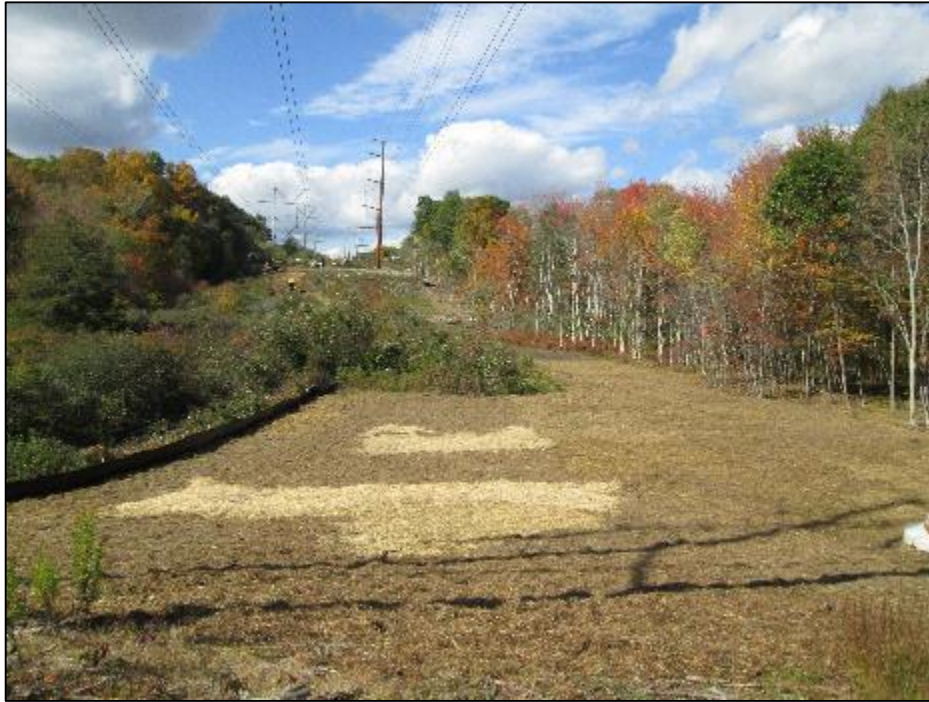
MS18, Str 95-96: Stripping gravel and fill from pad and access road, restoration and reclamation, seeding and spreading of hay on exposed topsoil.(Photo 7 & 8)

- CSSS: Non-project related work inside station.
- Drilling operations ongoing at Str 49, Str 113, and Str 121.
- Str 95-96: Access road and pads have been removed, restored and stabilized with straw mulch to their original, pre-construction grades and slopes. (Photos 7 & 8)
- Str pads restored to their original grades and slopes: Str 84-87, 95-100, and 269-270.

Photo #7: Hay spread over restored topsoil down-line of Str 96.

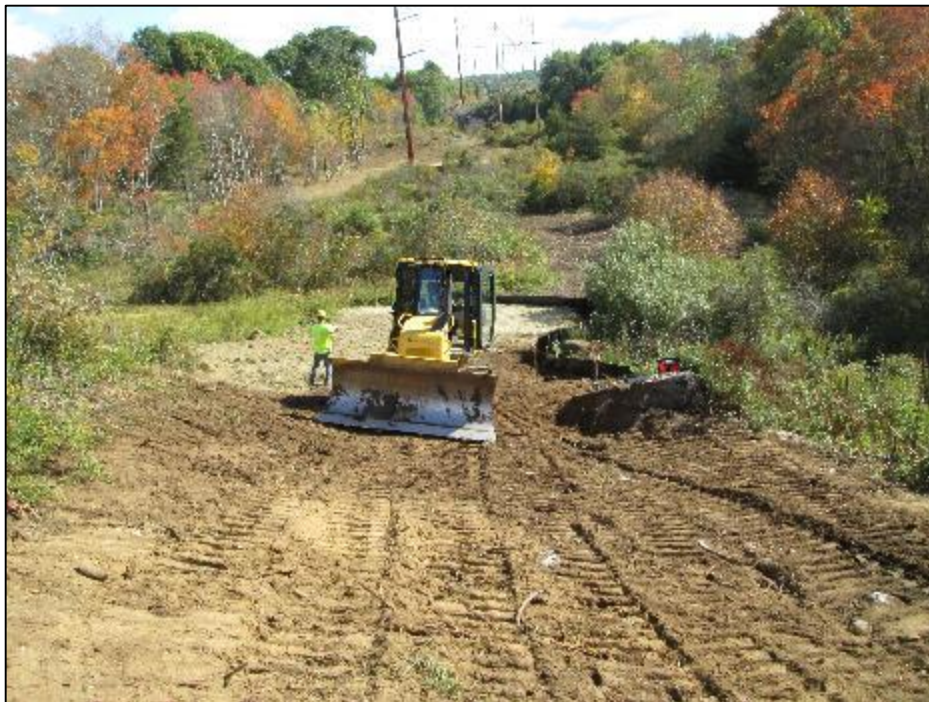
Photo #8: Spreading of hay over exposed topsoil and removal of fill up-line of Str 95.

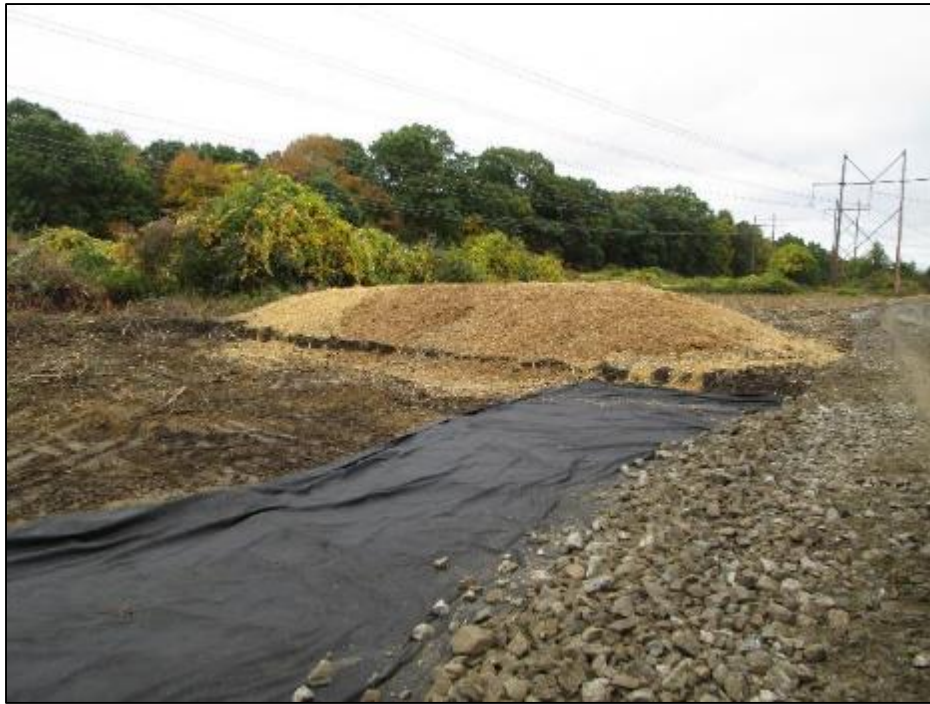
Photo #9: Striping of agricultural topsoil and installation of filter fabric at Str 227. (10/1)

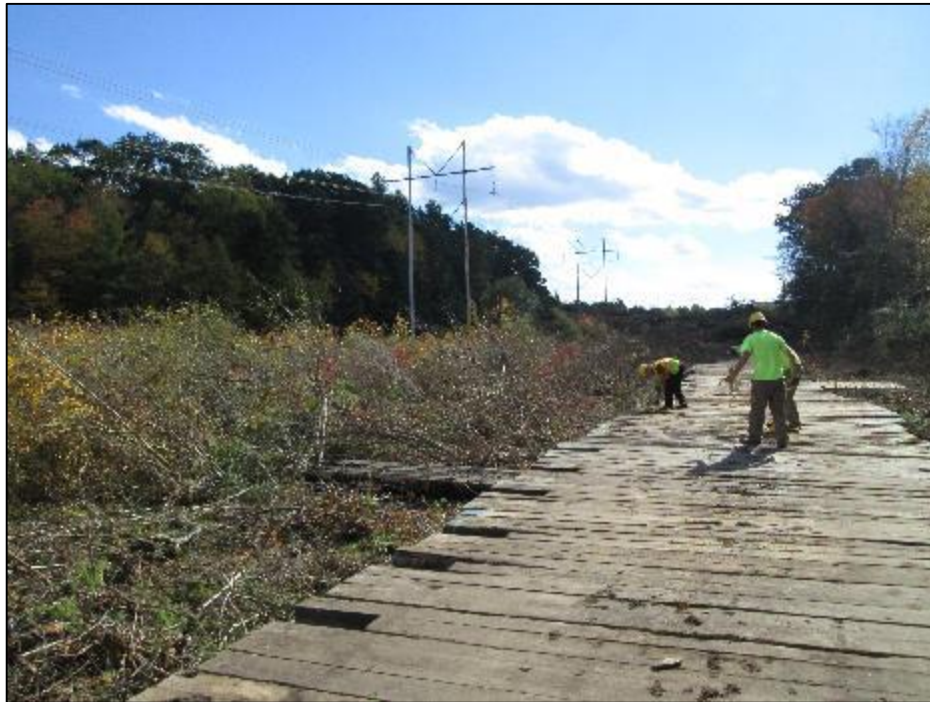
Photo #10: Connecting wetland mats with yellow rope in 100 year flood plain area between Str 206-207.
