**Docket No. 424 – Development and Management Plan Inspection**

The Connecticut Light and Power Company Certificate of Environmental Compatibility and Public Need for the Connecticut portion of the Interstate Reliability Project.

**IRP Overhead ROW**

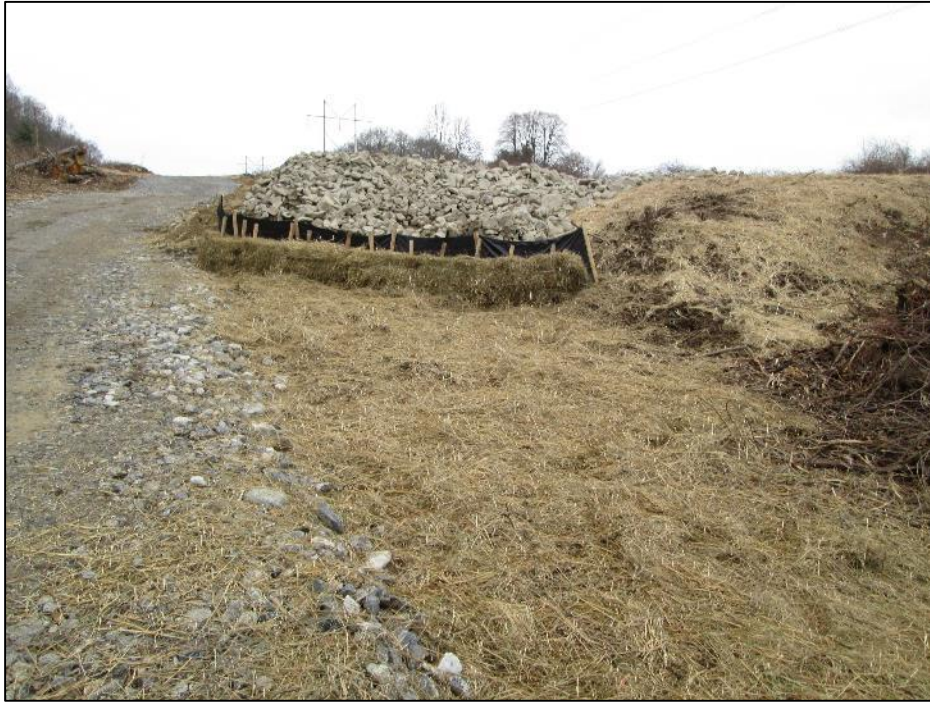
Photo #1: Observed plunge pool and hay bale reinforced silt fence at Str 284. (11/25)

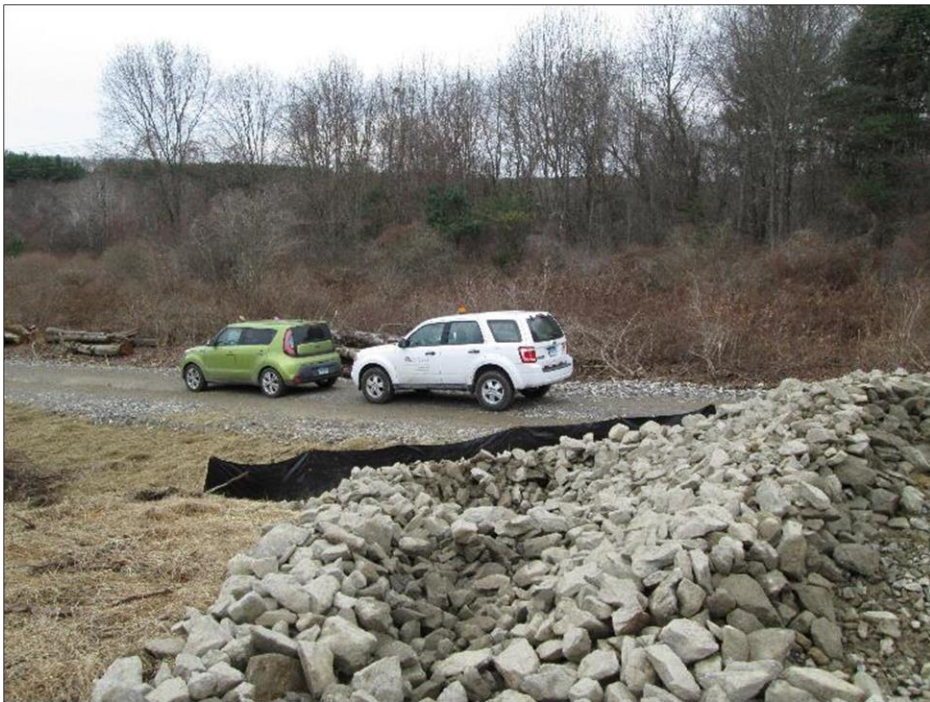
Photo #2: Observed plunge pool and hay bale reinforced silt fence at Str 284. (11/25)

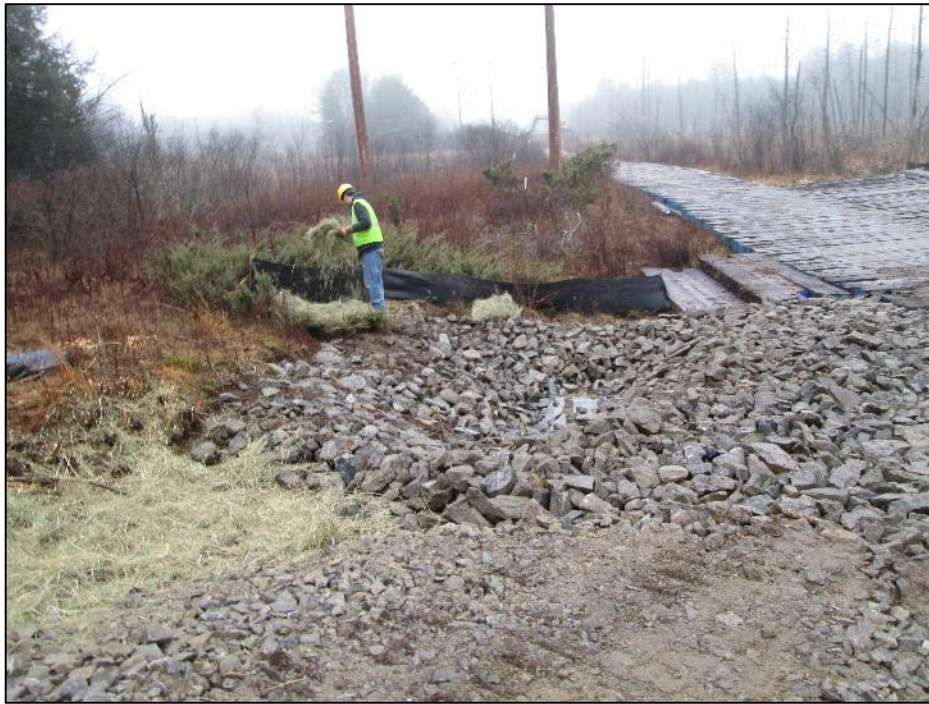
<b>Str 323:</b> Spreading of hay on exposed topsoil. (Photo 3)	Continue to follow this procedure.	NA
<b>Inland Wetland and Watercourse encroachment and mitigation</b>	<b>Interim Week (11/25)</b>	Mat installations in wetland areas are in accordance with the BMP Manual.	Continue to follow this procedure.	NA
	<b>Bi-Week (12/3)</b>	Mat installations in wetland areas are in accordance with the BMP Manual.	Continue to follow this procedure.	NA

Photo #3: Observed spreading of hay on exposed topsoil at Str 322. (12/3)

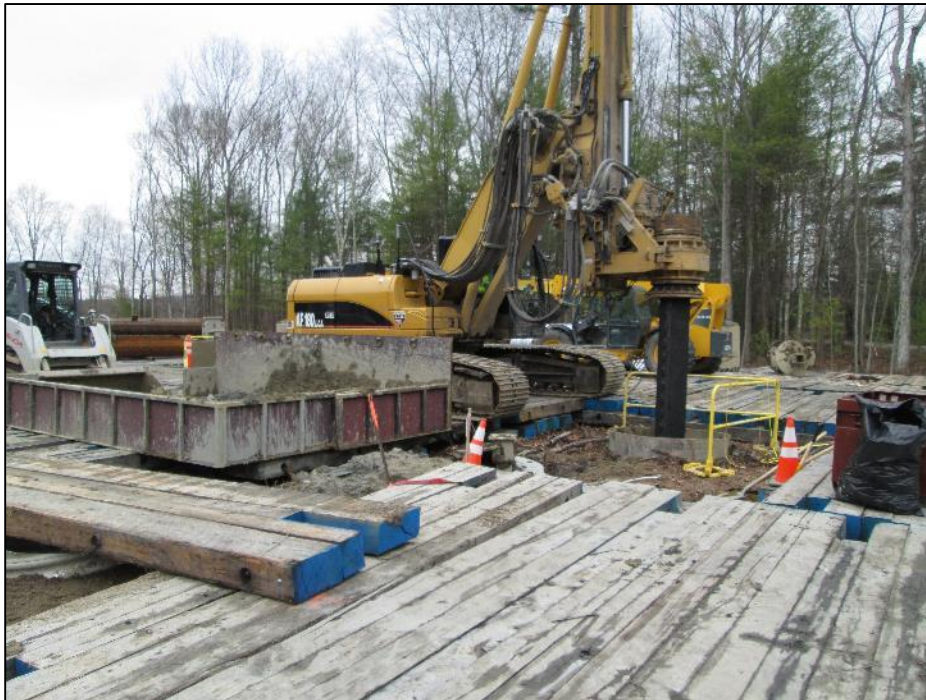
<b>Spills and Material Storage.</b>	<b>Interim Week (11/25)</b>	<p>Spill kits noted on all visited sites.</p> <p><b>Str 176:</b> Observed spin off container while drilling in wetland area. (Photo 4)</p>	<p>Continue to follow this procedure.</p> <p>Continue to follow this procedure.</p>	<p>NA</p> <p>NA</p>
	<b>Bi-Week (12/3)</b>	<p>Spill kits noted on all visited sites.</p> <p><b>Str 290:</b> Observed multiple petroleum based drips on access road and Str pad. (Photo 7 &amp; 8)</p> <p><b>Str 167:</b> Noted child pools under drilling machinery for precautionary containment measures.</p>	<p>Continue to follow this procedure.</p> <p>NA</p> <p>Continue to follow this procedure.</p>	<p>NA</p> <p>Northern crew immediately cleaned up drips with absorbent diapers and checked all trucks coming on site for leaks.</p> <p>NA</p>
<b>Cultural Resources</b>	<b>Interim Week (11/25)</b>	Pads in cultural areas are being installed with a geotextile separation fabric and sand buffer layer prior to the installation of the pad material.	NA	NA

Photo #4: Spin off container and emergency spill protection under drilling machinery at Str 176. (11/25)

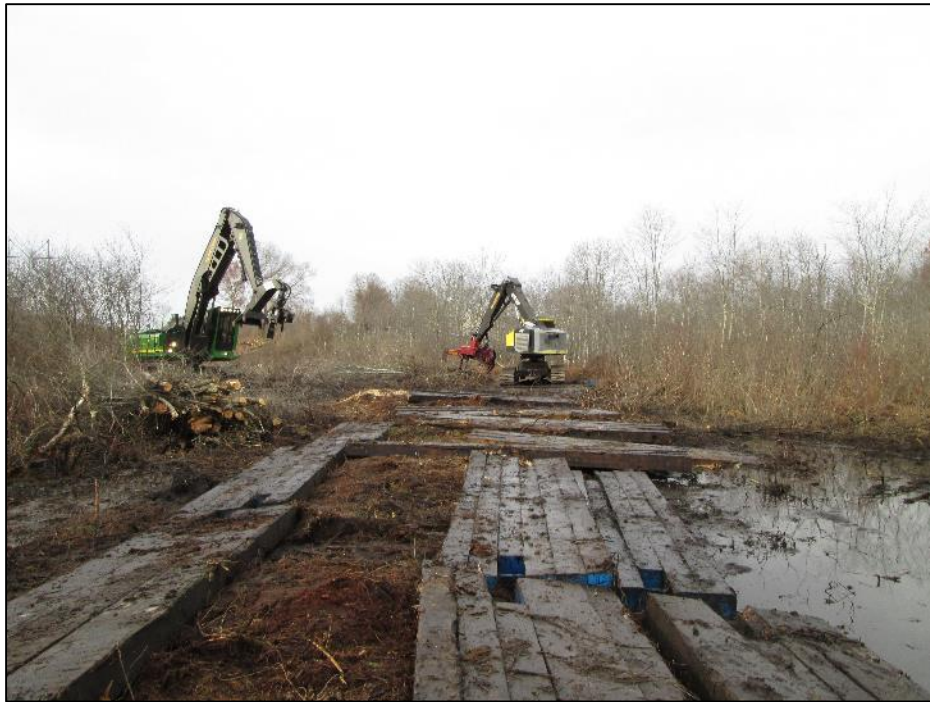
**MS59, Str 298-300:** Clearing operations. (Photo 5)

Photo #5: Clearing crew utilizing timber mats in wet areas to prevent unnecessary rutting between Str 298-299. (11/25)

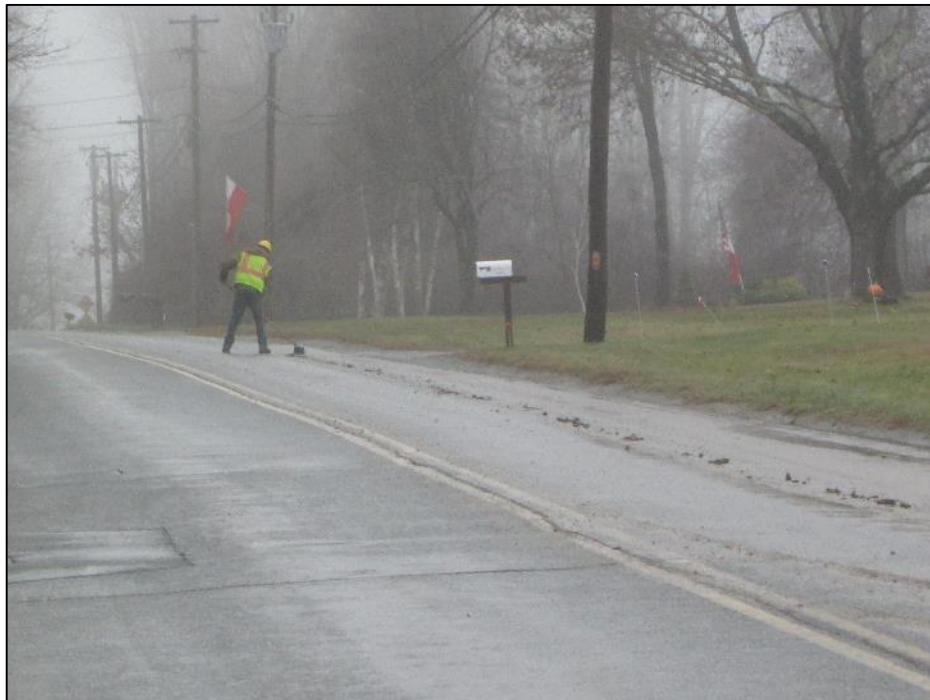
Photo #6: Observed sweeping of roadway after trucks leave construction site at Str 290. (12/3)

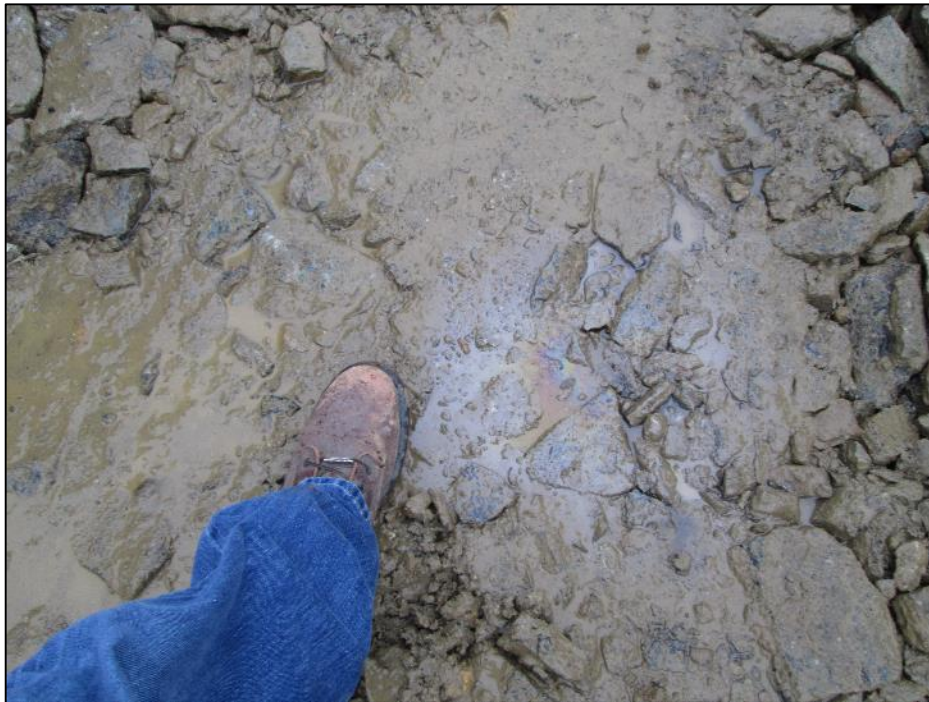
**MS58, Str 290:** Grading of pad and delivery of materials, sweeping of roadway, multiple petroleum drips on access road and Str pad 290. (Photo 3, 7 & 8)

Photo #7: Observed multiple petroleum drips on access road and Str pad 290. (12/3)

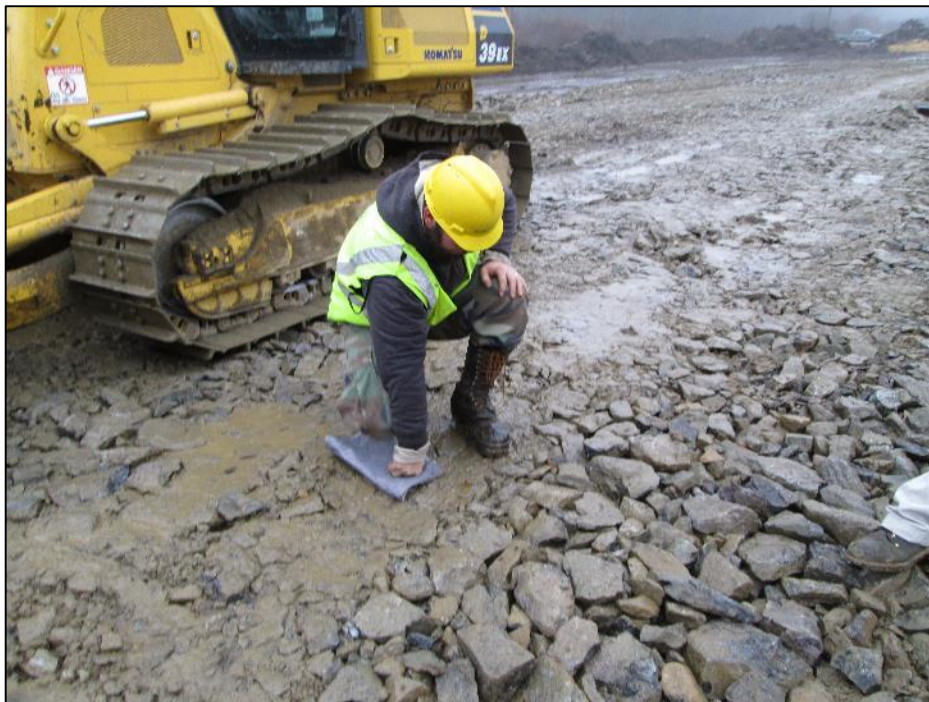
Photo #8: Northern crew immediately cleaned up drips with absorbent diapers at Str 290. (12/3)

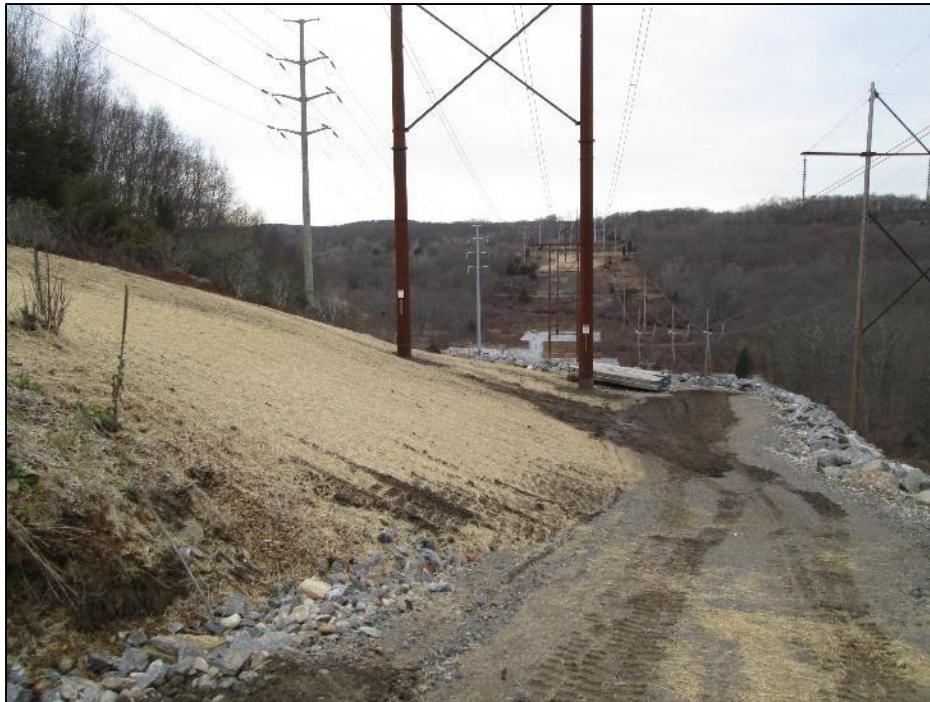
Photo #9: Erosion control of Str pad 22 restored to original grades and slopes. (11/25)

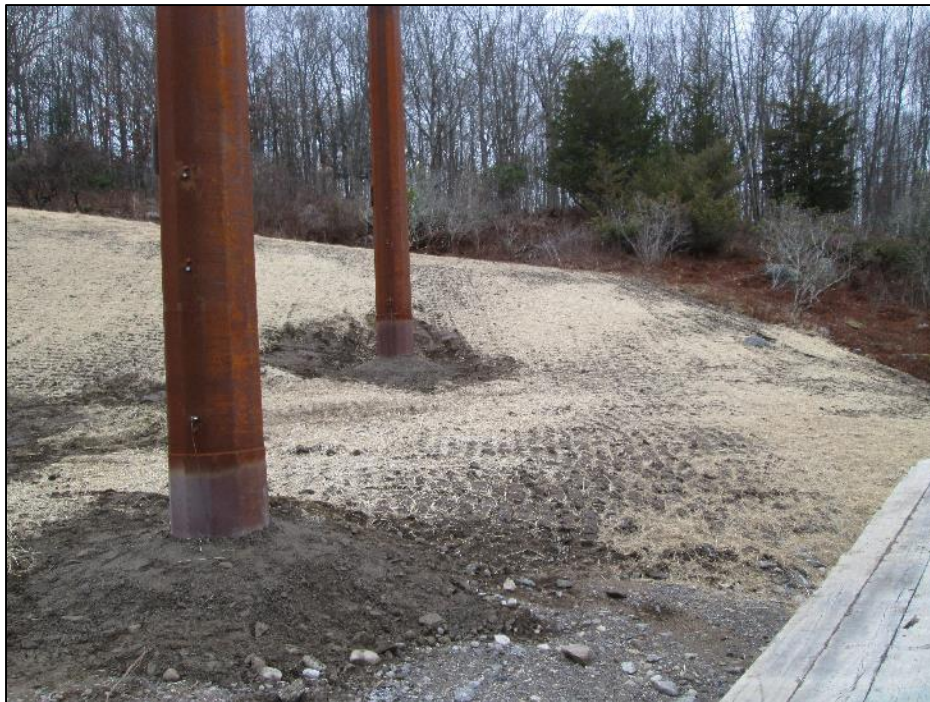
Photo #10: Erosion control of Str pad 22 restored to original grades and slopes. (11/25)
