Docket No. 424 – Development and Management Plan Inspection

The Connecticut Light and Power Company Certificate of Environmental Compatibility and Public Need for the Connecticut portion of the Interstate Reliability Project.

IRP Overhead ROW

Interim Week Inspection:

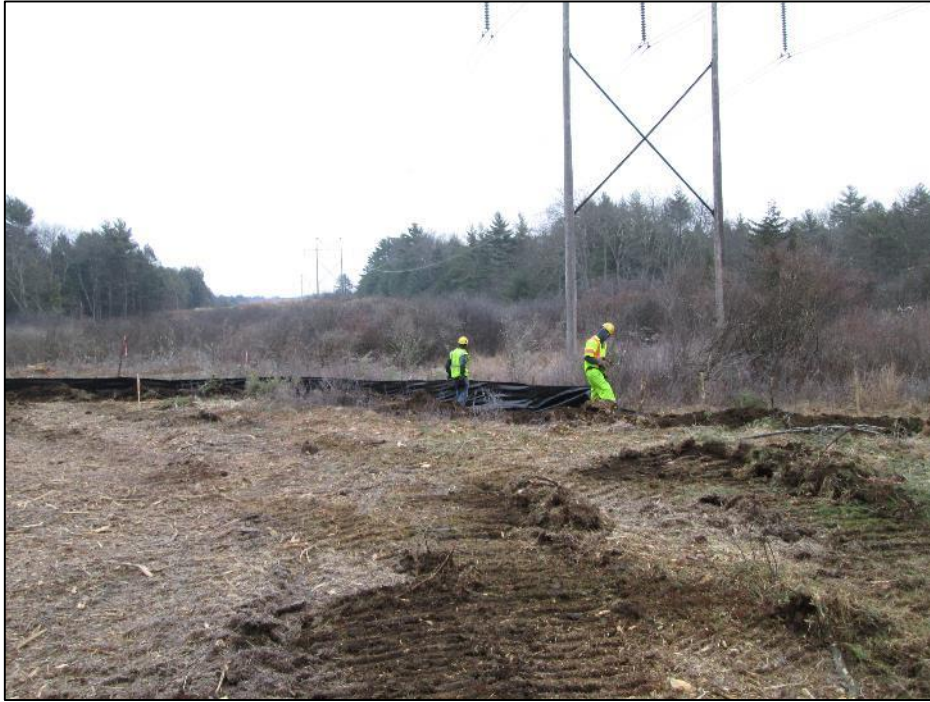
MS62-63, Str 315-317: Striping of topsoil for access road and installation of silt fence at Str 317. Delivery of construction materials, grading and compacting of Str pad 316. (Photo 1 & 4)

Bi-Week (12/16)	All crossings appear to be functioning in accordance with the BMP Manual. No sediment appears to be entering the streams or wetlands.	Continue to follow this procedure.	NA
Erosion and Sedimentation Controls	Interim Week (12/11)	Noted that stockpile areas along ROW are being surrounded with straw wattles and stabilized with blown straw. Str 315-316: Observed plunge pool and hay bale reinforced silt fence to prevent erosion between Str pads 315 & 316. Observed hay bales installed incorrectly on edge of plunge pool before crossing Munson Brook from Str 315. (Photo 2 & 3)	Continue to follow this procedure. Hay bales need to be rotated 90 degrees so strings are not touching the ground.	NA Northern Crew indicated that they intend to fix the hay bales later that day.
	Bi-Week (12/16)	Str 315-317: Observed hay bales re-installed correctly on edge of plunge pool before crossing Munson Brook from Str 315. Observed installation of silt fence. (Photo 1 & 4)	Continue to follow this procedure.	NA

Photo #1: Observed installation of silt fence at Str 317. (12/16)

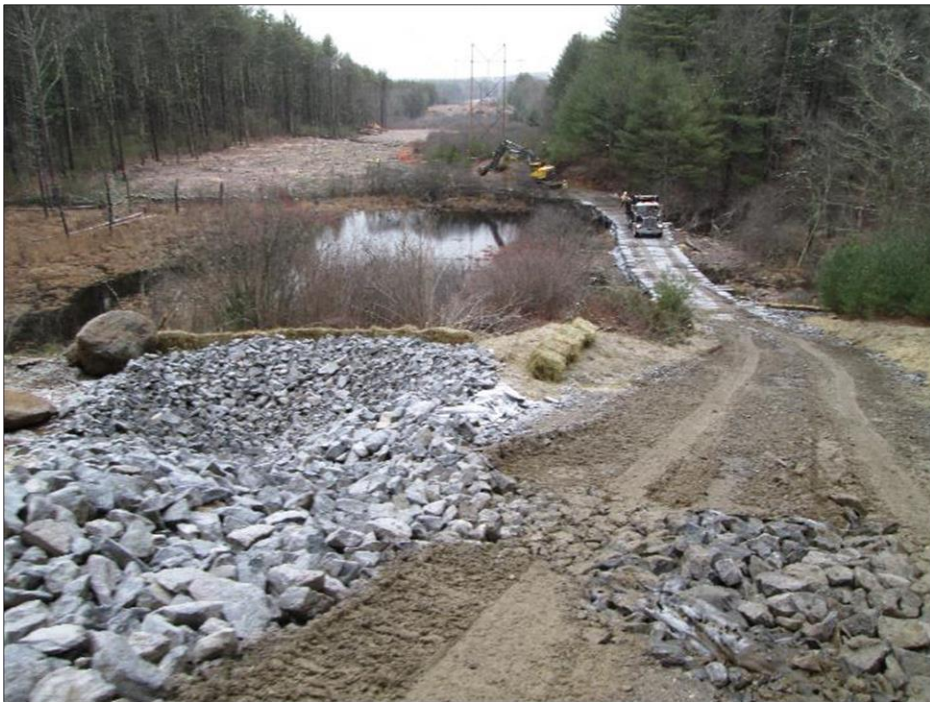
MS62, Str 315-316: Installation of access road, Delivery of construction materials. (Photo 2 & 3)

Photo #2: Observed plunge pool, armored water bar and hay bale reinforced silt fence up-line of Str 315. (12/11)

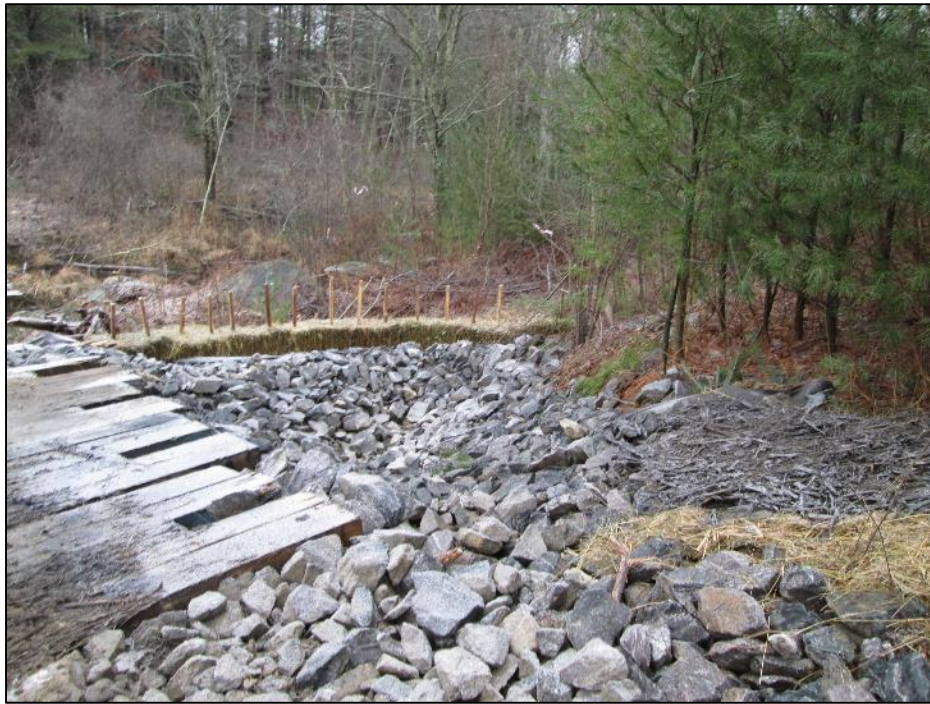
Photo #3: Observed hay bales installed incorrectly on edge of plunge pool up-line of Str 315. (12/11)

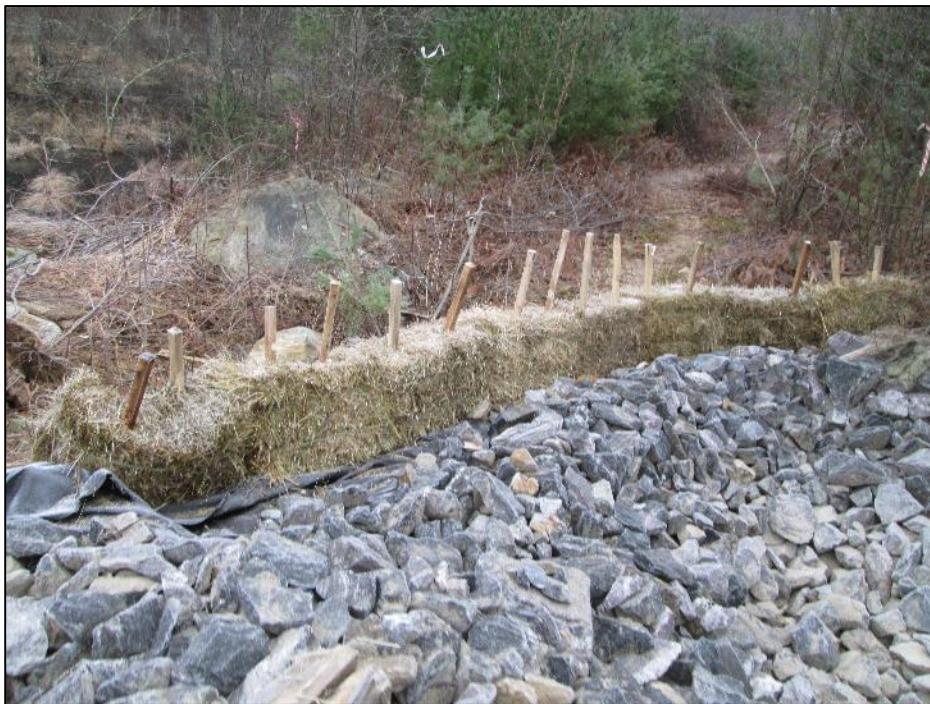
Photo #4: Observed hay bales re-installed correctly on edge of plunge pool up-line of Str 315. (12/16)

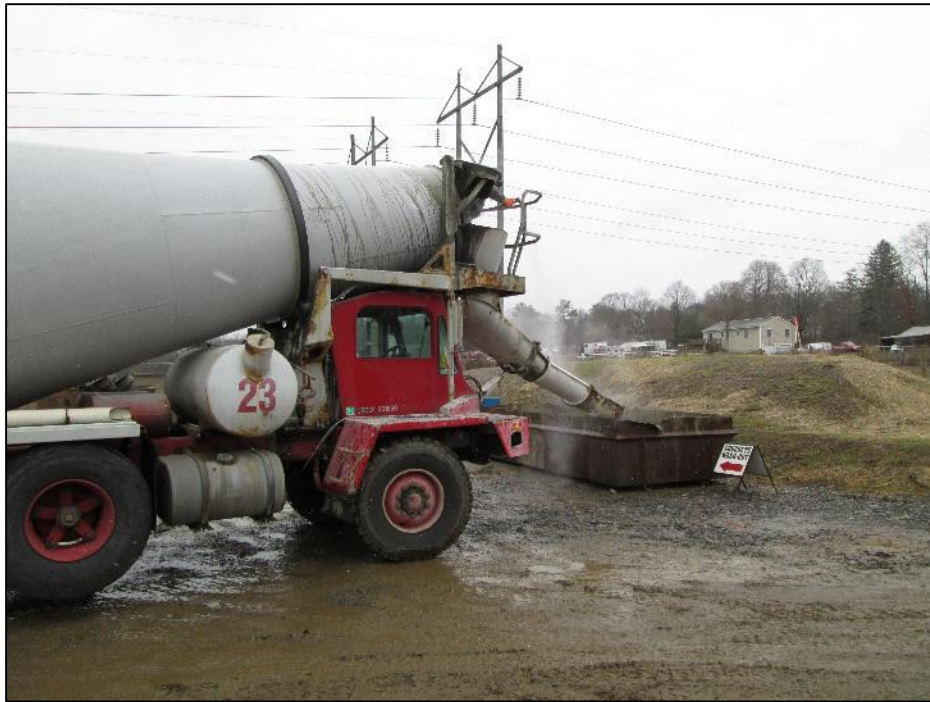
MS58, Str 241 & 243: Pouring of concrete foundation at Str 241. Concrete wash-out area at Str 243. (Photo 5)

Photo #5: Observed concrete wash-out upland at Str 243. (12/11)

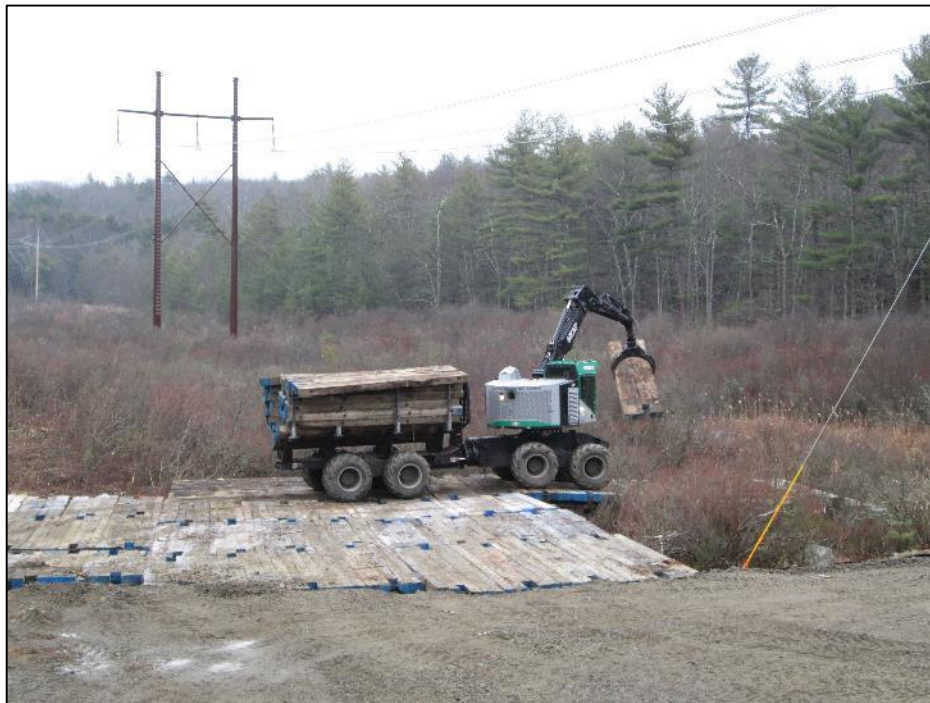
MS60, Str 305: Installation of structure pad utilizing timber mats. (Photo 6)

Photo #6: Building of Str pad 305 with timber mats in wetland. (12/16)

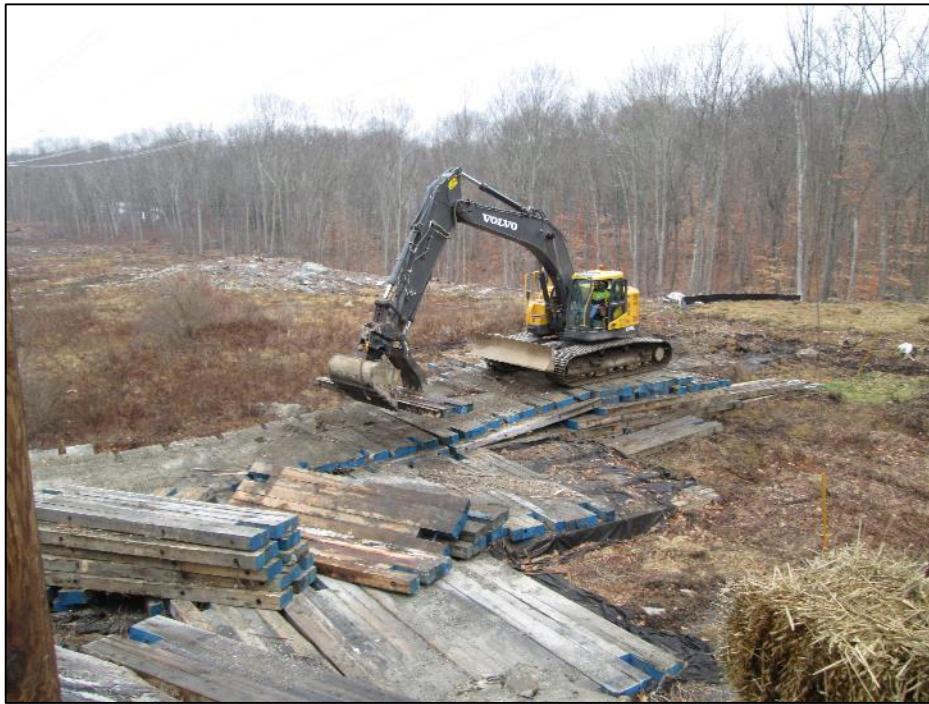
MS20, Str 104: Reclamation and restoration, removal of wetland mats and cleaning of debris. (Photo 7)

- Drilling operations ongoing at Str 162, Str 169, Str 182 and Str 192.
- Str 104: Construction pad 104 has been removed, restored and stabilized to their original, pre-construction grades and slopes. (Photo 7)
- Construction pads for structure assembly and erection that were removed, with their areas restored to original grades and slopes: Str 22, 84-100, 104, and 269-270.

Photo #7: Removal of wetland mats and restoring to pre-construction grades and slopes at Str 104. (12/16)

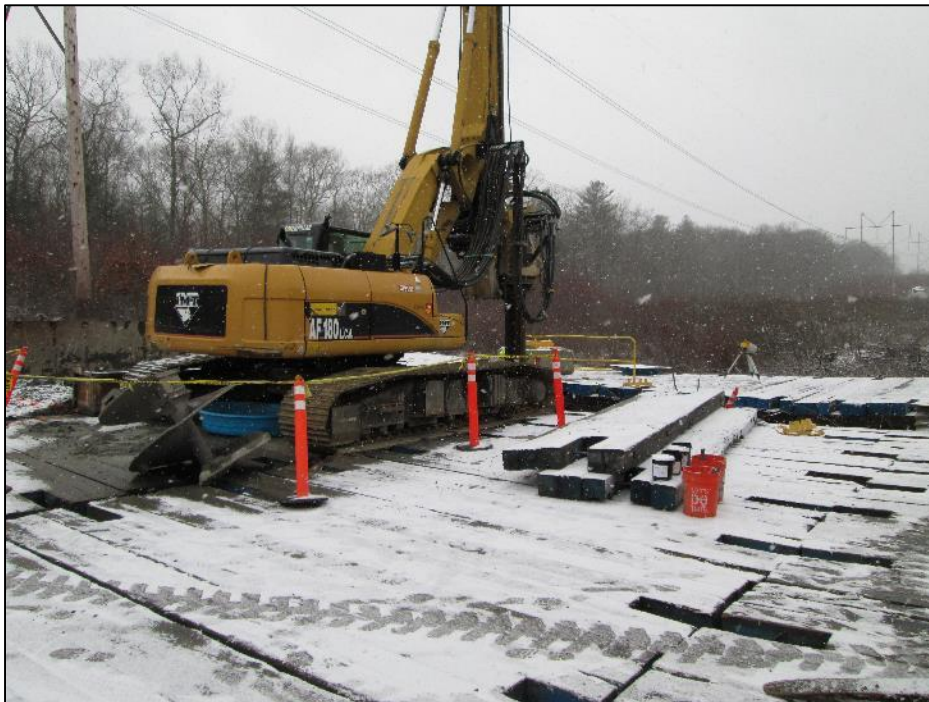
MS31, Str 161: Drilling operations. (Photo 8)

Spills and Material Storage.	Interim Week (12/11)	Spill kits noted on all visited sites. Str 161: Noted child pools under drilling machinery for precautionary measures. (Photo 8)	Continue to follow this procedure. Continue to follow this procedure.	NA NA
	Bi-Week (12/16)	Spill kits noted on all visited sites.	Continue to follow this procedure.	NA
Cultural Resources	Interim Week (12/11)	Pads in cultural areas are being installed with a geotextile separation fabric and sand buffer layer prior to the installation of the pad material.	NA	NA
	Bi-Week (12/16)	Pads in cultural areas are being installed with a geotextile separation fabric and sand buffer layer prior to the installation of the pad material.	NA	NA
Rare, Threatened, and Endangered Species	Interim Week (12/11)	NA	NA	NA
	Bi-Week (12/16)	NA	NA	NA

Photo #8: Observed child pool under drilling machinery for precautionary measures at Str 161. (12/11)
