**Docket No. 424 – Development and Management Plan Inspection**

The Connecticut Light and Power Company Certificate of Environmental Compatibility and Public Need for the Connecticut portion of the Interstate Reliability Project.

**IRP Overhead ROW**

**Interim Week Inspection:**

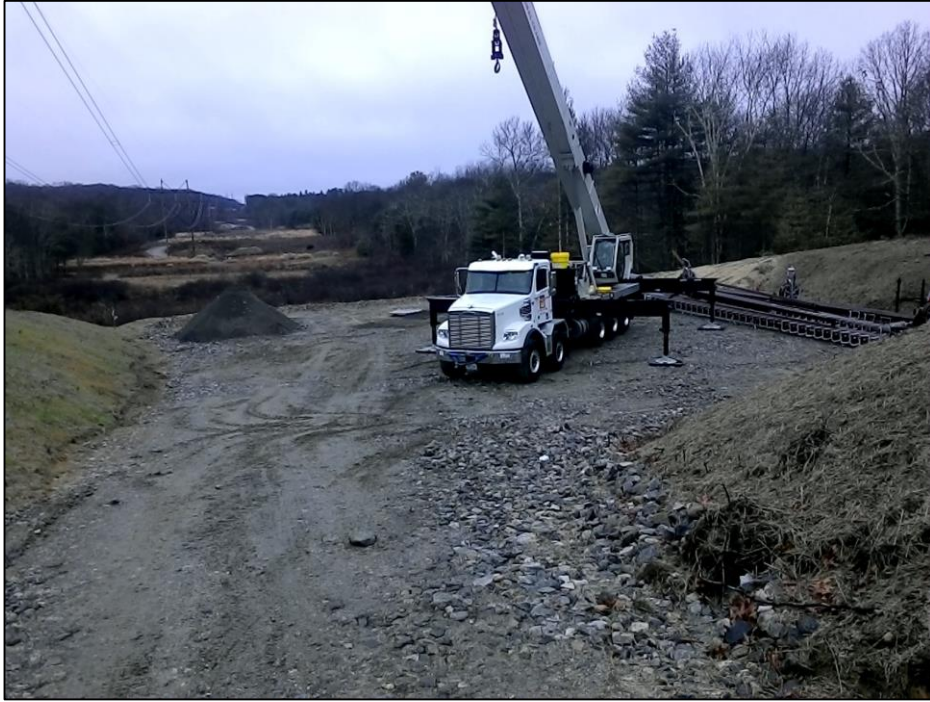
**MS28, Str 148:** Pad Clean-up for holiday. (photo 1)

Photo #1: Crew preparing to clean up Str 168 for holiday shutdown.

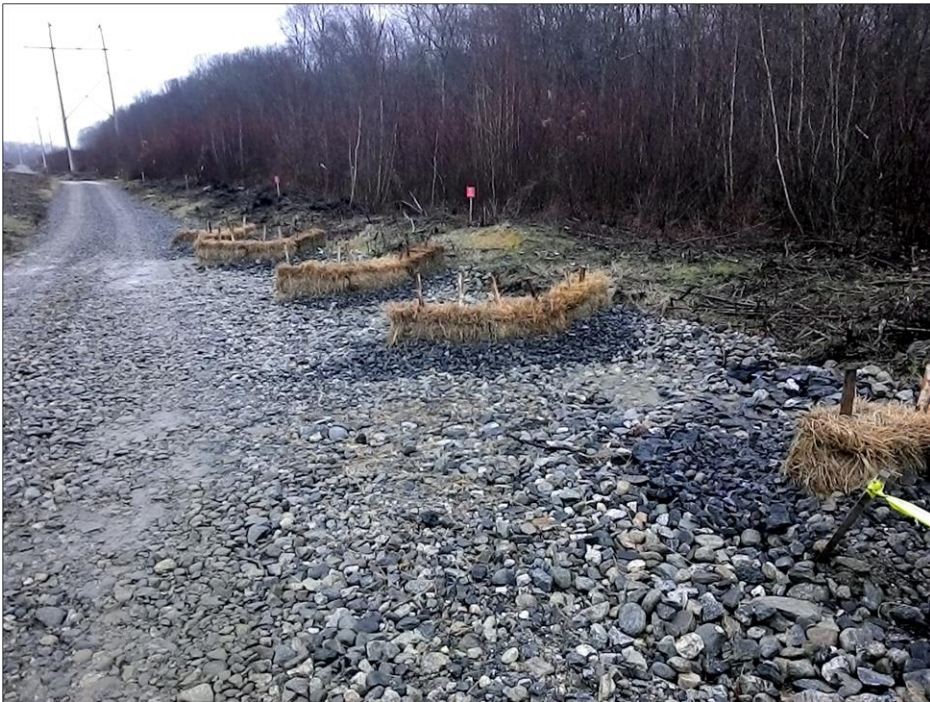
Bi-Week (12/29)			
Erosion and Sedimentation Controls	Interim Week (12/23)	<p>Noted that stockpile areas along ROW are being surrounded with straw wattles and stabilized with blown straw.</p> <p><b>Str 157:</b> Side swale check dams and Sedimentation trap functioning in accordance with BMP manual. (Photo 2-3)</p>	<p>Continue to follow this procedure.</p> <p>NA</p>	NA
	Bi-Week (12/29)			
Inland Wetland and Watercourse encroachment and mitigation	Interim Week (12/23)	<p>Mat installations in wetland areas are in accordance with the BMP Manual.</p>	<p>Continue to follow this procedure.</p>	NA
	Bi-Week (12/29)			
Spills and Material Storage.	Interim Week (12/23)	<p>Spill kits noted on all visited sites.</p> <p><b>Str 160:</b> Observed minor petroleum based spill (less than a pint) on Pad 160 from chainsaw fueling. (Photo 5-6)</p>	<p>Continue to follow this procedure.</p>	<p>NA</p> <p>Crews immediately contained Spill with spill materials.</p>

Photo #2: Check-dams functioning according to BMP manual down line of Str 157.

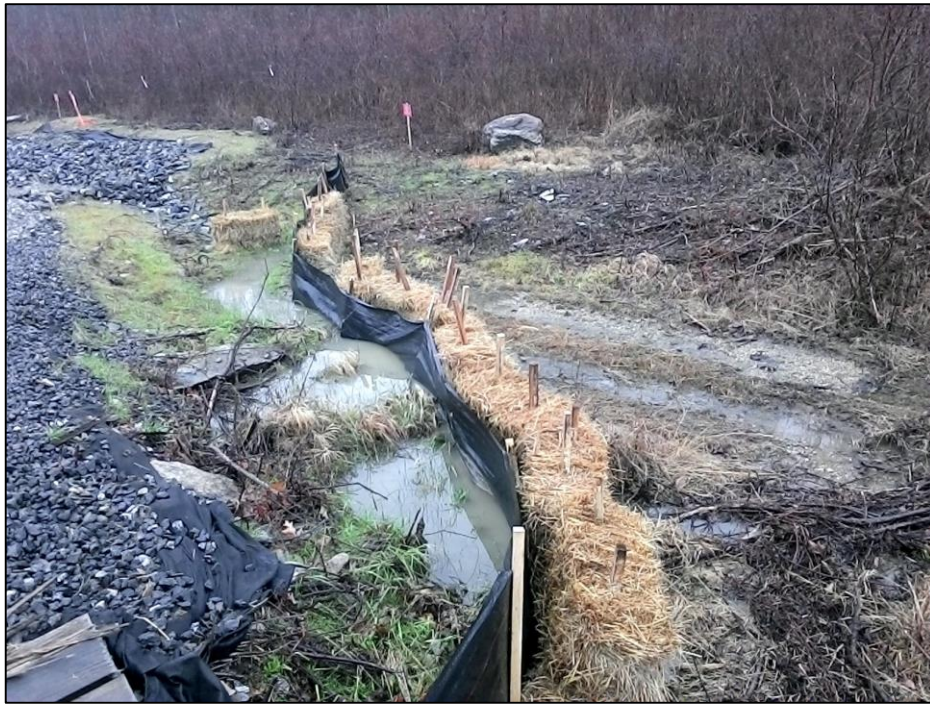
Photo #3: Straw bale reinforced silt fence at discharge point downtime of Str 157.

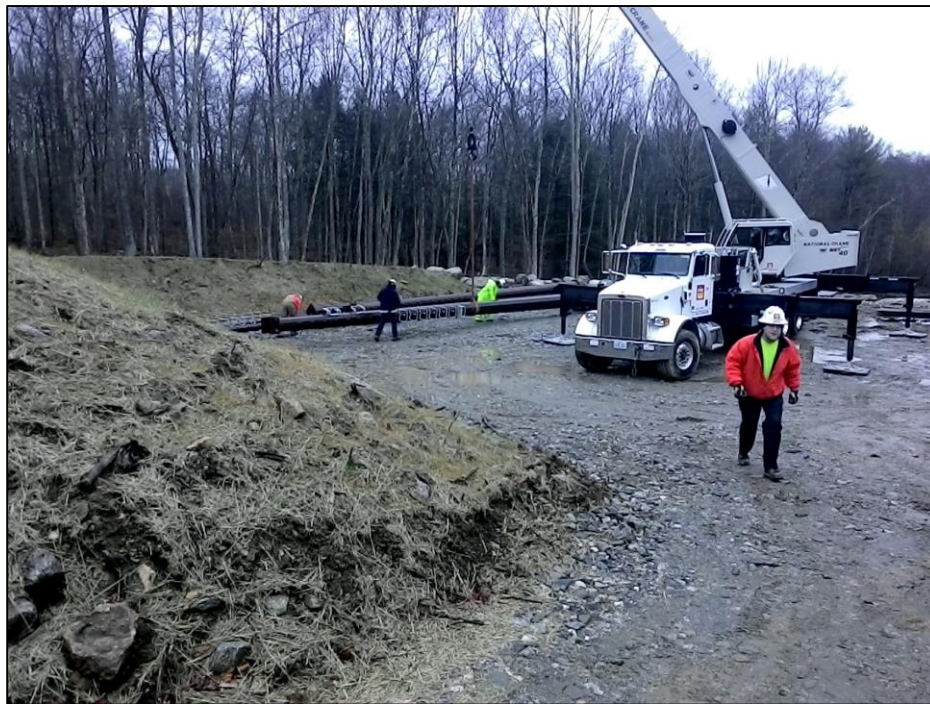
**MS30, Str 160:** Structure Erection. (Photo 4)

Photo #4: Crew preparing for Str 160 erection.

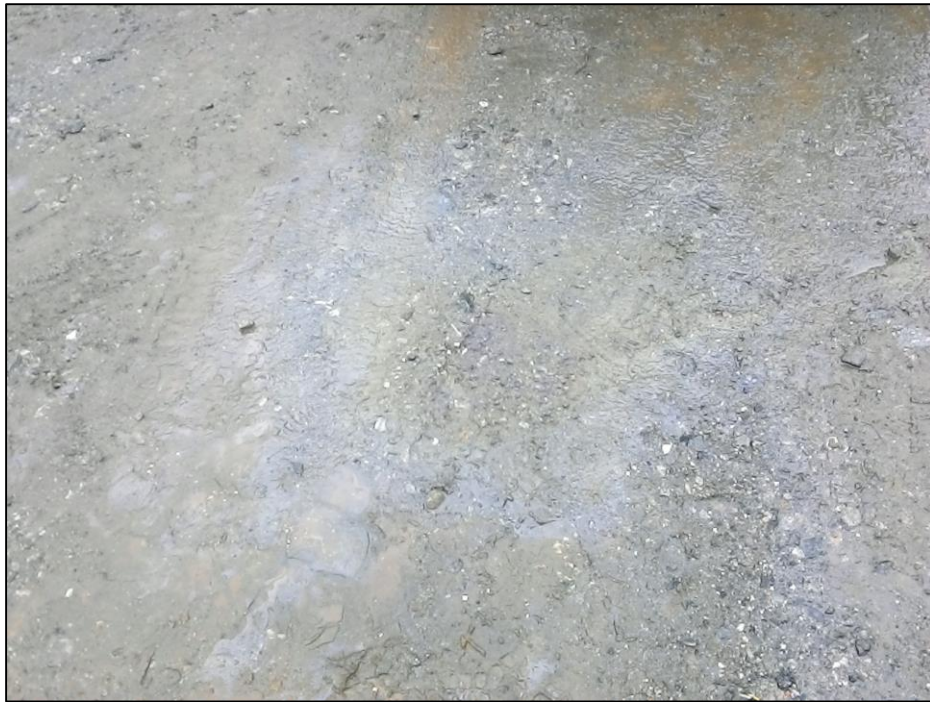
Photo #5: Observed Petroleum based spill on pad 160.

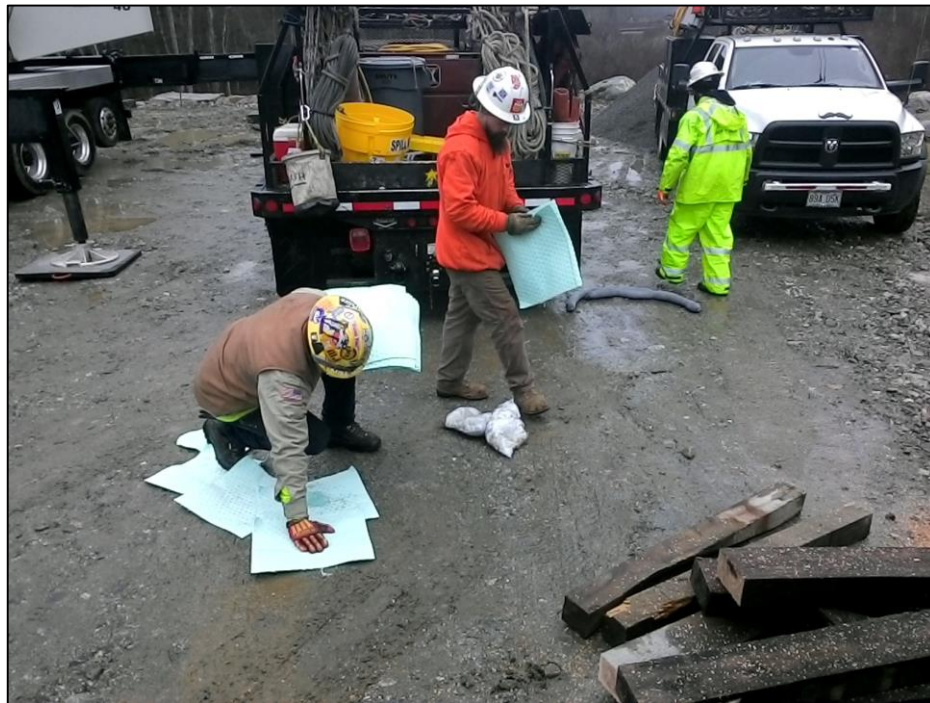
Photo #6: Crew immediately contained and cleaned up the area.

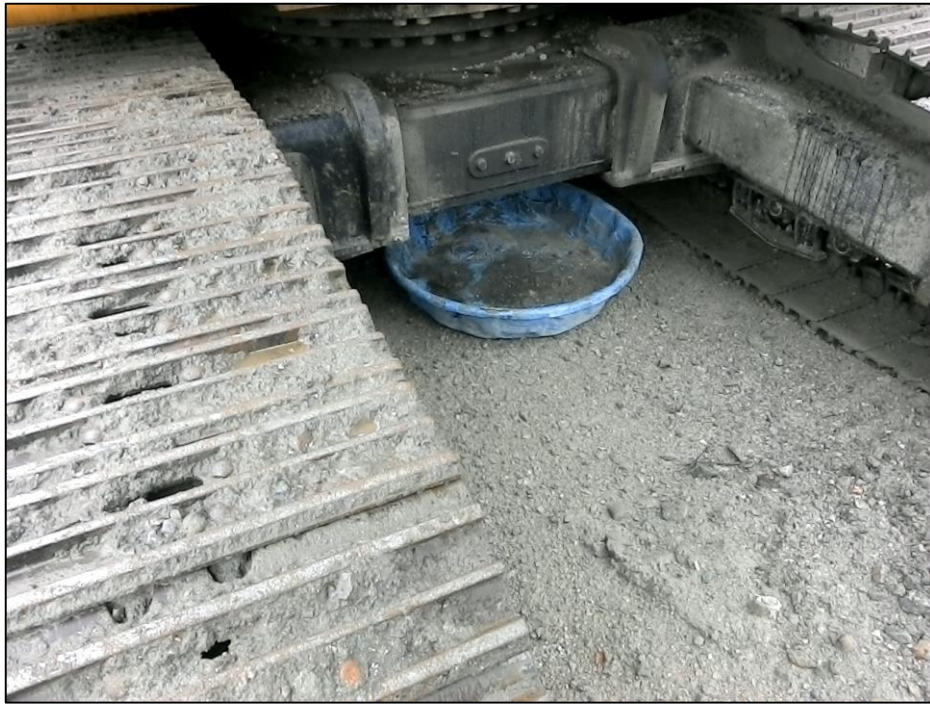
Photo #7: child pool apparent under equipment on Pad 166.

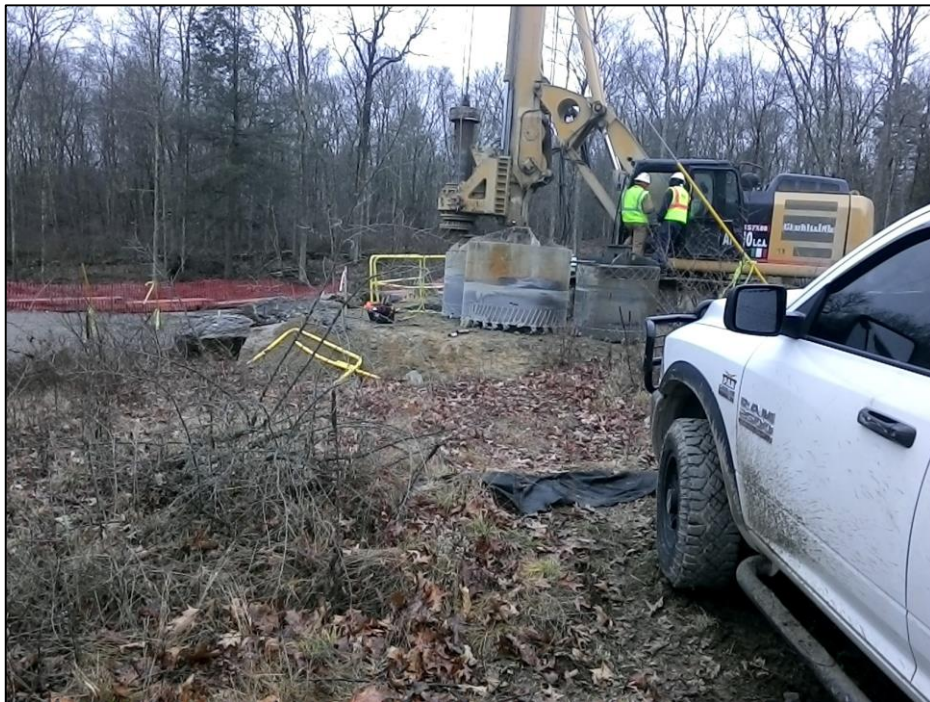
**MS35, Str 183:** Drilling Operations. (photo 8)

Photo #8: Rock coring for Str 183.

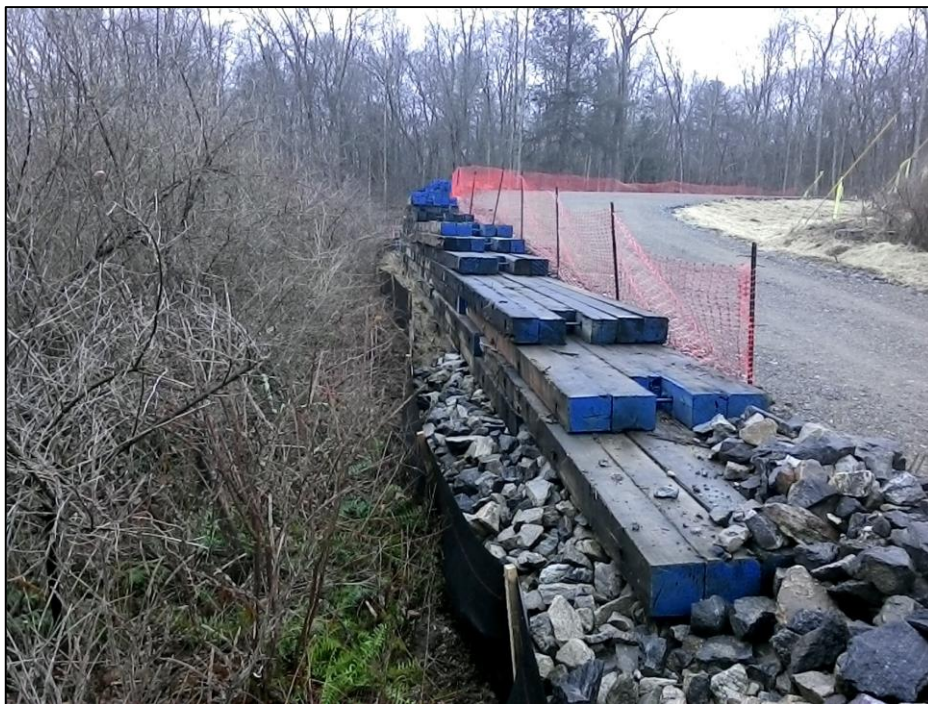
Photo #10: Erosion Controls and timber mat retaining wall down-line of Str 183.

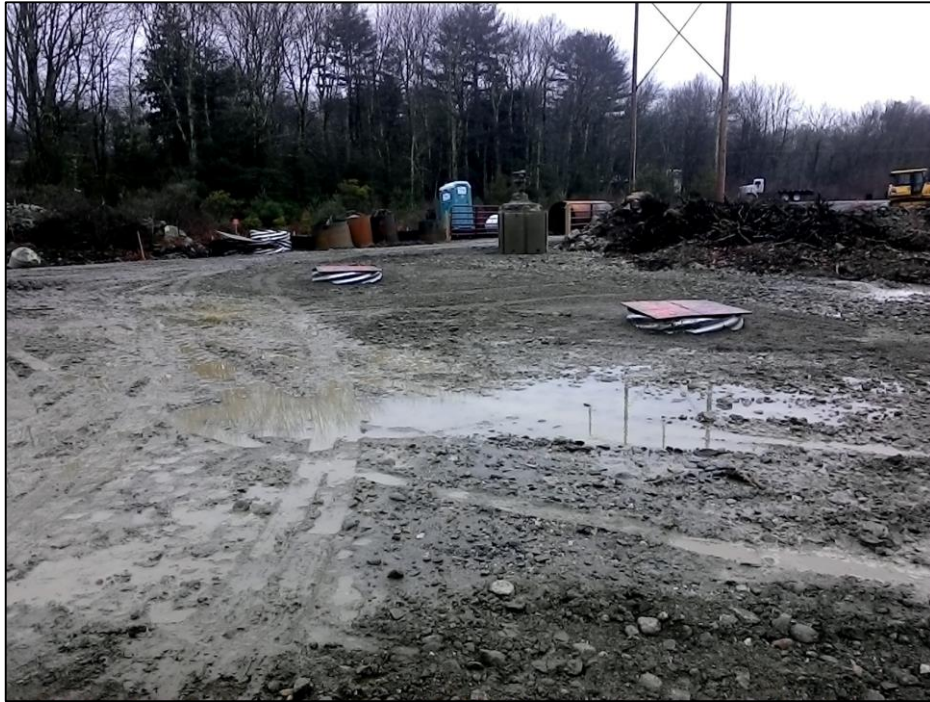
<b>Areas of Inspection</b>		<b>Observation:</b>	<b>Recommended Action:</b>	<b>Corrected Action:</b>
<b>Access Roads and Adjacent Roadways</b>	<b>Interim Week (12/23)</b>	Adjacent roadways clear and free of sediment at all visited sites.  In general, ROW access roads contain a 1/2" to 1" layer of mud along their surface. (photo 11)	Continue to follow this procedure.  Continue to monitor access roads to ensure sediment does not wash into sensitive areas during a rain event.	NA  N. Ganacoplos indicated he would continue to monitor access roads for deterioration.
	<b>Bi-Week (12/29)</b>			
<b>Vegetative Clearing Limits (Including trees to save or danger trees noted.)</b>	<b>Interim Week (12/23)</b>	Mechanical clearing along I.R.P. ROW is complete.	NA	NA
	<b>Bi-Week ( 12/29)</b>			
<b>Water Crossings</b>	<b>Interim Week (12/23)</b>	All crossings appear to be functioning in accordance with the BMP Manual. No sediment appears to be entering the streams or wetlands.	Continue to follow this procedure.	NA

Photo #11: Evidence of muddy access roads.
