Docket No. 424 – Development and Management Plan Inspection

The Connecticut Light and Power Company Certificate of Environmental Compatibility and Public Need for the Connecticut portion of the Interstate Reliability Project.

IRP Overhead ROW

Interim Week Inspection:

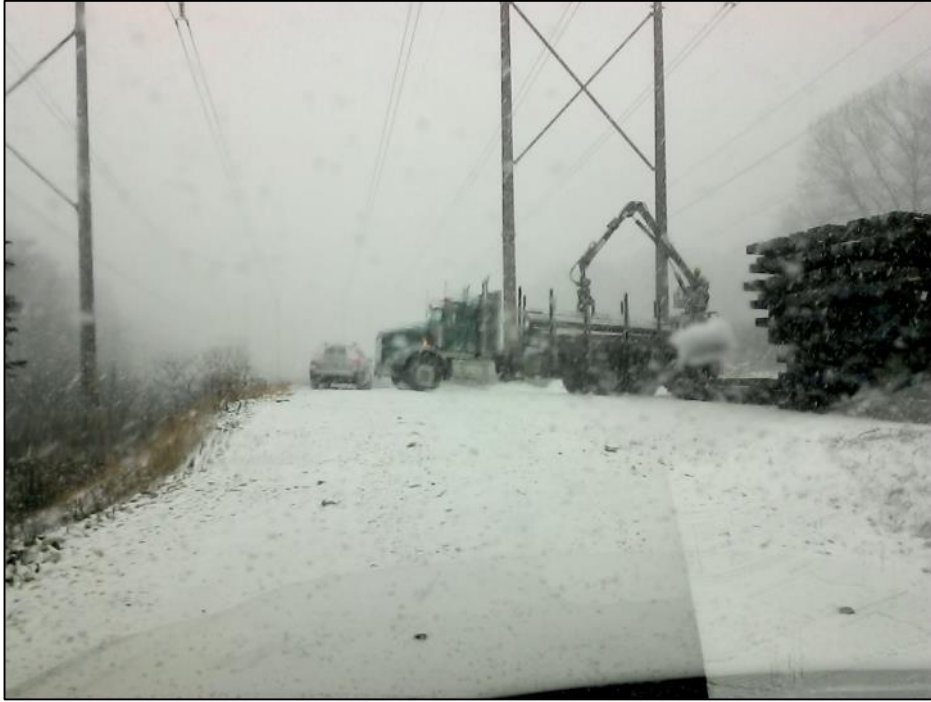
MS3, Str 15: Wetland Mat Removal. (Photo 1, 2)

Photo #1: Timber Mat removal in the vicinity of Str 15. (1/9)

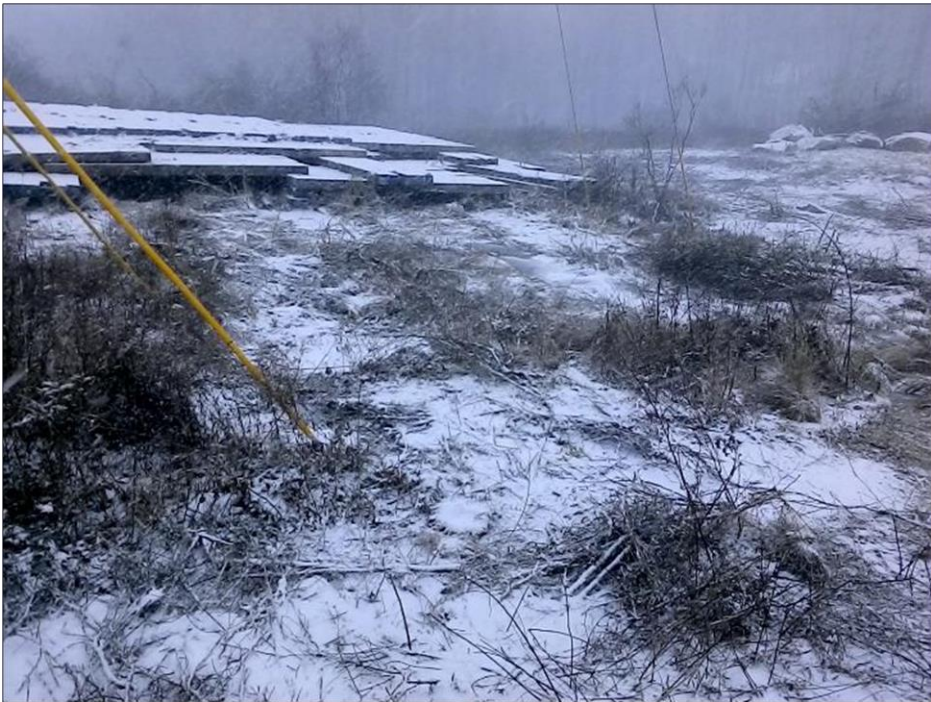
Photo #2: Wetland Mat Removal at Str 15.

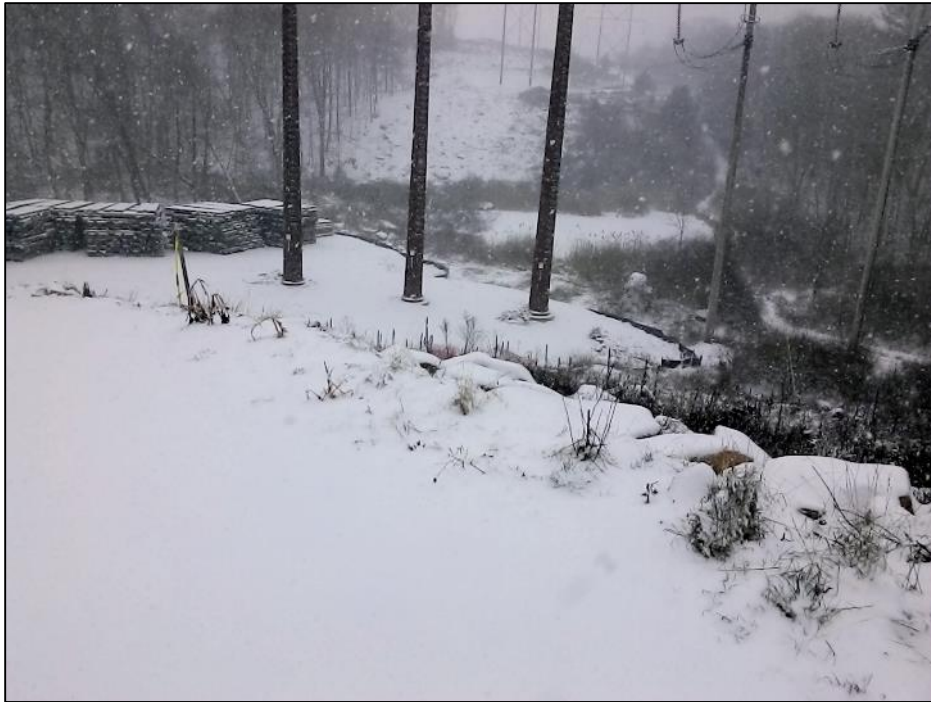
MS9, Str 49: Wetland Mat Removal. (Photo 3)

Photo #3: Wetland Timber Mats removed and silt fence installed at Str 49. (1/9)

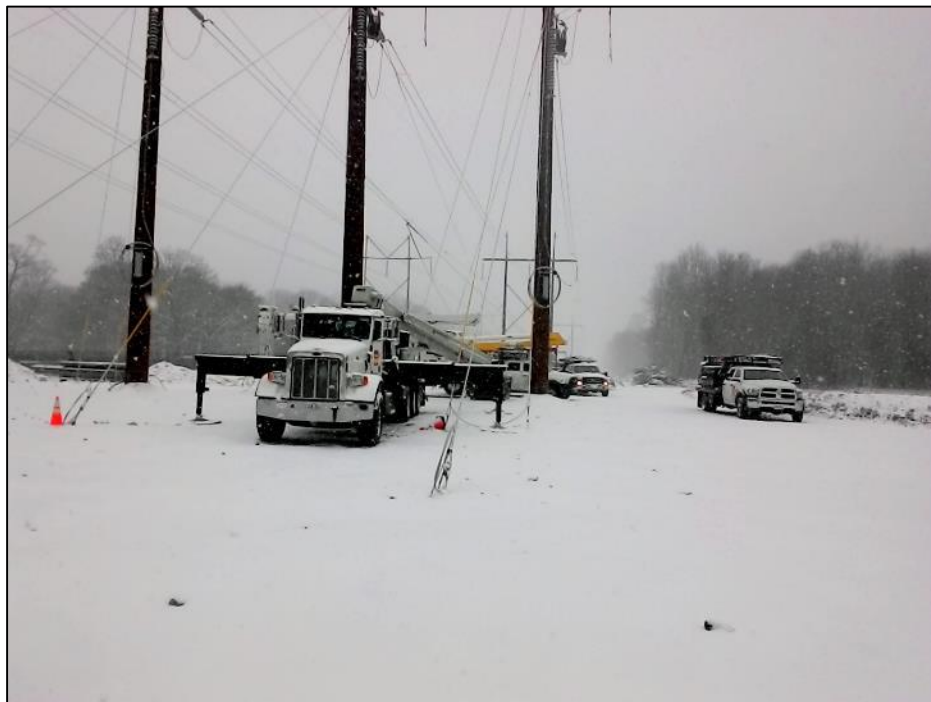
MS21, Str 111-125: Preparing for conductor pull operation. (Photo 4, 5)

Photo #4: Line Crews preparing for conductor pull from Str 111-125 (Str 111 in view). (1/9)

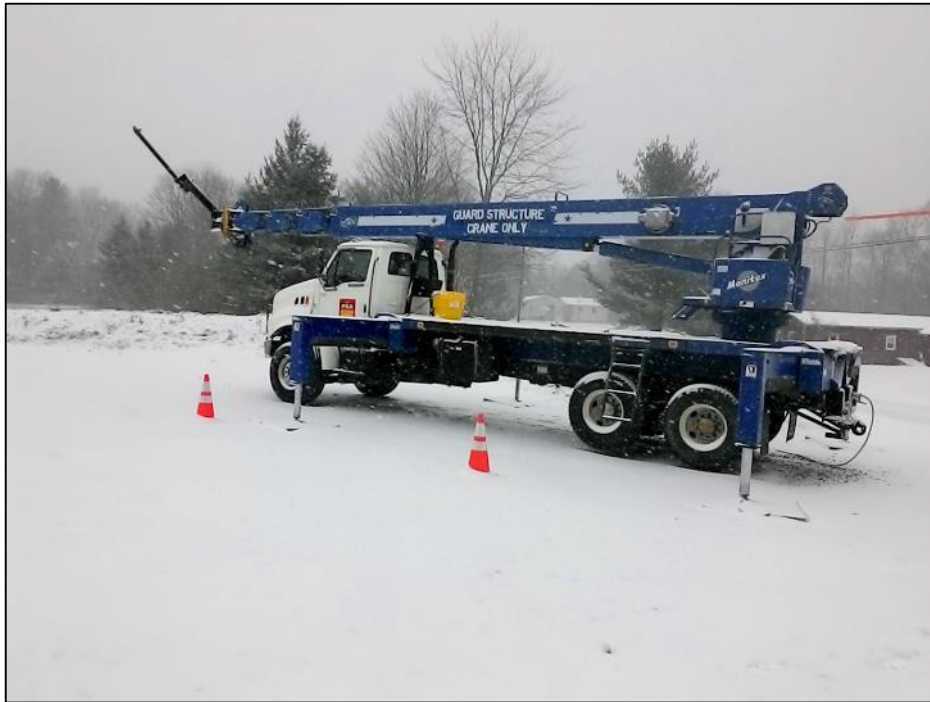
Photo #5: Spill kit visible onsite. (1/9)

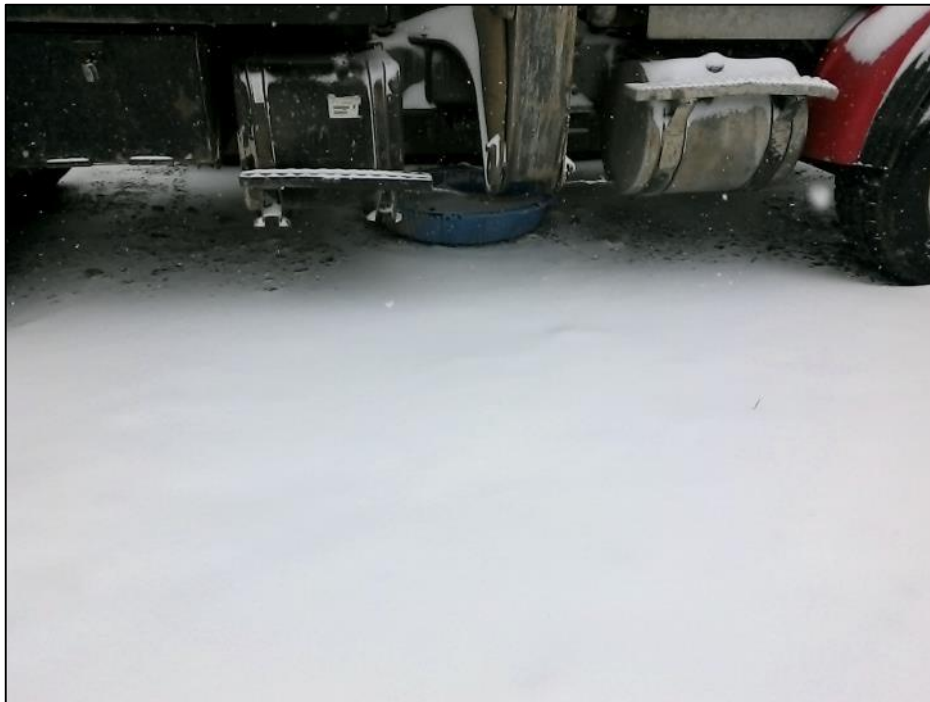
Spills and Material Storage.	Interim Week (1/9)	Spill kits noted on all visited sites. Str 193: Observed child pool left beneath parked equipment onsite. (Photo 6)	Continue to follow this procedure. Continue to follow this procedure.	NA
	Bi-Week (1/15)	Spill kits noted on all visited sites.	Continue to follow this procedure.	NA
Cultural Resources	Interim Week (1/9)	Pads in cultural areas are being installed with a geotextile separation fabric and sand buffer layer prior to the installation of the pad material.	NA	NA
	Bi-Week (1/15)	Cultural areas contained in accordance with D&M Plans.	Continue to follow this procedure.	NA
Rare, Threatened, and Endangered Species	Interim Week (1/9)	T. Ramborger indicated some Moth host Plant species have been re-flagged for clarity specifically for snow plowing.	NA	NA
	Bi-Week (1/15)	NA	NA	NA

Photo #6: Child Pool containment under equipment on pad 193. (1/9)

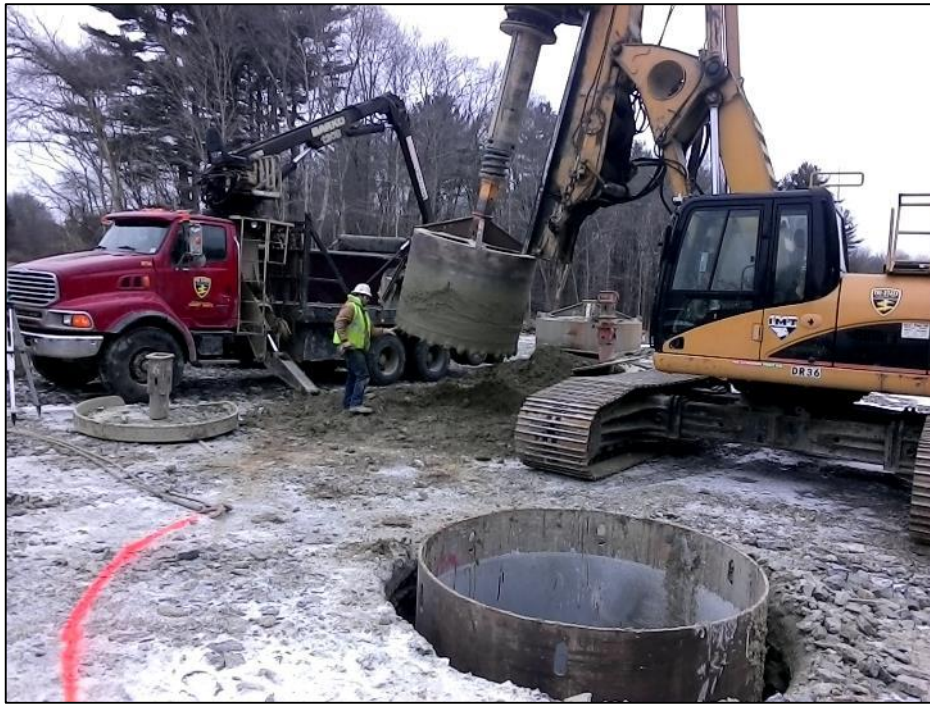
MS58, Str 293: Drilling Operation (Photo 7)

Photo #7: Drilling Operation for Str 293 (1/15)

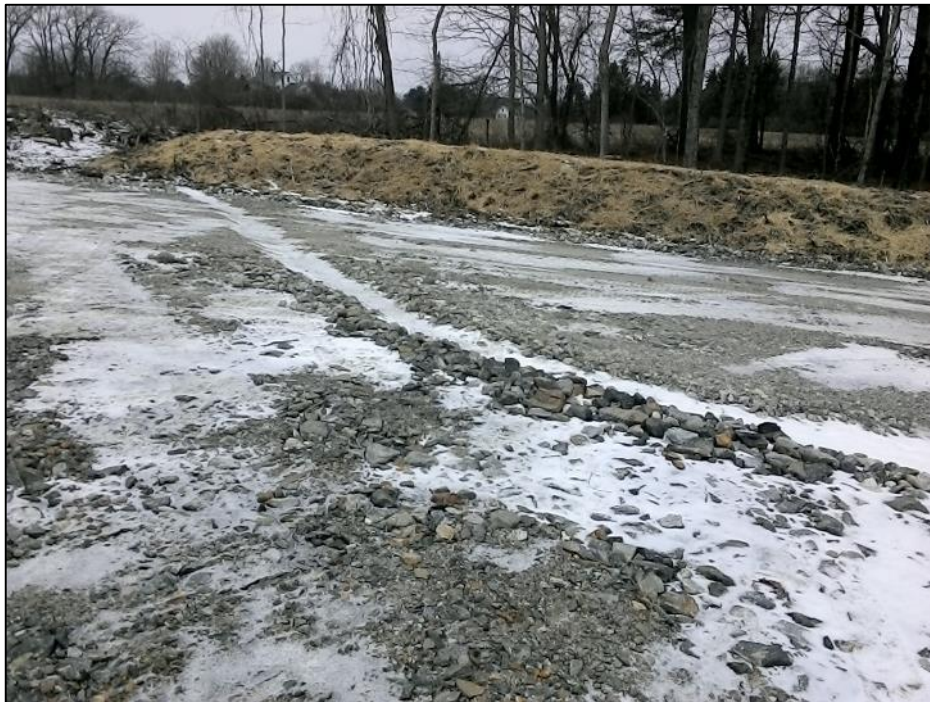
Photo #8: Waterbar installed across corner of pad upslope of wetland W20-188 entrance. (1/15)

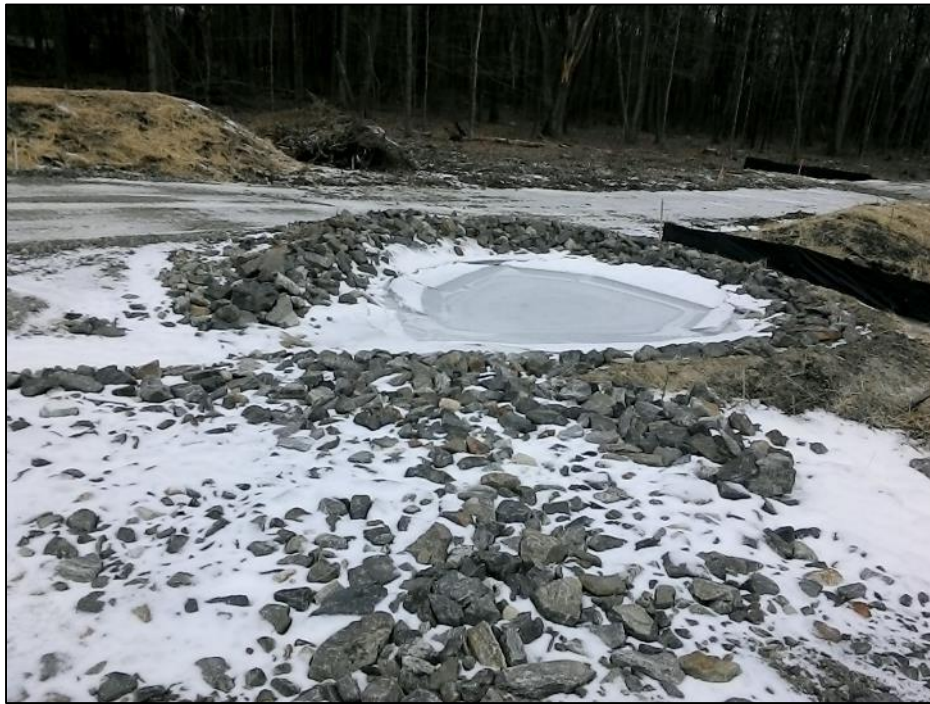
Photo #9: Sediment trap installed in accordance with BMP Manual and appears to be functioning correctly. (1/15)

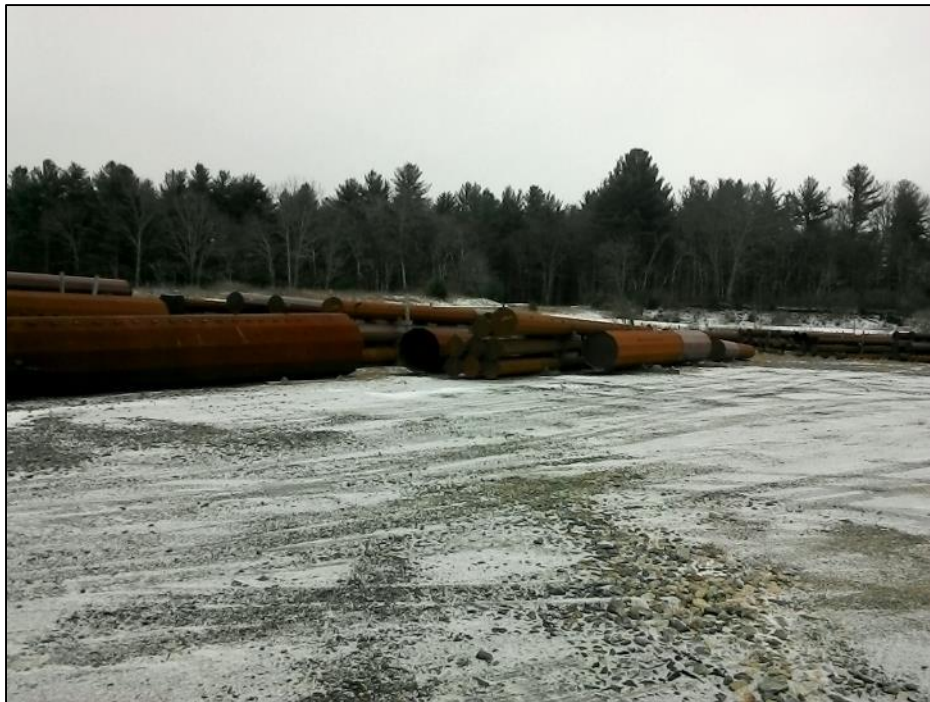
- Structure Lay down area off Hartford Road in Pomfret CT appears to be stable. (photo 10)
- Construction pads for structure assembly and erection that were removed, with their areas restored to original grades and slopes: Str 22, 84-100, and 269-270.

Photo #10: Pomfret lay down are appears stable and contained. (1/15)

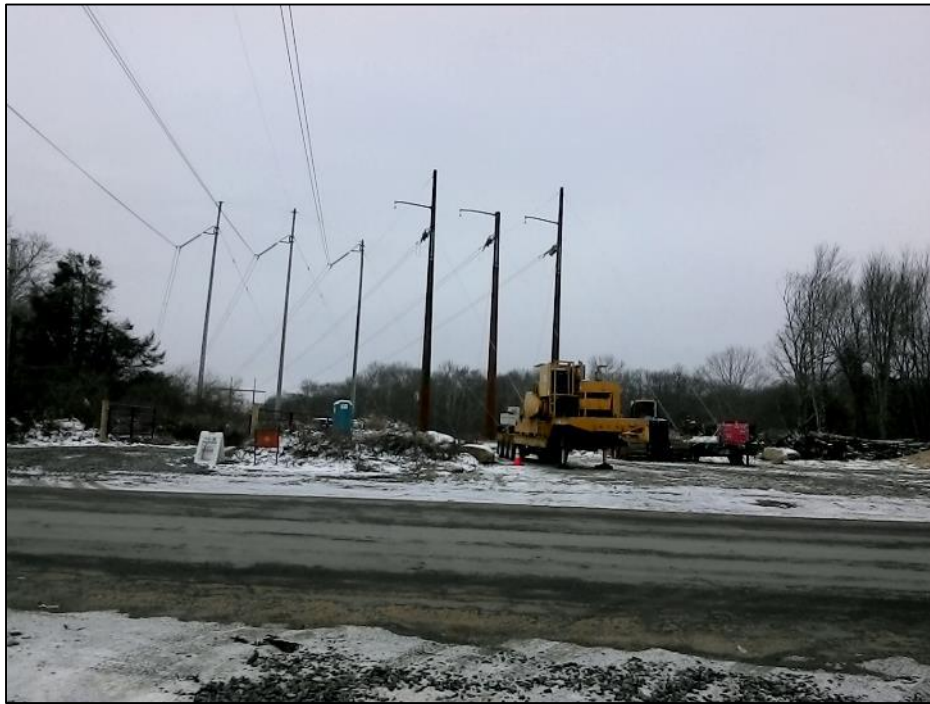
MS24, Str 125: Conductor Pulling Operation. (Partial Demobilization) (Photo 11)

Photo #11: Str 124 pulling area. (1/15)

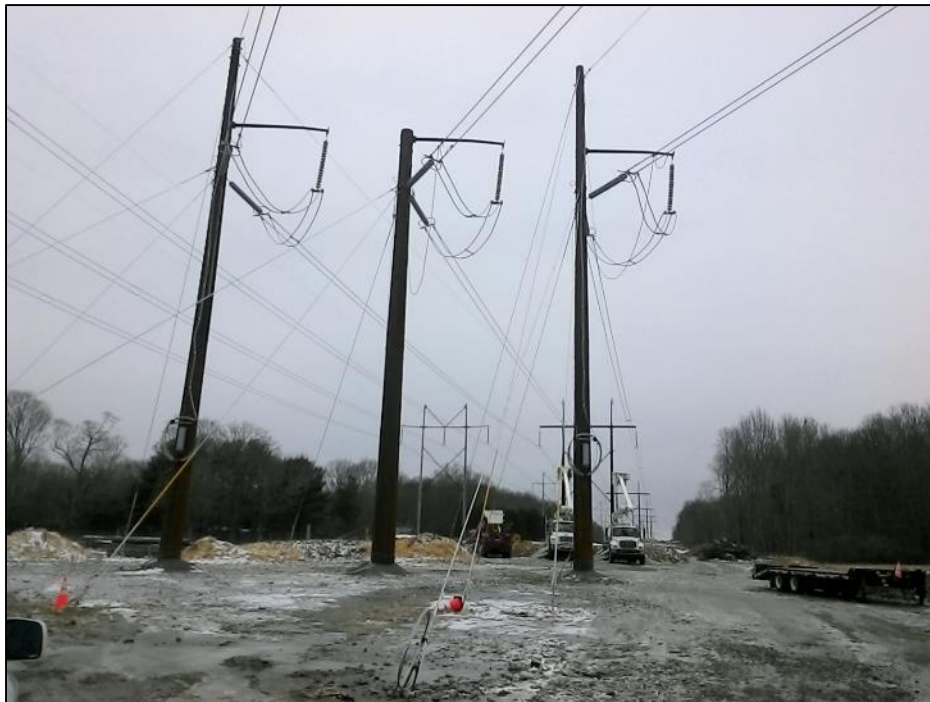
MS21, Str 111: Conductor Pulling Operation. (Photo 12)

Photo #12: Newly pulled conductor installed to dead-end Str 111. (1/15)
