Docket No. 424 - Development and Management Plan Inspection

The Connecticut Light and Power Company Certificate of Environmental Compatibility and Public Need for the Connecticut portion of the Interstate Reliability Project.

IRP Overhead ROW

Interim Week Inspection:

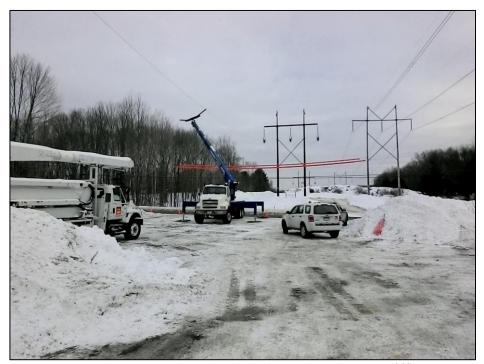
MS24, Str 124: Conductor Stringing. (Photo 1)

Photo #1: Conductor lead stringing up-line of Str 124. (2/4)

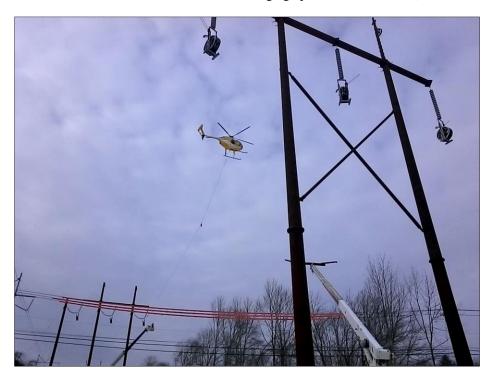
MS27, Str 141: Conductor Stringing. (Photos 2-3)

Photo #2: Conductor lead stringing with helicopter at Str 141(2/4)

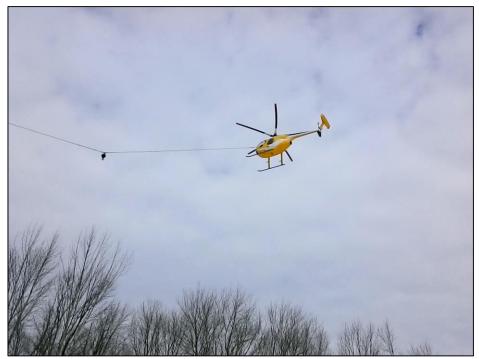
Photo #3: Conductor lead stringing with helicopter up-line of Str 141. (2/4)

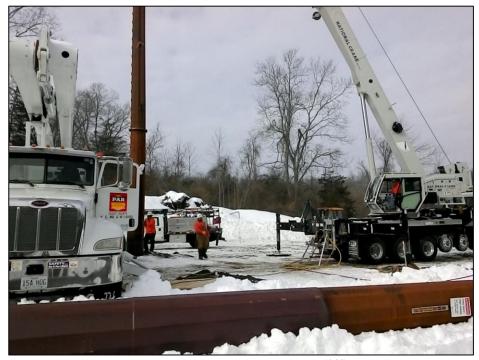
MS36, Str 187: Structure Erection. (Photo 4)

Photo #4: Structure 187 Erection. (2/4)

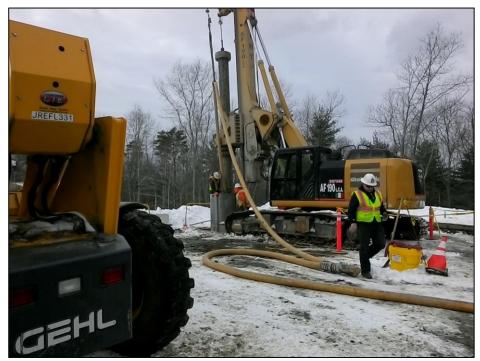
MS38, Str 197: Rock Core Drilling Operations. (Photo 5)

Photo #5: Rock core drilling operation with mechanical head drill rig for Str 197.(2/4)

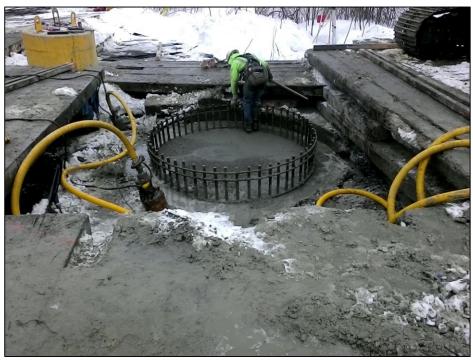
MS58, Str 291: Concrete Foundation Pour. (Photo 6)

Photo #6: Concrete pour for structure 291 foundation. (2/4)

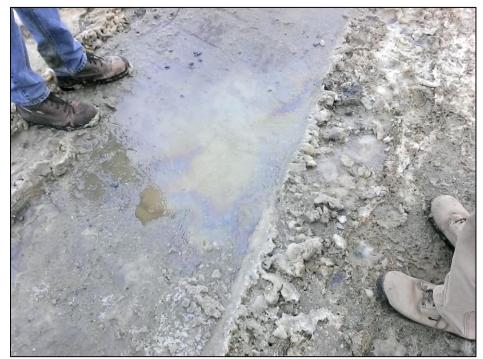
Str 191: Observed apparent	NA	T. Ramborger notified
Spills and Material Storage.	Interim Week (2/4)	petroleum-based sheen on timber mat. T. Ramborger indicated that the sheen is contained on the timber mat and therefore is not a spill to the environment. As a result, the leak does not require a spill report (call-in) to CT DEEP. (Photo 7)	NA	appropriate parties on the drill crew to clean up the petroleum based leak.
		Str 197: Observed area of spill that occurred on 1/30/15 completely cleaned of any evidence of spill. T. Ramborger indicated that McVac arrived to the area of the spill shortly after being alerted and promptly cleaned all affected areas. (Photos 8-9)	Continue to follow this	
Spills		Spill kits noted on all visited sites. Str 264: Observed child pool beneath Drill.	procedure. Continue to follow this procedure.	
	(2/12)	Spill kits noted on all visited sites.	Continue to follow this procedure.	NA

Photo #7: Area of petroleum leak on mats at Str 291 (2/4)

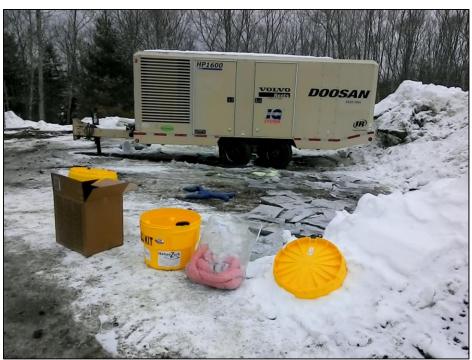
Photo #8: Area of diesel spill before cleanup up-line of Str 197. (1/30)

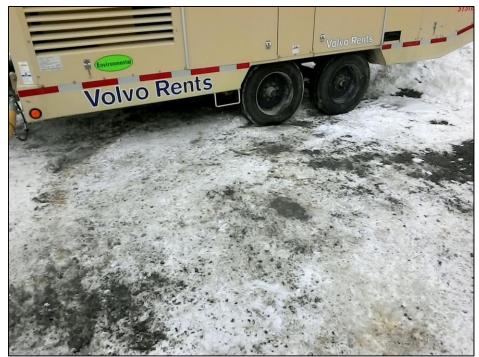
Photo #9: No visual evidence of the spill that occurred on 1/30/15 up-line of Str 197. (2/4)

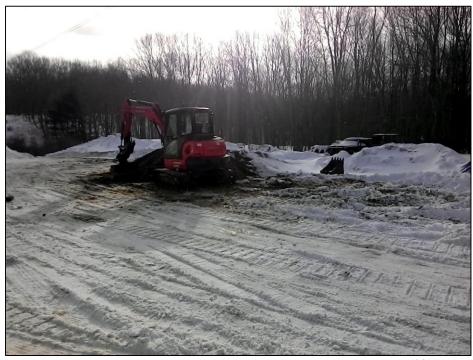
MS24, Str 126: Snow Removal. (Photo 10)

Photo #10: Snow removal in accordance with D&M Plans at Str 126. (2/11)

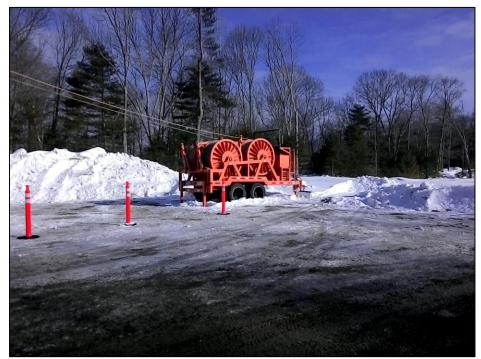
MS27, **Str 143**: Preparations for pulling cable. (Photo 11)

Photo #11: Preparation for pulling cable at Str 143. (2/11)

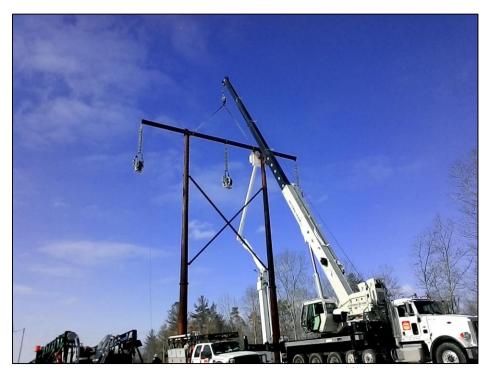
MS38, Str 197: Structure Erection. (Photo 12)

Photo #12: Structure Erection at Str 197. (2/11)

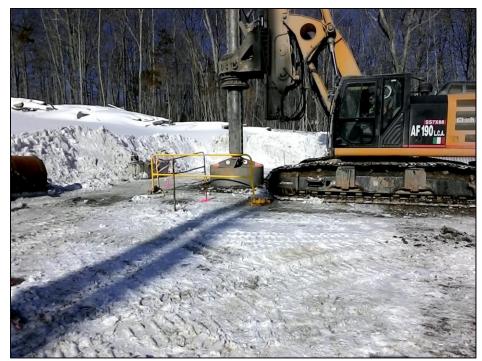
MS38, Str 199: Drilling Operations (Photo 13)

Photo #13: Drilling Operations at Str 199. (2/11)

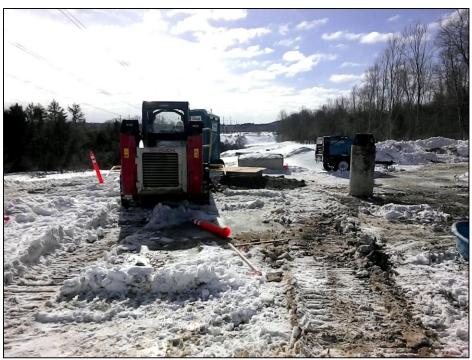
MS44, Str 223: Demobilizing. (Photo 14)

Photo #14: Demobilization at Str 223. (2/11)

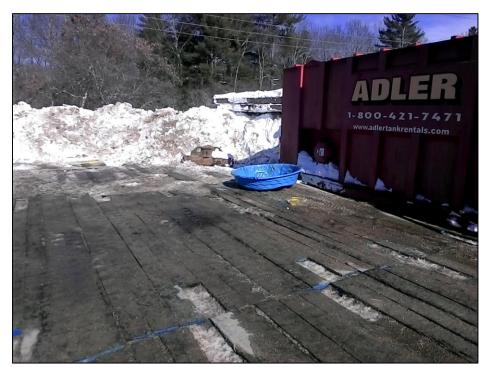
Bi-Week (2/12)	Str 277: Observed child pool on site. (Photo 15)	Continue to follow this procedure.	NA
esources	Interim Week (2/4)	Cultural areas protected in accordance with D&M Plans.	NA	NA
Cultural Resources	Bi-Week (2/12)	Cultural areas protected in accordance with D&M Plans.	NA	NA

Photo #15: Observed child pool on site at Str 277. (2/11)
