Docket No. 424 - Development and Management Plan Inspection

The Connecticut Light and Power Company Certificate of Environmental Compatibility and Public Need for the Connecticut portion of the Interstate Reliability Project.

IRP Overhead ROW

Interim Week Inspection:

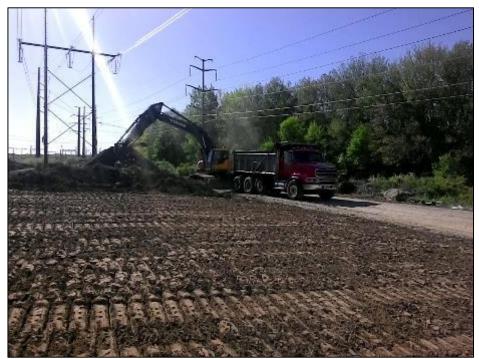
MS1, **Str 3**: Restoration Operations. (Photo 1)

Photo #1: Removing material from Str 3 pad as part of restoration. (5/14)

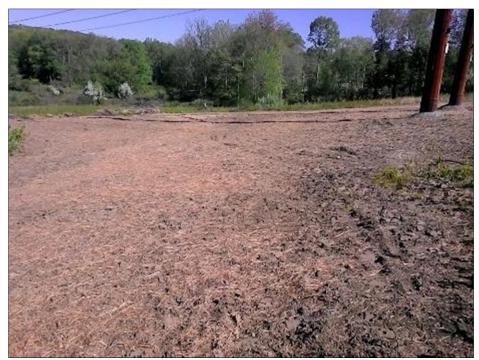
Photo #2: Str 6 seeded and awaiting stabilization. (5/14)

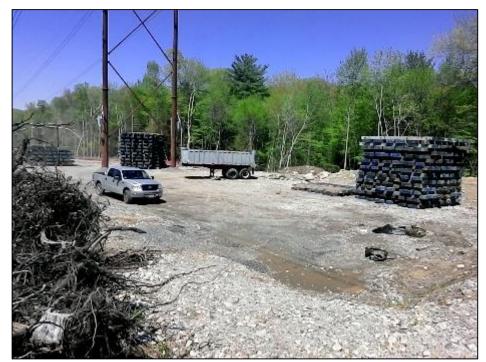
MS32, Str 166: Wetland Mat Removal. (Photo 3)

Photo #3: Mat removal and stockpiling at Str 166. (5/14)

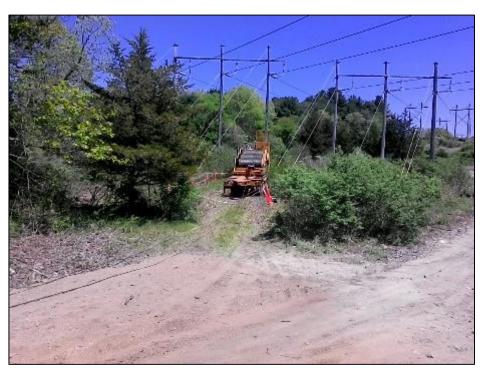
MS48, Str 241: Conductor Installation. (Photo 4)

Photo #4: Pulling conductor from Str 241. (5/14)

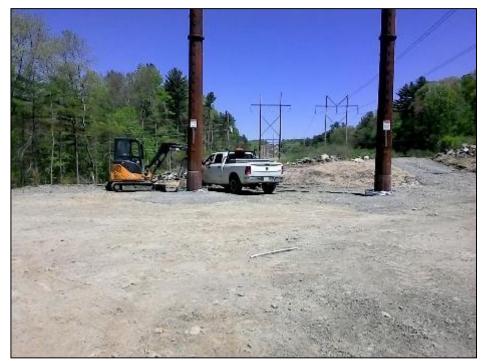
MS64, Str 326: Grounding Operations. (Photo 5)

Photo #5: Grounding operations at Str 326. (5/14)

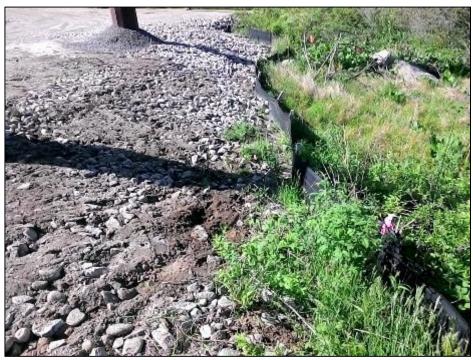
Bi-Week (5/21)	All crossings appear to be functioning in accordance with the BMP Manual. No sediment appears to be entering the streams or wetlands.	Continue to follow this procedure.	NA
Erosion and Sedimentation Controls	Interim Week (5/14)	All observed site controls appear to be functioning in accordance with the BMP Manual. No sediment appears to be entering any resource areas.	Continue to follow this procedure.	NA
Erosion and Sedin	Bi-Week (5/21)	All observed site controls appear to be functioning in accordance with the BMP Manual. No sediment appears to be entering any resource areas.	Continue to follow this procedure.	NA
tercourse encroachment and itigation	Interim Week (5/14)	Mat removal in wetland areas in accordance with the BMP Manual. Str 4: T. Ramborger indicated that an area of temporary wetland fill has been approved by the U.S. Army Corps. of Engineers, CT DEEP, and CSC to become permanent in an attempt to further stabilize the maintenance pad. The area has been graded, and will have silt fence installed until stabilization occurs. (Photo 6)	Continue to follow this procedure. NA	NA NA

Photo #6: Area of temporary wetland fill at Str 4 approved to remain as permanent. (5/14)

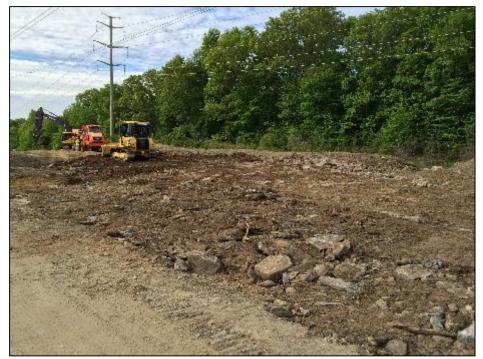
MS3-4, Str 16-17: Restoration Operations. (Photo 7)

Photo #7: Removal of pulling pad between Str 16 and 17 as part of restoration. (5/21)

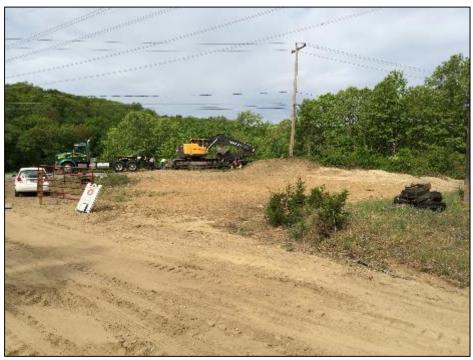
MS7, Str 34: Removal of Guard Pad. (Photo 8)

Photo #8: Removal of guard pad at Str 34 as part of restoration (5/21)

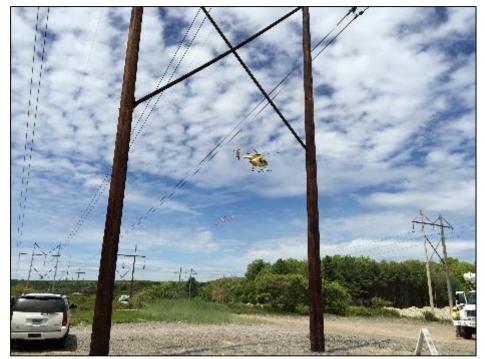
MS53, Str 264: Conductor Installation. (Photo 9)

Photo #9: Pulling conductor with helicopter at Str 264. (5/21)

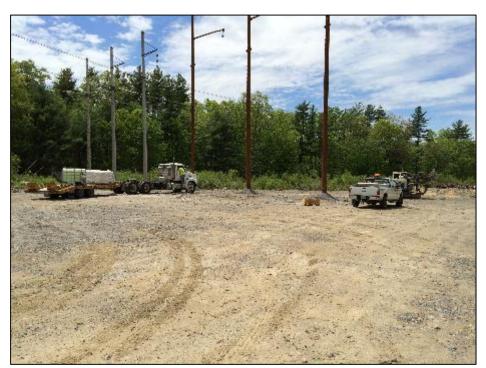
MS64, Str 325: Installation of Anchors. (Photo 10)

Photo #10: Installation of anchors at Str 325. (5/21)
