Docket No. 424 – Development and Management Plan Inspection

The Connecticut Light and Power Company Certificate of Environmental Compatibility and Public Need for the Connecticut portion of the Interstate Reliability Project.

IRP Overhead ROW

Interim Week Inspection:

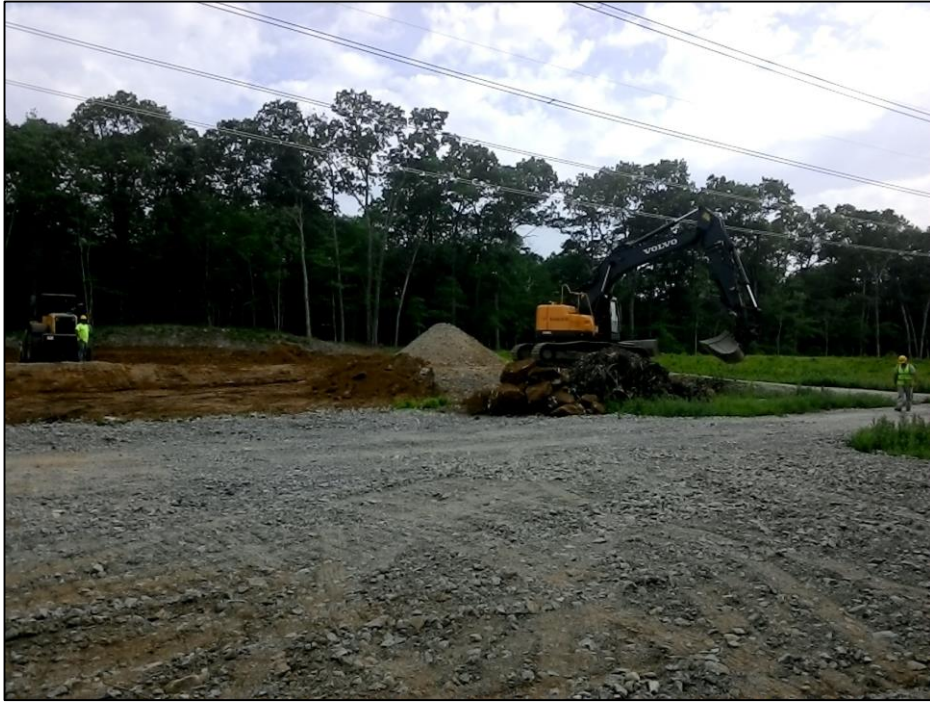
MS22, Str 115: Restoration Operations. (Photo 1)

Photo #1: Pad removal as part of restoration at Str 115. (6/11)

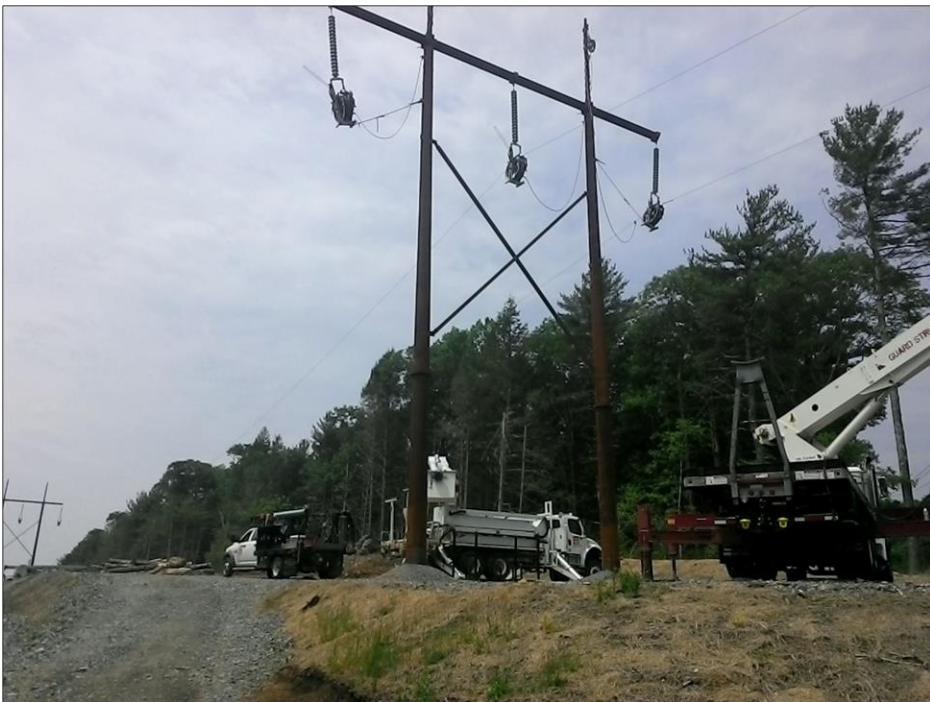
MS61, Str 309: Stringing Operations. (Photo 2)

Photo #2: Stringing operations at Str 309. (6/11)

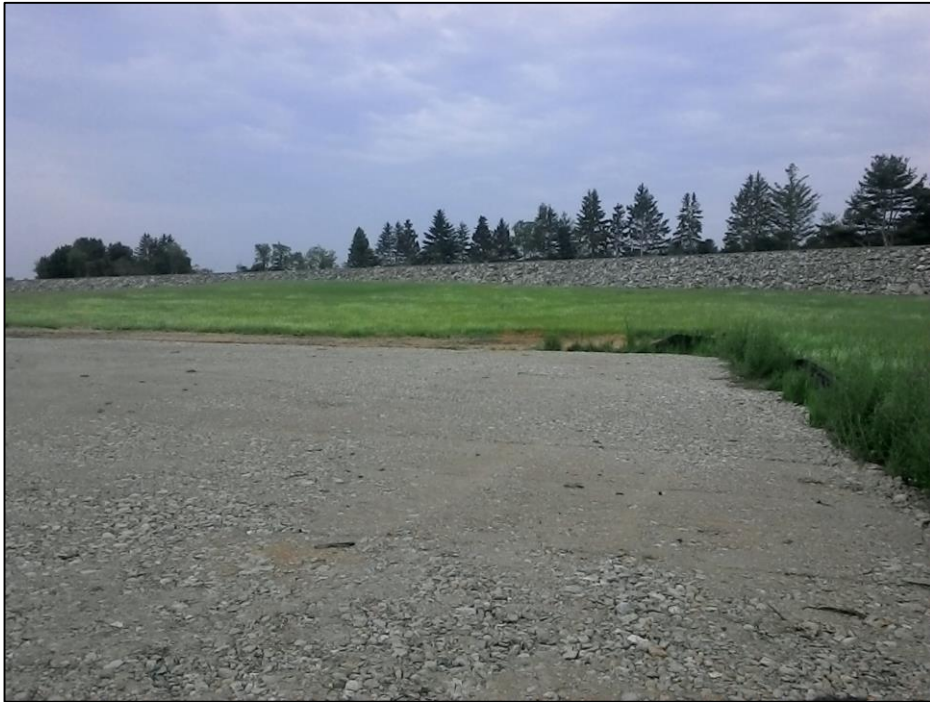
Areas of Inspection		Observation:	Recommended Action:	Corrected Action:
Access Roads and Adjacent Roadways	Interim Week (6/11)	All observed access roads and ROW's appear to be in accordance with BMP Manual. Str 82-83: Observed numerous pieces of geotextile fabric scattered around the pad. (Photo 3)	Continue to follow this procedure. Recommend picking up all loose fabric pieces from the pad (which is to remain – see notes).	NA N. Ganacoplos indicated that he had spoken with the contractor about resolving the issue.
	Bi-Week (6/18)	All observed access roads and ROW's appear to be in accordance with BMP Manual.	Continue to follow this procedure.	NA
Vegetative Clearing Limits (Including trees to save or danger trees noted.)	Interim Week (6/11)	Mechanized Clearing along IRP ROW complete.	NA	NA
	Bi-Week (6/18)	Mechanized Clearing along IRP ROW complete.	NA	NA
Water Crossings	Interim Week (6/11)	All crossings appear to be functioning in accordance with the BMP Manual. No sediment appears to be entering the streams or wetlands.	Continue to follow this procedure.	NA

Photo #3: Geotextile fabric and other debris on pad between Str 82 and 83. (6/11)

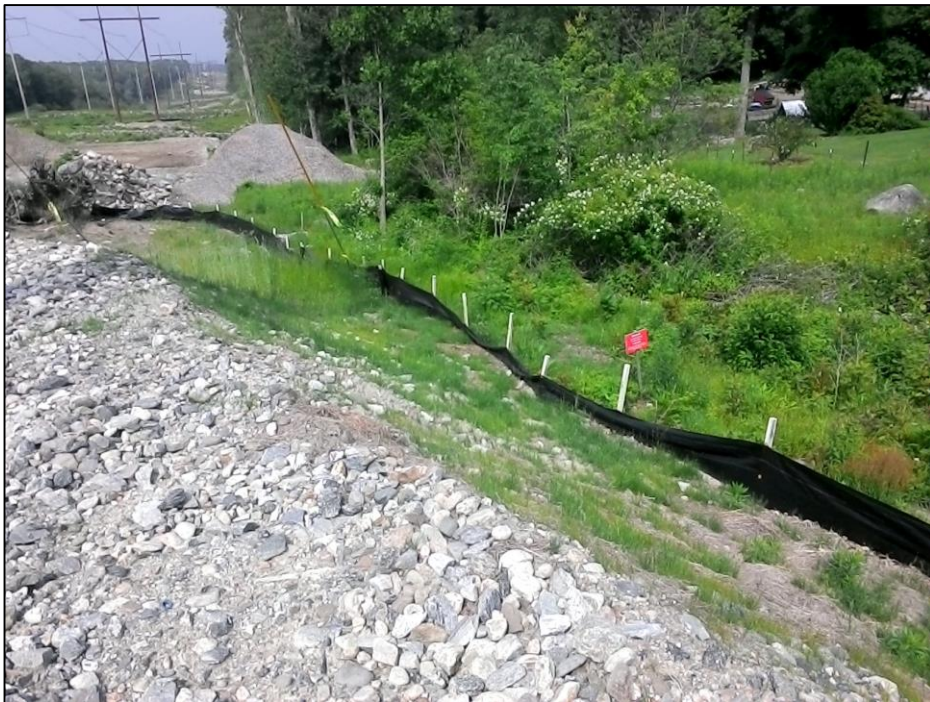
Photo #4: Area of silt fence in need of repair at Str 121. (6/11)

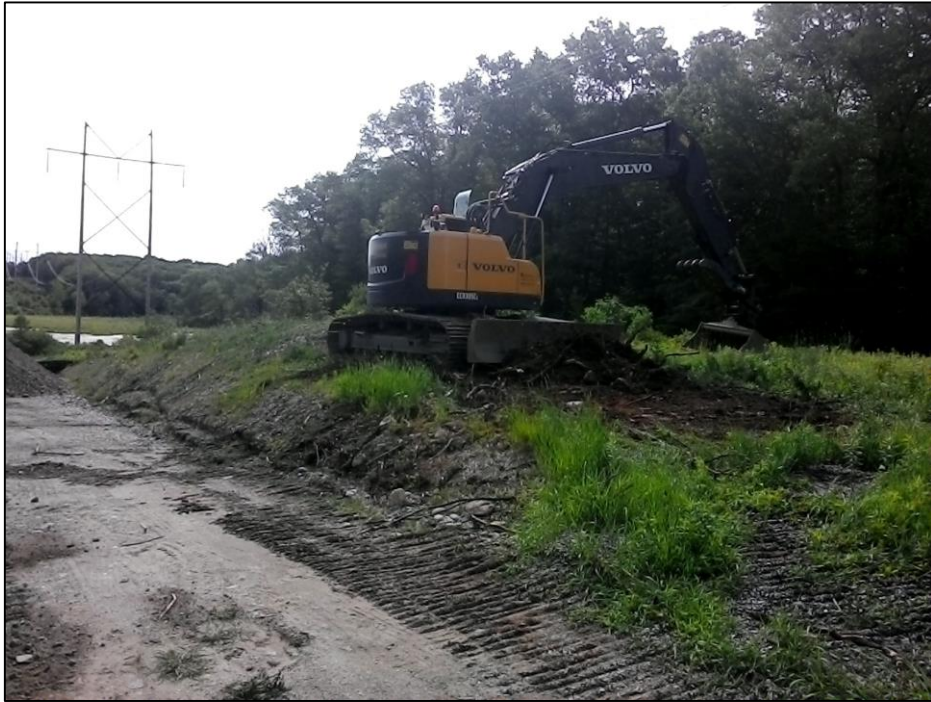
MS23, Str 120: Restoration Operations. (Photo 5)

Photo #5: Str 120 pad removal and topsoil spreading as pad of restoration. (6/18)

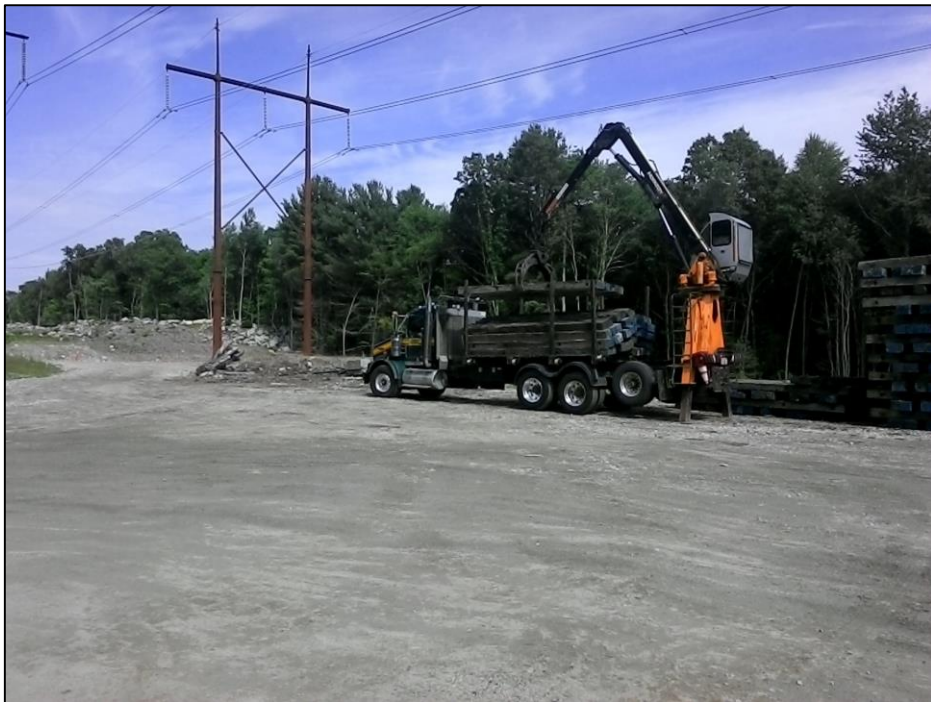
MS24, Str 126: Wetland Mat Removal. (Photo 6)

Photo #6: Removing mats at Str 126. (6/18)

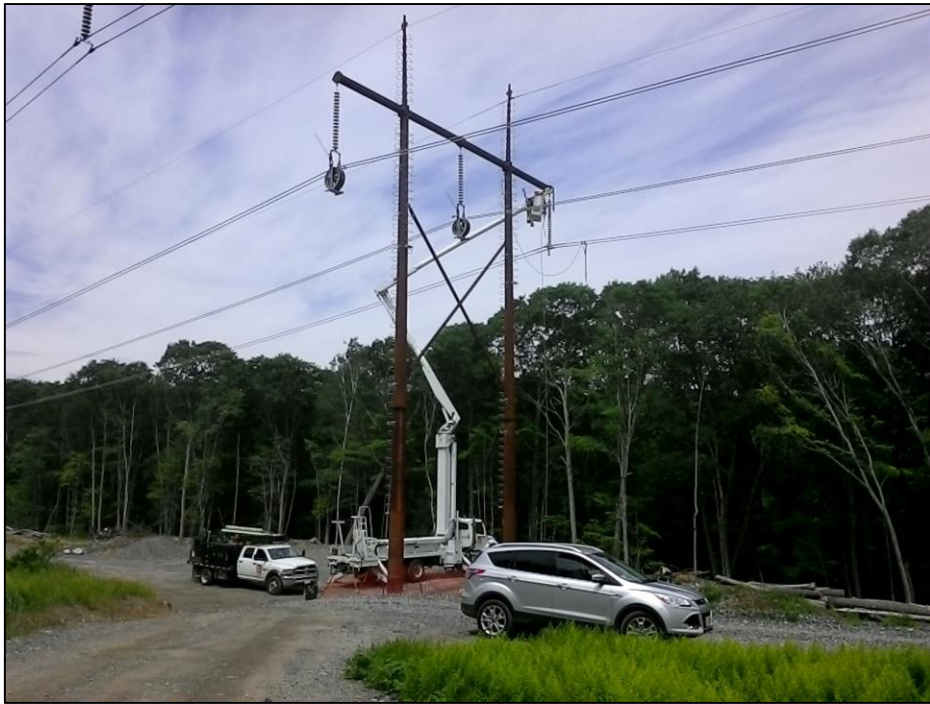
MS62, Str 313: Conductor Mounting to Structure Insulator (i.e. Conductor Clipping). (Photo 7)

Photo #7: Conductor clipping at Str 313. (6/18)

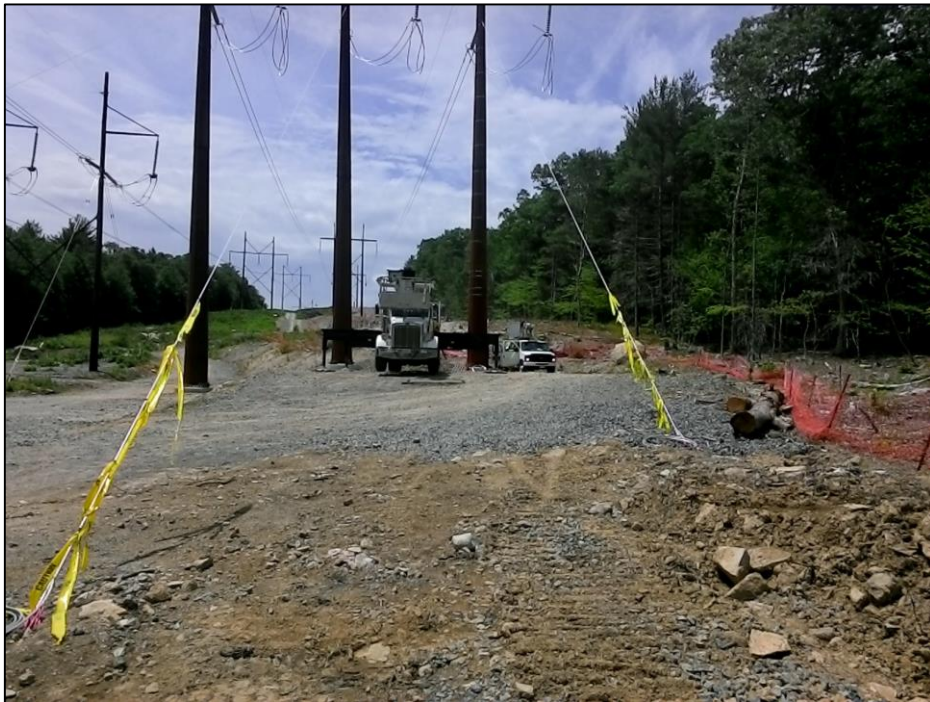
MS66, Str 337: Fiber Optic Installation. (Photo 8)

Photo #8: Preparing fiber optics at Str 337. (6/18)

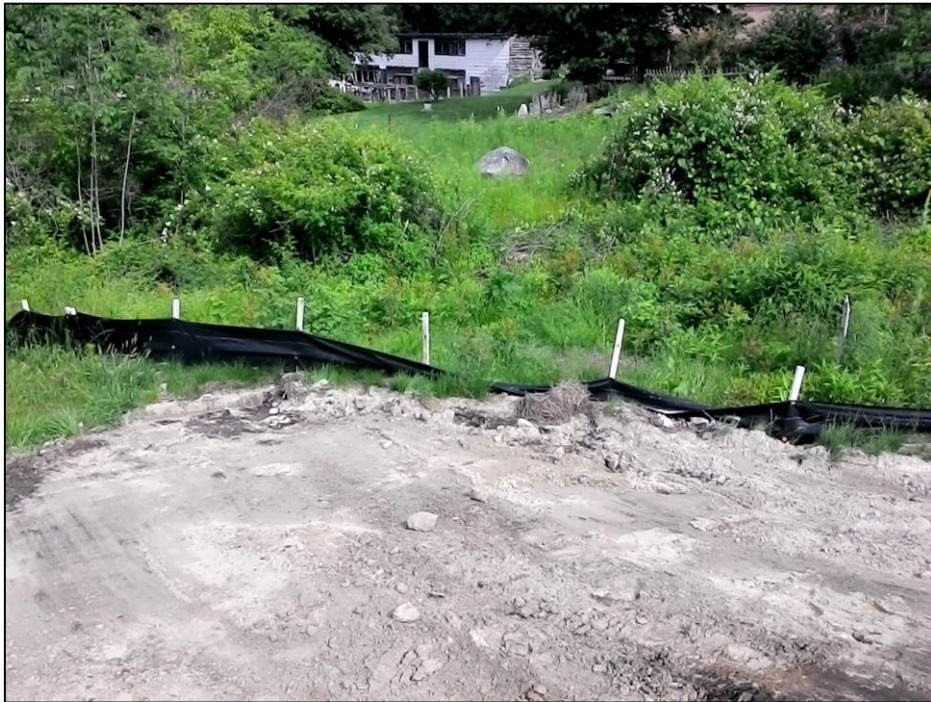
Photo #9: Area of damaged silt fence at Str 121. (6/18)

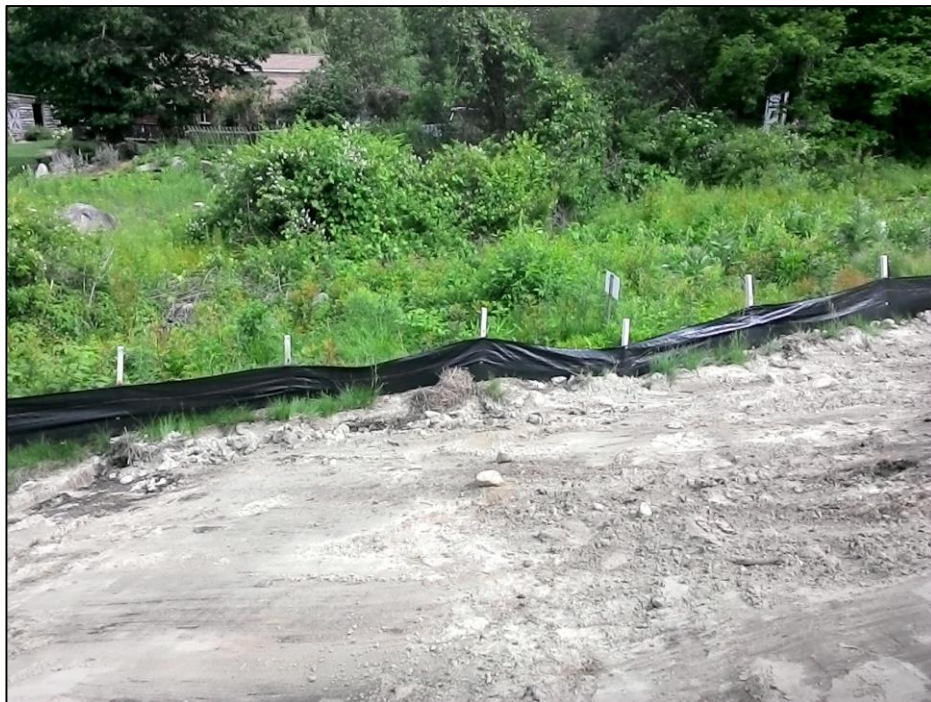
Photo #10: Silt fence re-stapled. (6/18)

Bi-Week (6/18)	All crossings appear to be functioning in accordance with the BMP Manual. No sediment appears to be entering the streams or wetlands.	Continue to follow this procedure.	NA
Erosion and Sedimentation Controls	Interim Week (6/11)	Majority of observed site controls appear to be functioning in accordance with the BMP Manual. No sediment appears to be entering any resource areas. Str 121: Length of silt fence un-stapled. (Photo 4)	Continue to follow this procedure. Recommend re-stapling as soon as possible.	NA Contractor crew chief on-site indicated he would re-staple all areas of silt fence as necessary.
	Bi-Week (6/18)	Majority of observed site controls appear to be functioning in accordance with the BMP Manual. No sediment appears to be entering any resource areas. Str 121: Length of silt fence un-stapled. (Photo 9)	Continue to follow this procedure. Recommend re-stapling as soon as possible.	NA T. Ramborger immediately re-stapled the silt fence on-site. (Photo 10)
