#### Docket No. 424 - Development and Management Plan Inspection

The Connecticut Light and Power Company Certificate of Environmental Compatibility and Public Need for the Connecticut portion of the Interstate Reliability Project.

#### IRP Overhead ROW

### **Interim Week Inspection:**

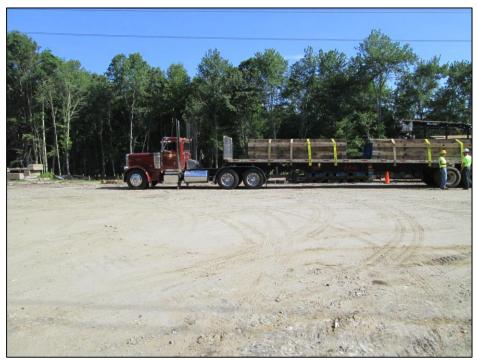
MS24, Str 126: Wetland Mat Removal. (Photo 1)

Photo #1: Mat removal at Str 126. (6/25)

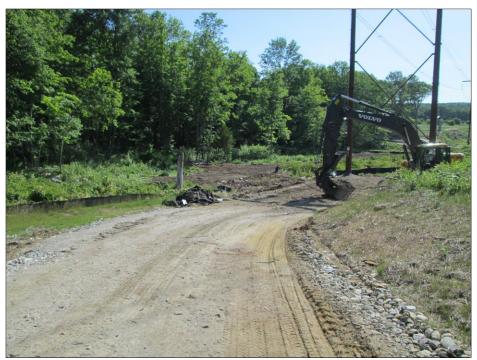
**MS27, Str 143:** Restoration Operations. (Photo 2)

Photo #2: Restoration operations at Str 143. (6/25)

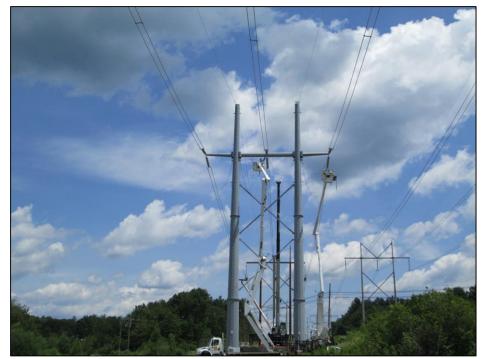
MS54, Str 272: Conductor attachment to structure

insulator (Clipping). (Photo 3)

Photo #3: Conductor clipping at Str 272. (6/25)

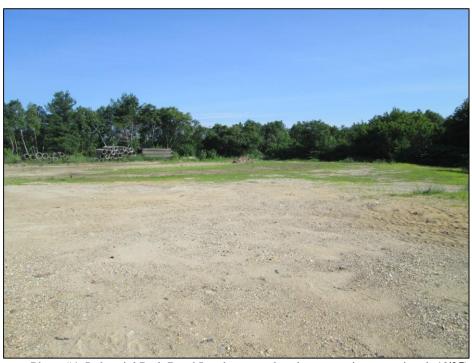
- Visited Industrial Park Road Laydown yard for final inspection. Yard now considered complete and no longer project associated (Photo 4)
- Areas of IRP Project considered complete and permanently stabilized:
  - CSSS, LRSS, KSS, Windham Materials Laydown areas 1 and 2, River Road Laydown yard, 87 Boston Post Road Laydown Yard, Industrial Park Road Laydown yard

Photo #4: Industrial Park Road Laydown yard no longer project associated. (6/25)

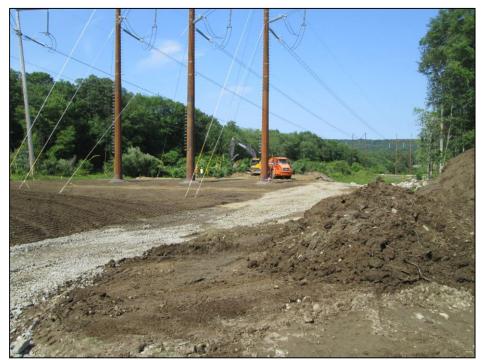
MS29, Str 151: Restoration Operations. (Photo 5)

Photo #5: Pad removal as part of restoration operations at Str 151. (7/2)

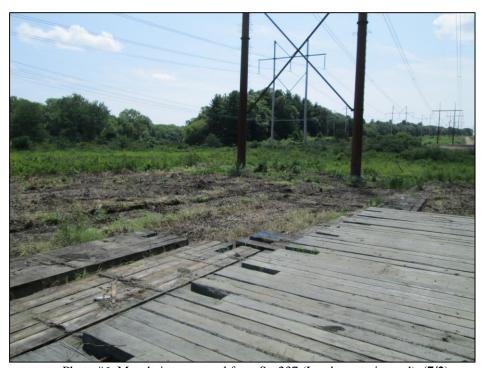
MS47, Str 237: Mat Removal. (Photo 6)

Photo #6: Mats being removed from Str 237 (Loader not pictured). (7/2)

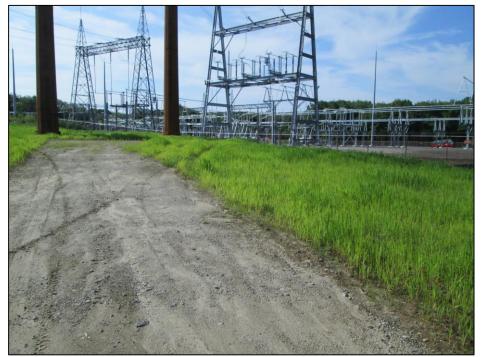
Photo #7: Str 1 considered stabilized. (70% growth over 90% area) (7/2)

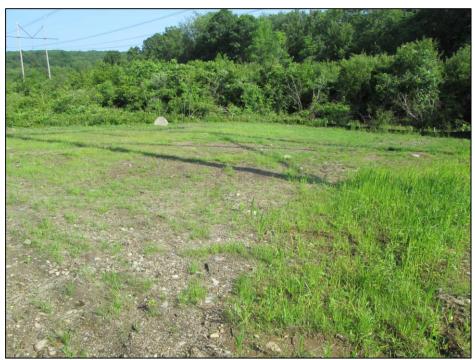
Photo #8: Str 5 not yet considered fully stabilized. (7/2)

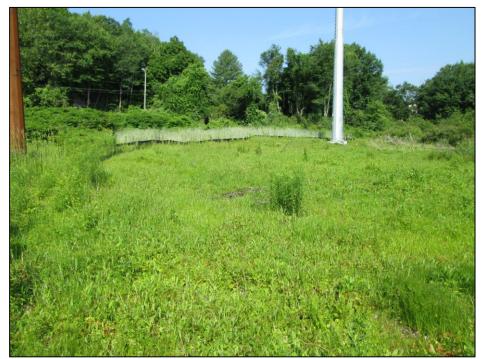
Photo #9: Str 23 not yet considered fully stabilized. (7/2)

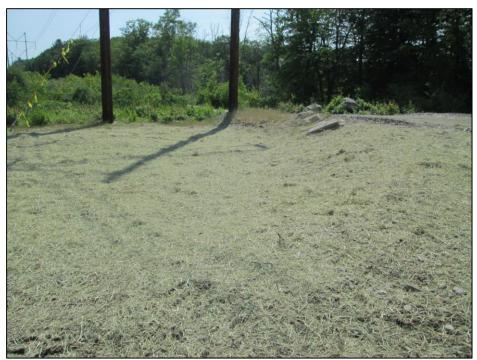
Photo #10: Restoration operations complete at Str 163. Awaiting germination. (7/2)

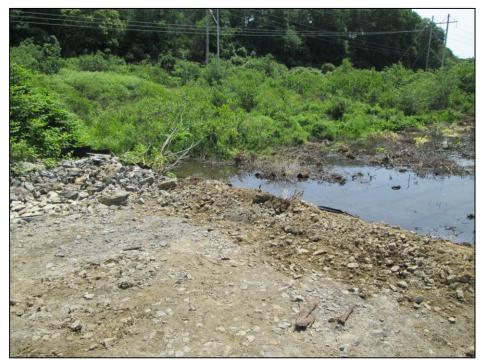
Photo #11: Wetland mats removed from Str 240. Temporary site controls have been established until restoration and stabilization occur. (7/2)
