Page 1 of 10 IRP Bi-Weekly CSC Report #43 9/3/2015 and 9/10/2015

Docket No. 424 – Development and Management Plan Inspection

The Connecticut Light and Power Company Certificate of Environmental Compatibility and Public Need for the Connecticut portion of the Interstate Reliability Project.

IRP Overhead ROW

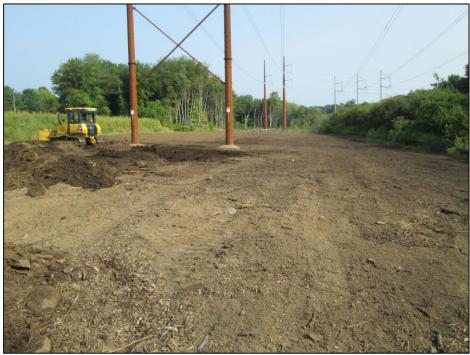
MS57, Str 290: Restoration Operations. (Photo 1)

Photo #1: Removal and re-grading of Str 290 pad. (9/3)

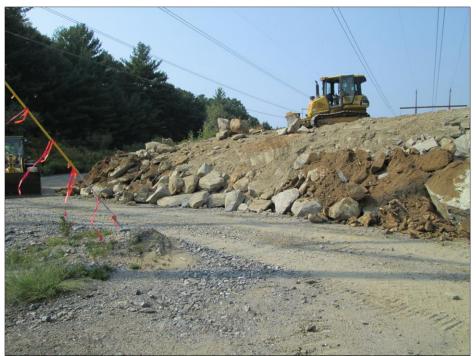
MS60, Str 305: Restoration Operations. (Photo 2)

Photo #2: Removal of Str 305 pad. (9/3)

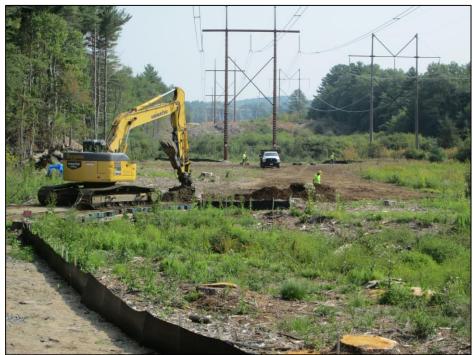
MS63, Str 317: Restoration Operations. (Photo 3)

Photo #3: Removal of Str 317 access road and straw being laid down for temporary stabilization. (9/3)

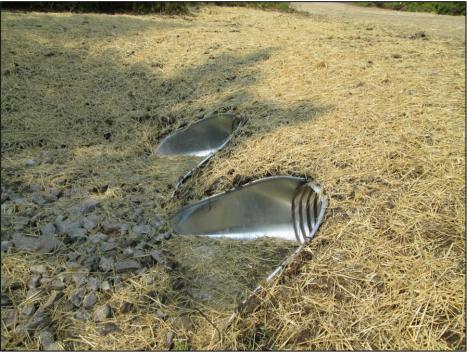
MS27, Str 139: Observed recently installed culvert. (Photo 4)

Photo #4: Double culvert installed between Str 139 and 140. (9/3)

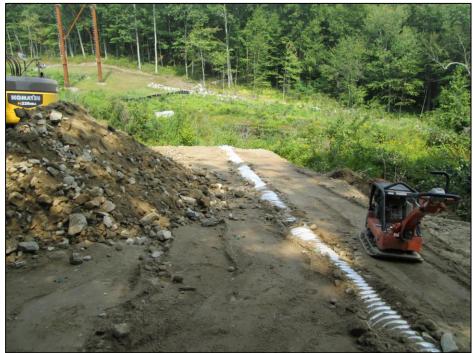
MS26, Str 136: Observed culvert installation. (Photo 5)

Photo #5: Installation of Str 136 culvert. (9/3)

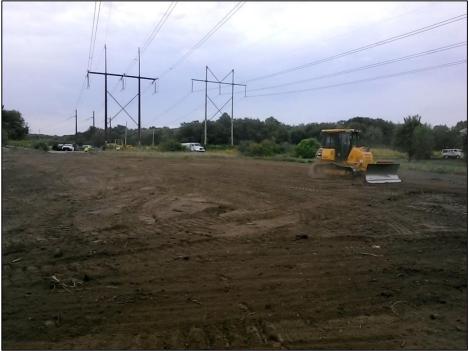
MS58, Str 291: Restoration Operations. (Photo 6)

Photo #6: Spreading topsoil as part of restoration of Str 291. (9/10)

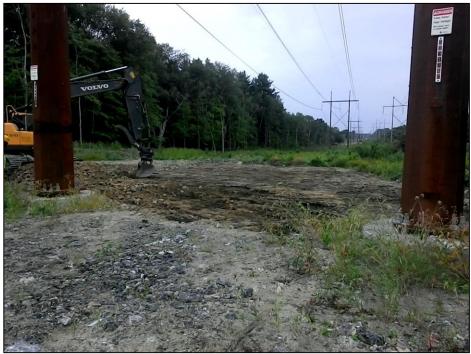
MS58, Str 293: Restoration Operations. (Photo 7)

Photo #7: Removal of stone at Str 293 pad as part of restoration. (9/10)

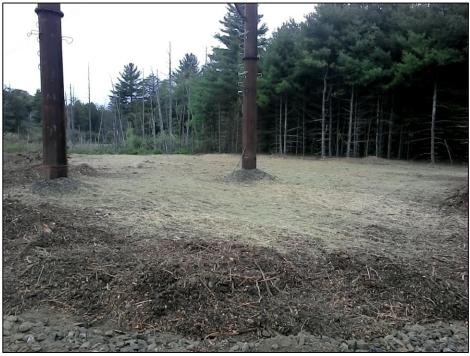
MS63, Str 320: Restoration Operations. (Photo 8)

Photo #8: Str 320 pad removed, graded, seeded, and temporarily stabilized with straw. (9/10)

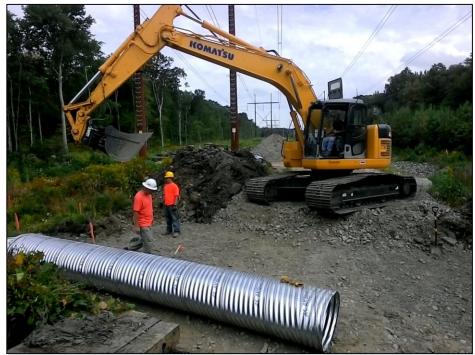
MS29, Str 154: Culvert Installation. (Photo 9)

Photo #9: Installation of new culvert at Str 154. (9/10)

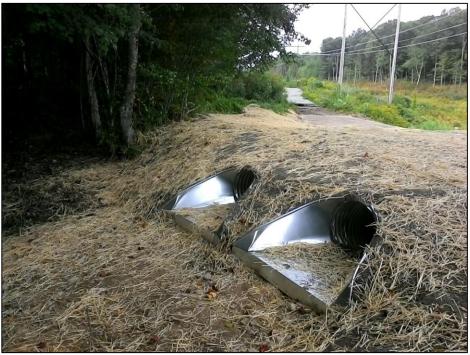
MS26, Str 137: Observed new culvert. (Photo 10)

Photo #10: Double culvert installed last week at Str 137. (9/10)
