Docket No. 424 – Development and Management Plan Inspection

The Connecticut Light and Power Company Certificate of Environmental Compatibility and Public Need for the Connecticut portion of the Interstate Reliability Project.

IRP Overhead ROW

Interim Week Inspection:

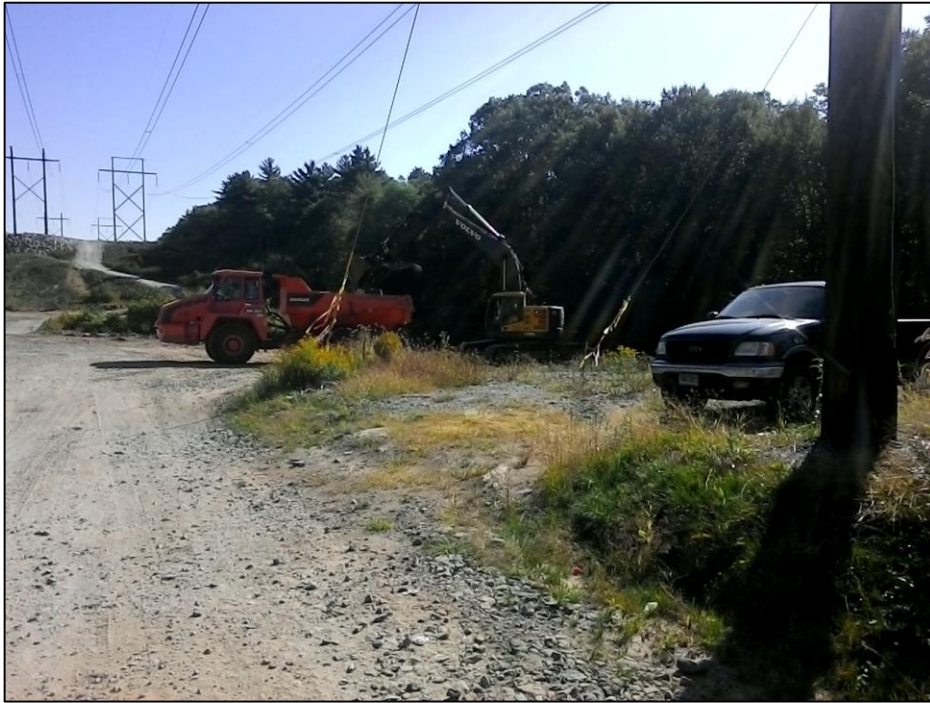
MS66, Str 337: Restoration Operations. (Photo 1)

Photo #1: Stone removal at Str 337. (9/18)

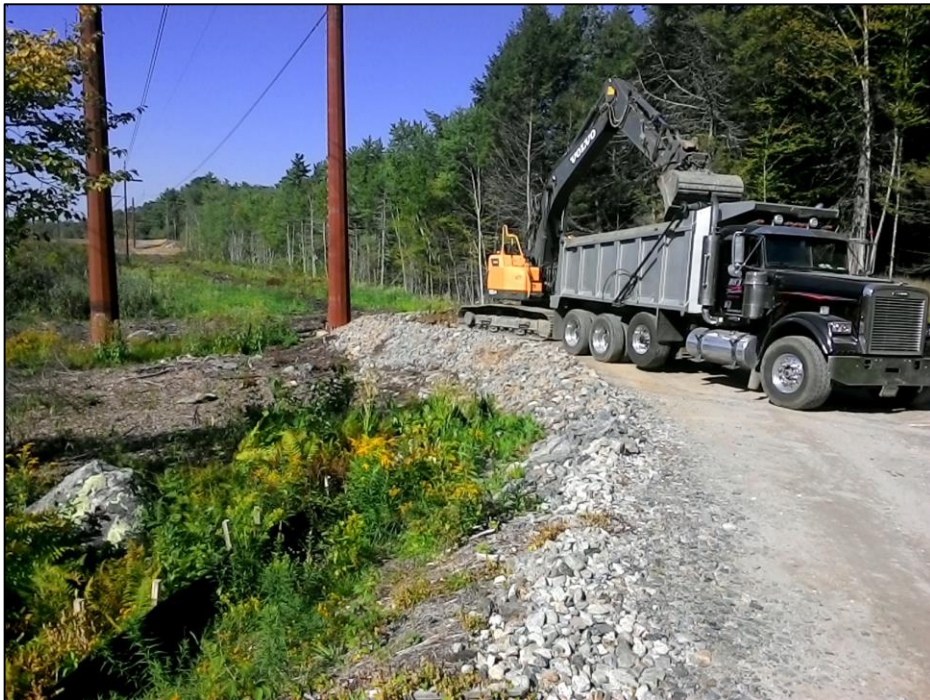
MS61, Str 307: Road Removal. (Photo 2)

Photo #2: Removal of access road at Str 307. (9/18)

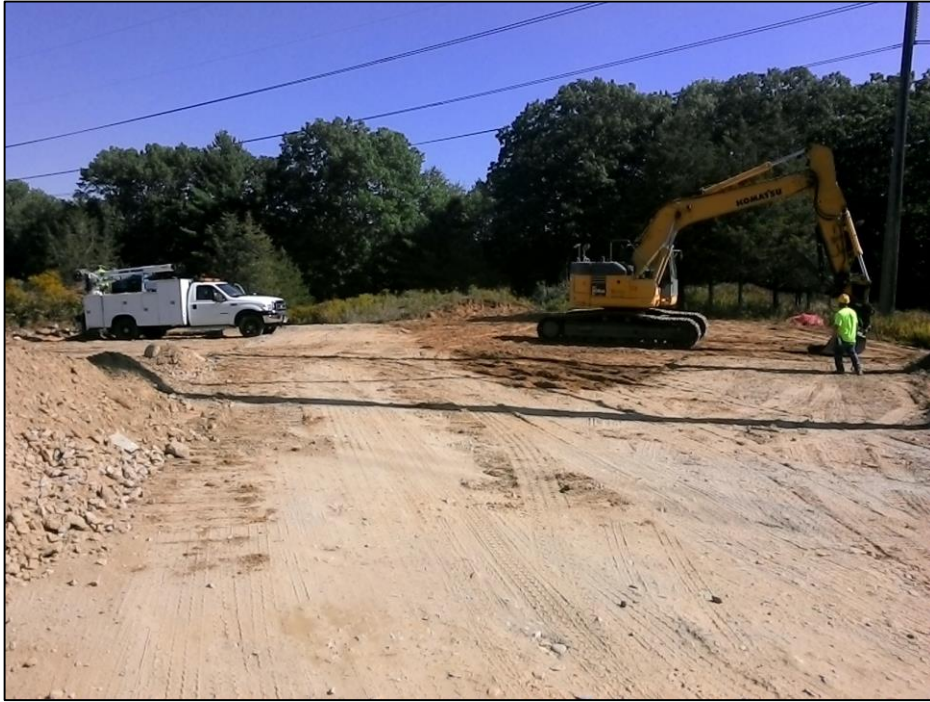
MS50, Str 254: Restoration Operations. (Photo 3)

Photo #3: Earthwork at Str 254. (9/18)

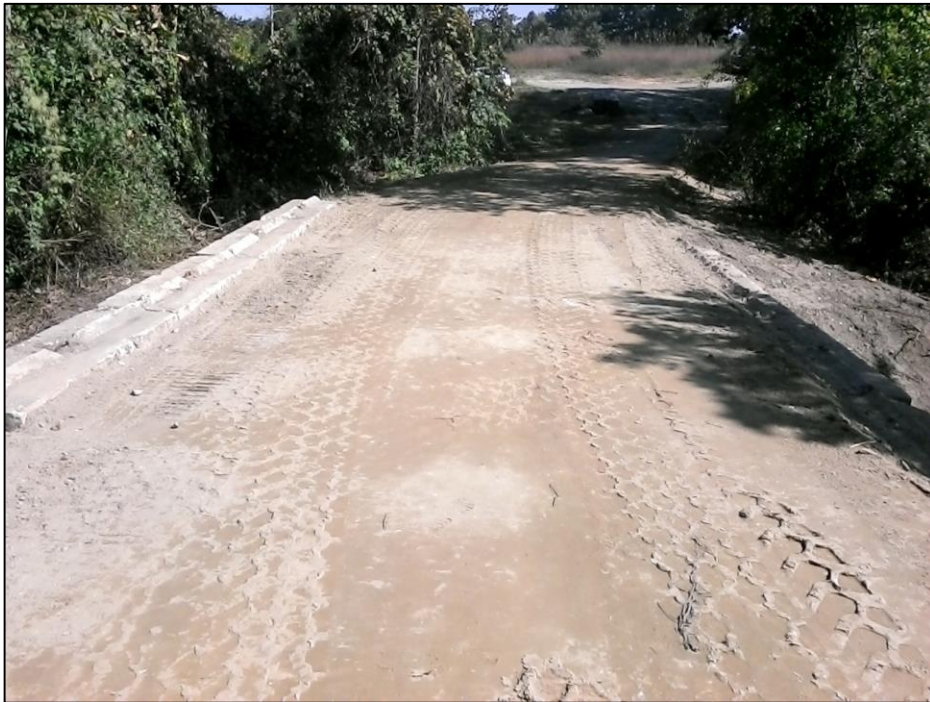
MS44, Str 221-223: Observed new Day Street culvert. (Photos 4-5)

Photo #4: Day Street culvert installed but awaiting temporary stabilization. (9/18)

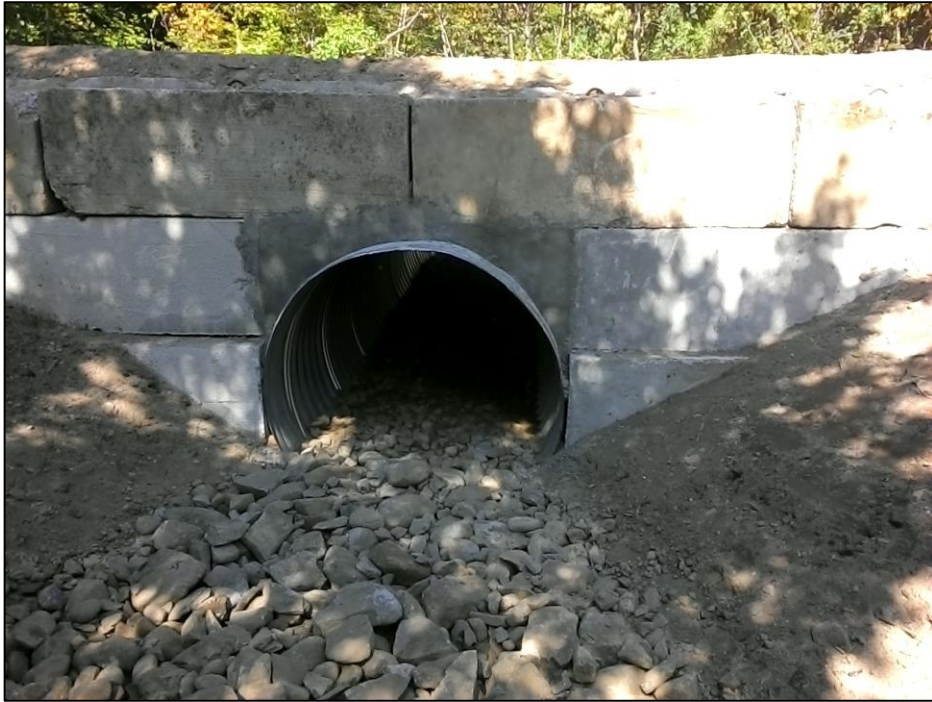
Photo #5: Day Street culvert outfall. (9/18)

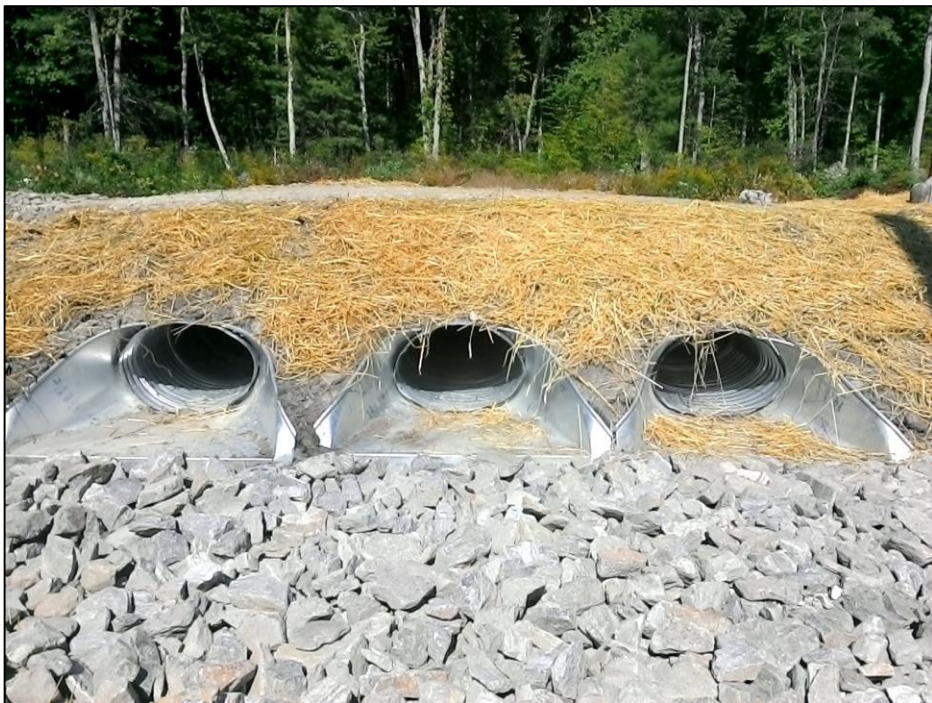
MS29, Str 154: Observed new culvert. (Photo 6)

Photo #6: str 154 culvert seeded and temporarily stabilized with straw. (9/18)

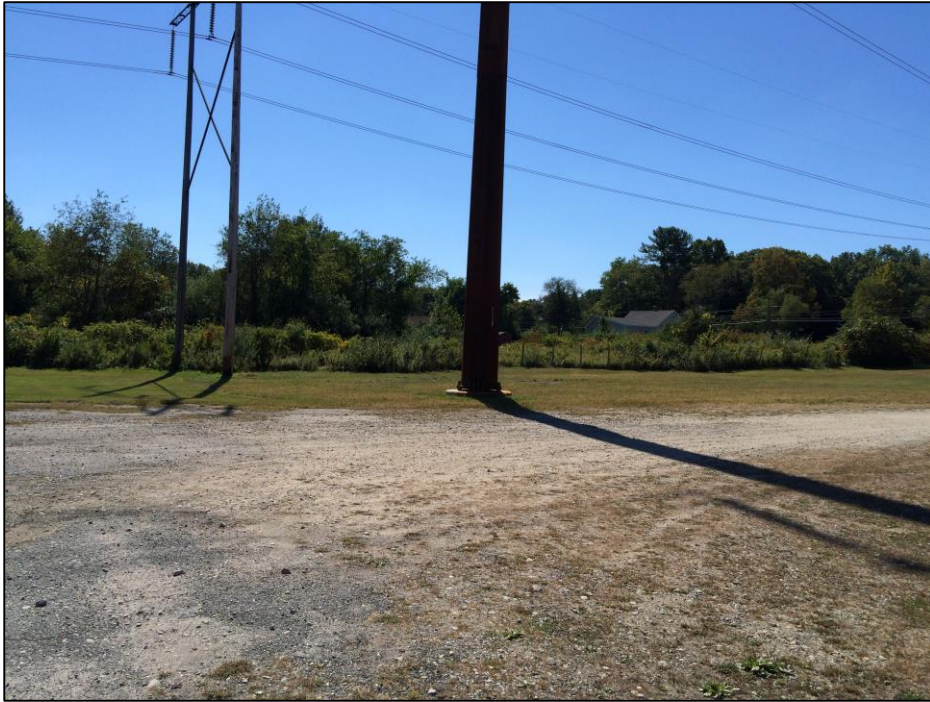
MS, Str 38: Visited Str 38. Site now considered permanently stabilized. (Photo 7)

Photo #7: Str 38 considered fully stabilized (70% growth over 90% area). (9/24)

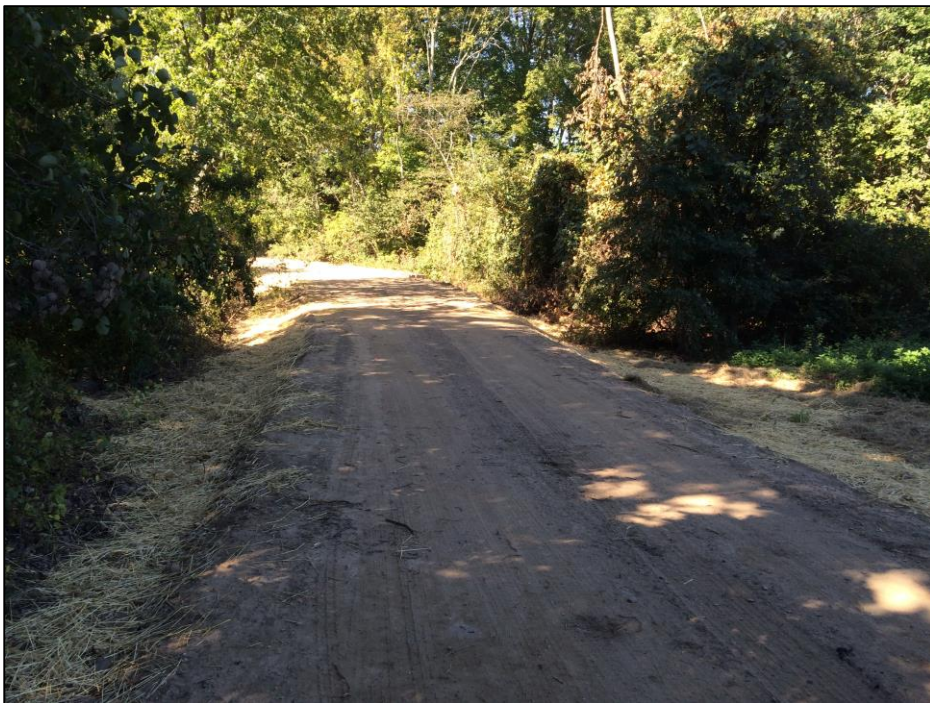
MS, Str 221-222: Day Street culvert in place, seeded, and temporarily stabilized with straw. (Photo 8)

Photo #8: All bare areas around the Day Street culvert seeded and temporarily stabilized with straw. (9/24)

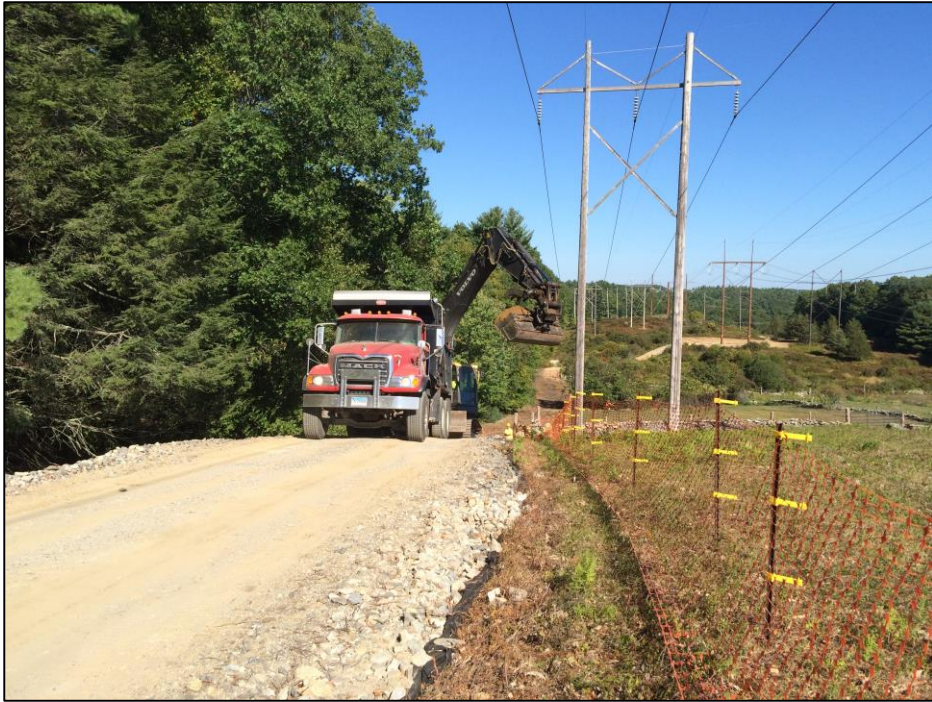
MS, Str 253: Removal of access road. (Photo 9)

Photo #9: Str 253 access road removal. (9/24)

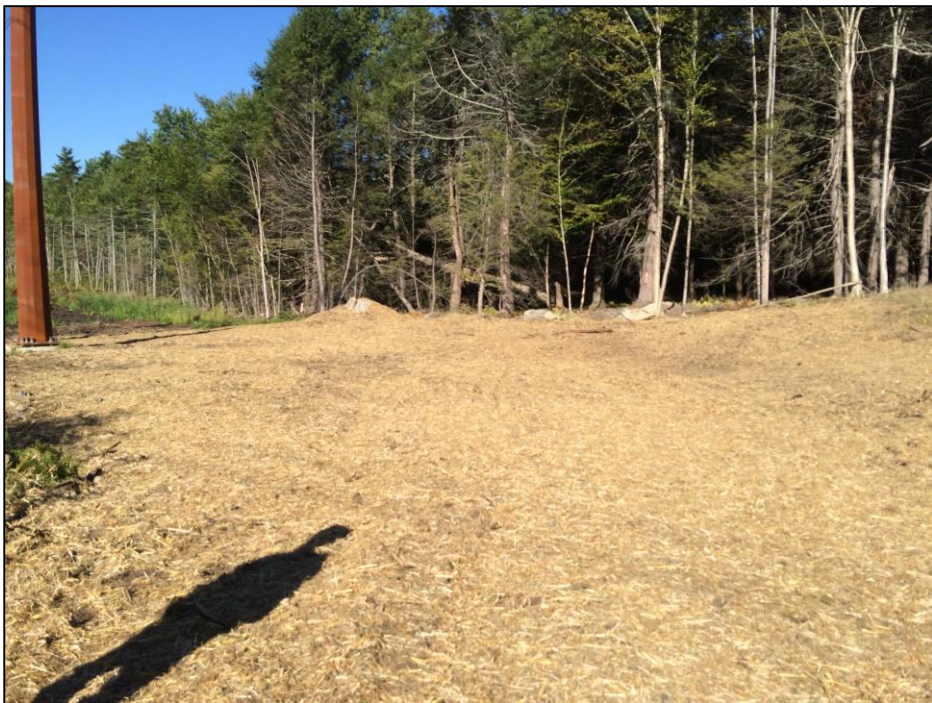
MS, Str 307: Site has been seeded and temporarily stabilized with straw. (Photo 10)

Photo #10: Str 307 seeded and temporarily stabilized with straw. (9/24)

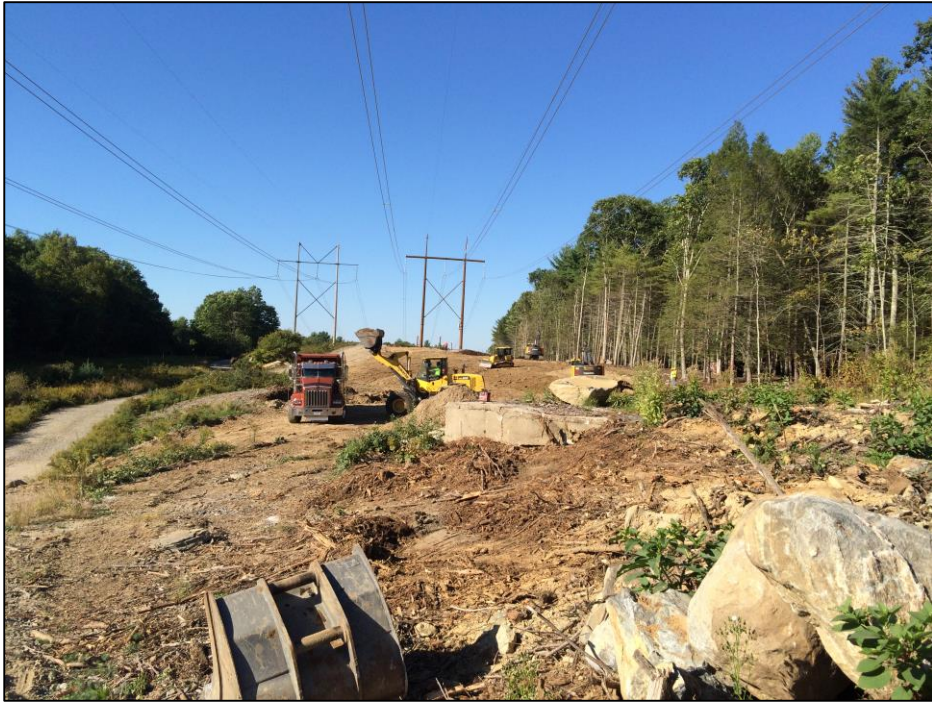
MS, Str 308: Re-grading and earthwork as part of restoration operations. (Photo 11)

Photo #11: Re-grading and general earthwork at Str 308 as part of restoration operations. (9/24)

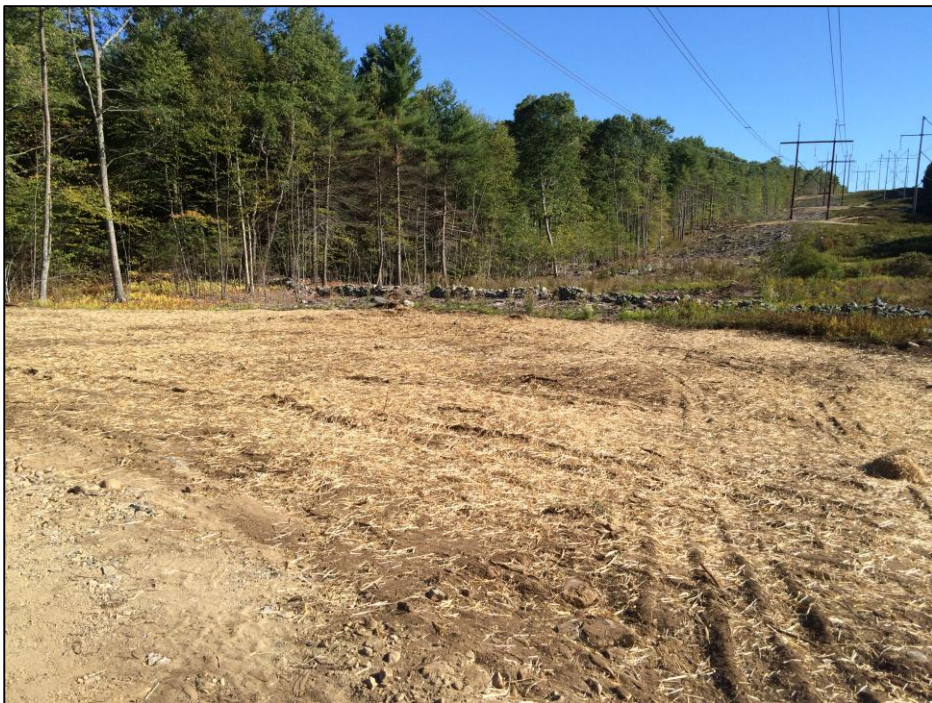
MS, Str 331: Site has been seeded and temporarily stabilized with straw. (Photo 12)

Photo #12: Str 331 seeded and temporarily stabilized with straw. (9/24)
