**Docket No. 424 – Development and Management Plan Inspection**

The Connecticut Light and Power Company Certificate of Environmental Compatibility and Public Need for the Connecticut portion of the Interstate Reliability Project.

**IRP Overhead ROW**

**Interim Week Inspection:**

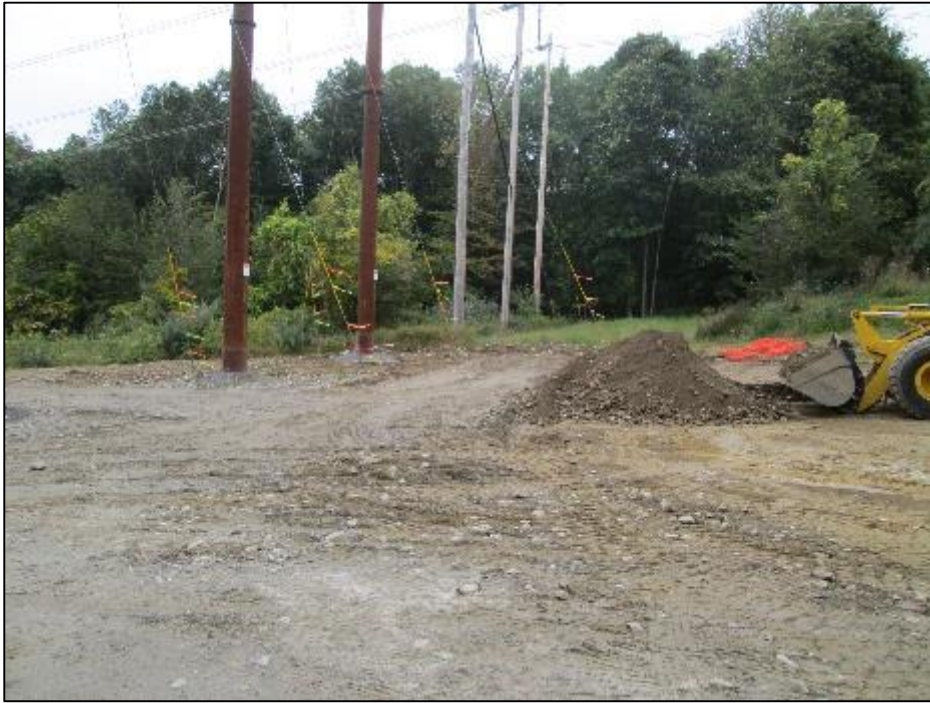
**MS14, Str 72:** Restoration Operations. (Photo 1)

Photo #1: Re-grading and general earthwork at Str 72 as part of restoration operations. (10/2)

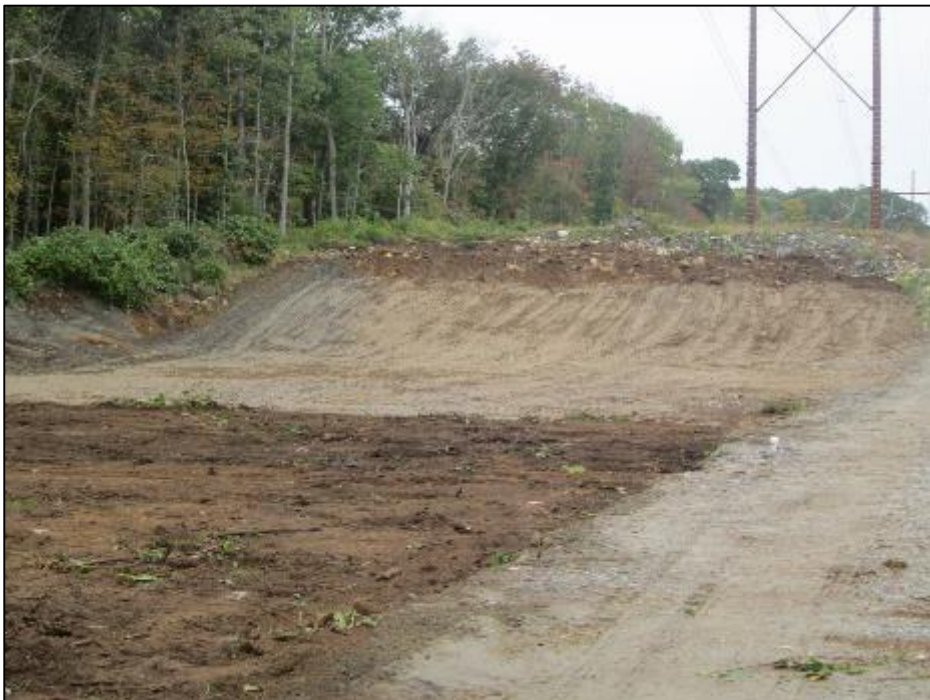
**MS19, Str 103:** Restoration Operations. (Photo 2)

Photo #2: Re-grading and general earthwork at Str 103 as part of restoration operations. (10/2)

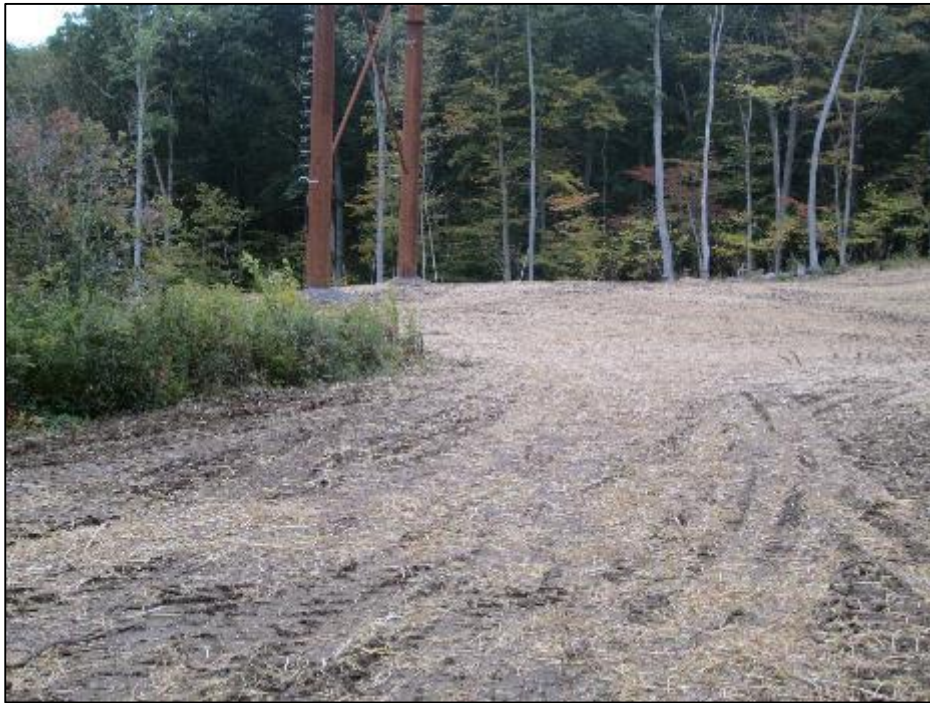
**MS20, Str 105:** Pad Restoration - Mat Removal/Access Road Construction. (Photo 3,6)

Photo #3: Str 105 seeded and temporarily stabilized with straw. (10/2)

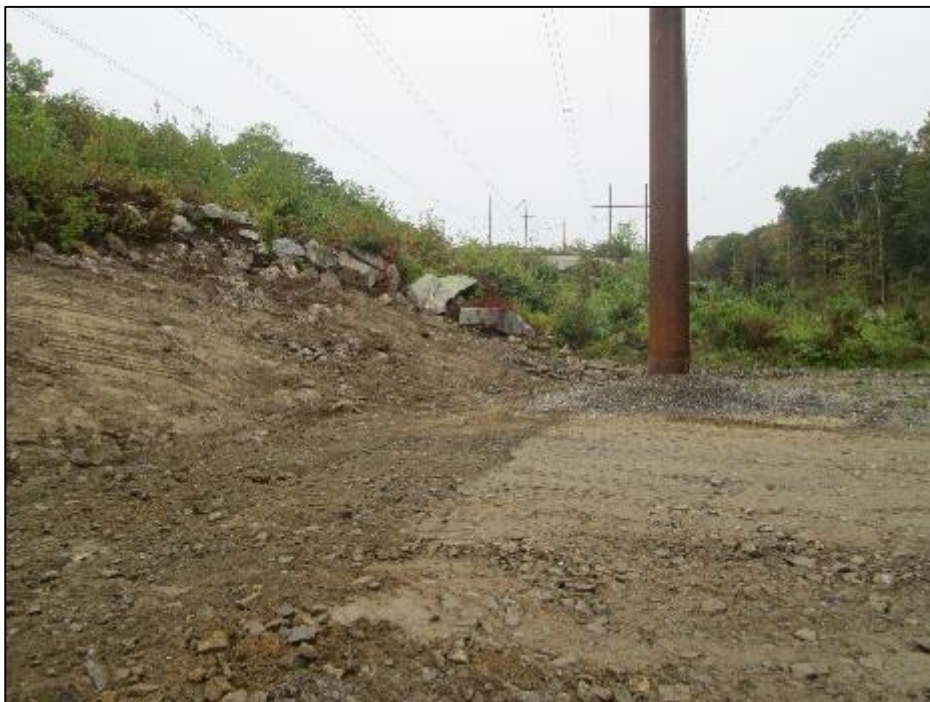
**MS24, Str 127:** Restoration Operations. (Photo 4)

Photo #4: Re-grading and general earthwork at Str 127 as part of restoration operations. (10/2)

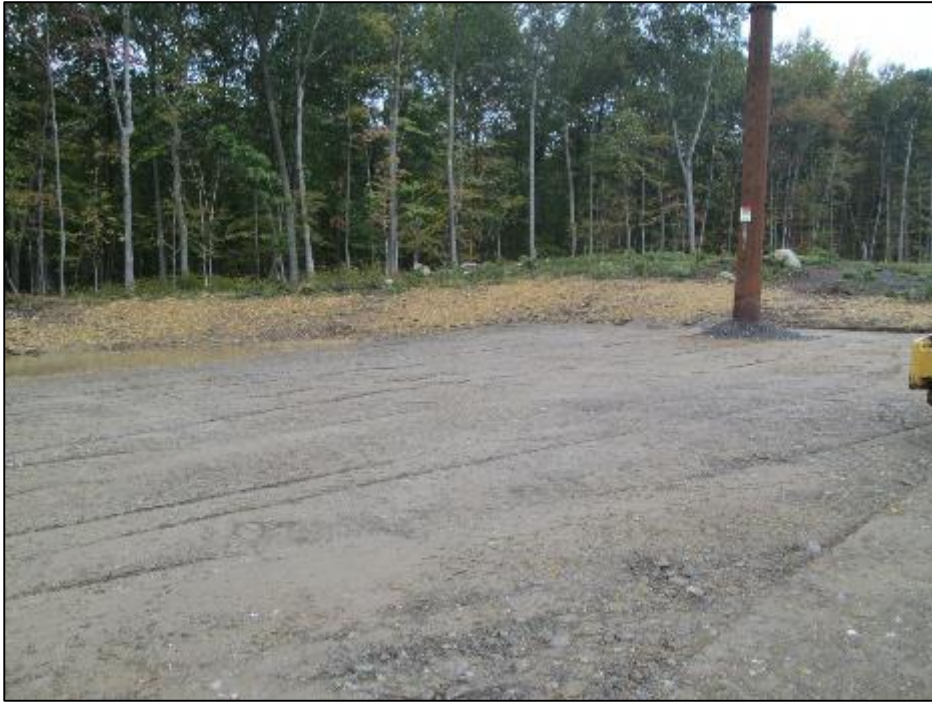
**MS25, Str 129:** Restoration Operations. (Photo 5)

Photo #5: Restoration operations at Str 129. (10/2)

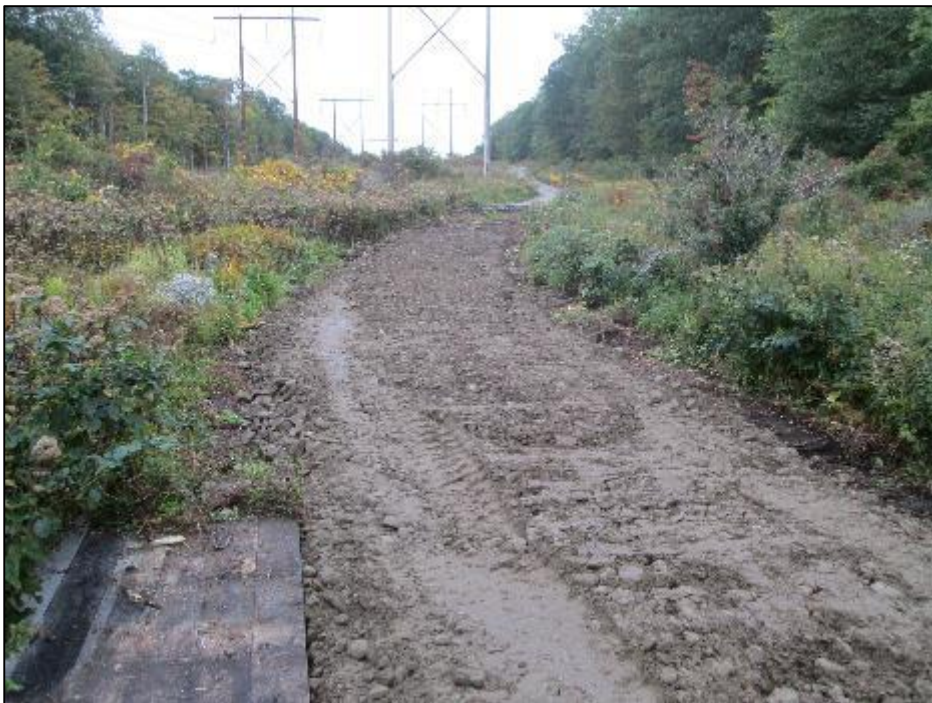
Photo #6: Str 105-106 access road being constructed as mats are removed. (10/2)

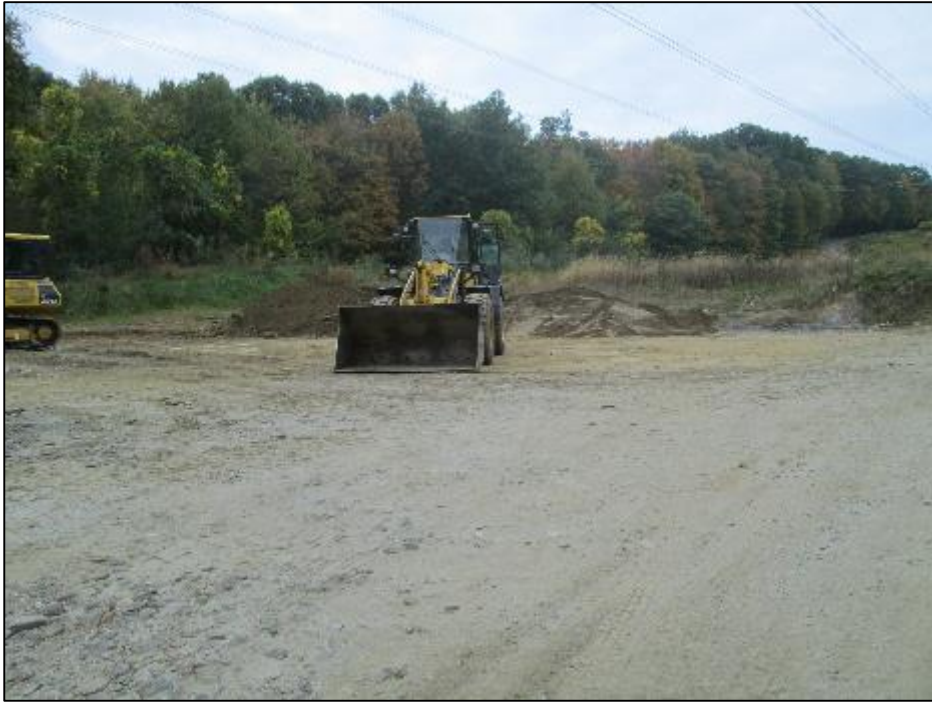
**MS14, Str 72:** Restoration Operations – Earthwork and Re-grading. (Photo 7)

Photo #7: Earthwork and re-grading at Str 72. (10/9)

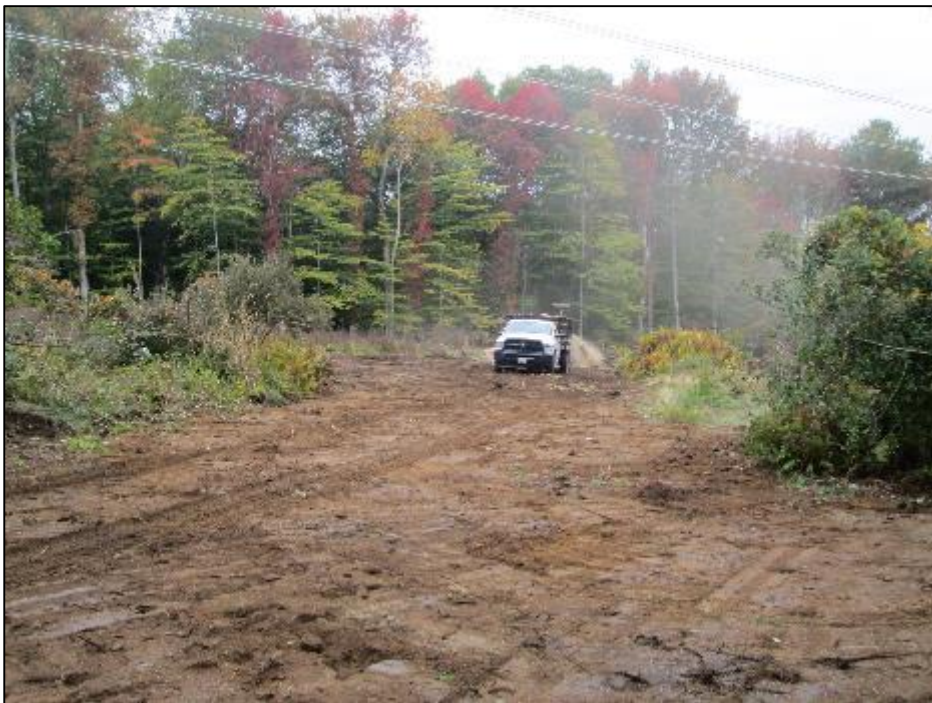
**MS14, Str 73-74:** Temporary stabilization with blown straw. (Photo 8)

Photo #8: Blowing straw around pull pad between Str 73 and 74. (10/9)

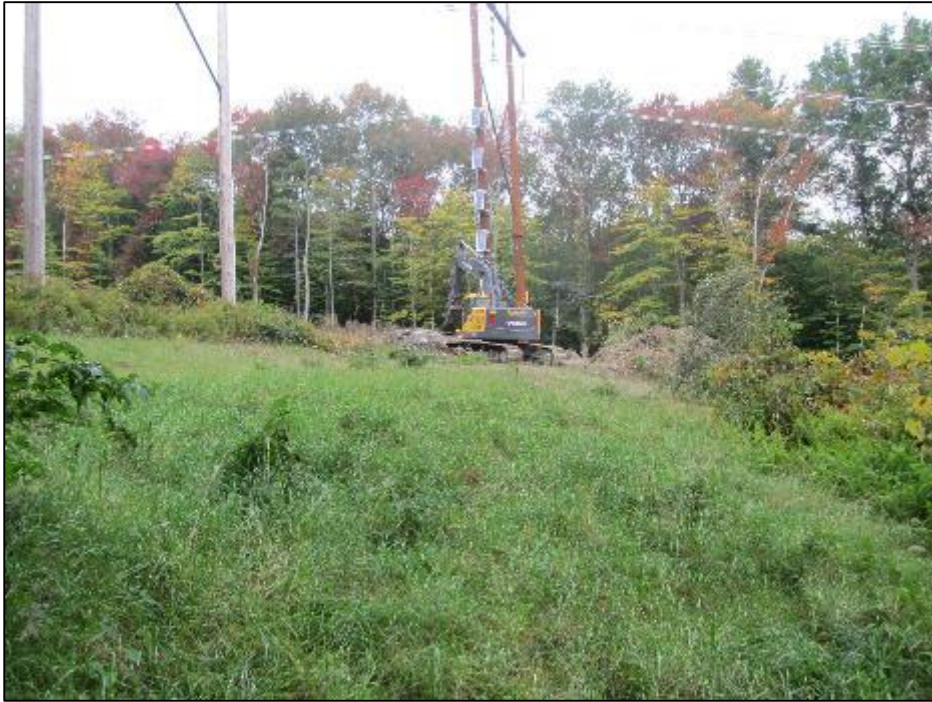
**MS14, Str 73:** Restoration Operations – Earthwork and Re-grading. (Photo 9)

Photo #9: Earthwork and re-grading at Str 73. (10/9)

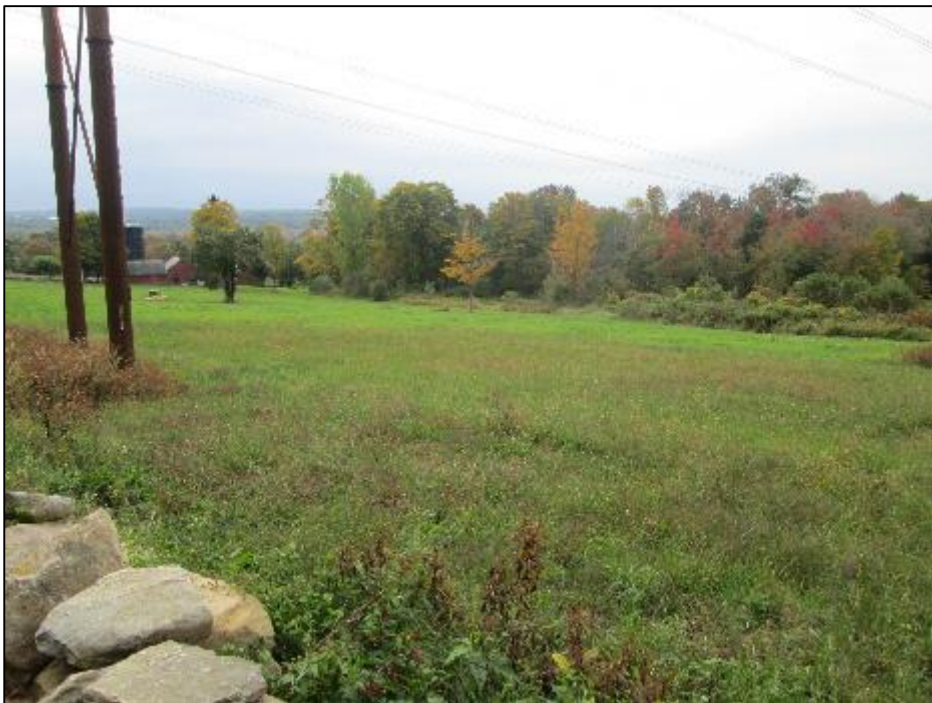
**MS10, Str 56:** Site Restored – **Final Site Inspection.** (Photo 10)

Photo #10: Final site inspection of Str 56. Site fully restored and permanently stabilized. (10/9)

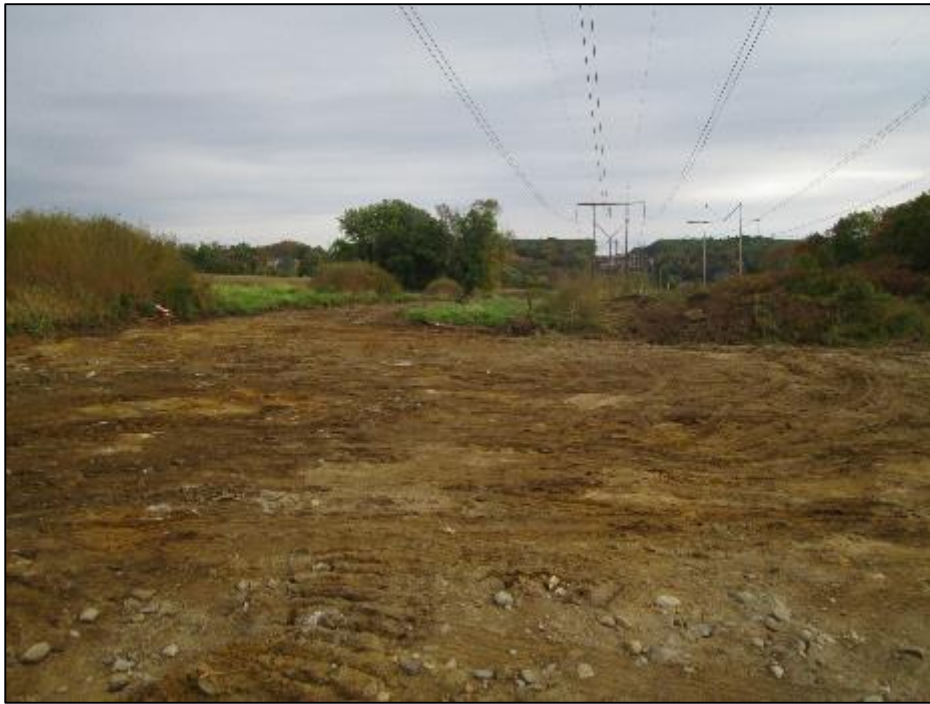
**MS10, Str 52:** Restoration Operations – Removal of construction stone from Pad. (Photo 11)

Photo #11: Construction pad removal from Str 52 area. (10/9)

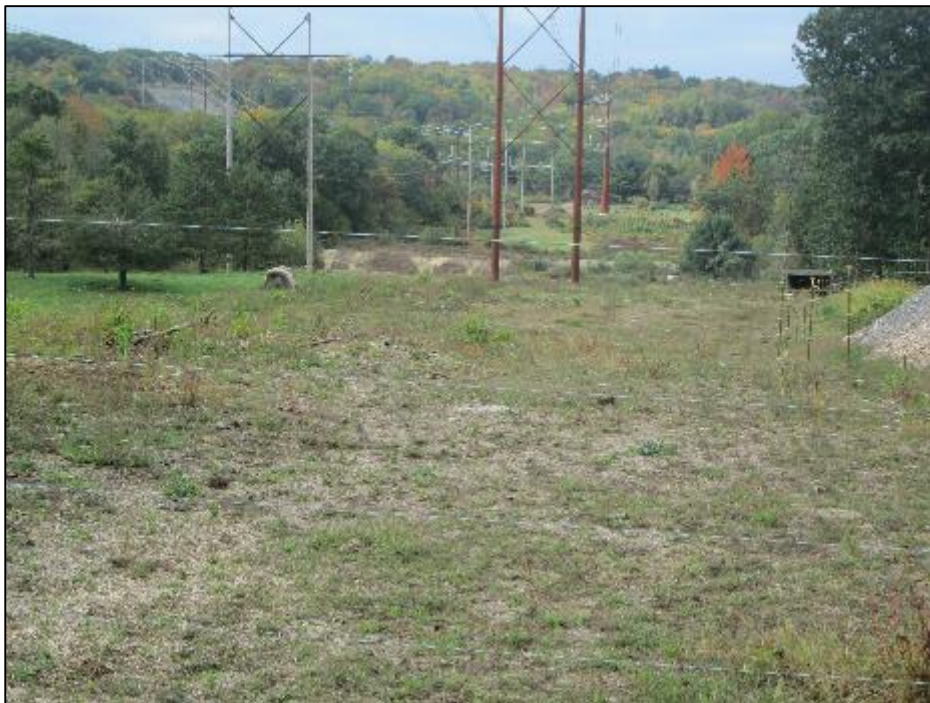
**MS7, Str 36:** Site Restored – **Final Site Inspection.** (Photo 12)

Photo #12: Final site inspection of Str 36. Site fully restored and permanently stabilized. (10/9)

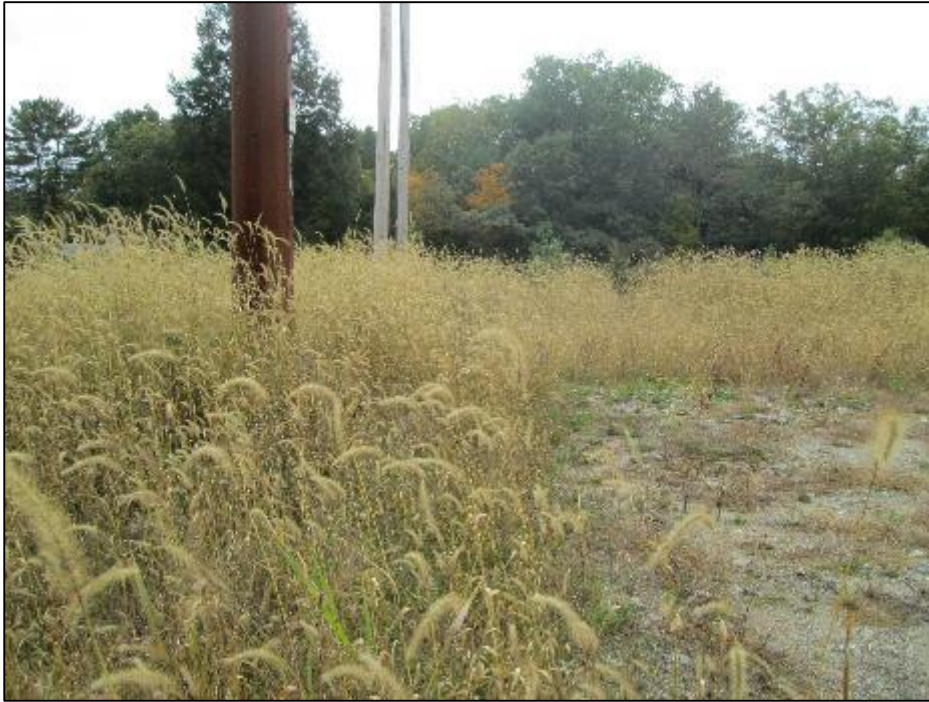
**MS7, Str 37:** Site Restored – **Final Site Inspection.** (Photo 13)

Photo #13: Final site inspection of Str 37. Site fully restored and permanently stabilized. (10/9)

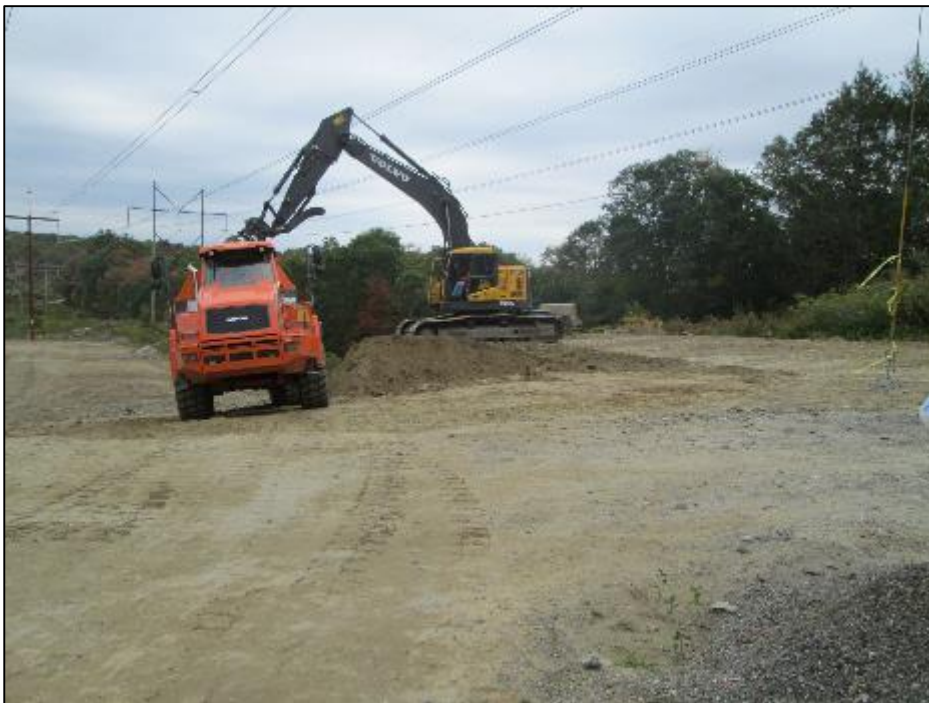
**MS35, Str 180:** Restoration Operations – Removal of construction stone from Pad. (Photo 14)

Photo #14: Removal of stone from Str 180 pad. (10/9)

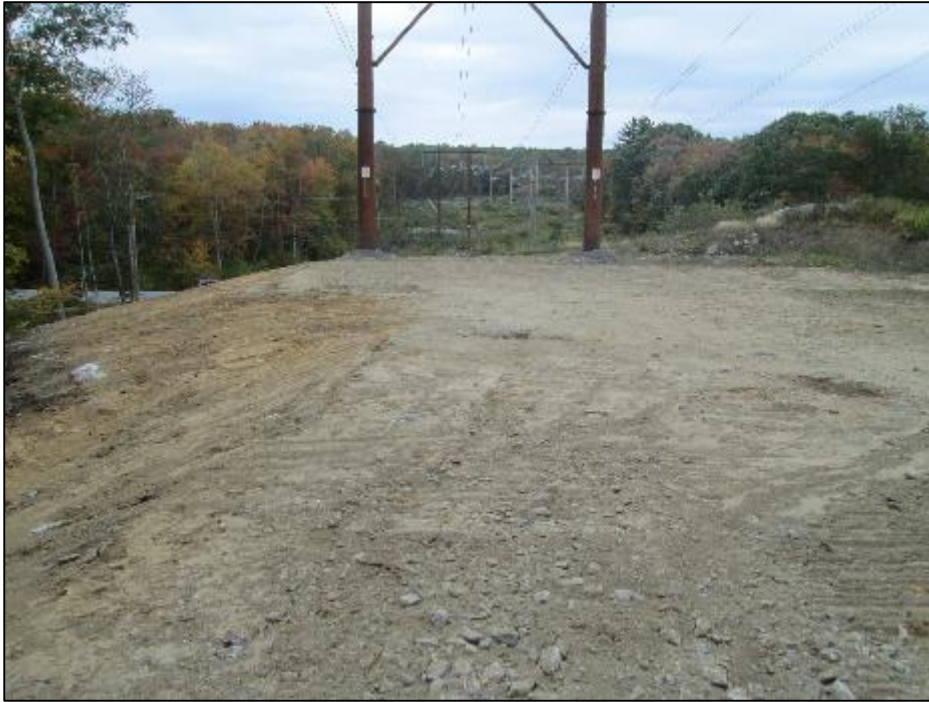
**MS35, Str 181:** Restoration Operations – Site Awaiting Temporary Stabilization Measures. (Photo 15)

Photo #15: Site re-graded and awaiting temporary stabilization. (10/9)

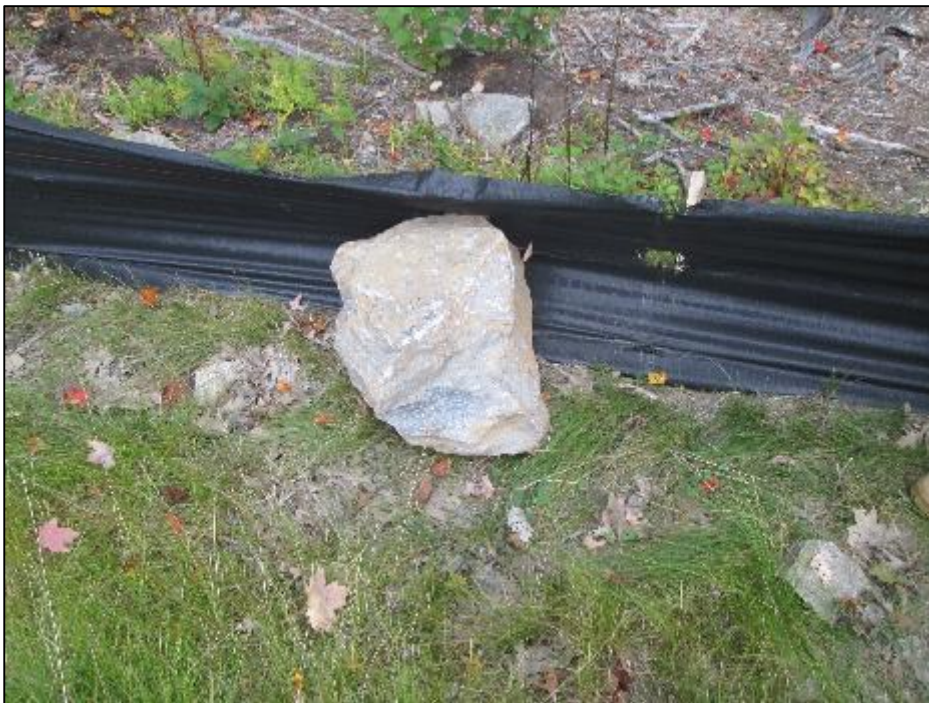
Photo #16: Silt fence torn by loose boulder. (10/9)

<b>Bi-Week (10/9)</b>	All crossings appear to be functioning in accordance with the BMP Manual. No sediment appears to be entering the streams or wetlands.	Continue to follow this procedure.	NA
<b>Erosion and Sedimentation Controls</b>	<b>Interim Week (10/2)</b>	All observed site controls appear to be functioning as intended and in accordance with the BMP Manual.  T. Ramborger indicated that on Wednesday - 9/30, during the heavy rainfall, there were no reported issues from any of the EI's.	Continue to follow this procedure.  NA	NA  NA
	<b>Bi-Week (10/9)</b>	All observed site controls appear to be functioning as intended and in accordance with the BMP Manual.  Observed an area of damaged silt fence at Str 181. Crewman on site indicated that a loose rock caused the damage. (Photo 16)	Continue to follow this procedure.  Repair area of rock damage ASAP	NA  Crewman indicated that the E&S team had been contacted and were on their way.
