RE: Comments on Docket No. 424, Interstate Reliability Project  
Relating to Wetland/Watercourse Issues in Thompson

Comments on CL&P Interstate Reliability Project  
Connecticut Siting Council Docket No. 424  
By Marla Butts, Thompson Wetlands Agent  
May 29, 2012

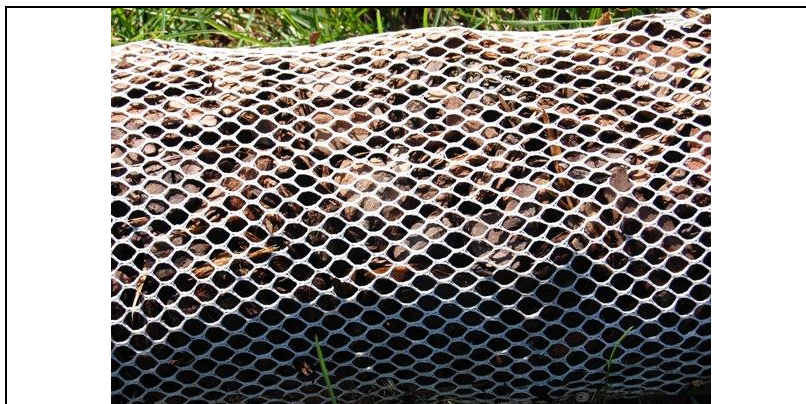
From the tree clearing activities there will be large amounts of slash or woodchips. The 2002 Connecticut Guidelines for Soil Erosion and Sediment Control ("Guidelines") only references using wood chips for temporary slope protection. The Guidelines have no reference on the use wood chips berms, tubular mesh filter socks (see photograph below) or wattles.

Example of mesh tubing filled with bark chips. Photo taken from [http://www.supertex-inc.com/earthgarde/mainsite/?page\\_id=11](http://www.supertex-inc.com/earthgarde/mainsite/?page_id=11)

**Recommendation:** CL&P should be required to investigate and develop sediment and erosion control measures which make use of the tree clearing waste as a sediment barrier and a water diversion device. In keeping with the Guidelines, such measures would need a definition, purpose, applicability, planning considerations, specification for materials and installation and maintenance. Specific specification and details should be provided for the installation and maintenance of tubular mesh filter socks as temporary water diversions, sediment barriers and temporary movable water bars (see Guidelines pages 5-7-9, 5-11-4 and 5-7-6, respectively for guidance).

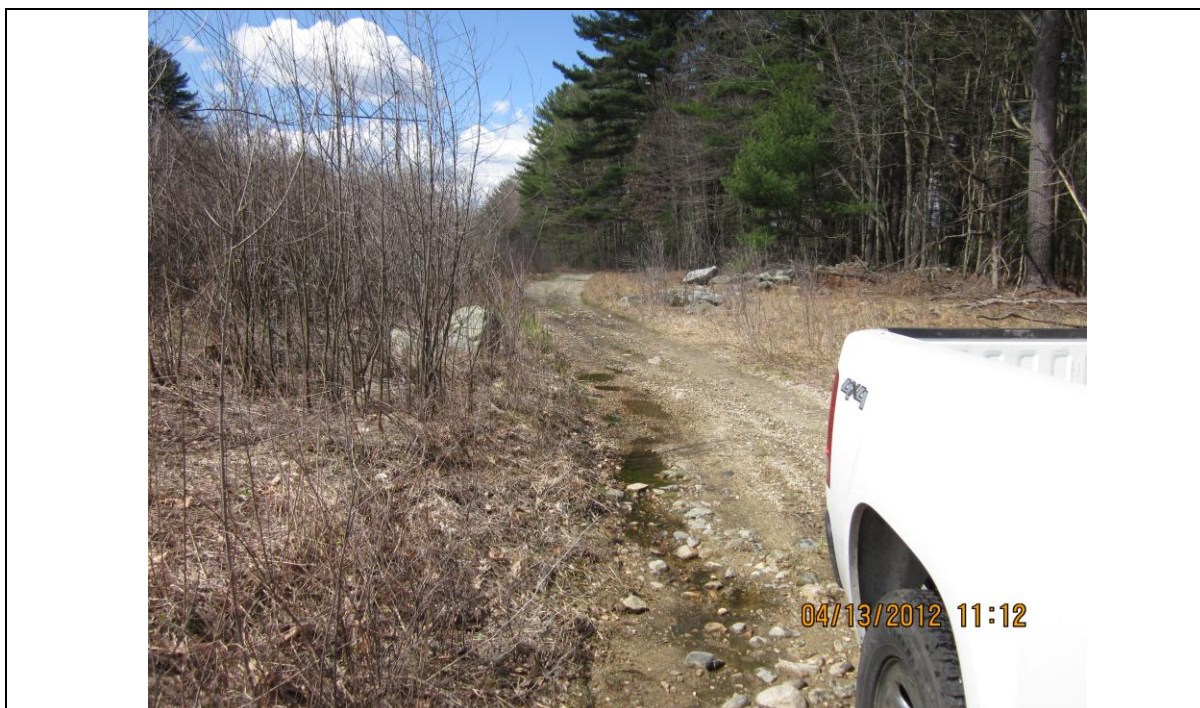
- 1) At or about Station 1895+57, where a temporary culvert is proposed, erosion in the roadway indicates an intermittent water flow runs down the access road before exiting into wetlands north of the alignment. (see IMG\_0222 & IMG\_0223) **Recommendation:** Post-construction stormwater management needs to be designed here to prevent a repeat of access road erosion.

IMG\_0223 Taken facing southwest on access roadway water flow entering roadway near central portion of picture. Note proposed temporary culvert is proposed for central portion of photo and water seen flowing in road infiltrates into ground before IMG\_0222.

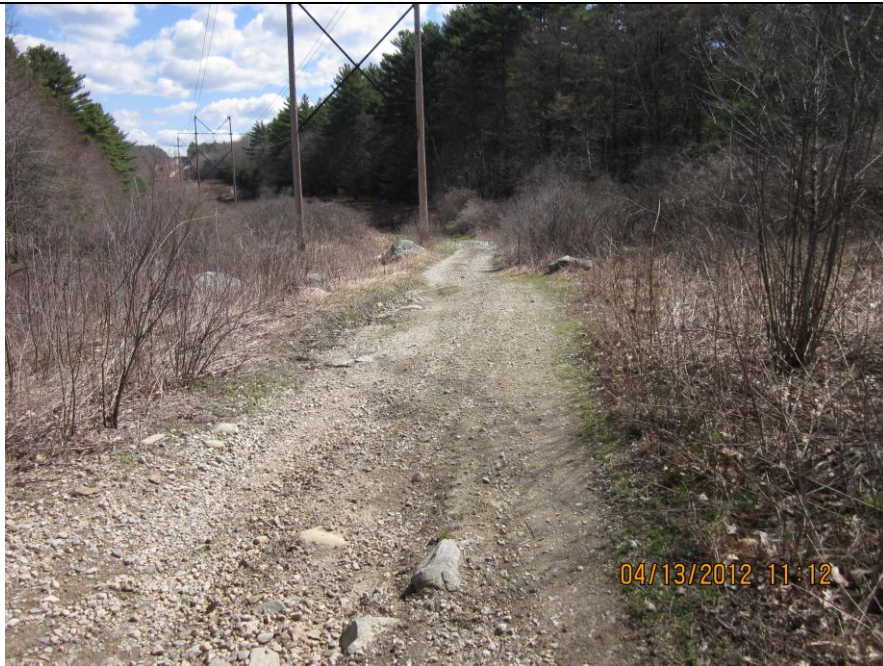
IMG\_0222 Taken facing northeast just northeast of photo IMG\_0223 showing continued evidence of water flow along access roadway. Note water flow exists roadway near central portion of photo. Station 1898 is in background.

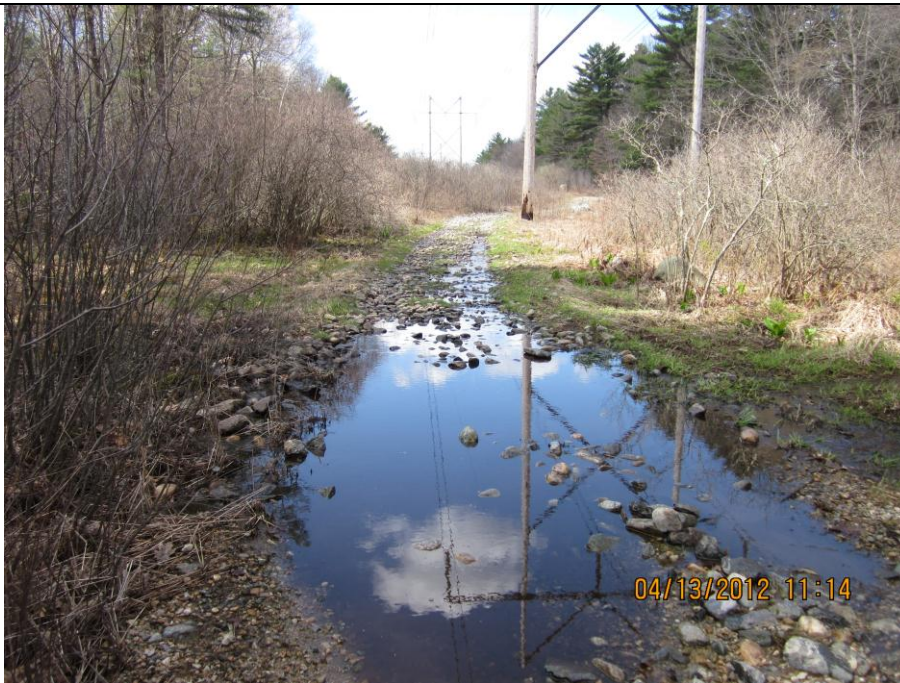
- 2) At or about Station 1898±, where a temporary culvert is proposed, water flowing onto the access road and was flowing down for a distance to a low point in the road (see IMG\_0224 below).

IMG\_0224 Taken facing southwest at a low point in the access road showing conditions caused by a watercourse flowing down the access road.

**Recommendation:** If contributing drainage area is less than 100 acres, CL&P should put in a permanent culvert where the watercourse first enters into the road or provide a permanent diversion channel to carry the water to the low point in the road with a temporary culvert at the low point and permanent ford for post construction use.

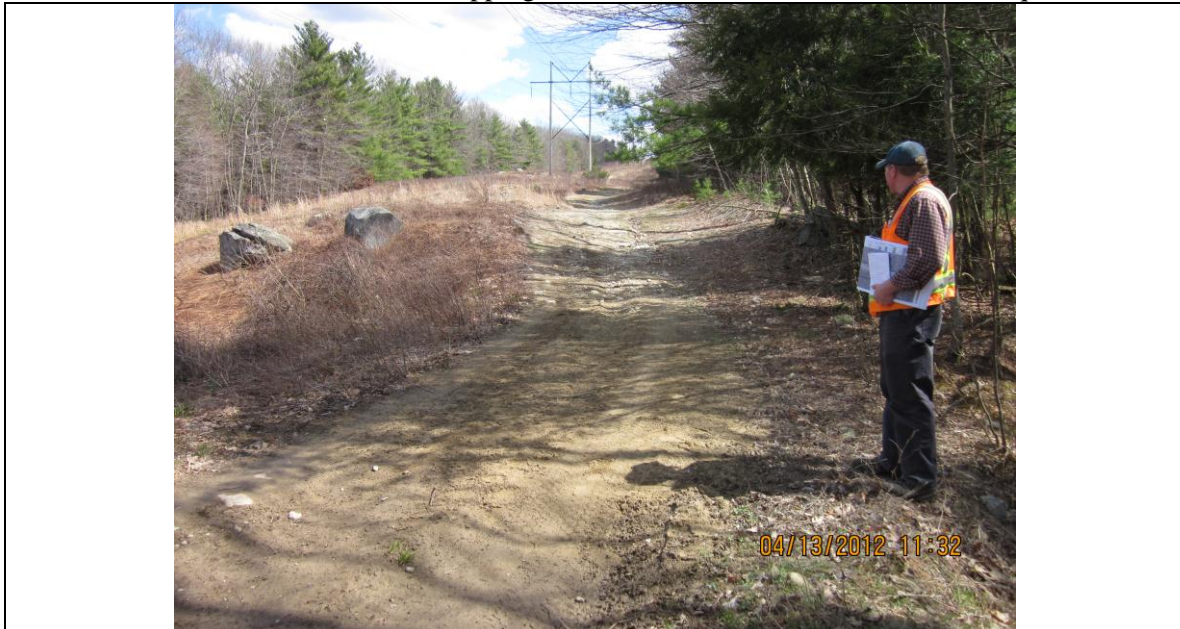
- 4) At or about Station 1912+50, cross culvert is almost completely blocked resulting in overtopping of road (see IMG\_0225 below). **Recommendation:** As a permanent culvert, armoring of the access road with stone to facilitate overtopping of the road without erosion should be required.

IMG\_0225 Taken facing northeast at Station 1912+50 showing recent repair of access road in foreground apparently from road overtopping at blocked cross culvert. Note erosion from access road drains into wetlands/watercourses.

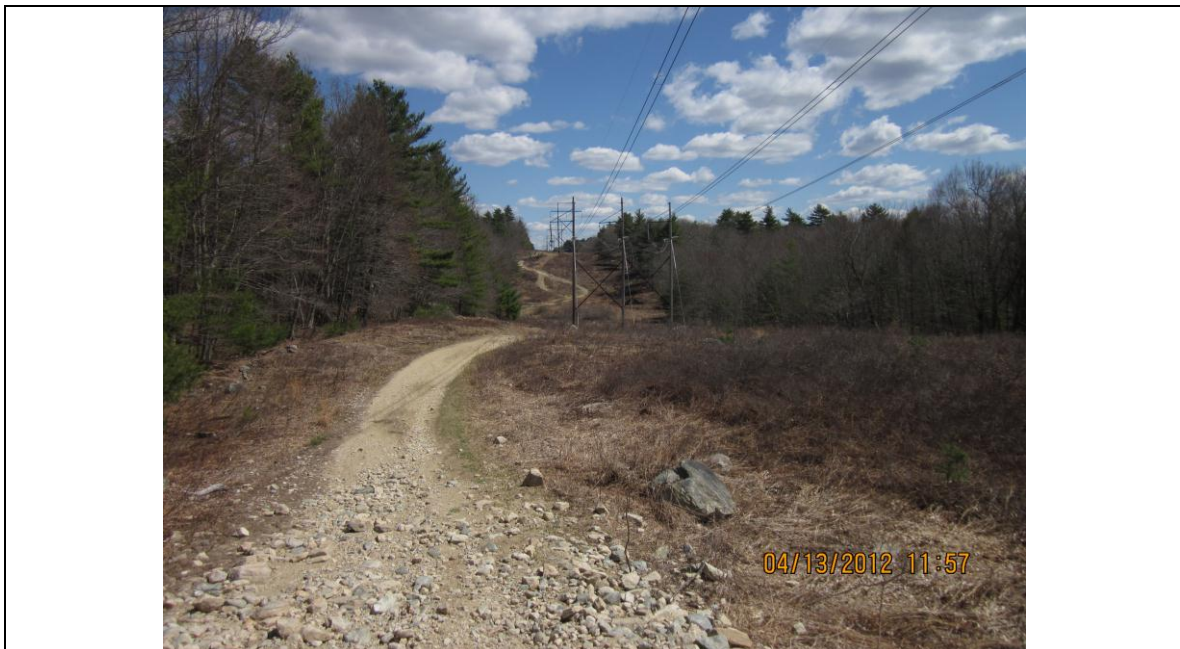
- 5) Between Stations 1912+50 and 1935+00 the access roadway is steep with some erosion. **Recommendation:** Require use of temporary waterbars and/or diversions in and along roadway to minimize the concentration of stormwater runoff flows and deflect runoff to non-wetland areas.
- 6) Between Stations 1945 and 1950± the access road drain to a wetlands that crosses the alignment just before the Rhode Island border (see IMG\_0226 and IMG\_0227 below). No significant siltation of the wetlands was noted at this time. **Recommendation:** Require use of temporary waterbars and/or diversions in and along roadway to minimize the concentration of stormwater runoff flows and deflect runoff to non-wetland areas.

IMG\_0226 Taken facing northeast at Station 1940± showing eroded steep access road and condition of access road as it approaches wetlands near the Rhode Island border.

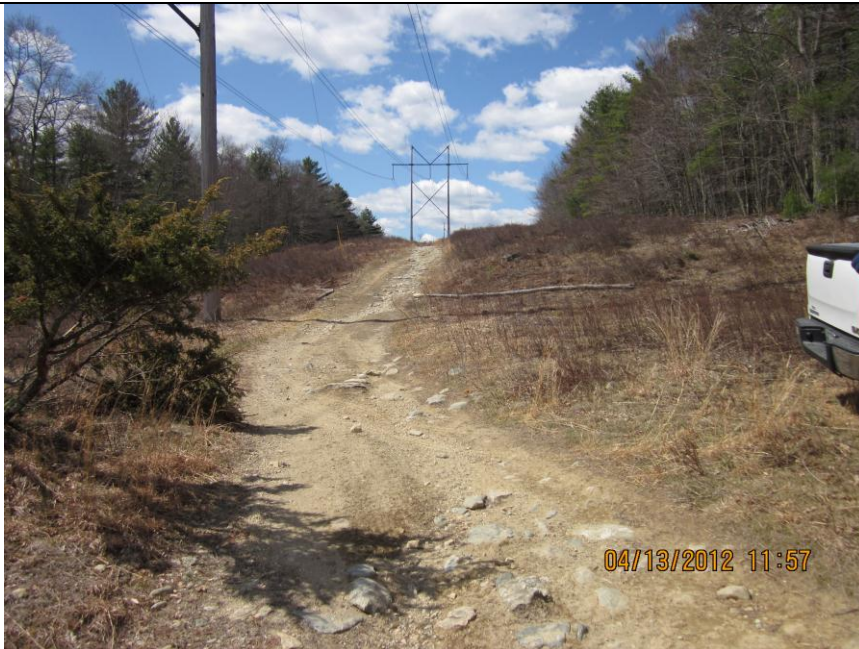
IMG\_0227 Taken facing southwest at Station 1946+ showing eroded steep access road that drains towards wetlands near Rhode Island border.
