**ENVIRONMENTAL MONITORING**  
**DAILY SITE OBSERVATION FORM**

**Report No. 5**

Project: Verizon Wireless Southington East Street Facility  
 Address: 99 East Street, Southington, Connecticut

APT Project #: CT1412300

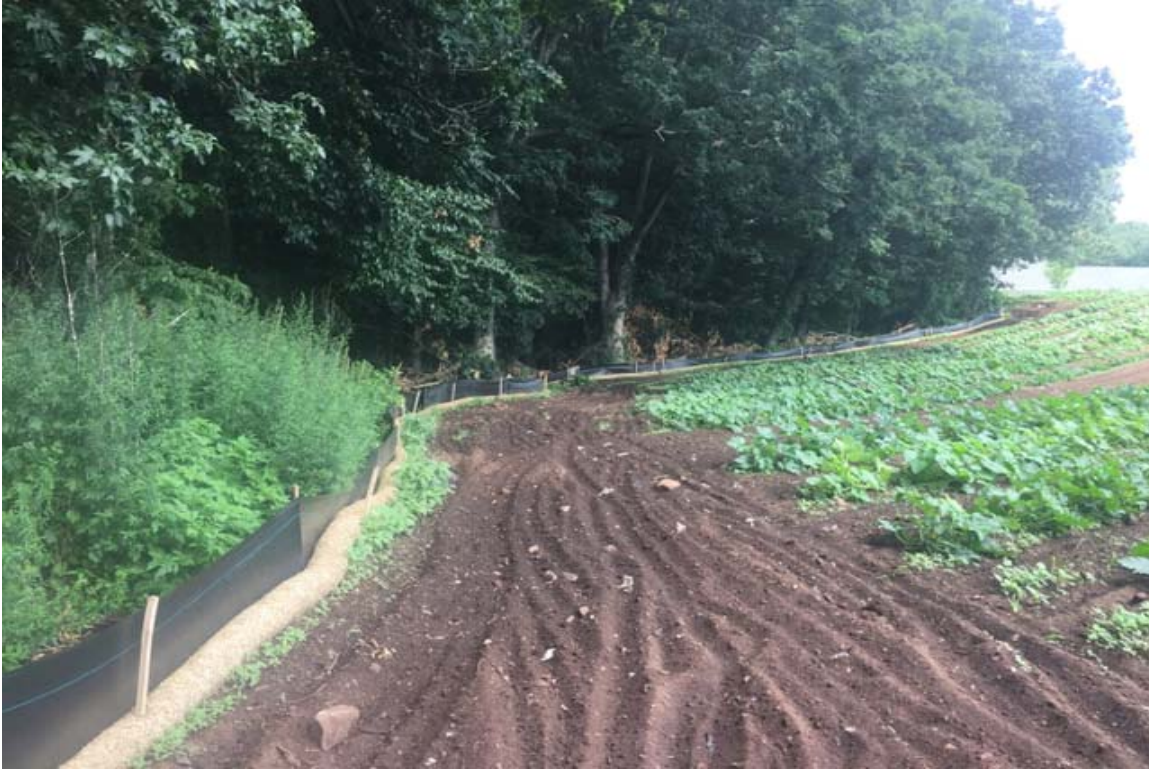
Photo 1: View of silt fence barrier looking east.

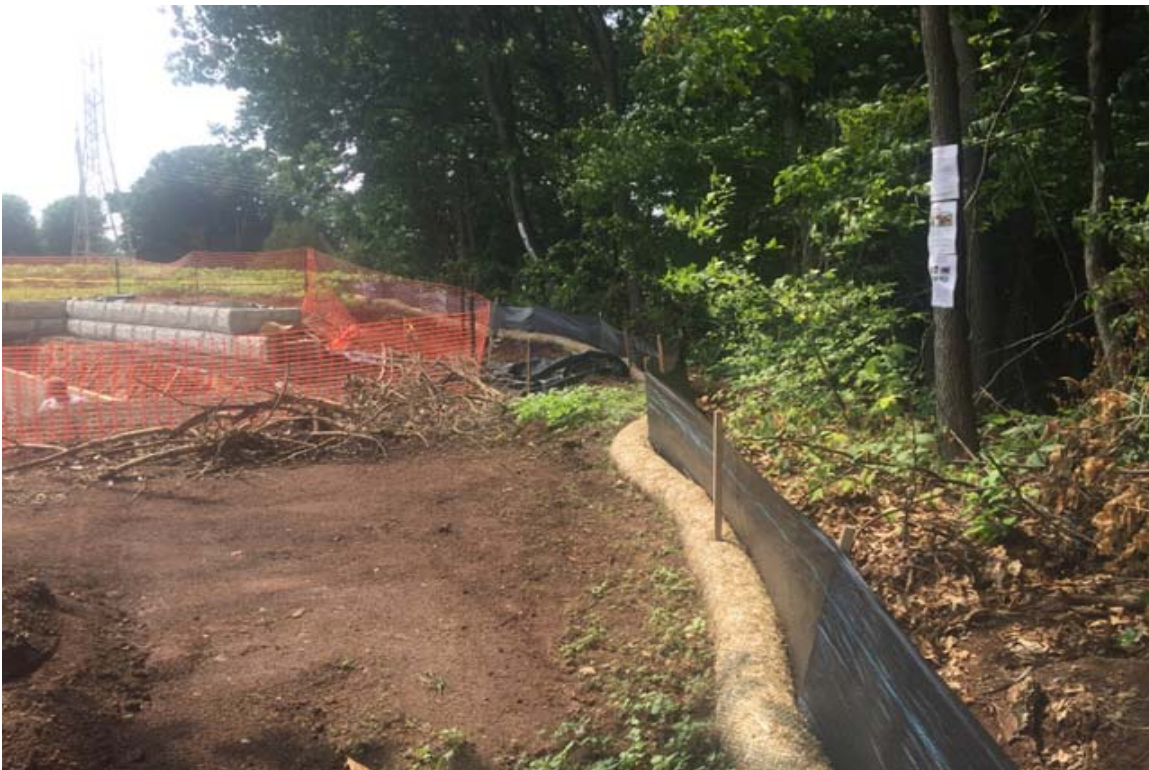
Photo 2: View of silt fence barrier looking west at north side of compound.

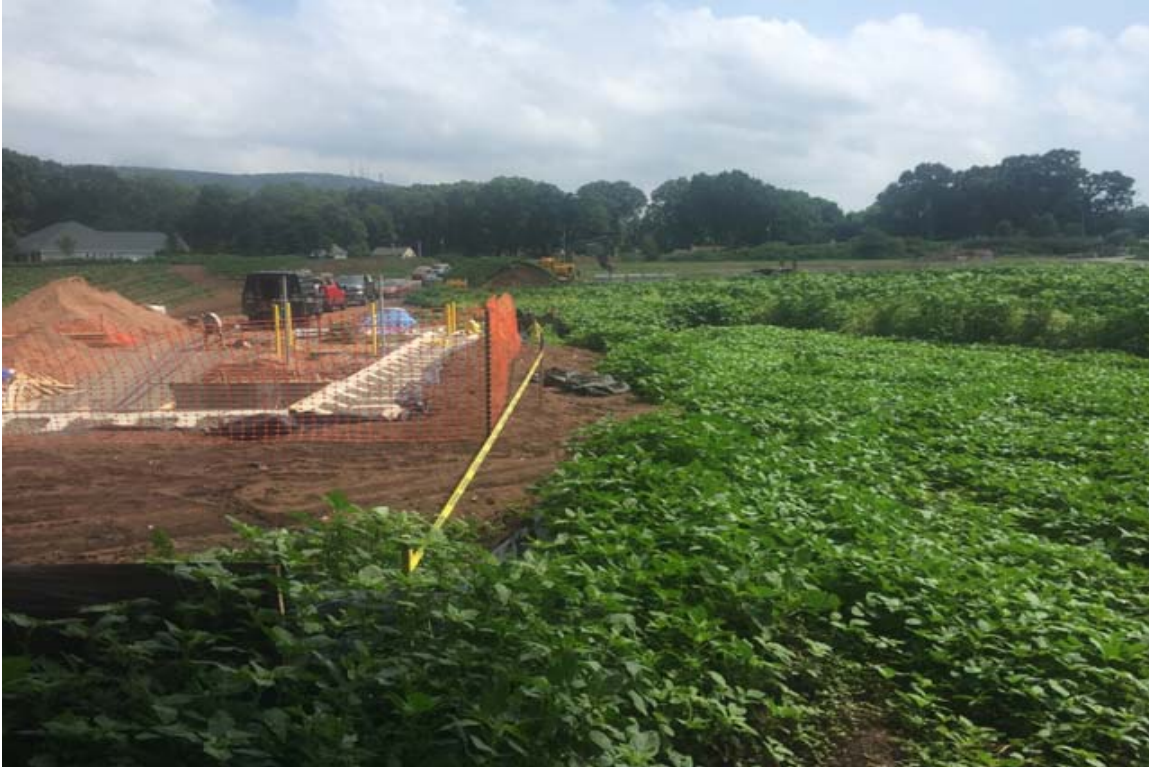
Photo 3: View of CA#2 break in silt fence requiring repair looking south; compound in left side of photo.

Corrective Action #2 – repair break in silt fence along northwest corner of compound	7/15/16
Project Modification Requested:	
Extra Work Space Requested <input type="checkbox"/> Change to Work Area <input checked="" type="checkbox"/> <b>Description of Modification:</b> <ul style="list-style-type: none"> <li>Modify gravel access road French Mattress section because it currently is built up too high above existing grade and will conflict with agricultural use of property. Does not create an issue with compliance monitoring. Centek Engineering to approve design modification.</li> <li>Add retaining wall on west and north sides to hold back soil. Does not create an issue with compliance monitoring. Centek Engineering to approve design modification.</li> <li>Modify evergreen screening plantings around compound. Proposed species may be susceptible to droughty soil conditions. Select alternate species to withstand drought (i.e., Red Cedar, etc.).</li> </ul>

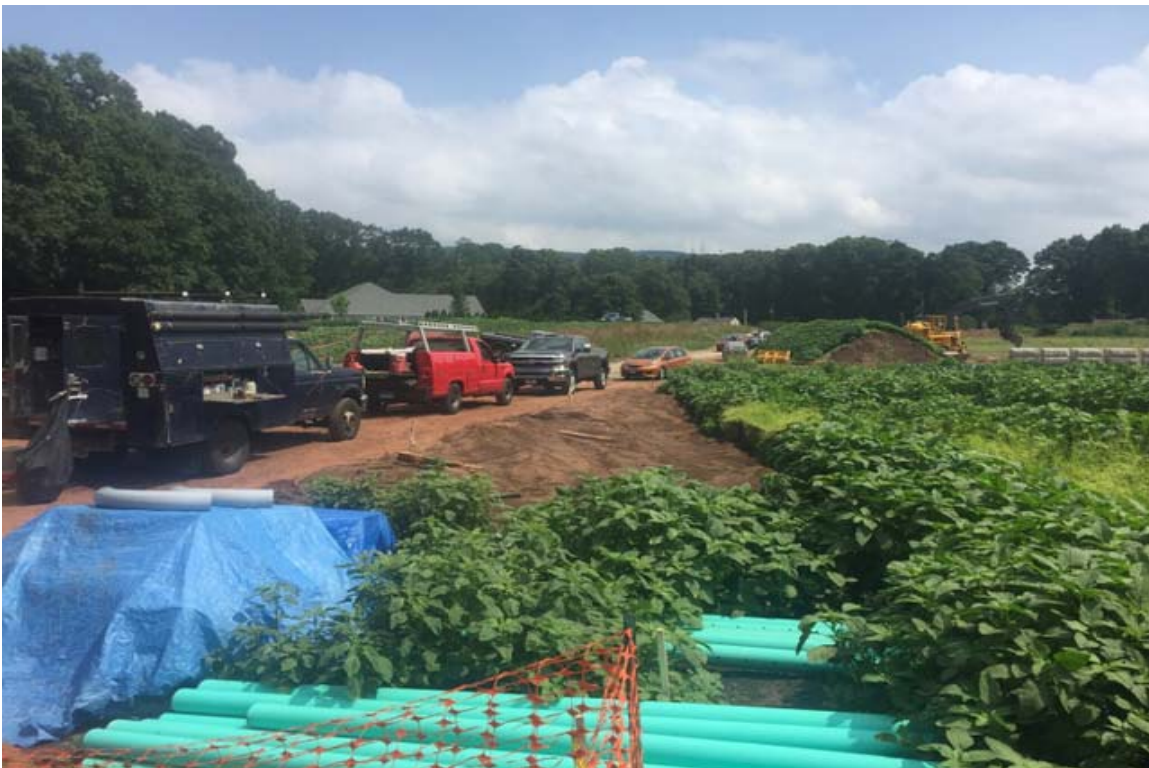
Photo 4: View of access road looking south from southwest corner of compound.

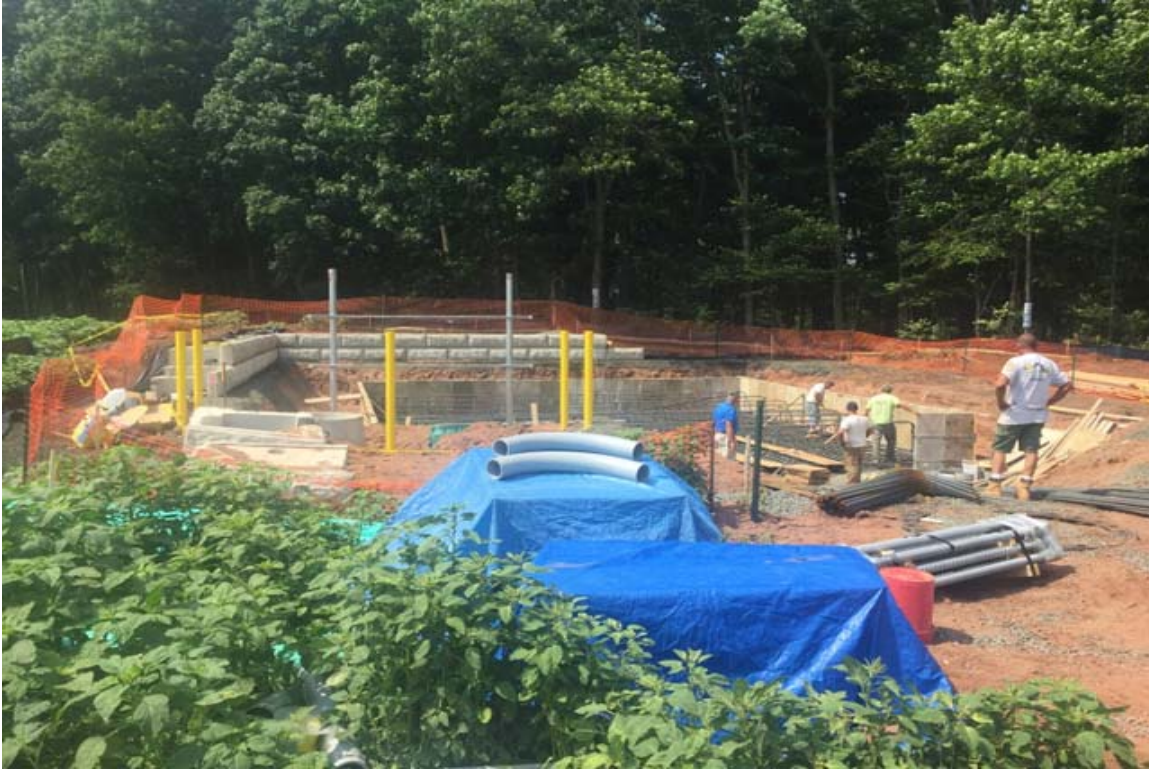
Photo 5: View of compound area looking north; tower foundation rebar being installed.

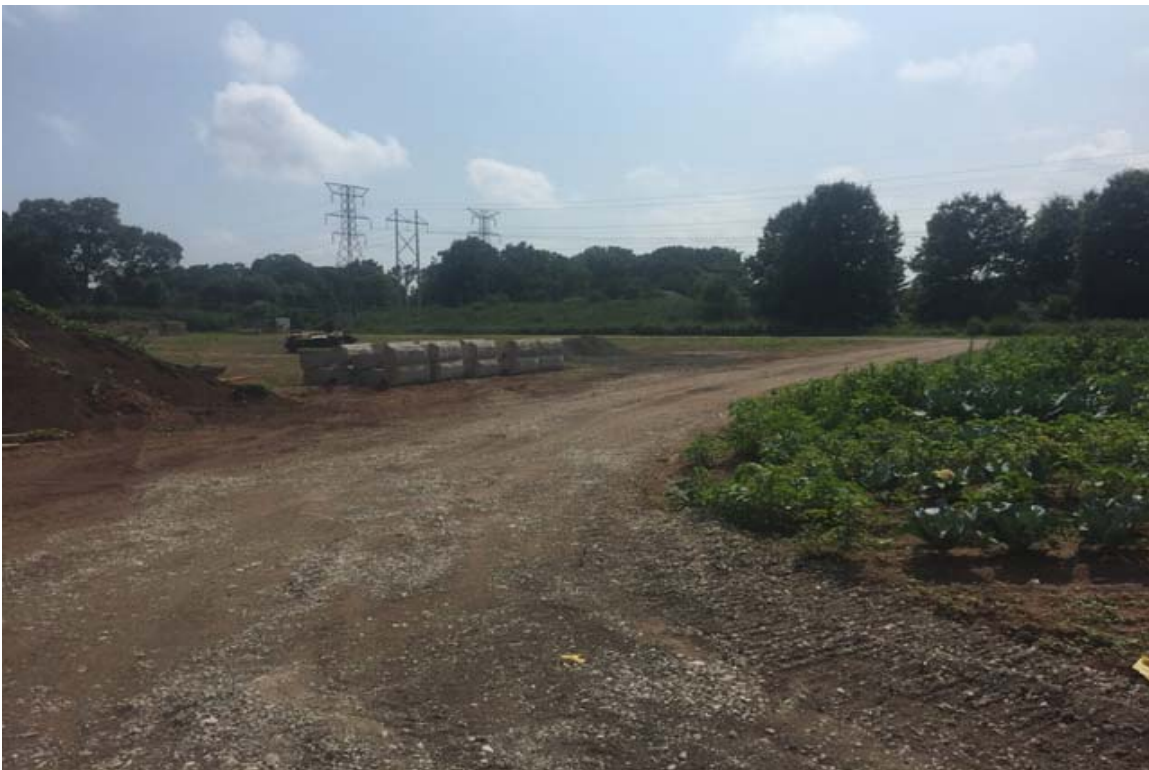
Photo 6: View of existing access road looking west.
