ENVIRONMENTAL MONITORING DAILY SITE OBSERVATION FORM

Report No._5_

Project: Verizon Wireless Plymouth West Relo Facility

Address: 33 Keegan Road, Plymouth, Connecticut

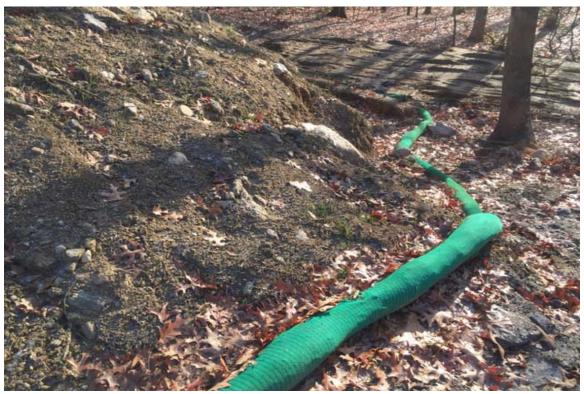
Photo 1: View of recently germinated winter rye on soil stockpile looking south.

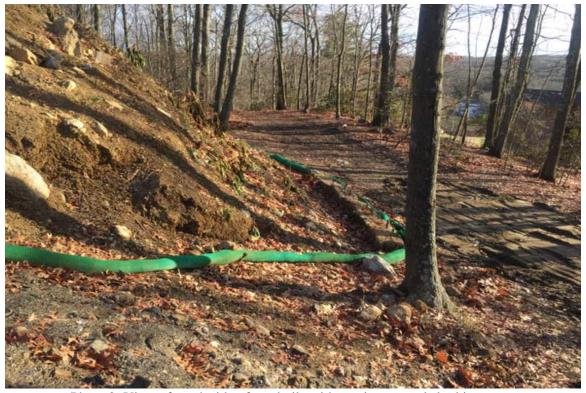
Photo 2: View of south side of stockpile with erosion controls looking west.

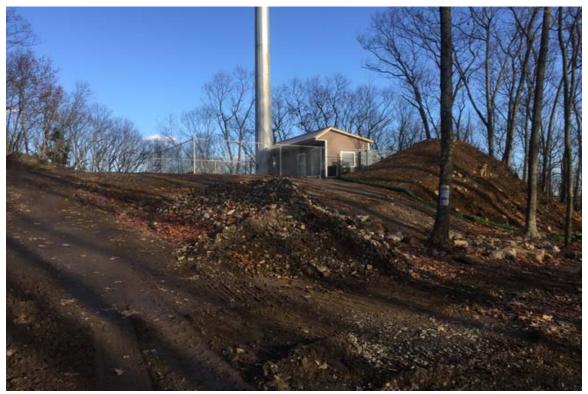
Photo 3: View east of tower; slope to be permanently stabilized with gravel.

12/09/16 – Previous CA #8 through #11 have been properly completed. Contractor estimates remaining site stabilization work will be completed week of 12/19/16. Work to be completed includes: rock armoring west side of compound and minor top dress end of access near compound. Otherwise, remaining portions of the site are stabilized for winter.

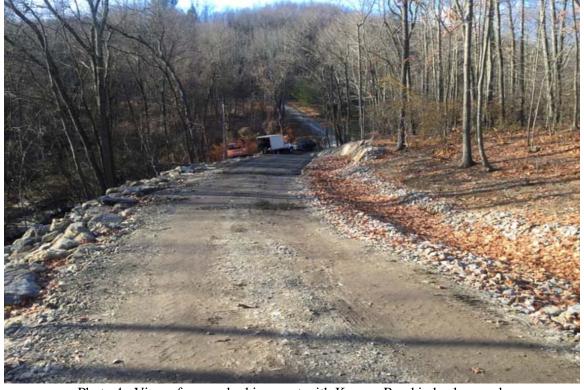
Photo 4: View of access looking west with Keegan Road in background.

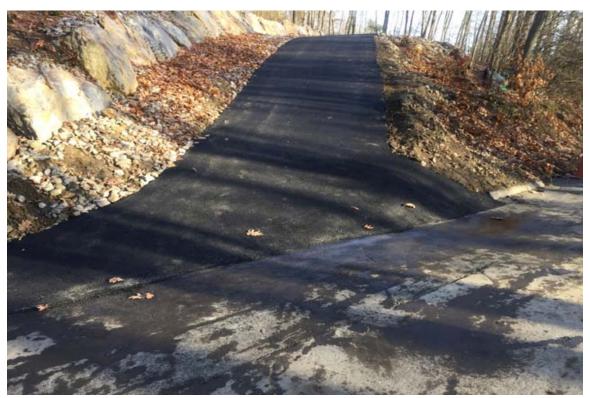
Photo 5: View of paved entrance of access looking southeast from Keegan Road.

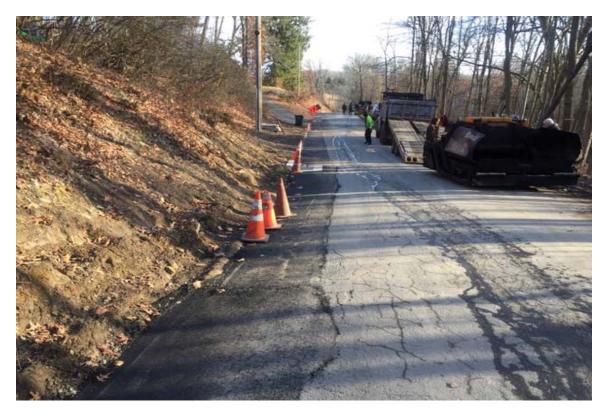
Photo 6: View of new catch basin and drainage system installed along east side of Keegan Road looking southeast.

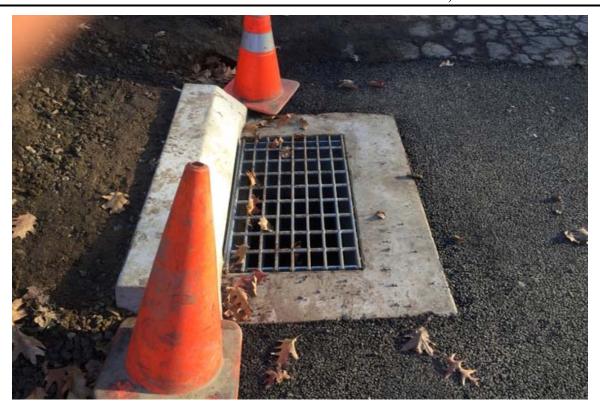
Photo 7: View of silt sock removed and cleaned out from new catch basin looking southeast.

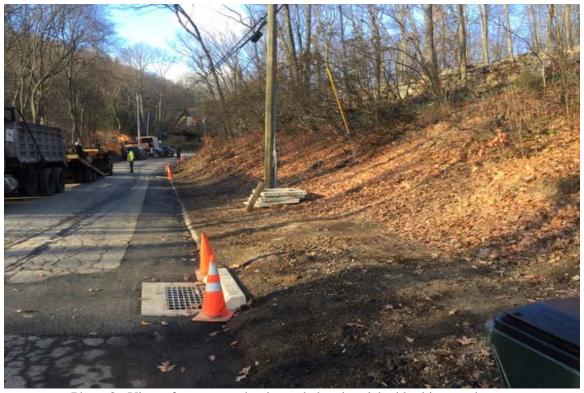
Photo 8: View of area around pole seeded and mulched looking northwest.

per site plans C-1; minor erosion observed			
CA #4 – west side of soil stockpile, remove sediment build up			
and temporary seed stockpile	8/26/16		
CA #5 – west side of compound south of access road – add			
perimeter control for runoff and sediment discharge from rill	8/26/16		
erosion on west compound slope			
CA #6 – access road entrance – repair silt fence at south end	8/26/16		
CA #7 – east catch basin on Keegan Road – clean out clogged	8/26/16		
silt sock	0/20/10		
CA#8 – clean catch basin silt sock of accumulated sediment	12/09/16		
CA#9 – seed and mulch exposed soil around new utility pole

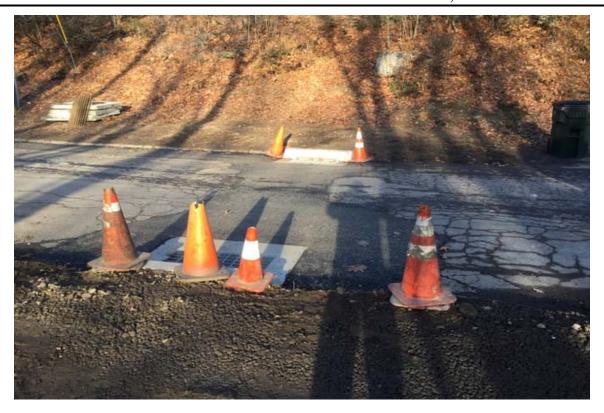
Photo 9: View of new catch basins looking northeast.

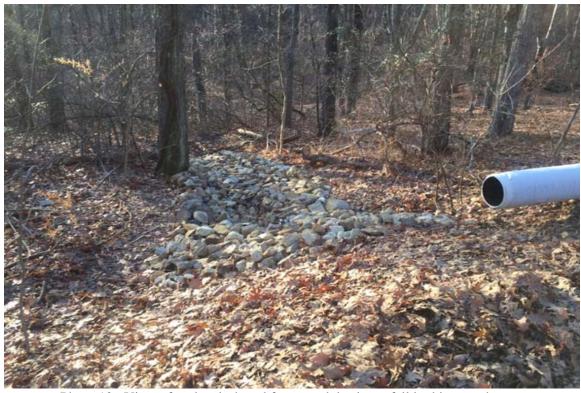
Photo 10: View of rock splash pad from catch basin outfall looking southwest.

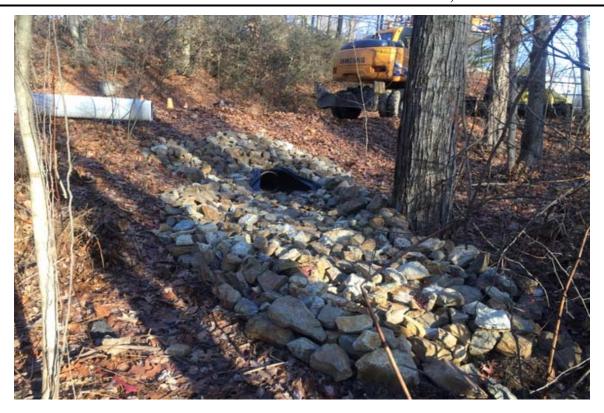
Photo 11: View of rock splash pad looking east with Keegan Road in background.

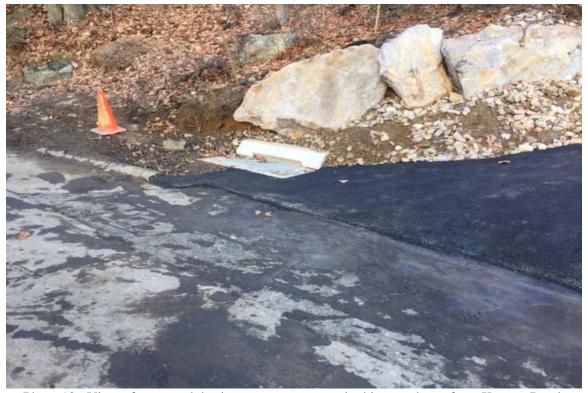
Photo 12: View of new catch basin at access entrance looking northeast from Keegan Road.
