Re: **Docket No. 456 – Cellco Partnership d/b/a Verizon Wireless  
33 Keegan Road, Plymouth, Connecticut  
Environmental Monitoring Report No. 6**

**ENVIRONMENTAL MONITORING**  
**DAILY SITE OBSERVATION FORM**

**Report No. 6**

Project: Verizon Wireless Plymouth West Relo Facility  
 Address: 33 Keegan Road, Plymouth, Connecticut

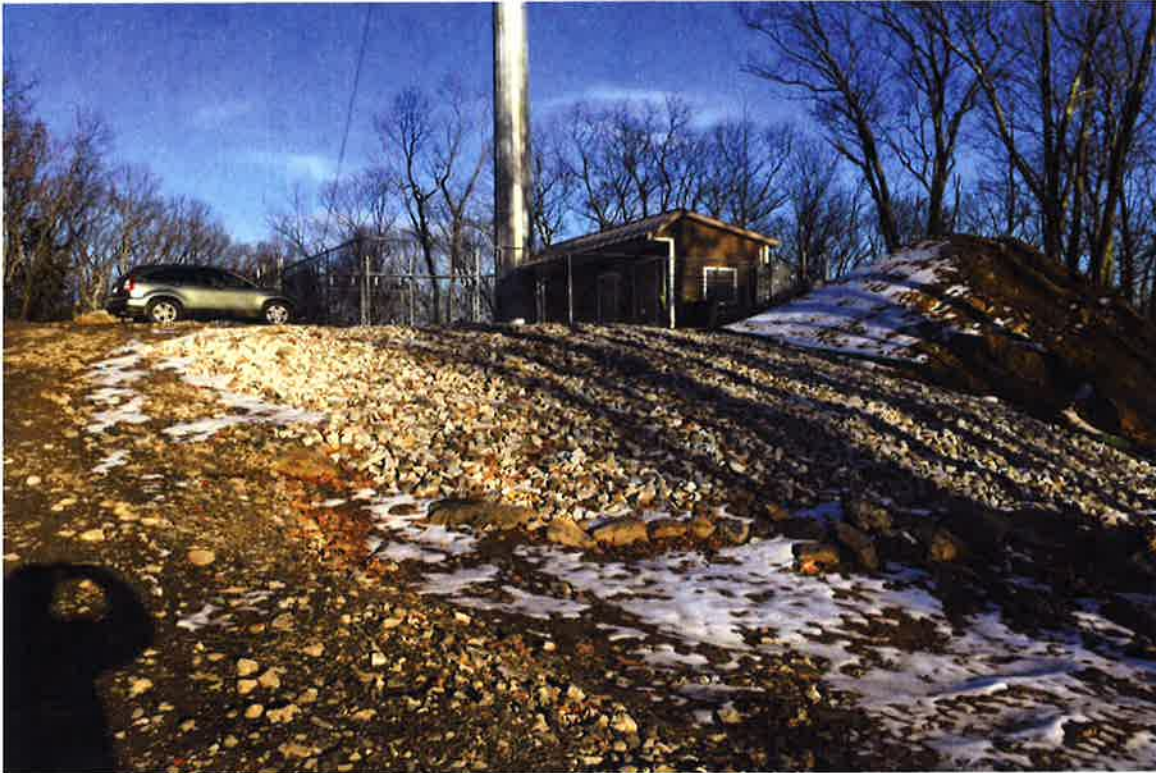
Photo 1: View of rock armored slope looking east.

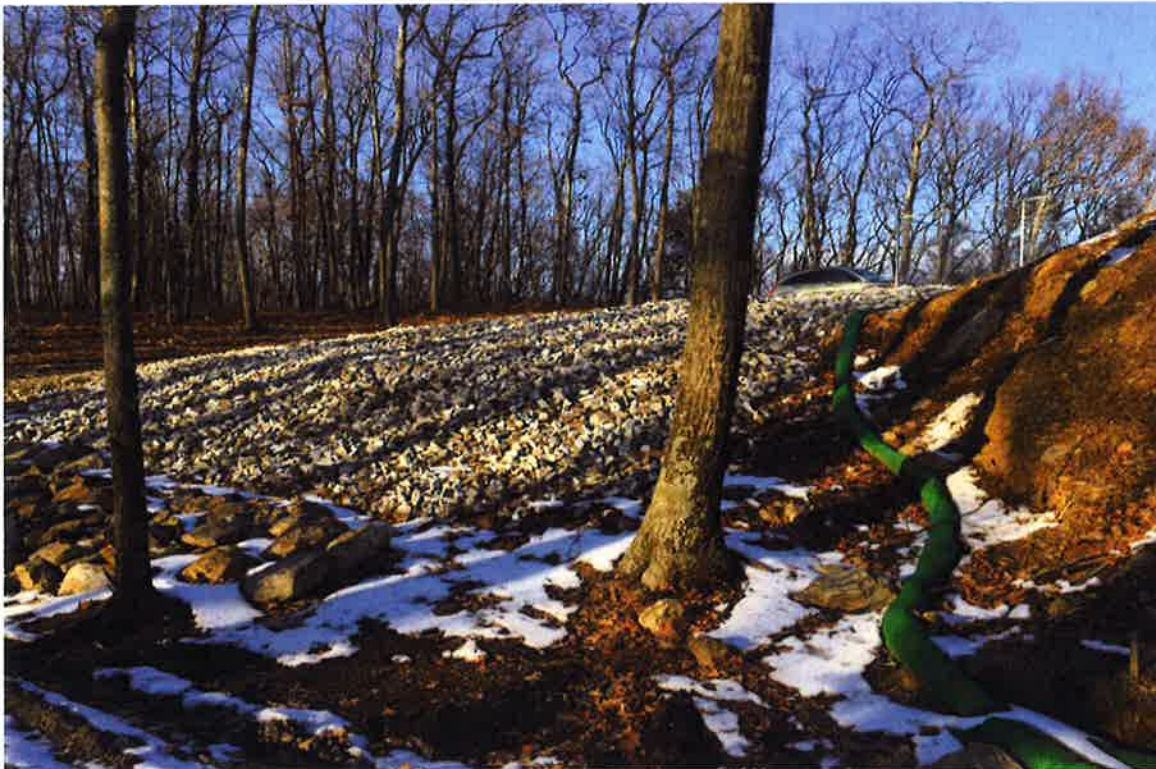
Photo 2: View of rock armored slope west of compound looking northeast.

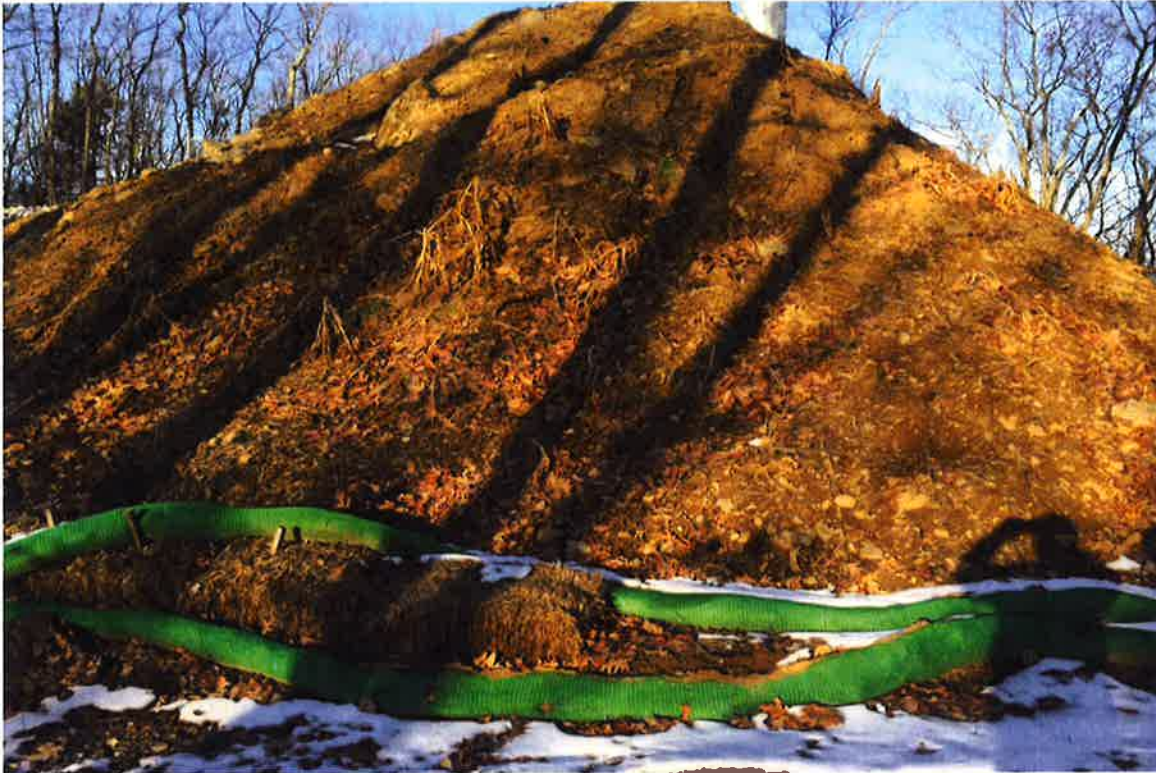
Photo 3: View of soil stockpile looking northeast.

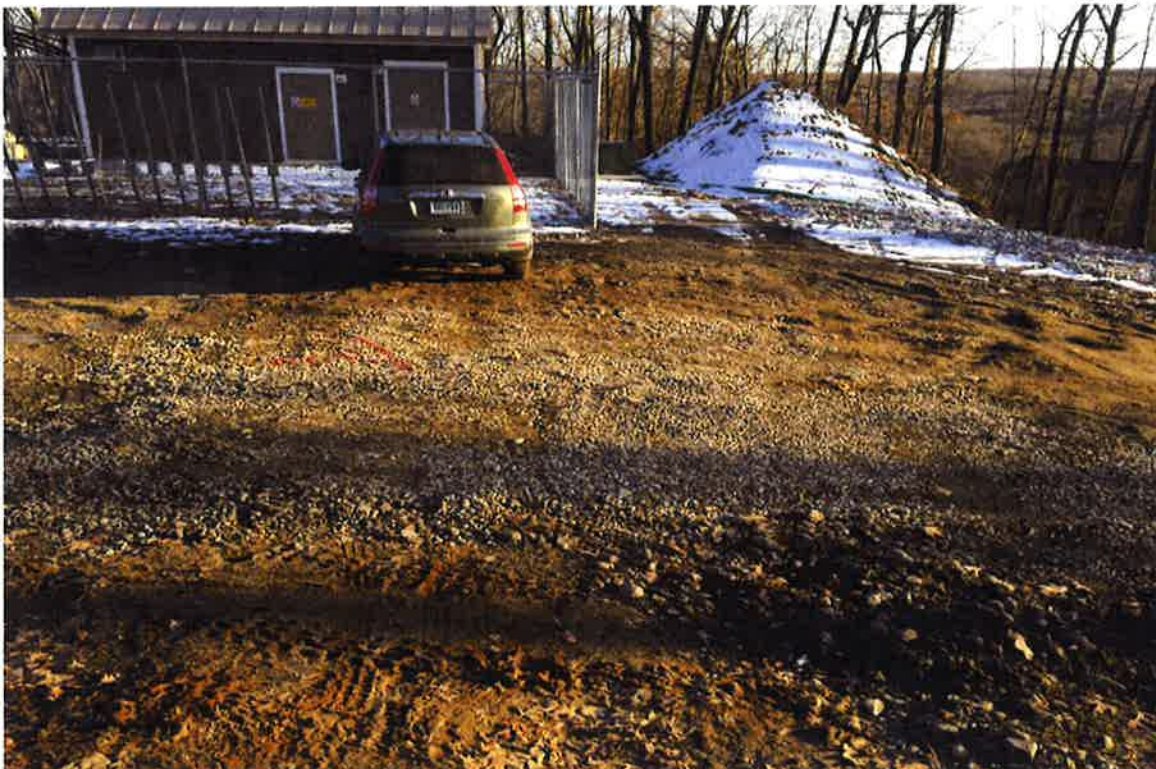
Photo 4: View of top of access drive top dressed with gravel looking south.
