**Subject: Docket No. 466, Frost Bridge to Campville 115-kV Project
Decision and Order Condition #4 – Independent Environmental Inspector Report**

Please find enclosed the Biweekly Independent Environmental Inspector Report, Report #33, for the **March 2nd**, and **March 9th, 2018**, inspection events for the construction of the Eversource Frost Bridge to Campville 115-kV Project.

Docket No. 466- Development and Management Plan Inspection

Frost Bridge to Campville 115kV Project

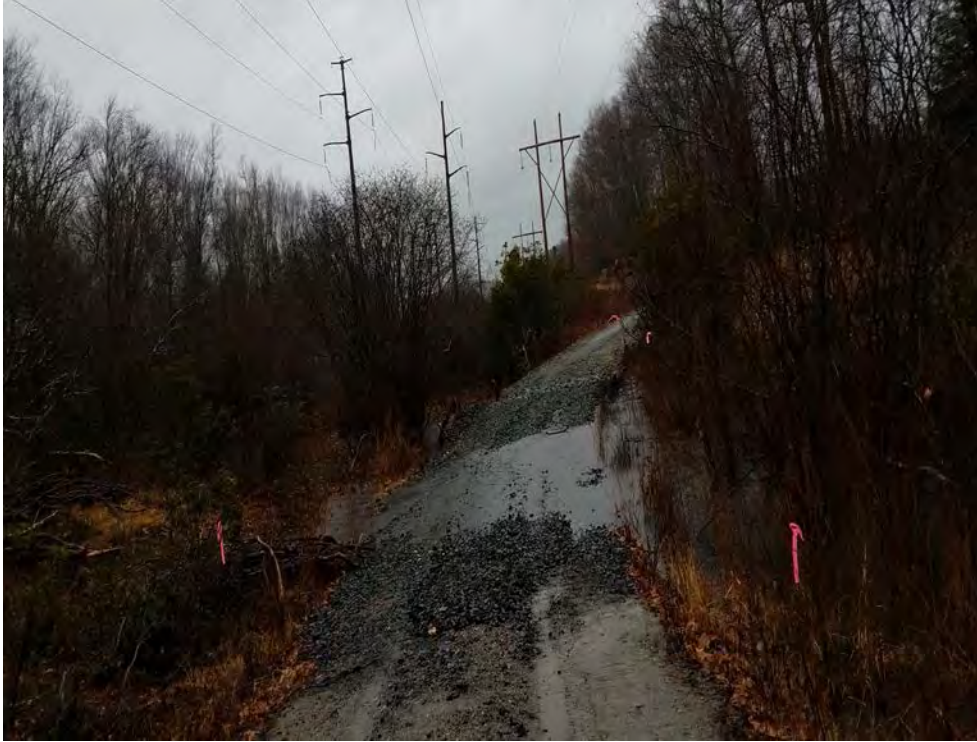
Water Crossings	Interim Week	<p>Hard Bottom crossing at S-E3 (Wetland W-E2, Between Str71 & Str72, Thomaston, Map 25) needs to be reconstructed so as to allow stream to flow through without deviation (see Photos 1 and 2). The existing construction is minimally functional and is not adequate for the existing flow or for higher volumes that the area may encounter during a long durational rainfall events.</p>		PENDING
	Bi-Week	<p>None observed at the time of this inspection event due to heavy snow covering the ROW.</p>	N/A

Photo 1: 03/02/2018, Thomaston: Map 25, S-E3 crossing between Str71 and Str72, Photo taken facing south towards Str71, Water overflowing access road approximately 20-feet north of the constructed crossing.

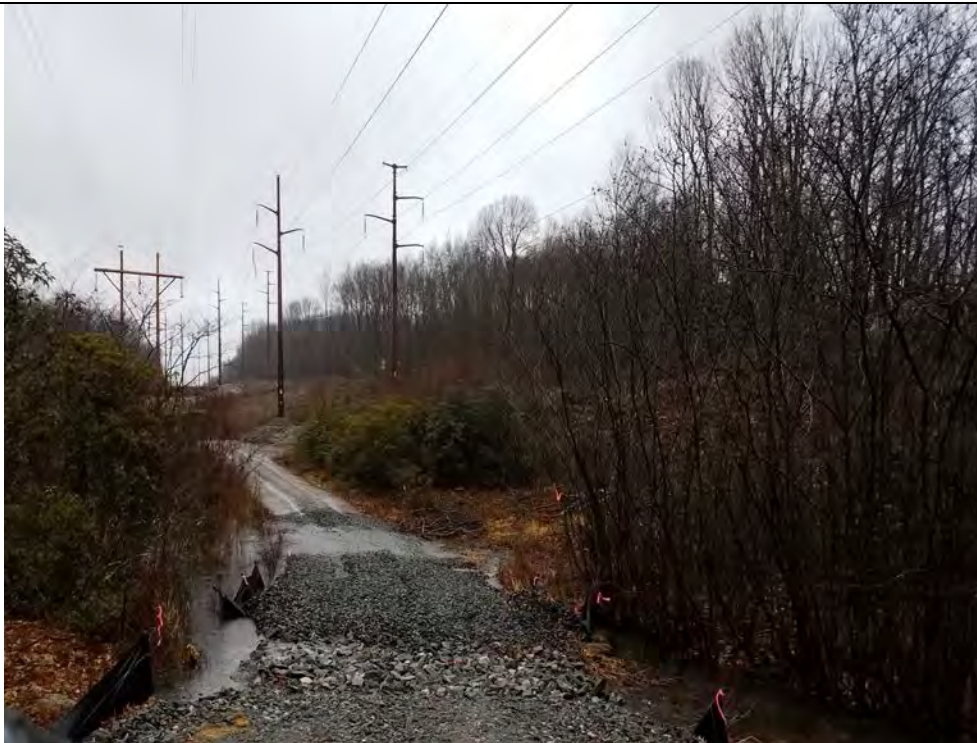
Photo 2: 03/02/2018, Thomaston: Map 25, S-E3 crossing between Str71 and Str72, Photo taken facing north towards Str72, water overflowing access road approximately 20-feet south of the constructed crossing.
