**Subject: Docket No. 466, Frost Bridge to Campville 115-kV Project  
Decision and Order Condition #4 – Independent Environmental Inspector Report**

Please find enclosed the Biweekly Independent Environmental Inspector Report, Report #40, for the **June 7**, and **June 15, 2018**, inspection events for the construction of the Eversource Frost Bridge to Campville 115-kV Project.

**Docket No. 466- Development and Management Plan Inspection**

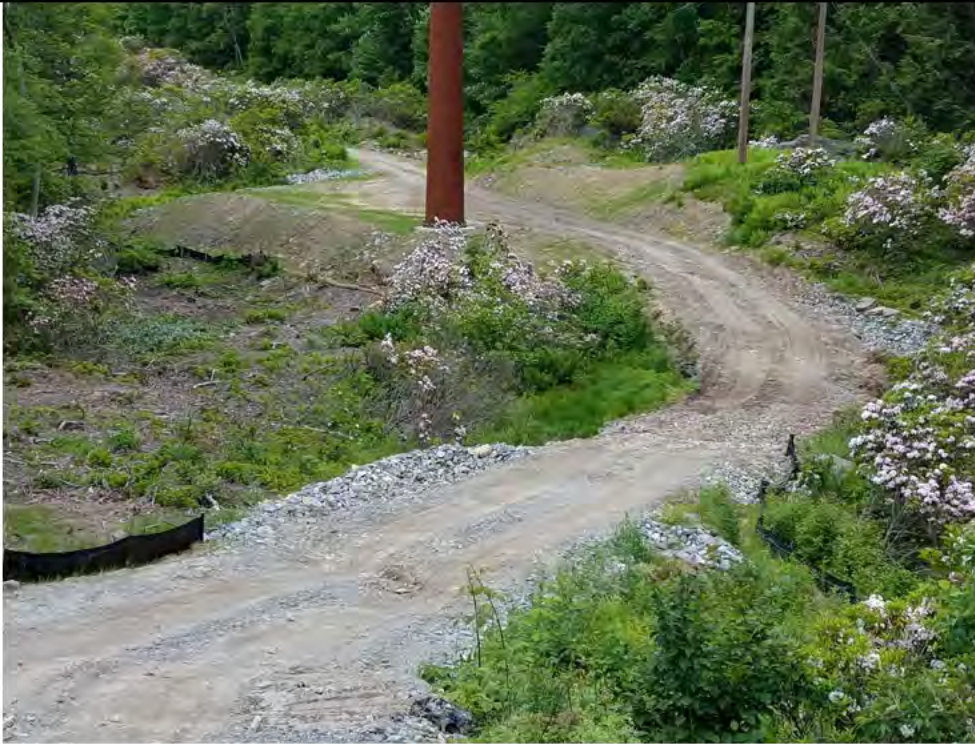
Photo 1: 06/15/2018, Watertown: Map 14, Wetland/Vernal Pool W-C20/VP-C20-1, timber mat crossing removed, stone access road graded, water bars & sediment traps cleaned out, and existing silt fence sections repaired.

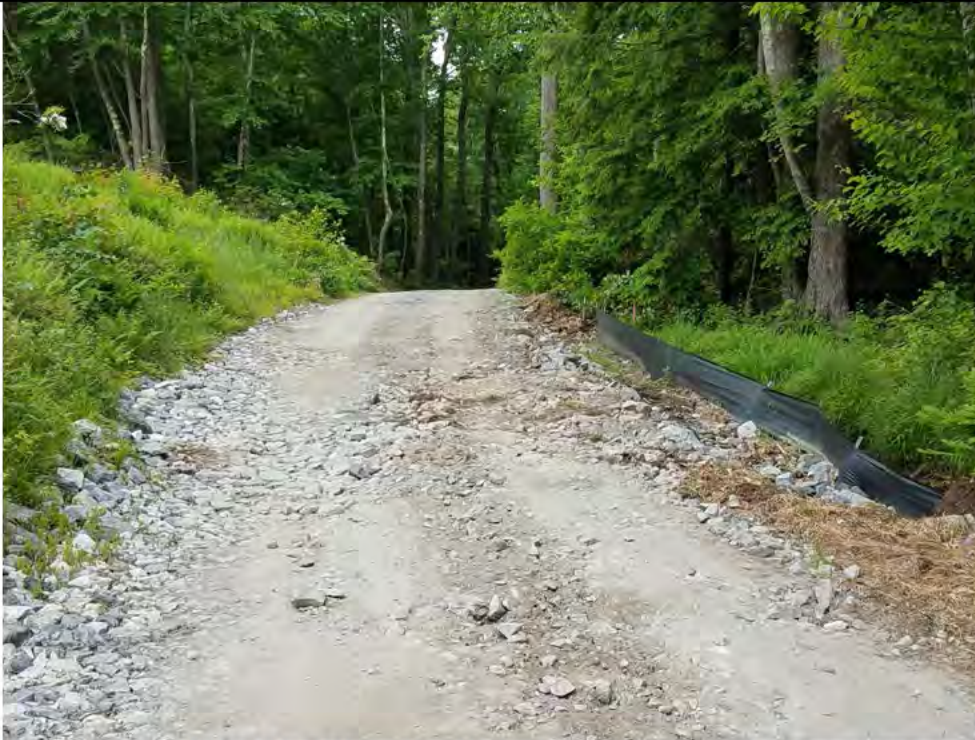
Photo 2: 06/15/2018, Watertown: Map 13, Wetland W-C18, timber mats removed, stone access road graded, and silt fence repaired. No visible impacts to wetland observed.

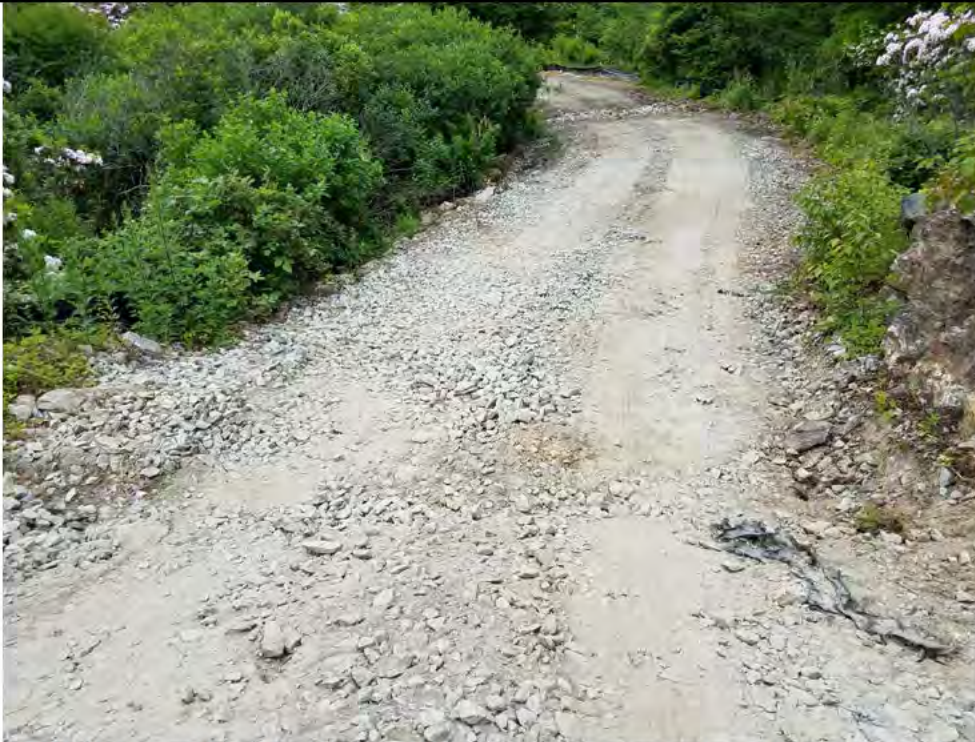
Photo 3: 06/15/2018, Watertown: Map 12, Wetland W-C15, stone access road graded, sections of silt fence removed (as instructed), full veg growth, area deemed stabilized, no soil movement around the area of the wetland. No visible impacts to the wetland.

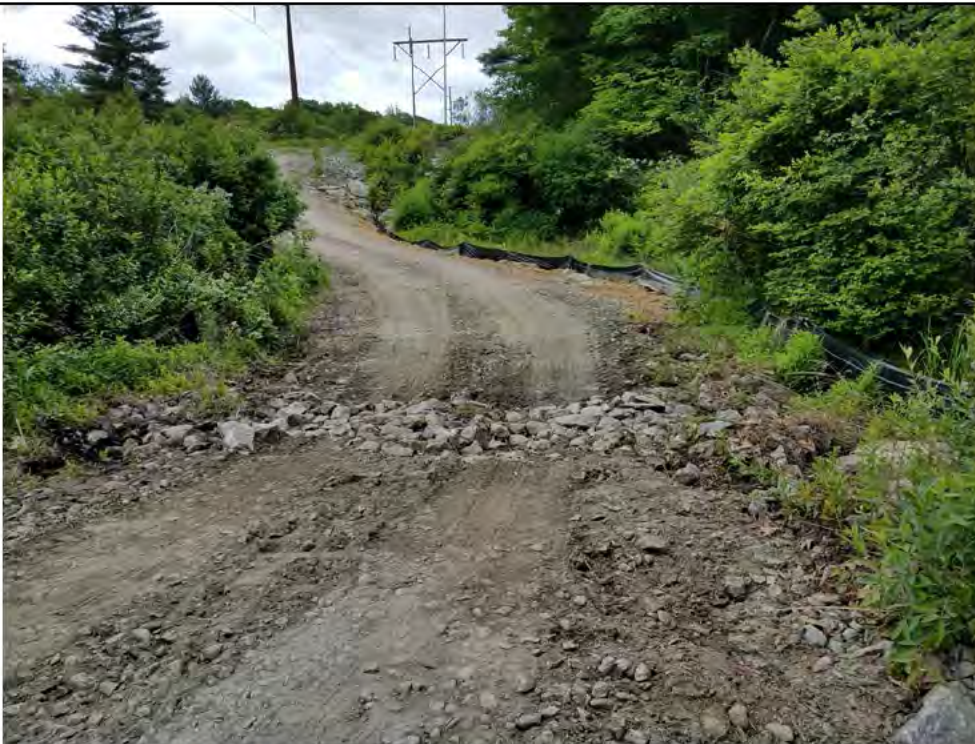
Photo 4: 06/15/2018, Watertown: Map 12, watercourse S-C15, timber mat crossing removed, stone hard bottom crossing improved, stone access road graded, and existing silt fence repaired.

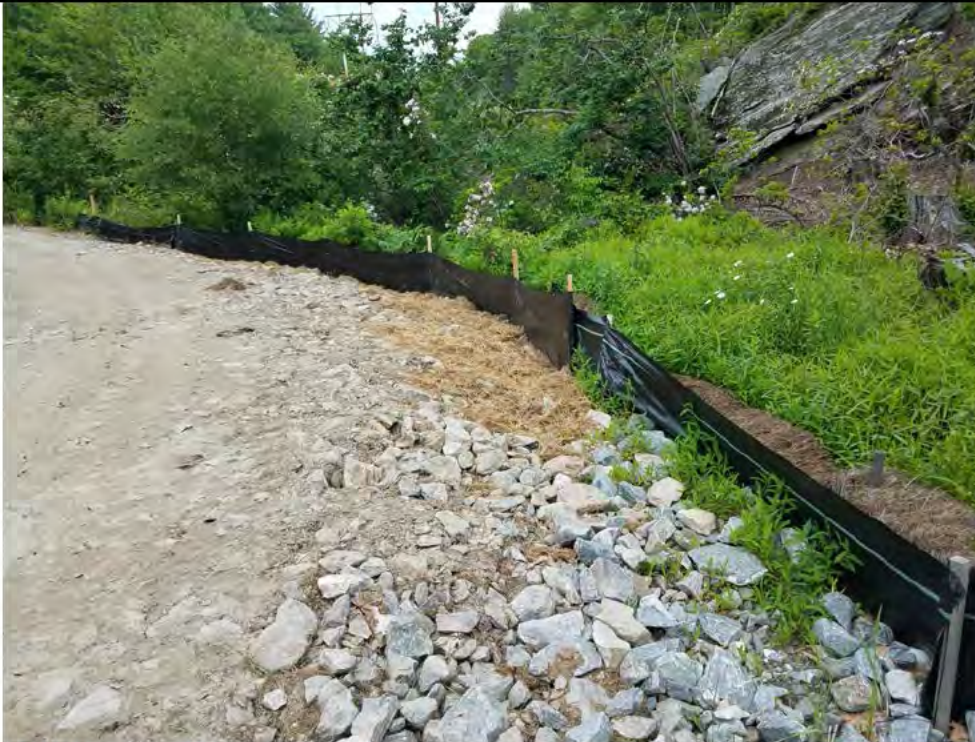
Photo 5: 06/15/2018, Watertown: Map 12, area of watercourse S-C4 and south end of W-C15, stone access road graded and improved, silt fence repaired and/or replaced, deteriorated hay bale/s appropriately distributed and utilized for stabilization of disturbed/exposed ground surface. No visible impacts to watercourse or wetland observed.

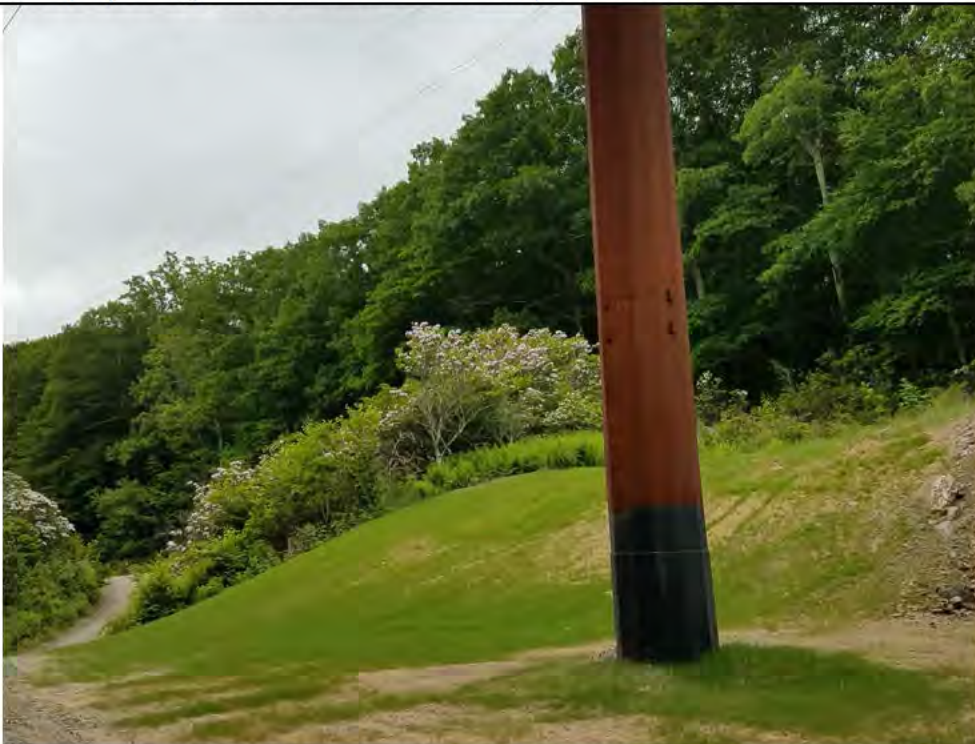
Photo 6: 06/15/2018, Watertown: Map 12, Str33, upland slope and pad, veg growth following hydroseed application approximately 2 weeks prior.

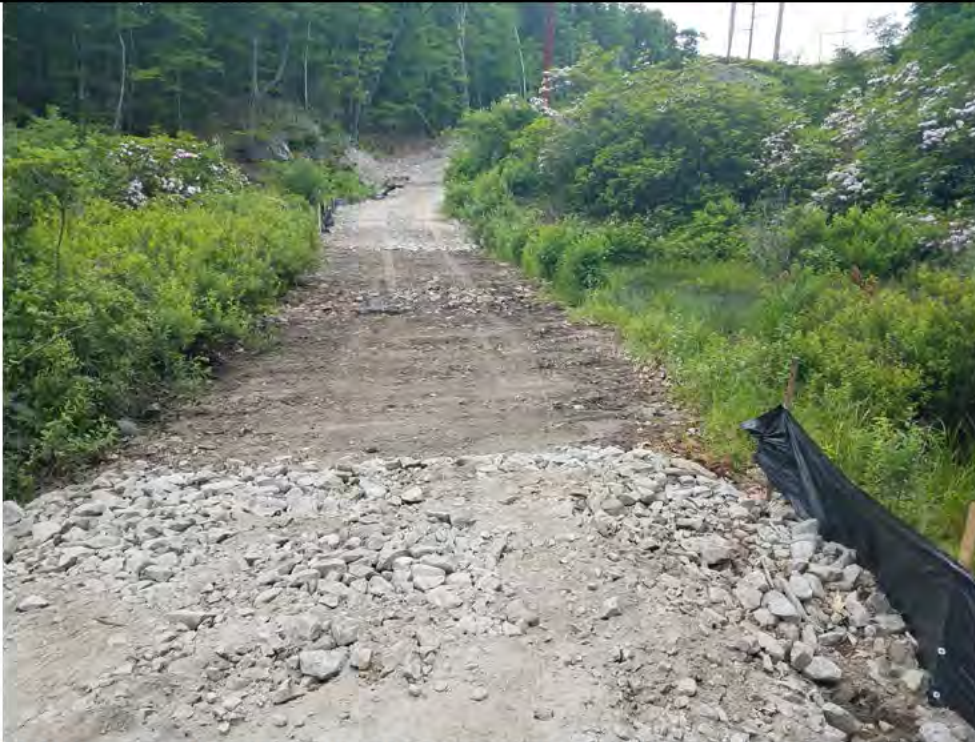
Photo 7: 06/15/2018, Watertown: Map 11, wetland/vernal pool W-C12/VP-C12-1, timber mat crossing removed, access road graded, and existing silt fence repaired. No visible impacts to wetland or vernal pool observed.

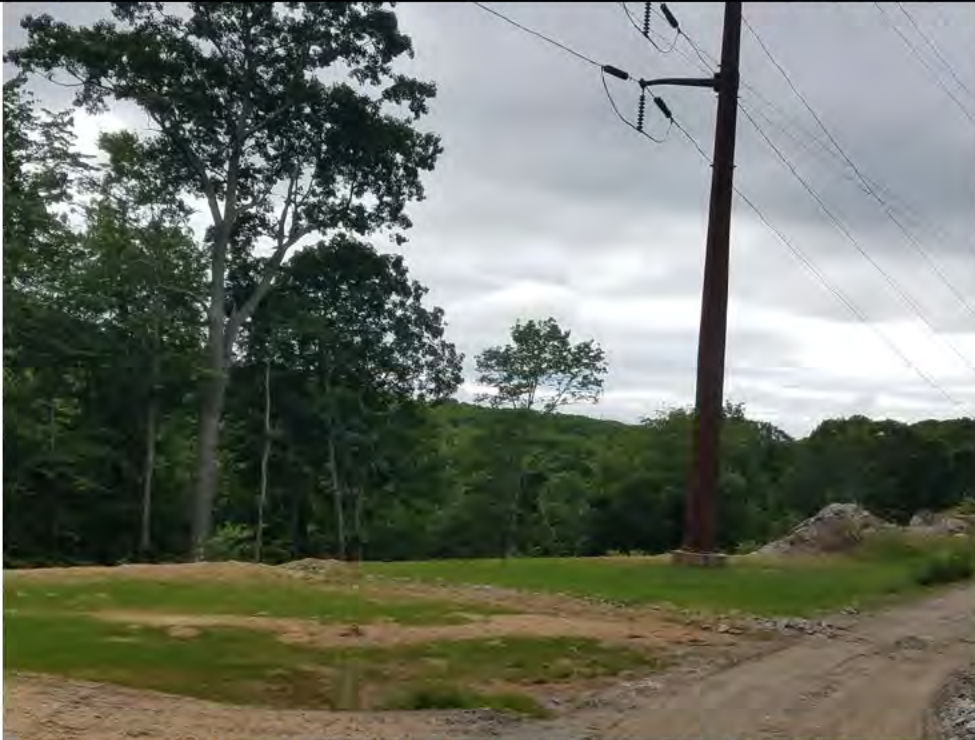
Photo 8: 06/15/2018, Watertown: Map 10, Str28/Str27 work pads, veg growth following hydroseed application approximately 2 weeks prior after regrading and drainage improvements. Access road graded and silt fence removed (as instructed) abutting wetland W-C3 (to the left, out of view in photo).

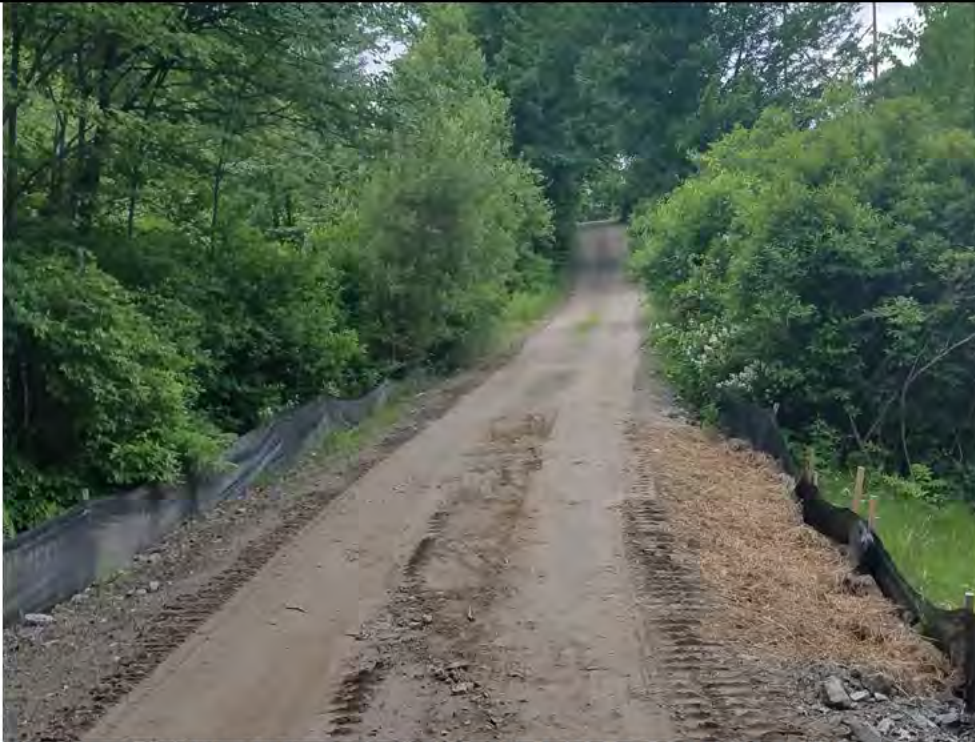
Photo 9: 06/15/2018, Watertown: Map 09A, access road to Str24-Str46 off of High Meadow Road, timber mats removed prior to last fall's winter shut down, silt fence repaired, hay mulch placed in disturbed ground area abutting wetland W-C2A.
