**Subject: Docket No. 466, Frost Bridge to Campville 115-kV Project
Decision and Order Condition #4 – Independent Environmental Inspector Report**

Please find enclosed the Biweekly Independent Environmental Inspector Report, Report #28, for the **December 22nd** and **December 28th, 2017**, inspection events for the construction of the Eversource Frost Bridge to Campville 115-kV Project.

Photograph Log Frost Bridge to Campville 115kV Project

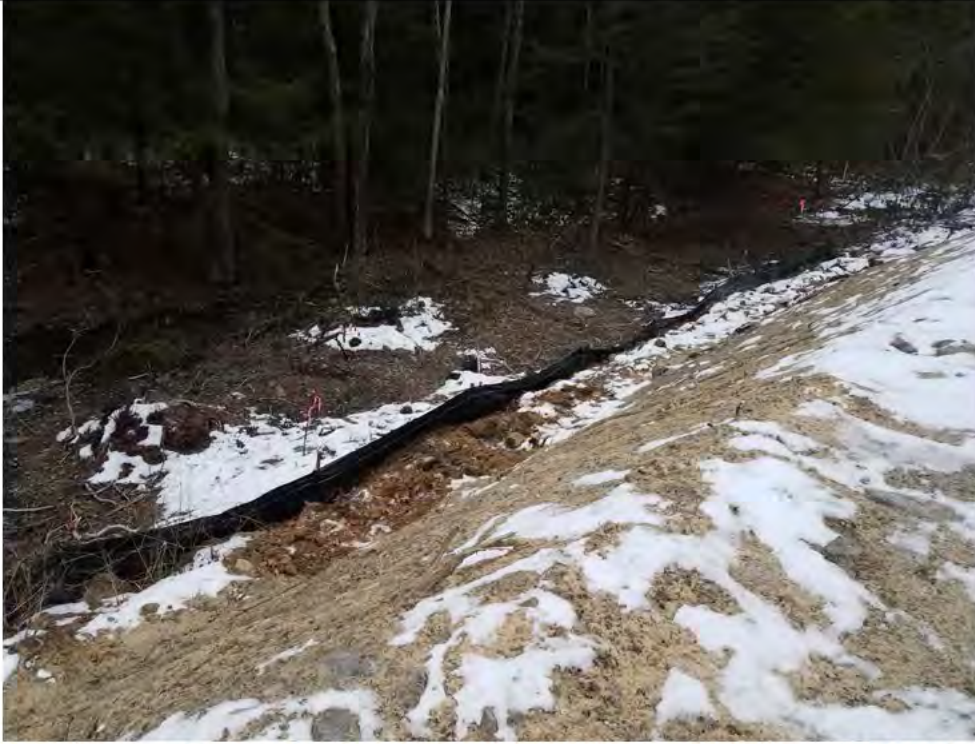
Photo 1: 12/22/2017, Watertown: Map14, CORRECTIVE ACTION- Str39, Silt fence repaired at toe of slope

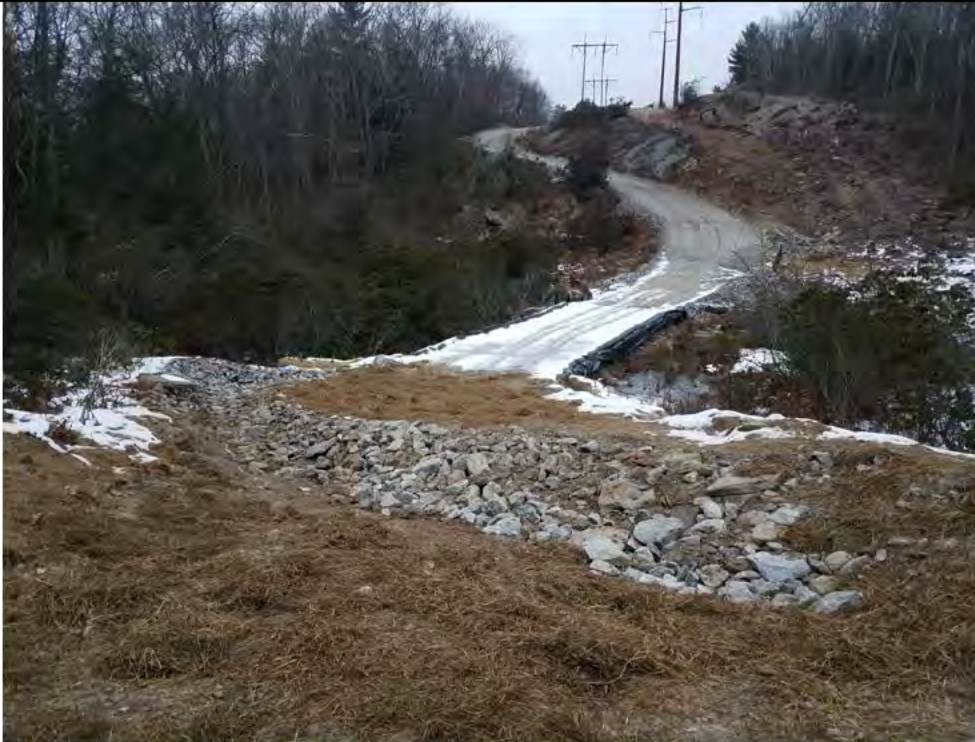
Photo 2: 12/22/2017, Watertown: Map14, CORRECTIVE ACTION- Upland of W-C20/VP-C20-1, access road grading, construction of stone filled water bar, and straw mulch for stabilization.

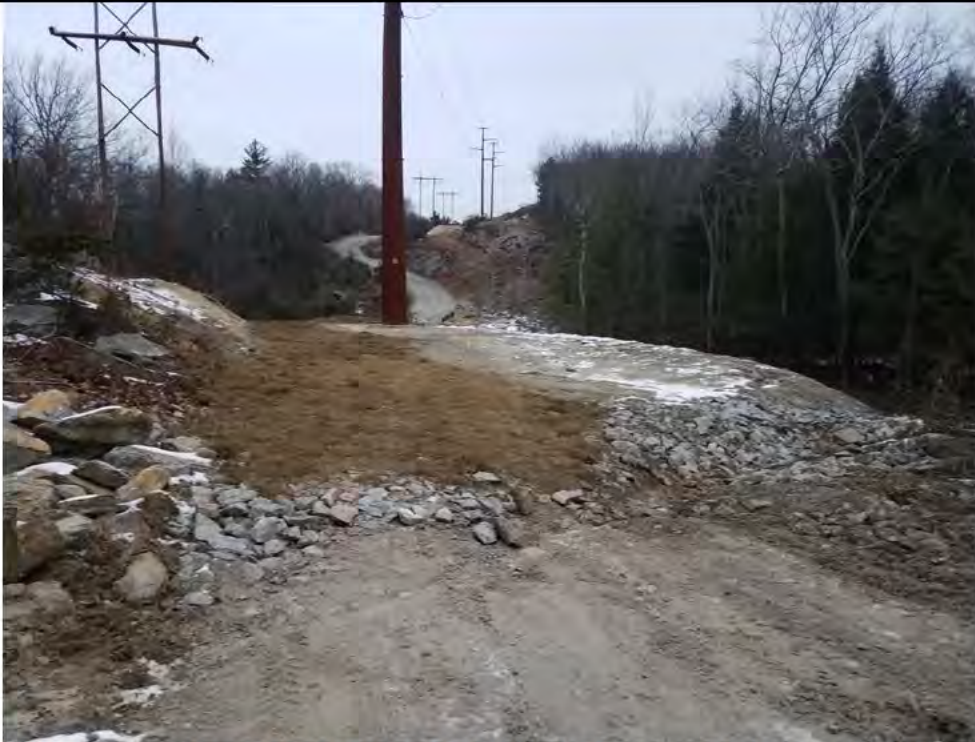
Photo 3: 12/22/2017, Watertown: Map14, CORRECTIVE ACTION-Str39 pad, graded pad, added straw mulch for stabilization, reformed water bar, lined water bar with stone.

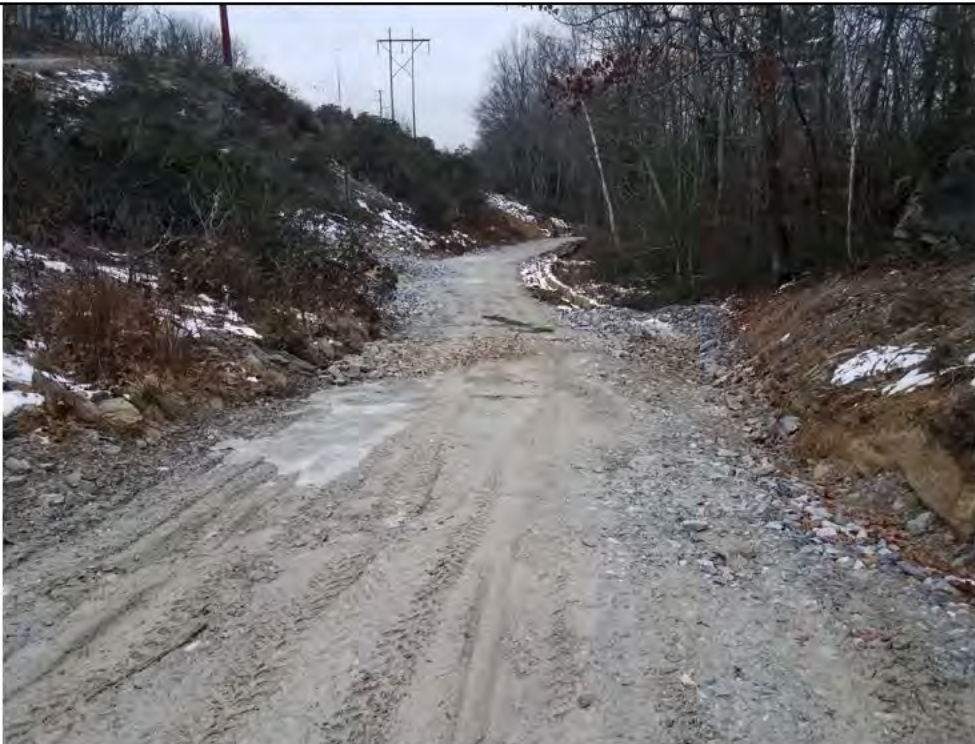
Photo 4: 12/22/2017, Watertown: Map14, CORRECTIVE ACTION- Access road between Str38 and Str39 graded, water bar and drainage swale reformed.

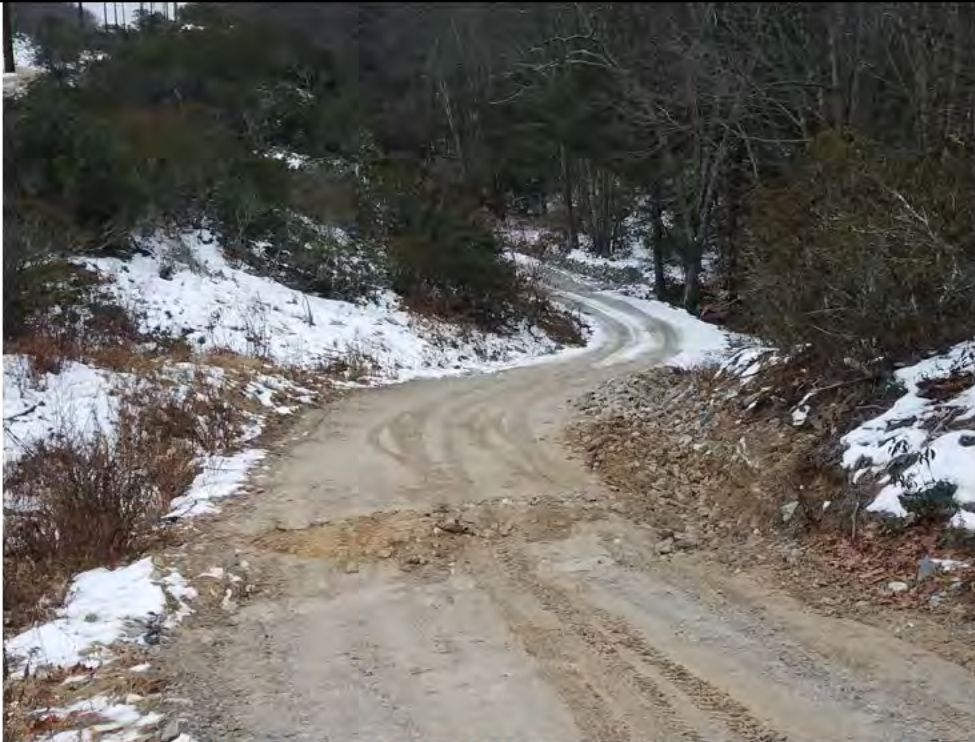
Photo 5: 12/22/2017, Watertown: Map12, CORRECTIVE ACTION- Access road between Str34 and Str35, graded access road, reformed water bar, and cleaned drainage swale.

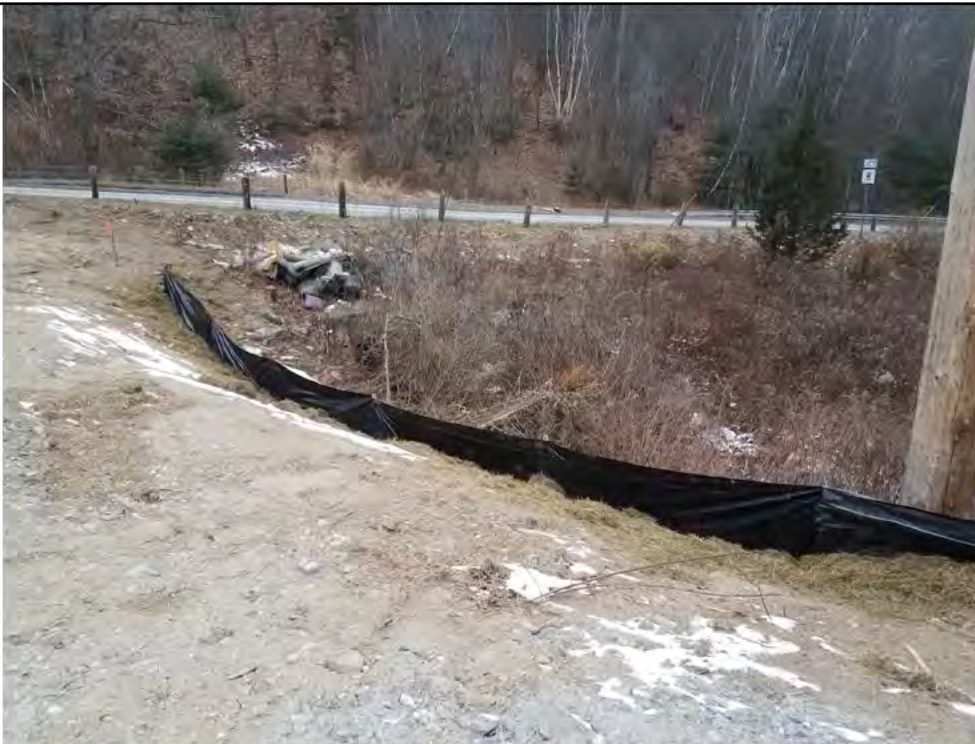
Photo 6: 12/22/2017, Watertown: Map 1, Installed silt fence at north corner of pad abutting watercourse S-A1.

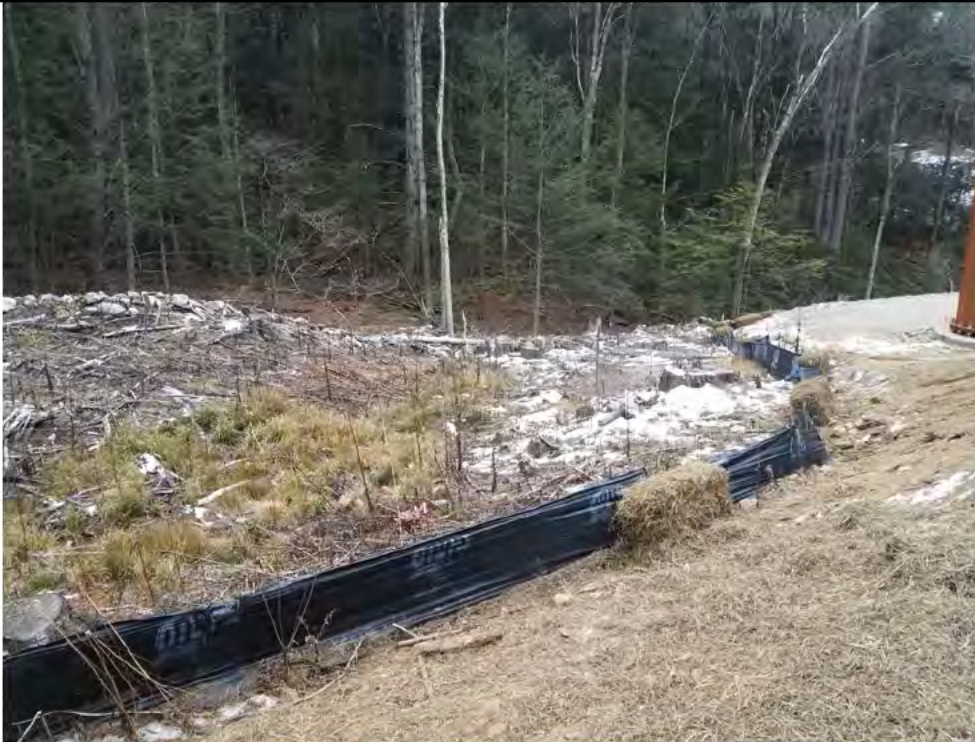
Photo 7: 12/22/2017, Harwinton: Map 32, **CORRECTIVE ACTION**- At edge of Str87 pad and W-F12/S-F11, repaired silt fence and added hay bales.

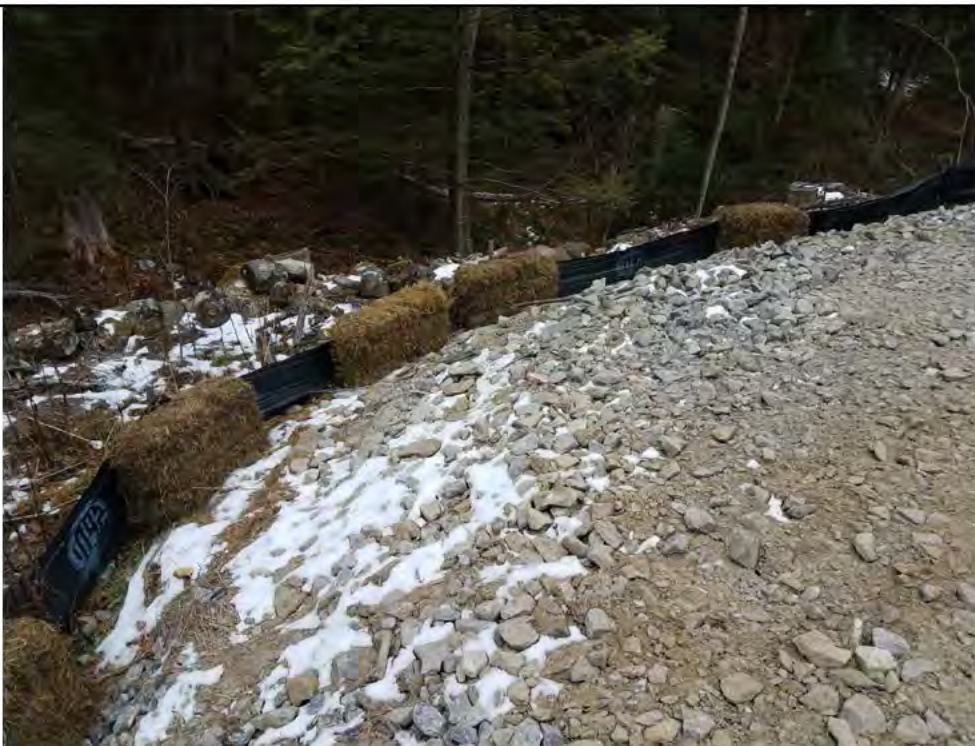
Photo 8: 12/22/2017, Harwinton: Map 32, **CORRECTIVE ACTION**- At edge of Str87 pad and S-F11/S-F10/W-F11, repaired silt fence and added hay bales.

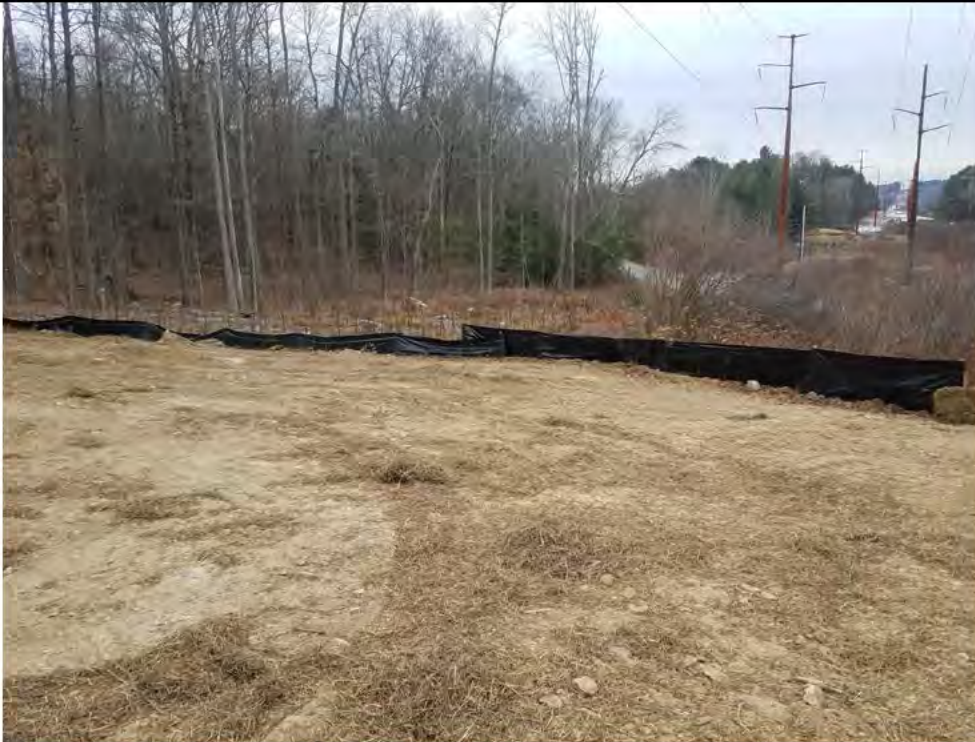
Photo 9: 12/22/2017, Harwinton: Map 35, CORRECTIVE ACTION- South edge of Str96 pad, repaired silt fence and added approximately 20' of new silt fence.

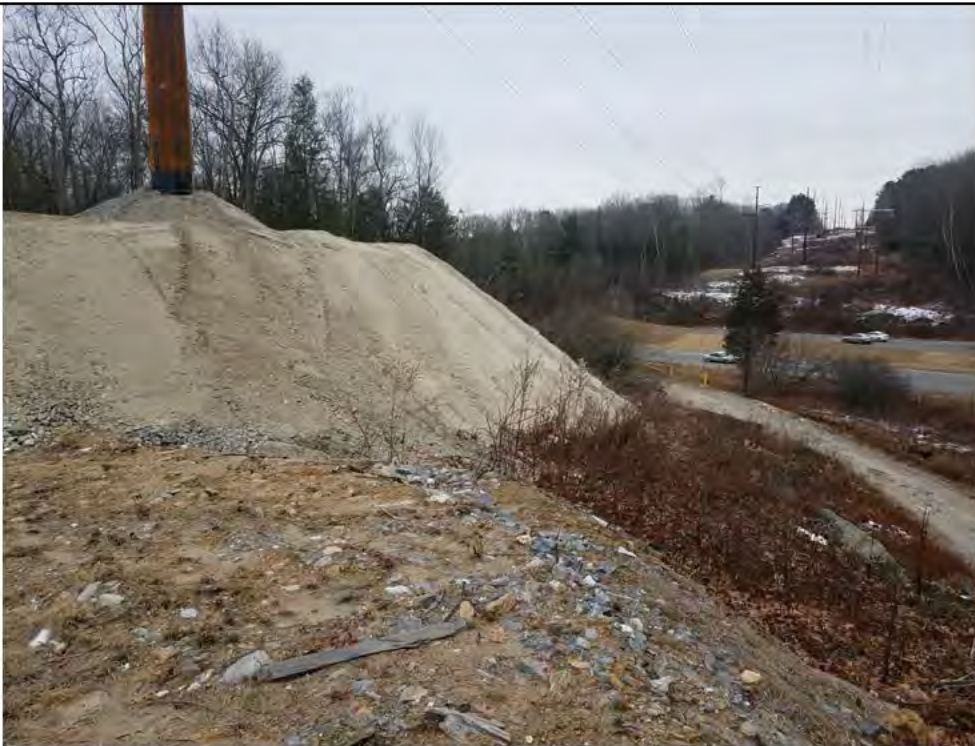
Photo 10: 12/22/2017, Litchfield: Map 30, Str85, restoration started, slope stabilization required.

Erosion and Sedimentation Controls	Interim Week	<p>All E&S controls are compliant in the areas inspected today. Photos of corrective action are provided as part of this report (see Photos).</p> <p>-Silt fence at toe of slope of the pad at Str39 has been repaired.</p> <p>-Access road at Str39 to W-C20 has been graded, water bars constructed, straw mulch placed and vehicle access restricted.</p> <p>-Access road between Str38 and Str39 has reformed water bars and</p>	<p>the sediment basin cleared.</p> <p>-The access road, water bars, and rip-rap swale have been repaired between Str36 and Str37.</p> <p>-The Silt fence has been repaired, access road graded, and water bars reformed in the area of W-C14.</p> <p>-A new line of silt fence has been installed at the north</p>	<p>corner of Str2 near S-A1.</p> <p>-Silt fence has been repaired and/or replaced at Str87 and W-F11/S-F10.</p> <p>-Silt fence repaired and extended at Str96.</p> <p>-Restoration completed at Str86, Str3236, and Str3171.</p> <p>-Slope stabilization needed at Str85 (see Photos)</p>

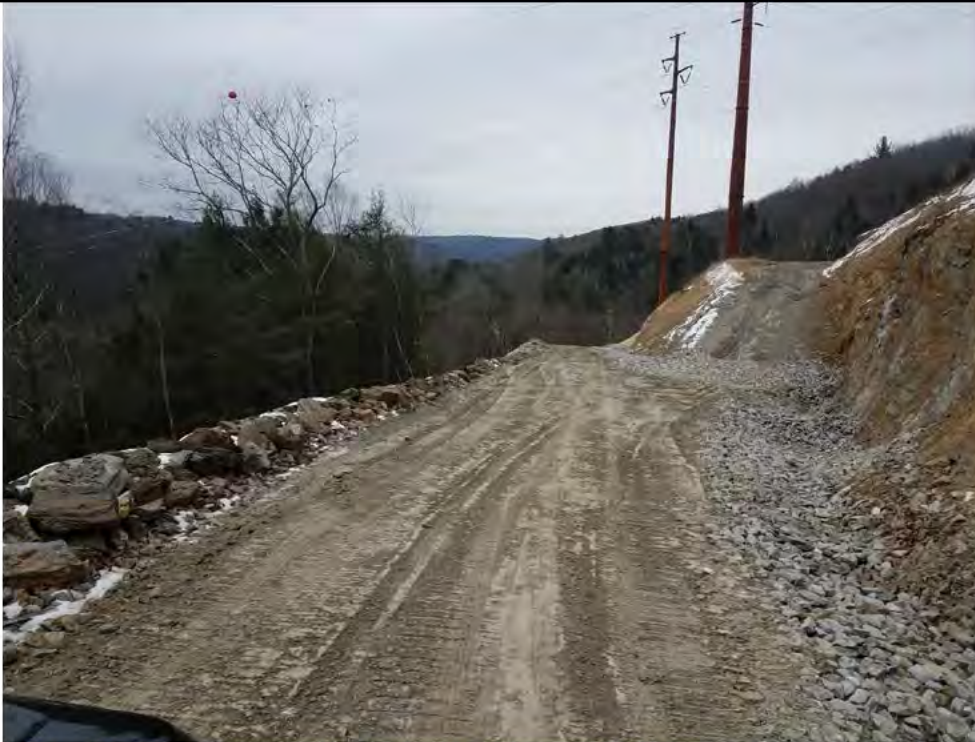
Photo 11: 12/22/2017, Litchfield: Access road to Str86, Str3236, and Str3171, graded, and stone filled drainage swale.

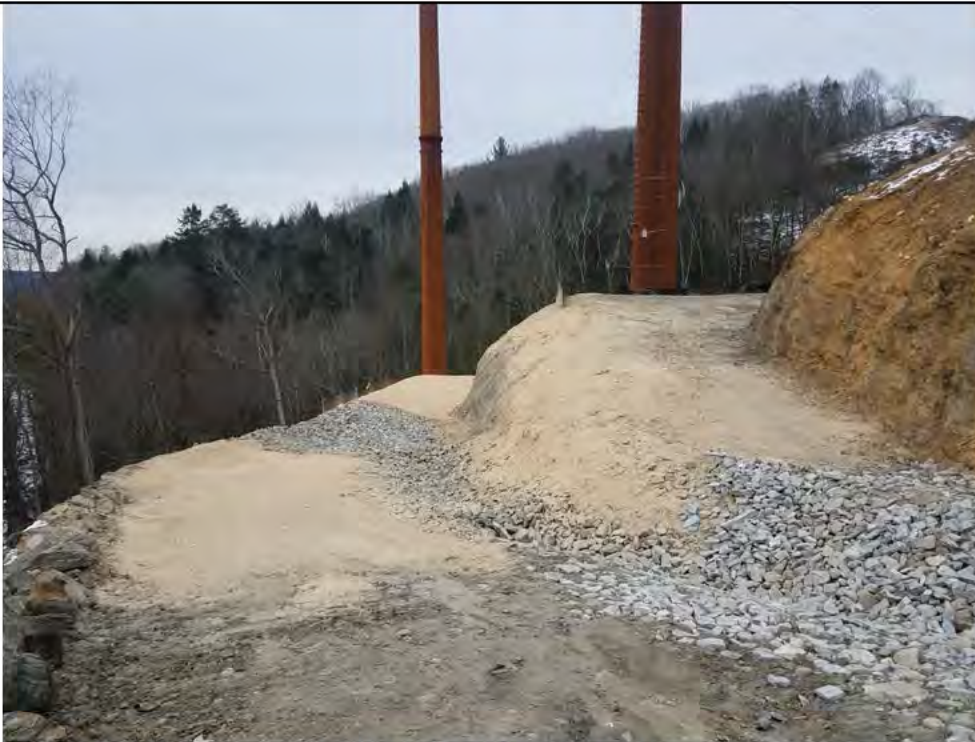
Photo 12: 12/22/2017, Litchfield: Access road to Str86, Str3236, and Str3171, restoration of slope and pad surfaces, area stabilized with hydroseed, stone filled drainage swale.

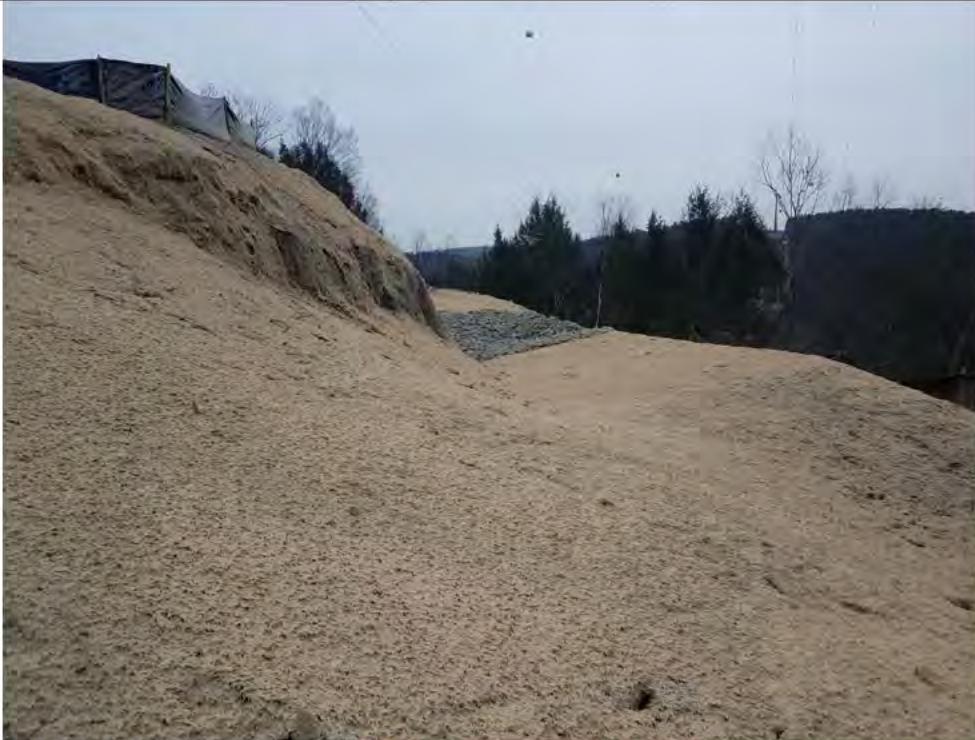
Photo 13: 12/22/2017, Litchfield: Str86, Str3236, and Str3171, restoration of slope and pad surfaces, area stabilized with hydroseed.

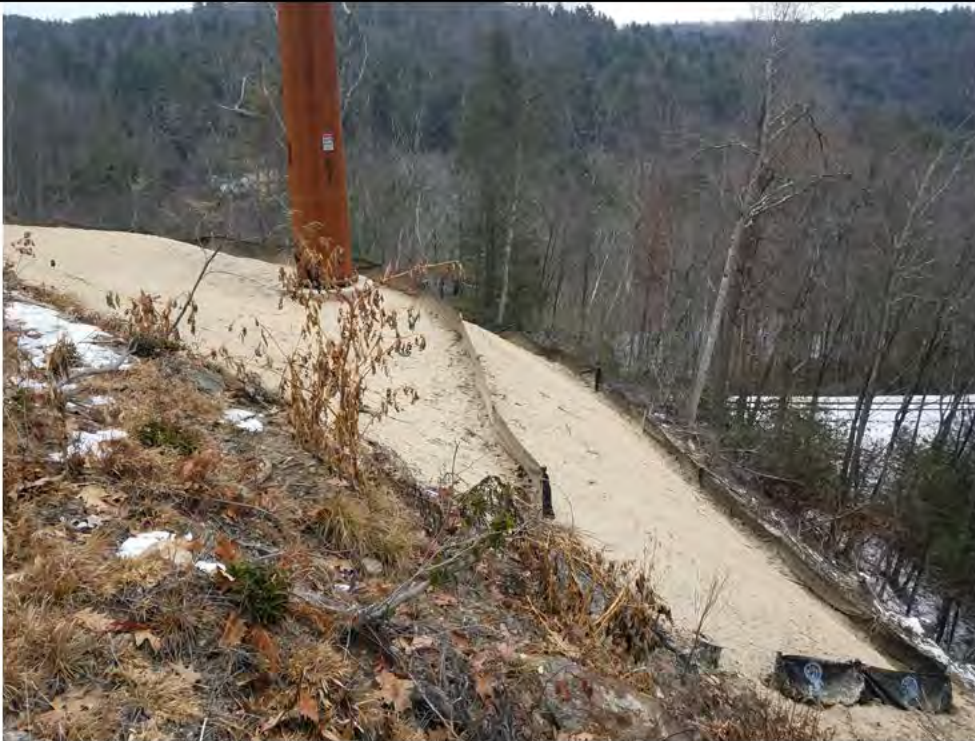
Photo 14: 12/22/2017, Litchfield: Str86, Str3236, and Str3171, restoration of slope and pad surfaces, area stabilized with hydroseed, installation of silt fence.

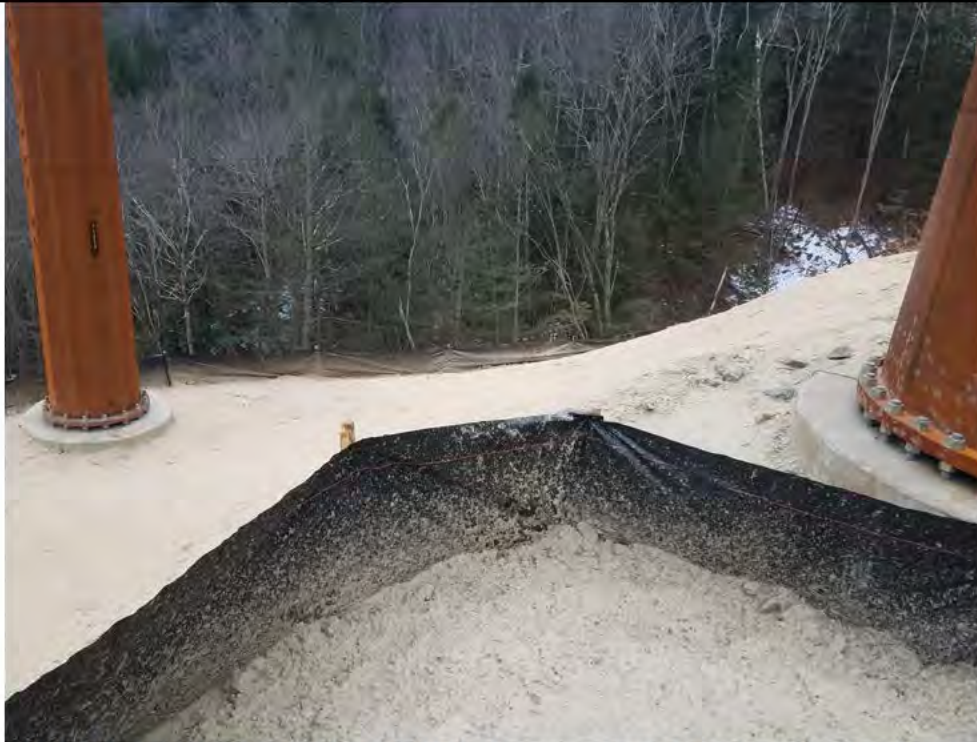
Photo 15: 12/22/2017, Litchfield: Str86, Str3236, and Str3171, restoration of slope and pad surfaces, area stabilized with hydroseed, installation of silt fence.

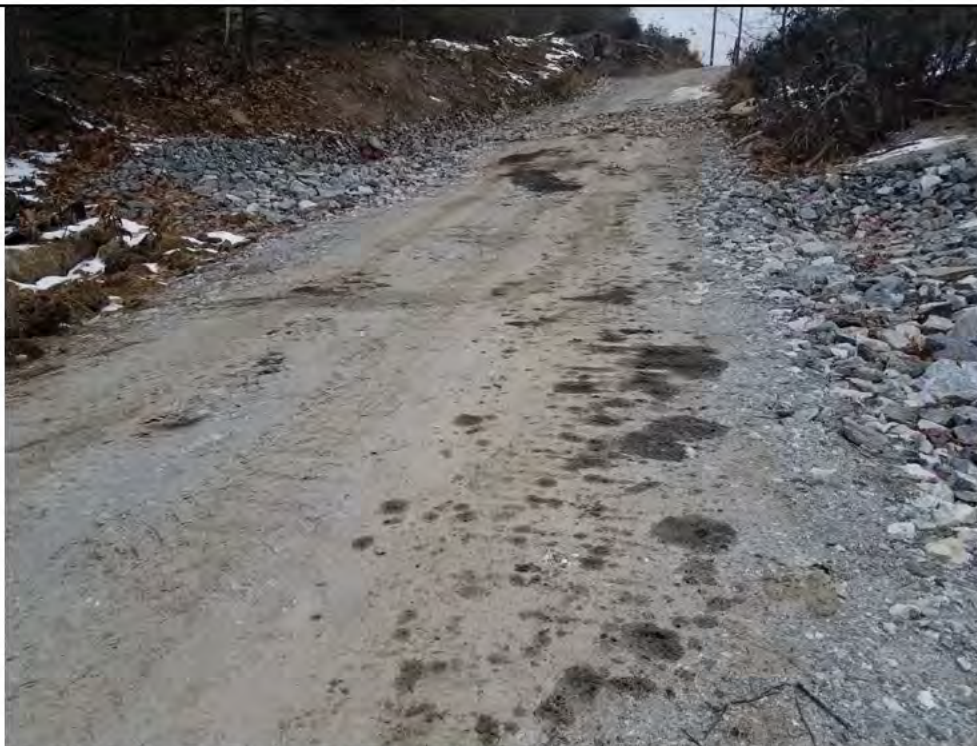
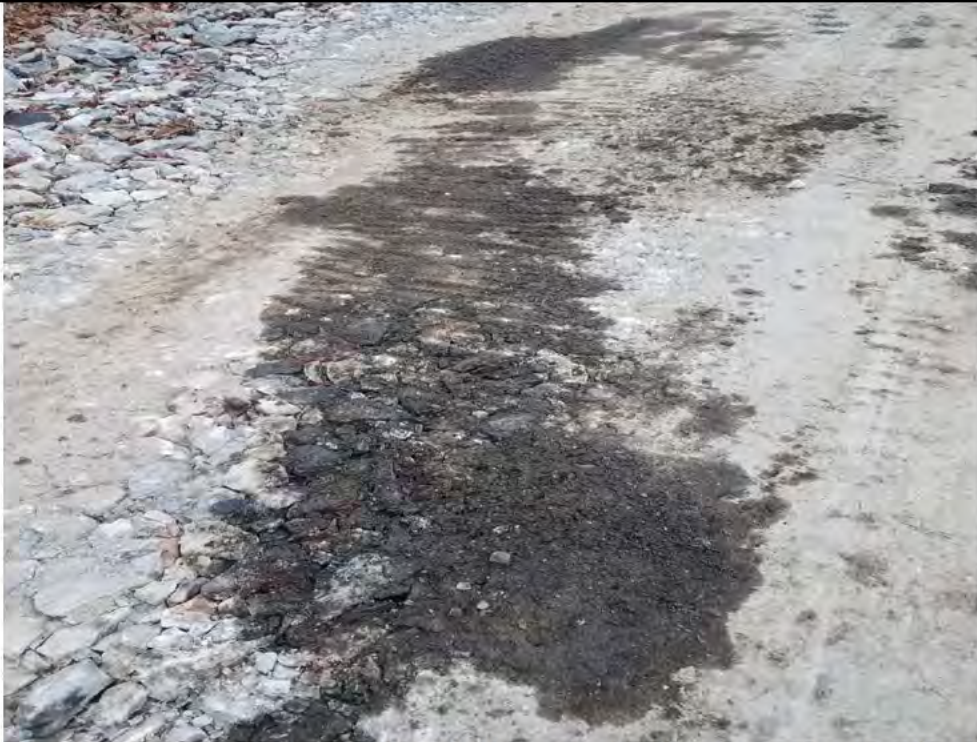
A hydraulic oil release was observed and reported to the construction manager. The cleanup occurred the same day and the release was phoned into the CTDEEP and a spill number was generated.

Photo 16: 12/22/2017, Watertown: Hydraulic oil release to the ground surface (access road) in the area of Str37.

Photo 17: 12/22/2017, Watertown: Hydraulic oil release to the ground surface (access road) in the area of Str37.

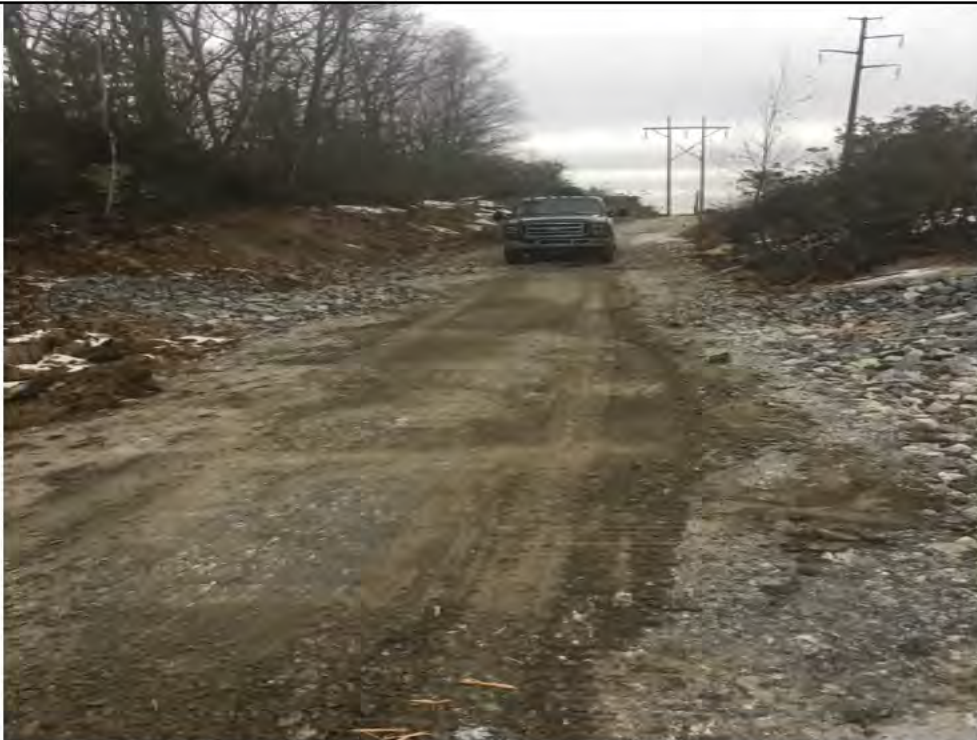
Photo 18: 12/22/2017, Watertown: **CORRECTIVE ACTION**- Spill cleanup completed by BluRoc, Hydraulic oil release to the ground surface (access road) in the area of Str37 was removed and transported off site for disposal. Spill was reported to CT DEEP and Spill number 2017-6625 was provided.

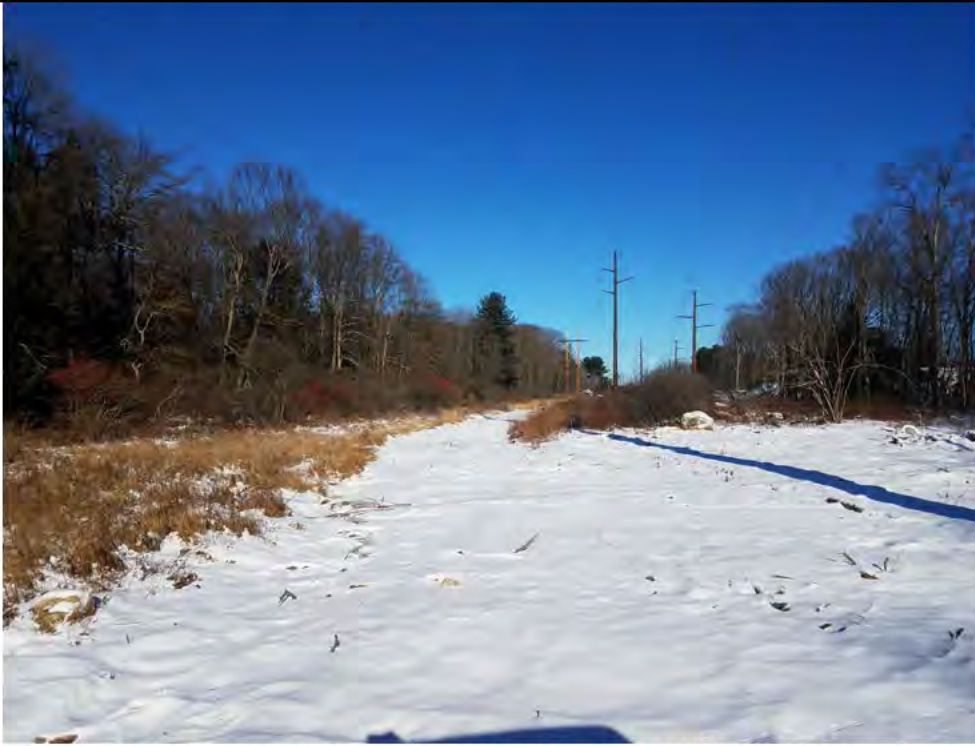
Water Crossings	Interim Week	<p>Timber mat crossings appear clean and maintained.</p> <p>The silt fence south of the culvert replacement area at W-F11 (south of Str87) was repaired and installed according to BMPs.</p>	N/A	<p>Timber mats were cleared of excess sediments.</p>
	Bi-Week	<p>Snow and ice covered. Restricted access to most areas.</p> <p>Timber mat road removed from W-E10 and W-F7/VP-E9-1 areas. See Photo 19.</p>	N/A	N/A

Photo 19: 12/28/2017, Litchfield: Map 28, W-E10, timber mat road and pads (Str78-Str80) removed, snow and ice covered wetland area.
