**Subject: Docket No. 466, Frost Bridge to Campville 115-kV Project
Decision and Order Condition #4 – Independent Environmental Inspector Report**

Please find enclosed the biweekly Independent Environmental Inspector Report, Report #3, for the **Januaryth** and **January 26th 2017**, inspection events for the construction of the Eversource Frost Bridge to Campville 115-kV Project.

Docket No. 466- Development and Management Plan Inspection

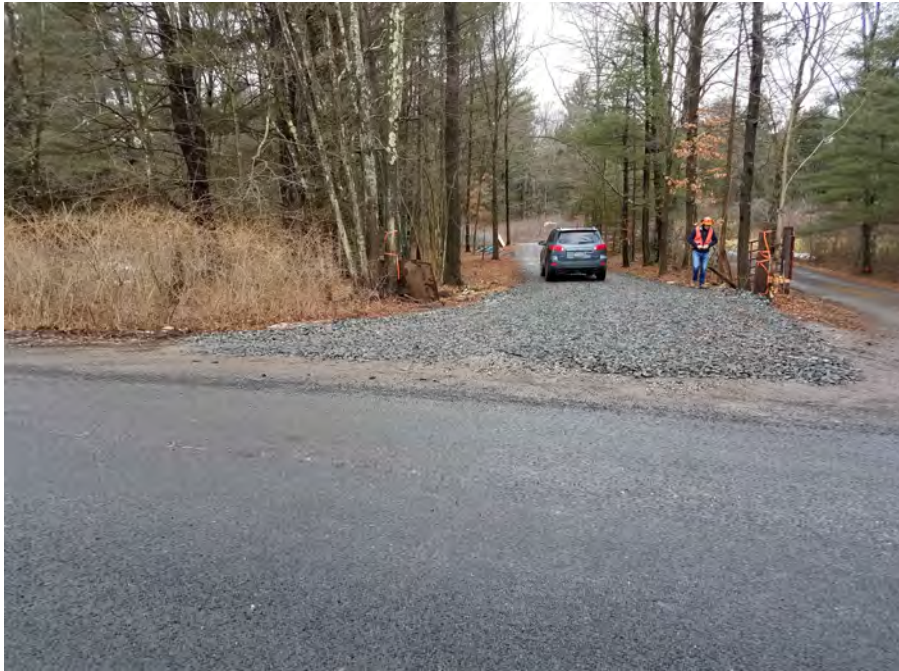
Photo #1: 1/19/17, Harwinton: Stone apron at access road entrance to Str94-Str88

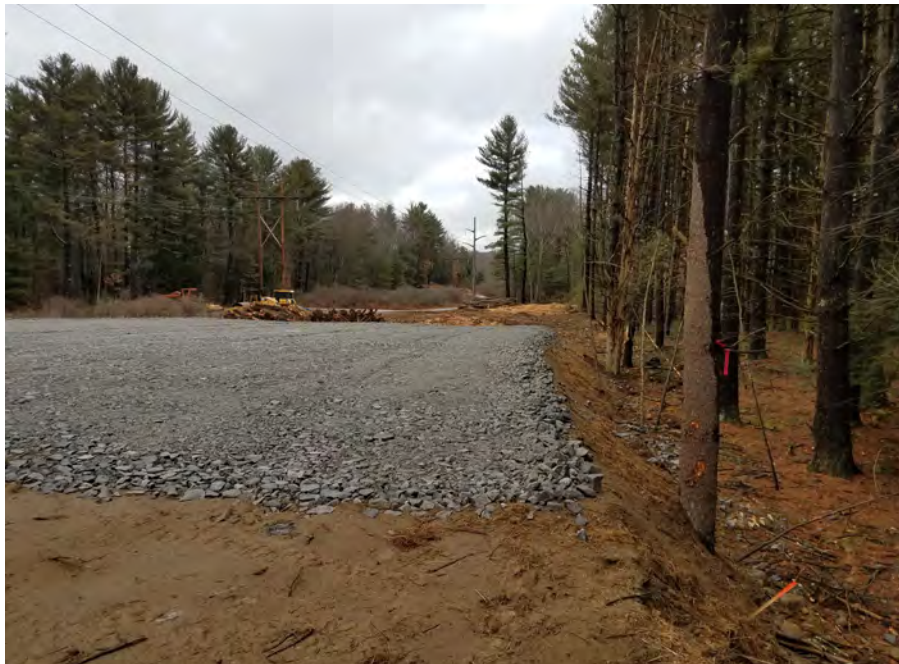
Photo #2: 1/19/17, Harwinton: Str92 pad, completed

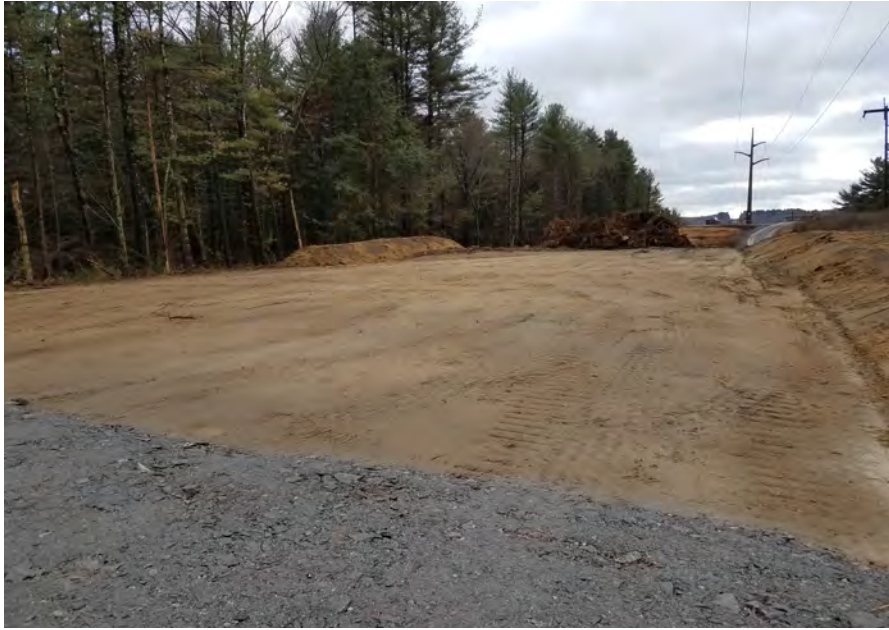
Photo #3 1/19/17, Harwinton: Pull pad between Str92 and Str91 construction:

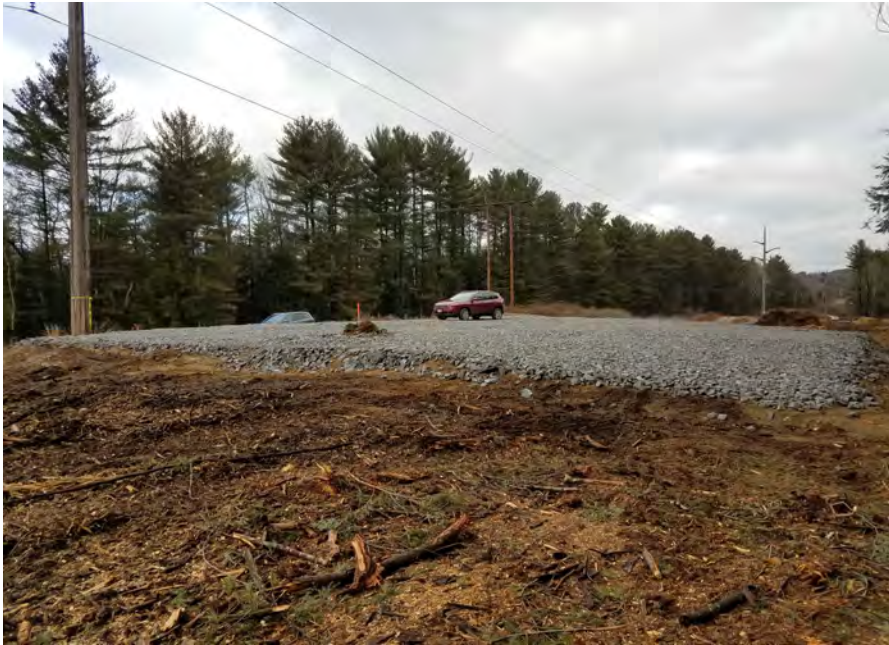
Photo #4:1/19/17, Harwinton: Str91 pad completed

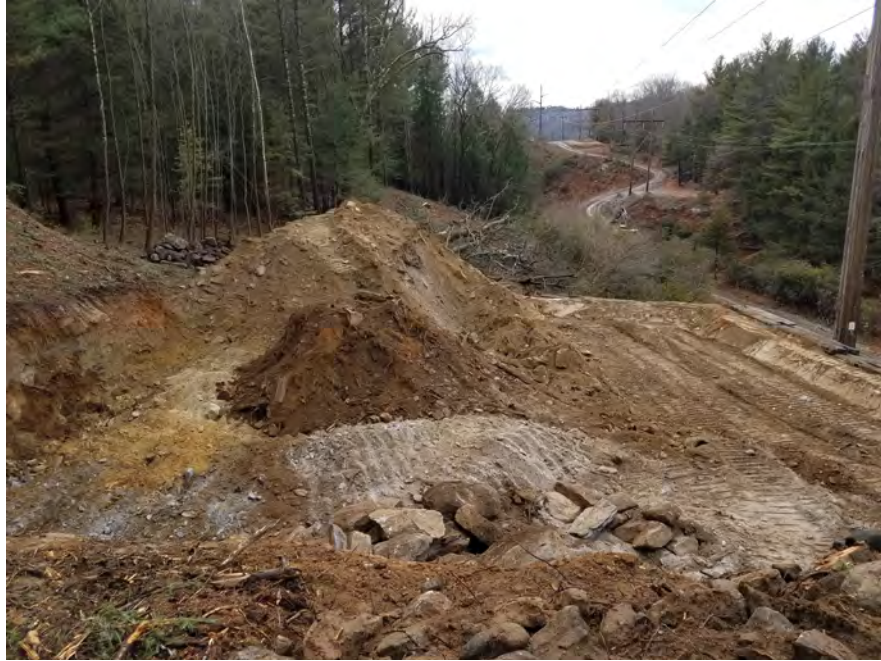
Photo #5:1/19/17, Harwinton: Str90 pad construction, soil and rock removal

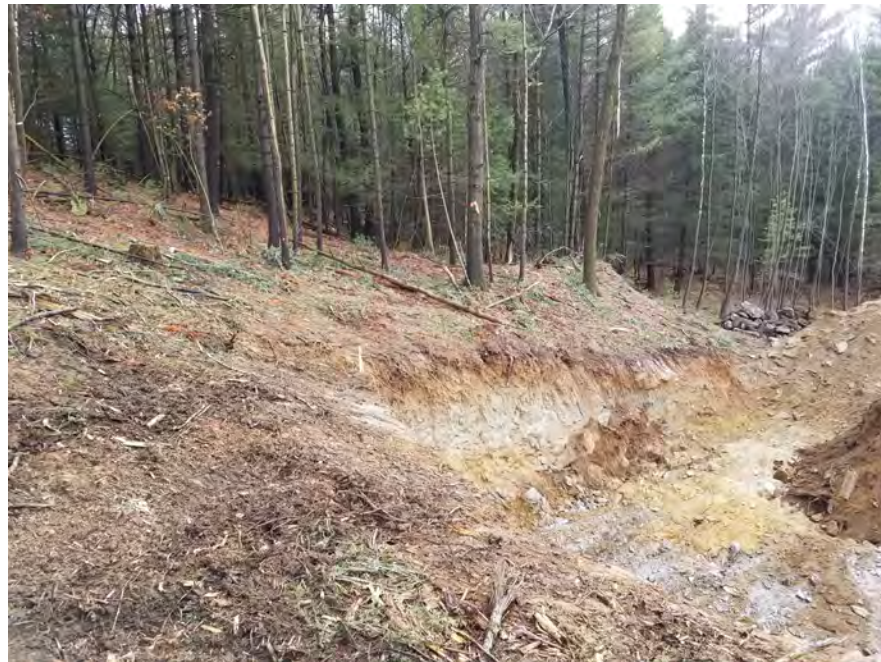
Photo #6:1/19/17, Harwinton: Str90 Pad construction prep

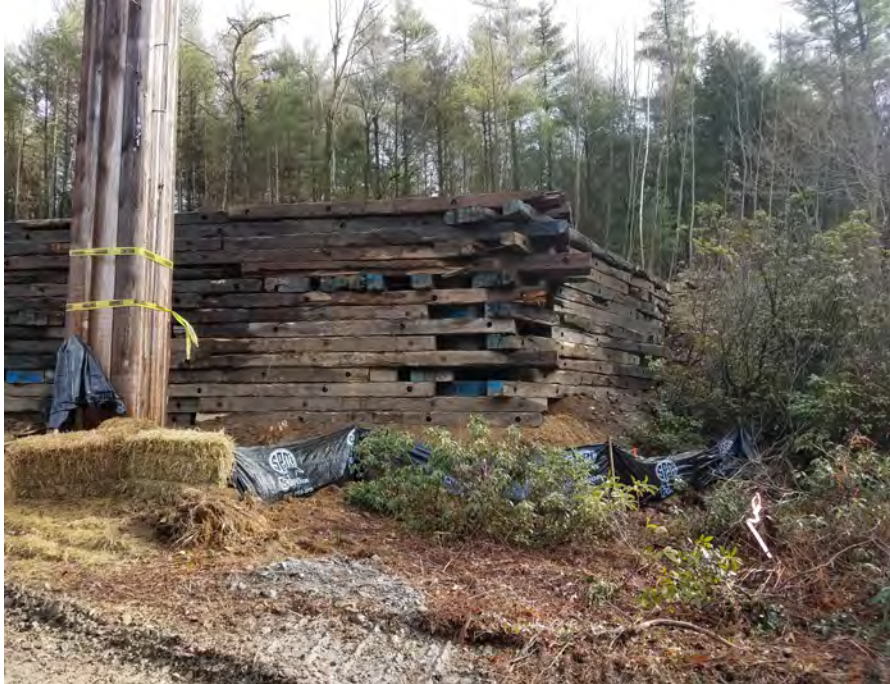
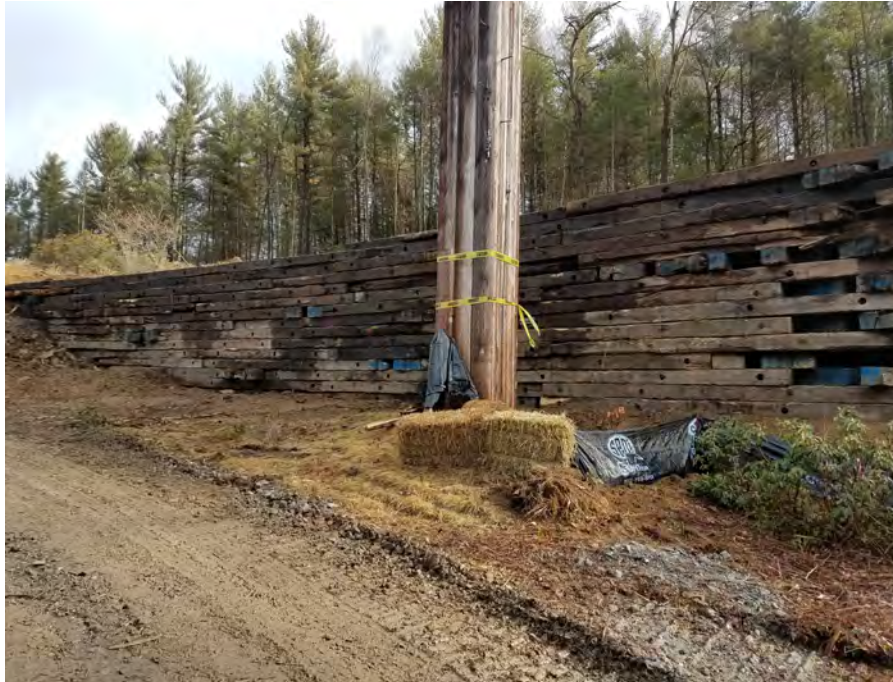
Photo #7: 1/19/17, Harwinton: Timber mat wall surrounding Str90

Photo #8: 1/19/17, Harwinton: Timber mat wall surrounding Str90

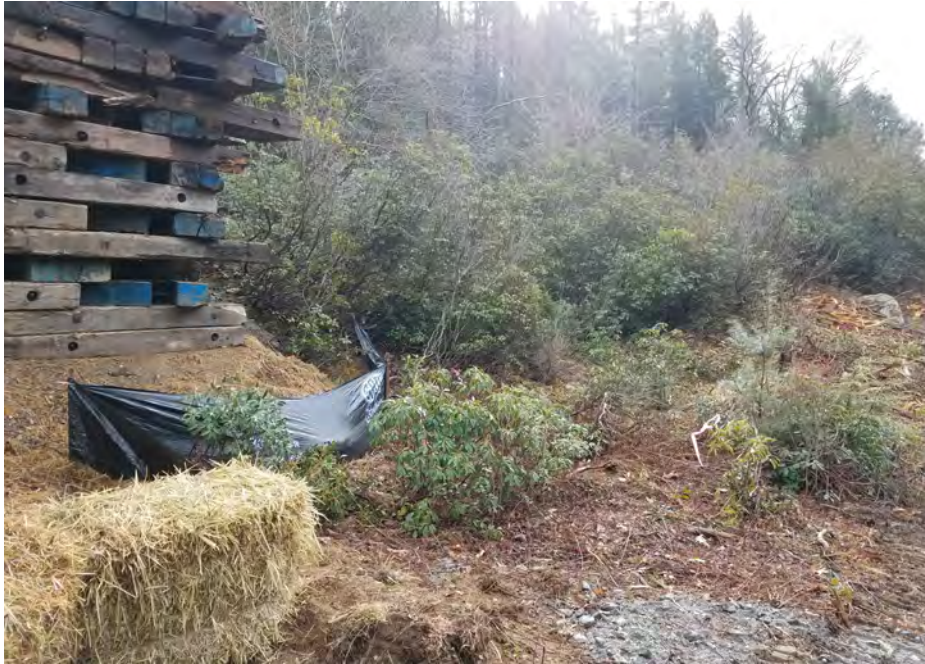
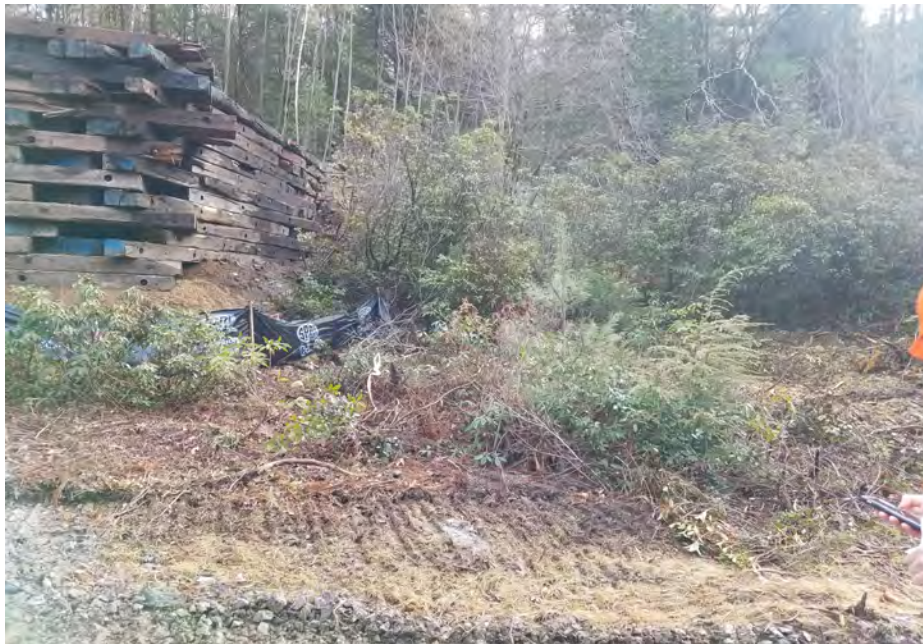
Photo #9: 1/19/17, Harwinton: W-F13 southwest corner of Str90 pad

Photo #10: 1/19/17, Harwinton: W-F13 southwest corner of Str90 pad

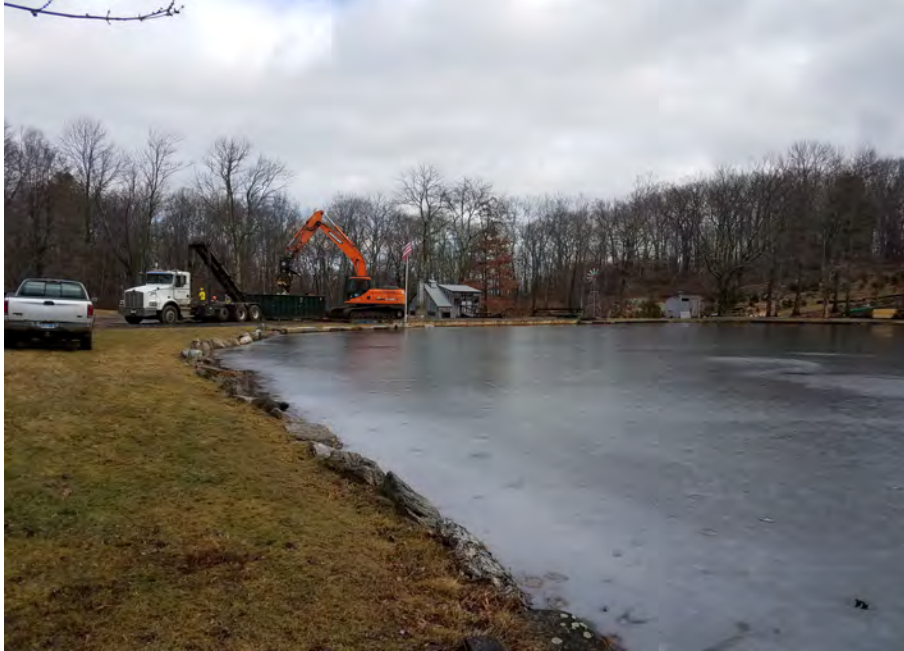
Interim Week	<p>Timber mats were being placed as structural support over the existing culvert and watercourse at the north end of Morton Pond in Thomaston (Map 21). Further inspection will occur on 1/26/17 after placement has been completed.</p>	N/A	N/A
Water Crossings	Bi-Week	<p>Timber mats previously placed (12/15/16 report) at the proposed culvert replacment (Detail Sheet 10, Map Sheet 32), were in the process of being moved approximately 10-feet to the west and reestablishing the water crossing and access road to Str87, Str3235, and Str3174.</p> <p>Timber mats placed on 1/5/17 at Morton Pond (Map Sheet 20A) were in need of cleaning and the ground surfaces at each end of the mats (east and west) are in need of stabilization and E&S controls to prevent excessive tracking of sediments and to divert surface water runoff from directly flowing into Morton pond or the spillway.</p>	<p>Continue to clear accumulated sediments from surface of timber mats to prevent impacts to S-F10 (intermittent watercourse).</p> <p>Clean Timber mats and stabilize surrounding grade to prevent tracking of sediments. Install E&S controls to control surface water runoff.</p>	<p style="text-align: center;">N/A</p> <p>Hay bales were placed at locations upgradient of Morton pond to control surface water flow down the access road to the drainage area that meanders into the pond, See attached photos and Map Sheet.</p>

Photo #11:1/19/17, Thomaston: Timber mat placement at watercourse/Morton Pond

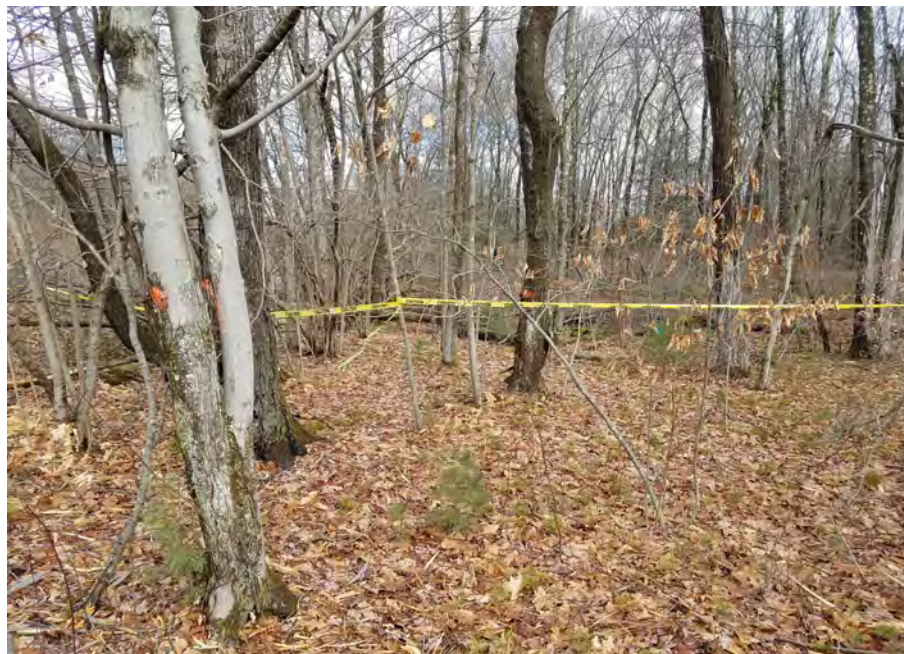
Photo #12:1/19/17, Thomaston: Additional caution tape and trees marked for removal, W-D4/VP-D4-1

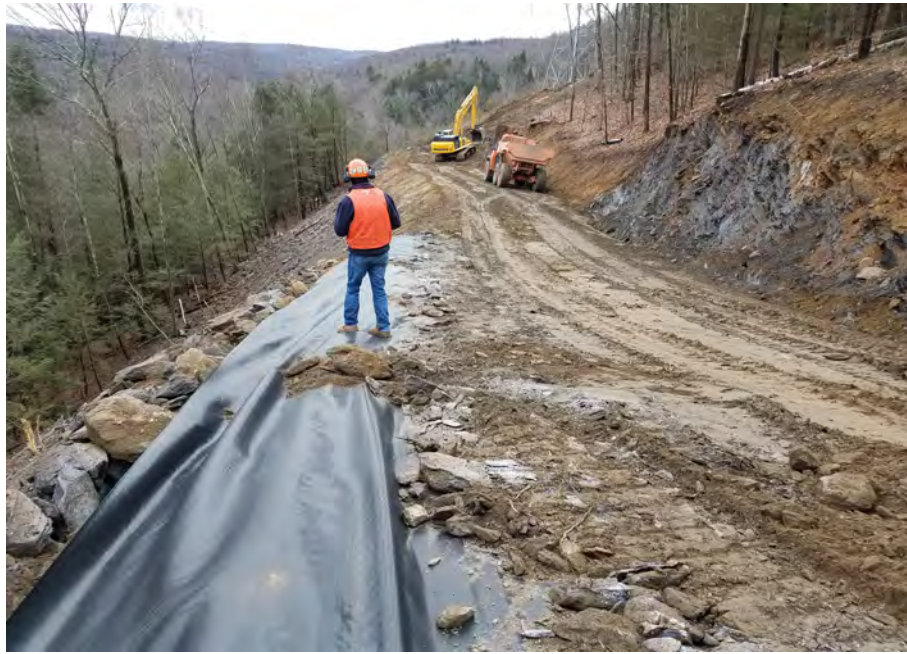
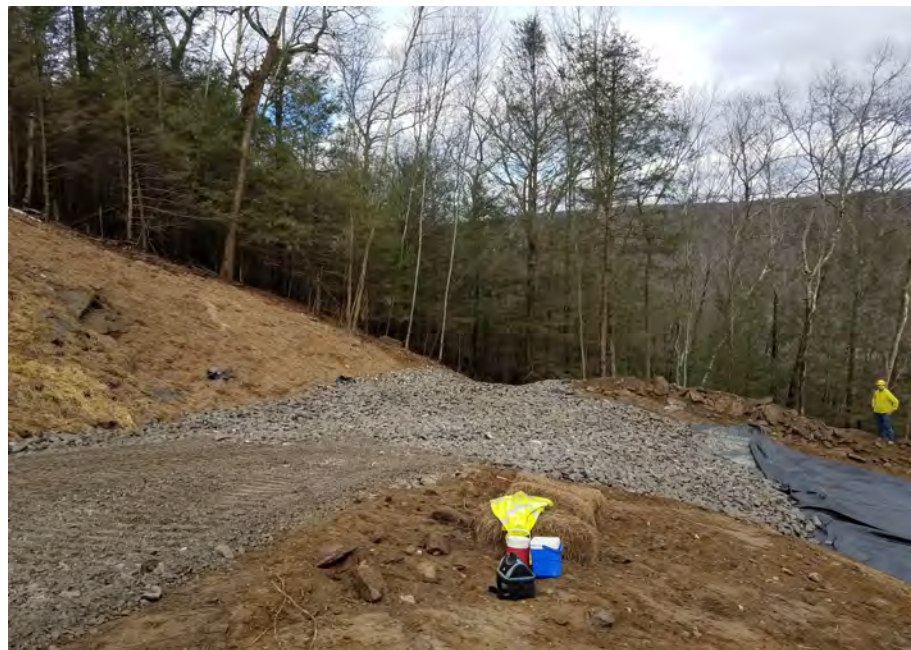
Photo #13:1/19/17, Litchfield: Access road to Str86, Str3236, Str3171 construction

Photo #14:1/19/17, Litchfield: Access road to Str86, Str3236, Str3171 construction

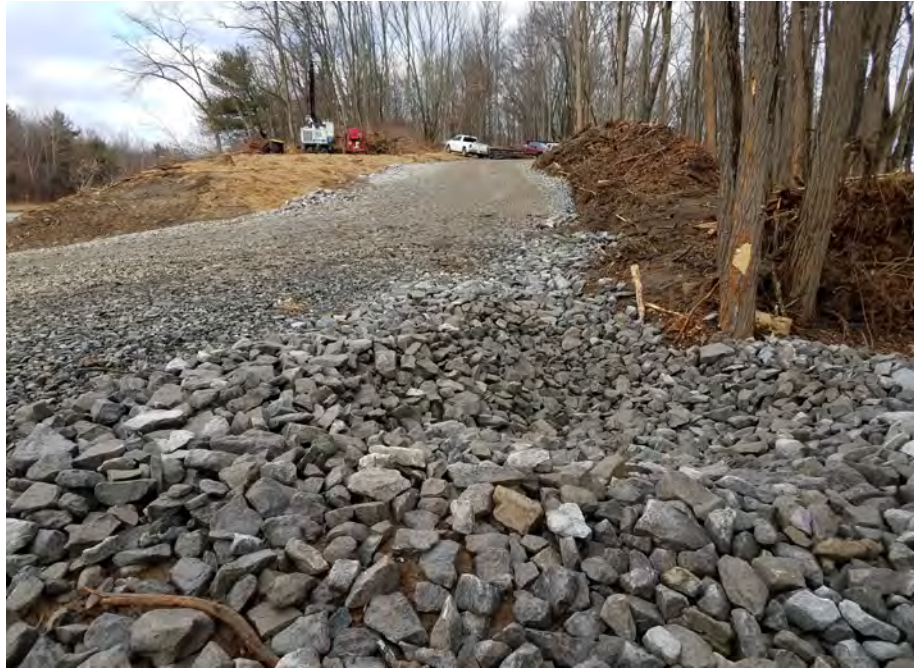
Photo #15:1/19/17, Litchfield: Access road to Str86, Str3236, Str3171, plunge pool at entrance/exit off Rt 8N

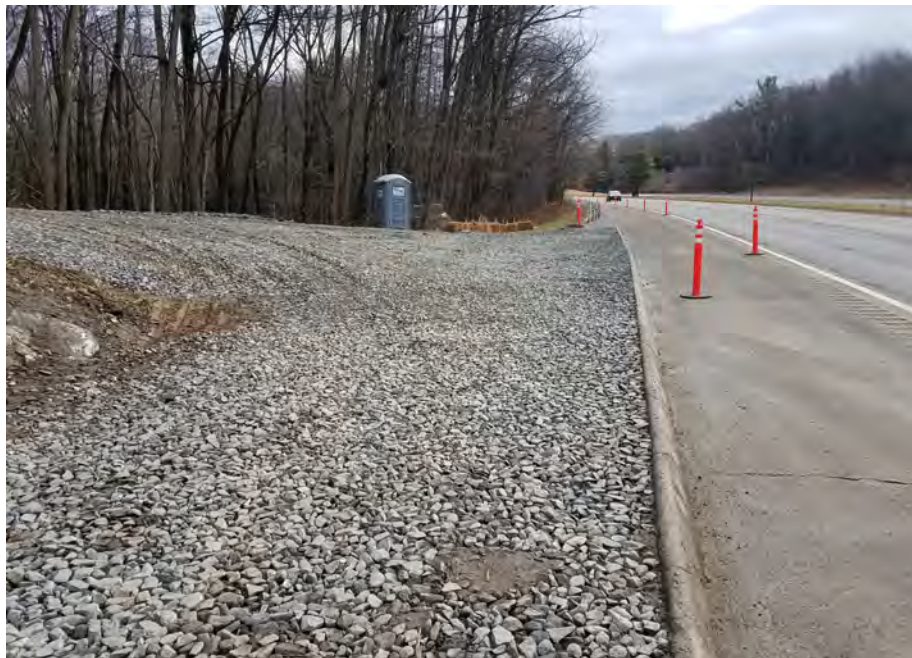
Photo #16:1/19/17, Litchfield: Access road to Str86, Str3236, Str3171, Rt 8N entrance/exit apron tracking pad

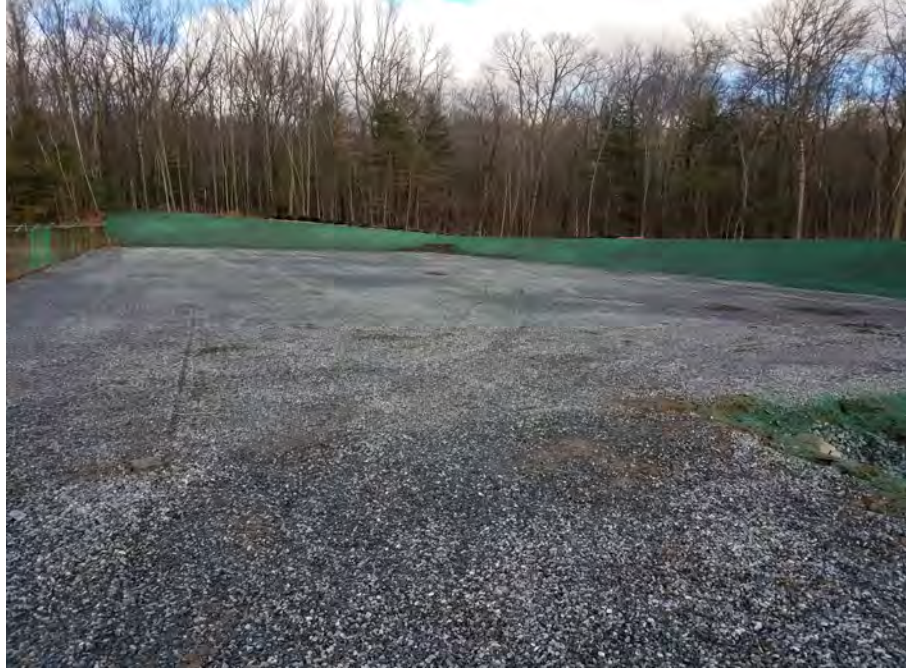
Erosion and Sedimentation Controls	Interim Week	Hydroseeding was completed at the Campville Substation, expansion area. Embankment failure (minor slipout) was observed in the northeast corner of the expansion area and standing water was observed in swale along the south edge of the substation.	Replace embankment material, compact, and reapply hydroseed. Knock down high points within the swale to allow proper drainage and flow.	N/A
	Bi-Week	Due to above freezing conditions the frost and snow cover melted and the resulting conditions required immediate placement of E&S controls to control runoff and stabilize areas.	N/A	Work activities stopped in most areas and E&S controls were implemented. See attached photos and Map Sheets.
Inland Wetland & Watercourse encroachment & mitigation	Interim Week	At the time of this Site inspection the Wetland Invasive Species Control Plan approval was still pending. No physical work is occurring within wetland and watercourse areas.	Wetland Invasive Species Control Plan approval is expected this week and work is scheduled to commence.	Wetland Invasive Species Control Plan, has been approved as of 1/20/17.

Photo #17:1/19/17, Harwinton: Campville Substation Expansion, hydroseeding embankment

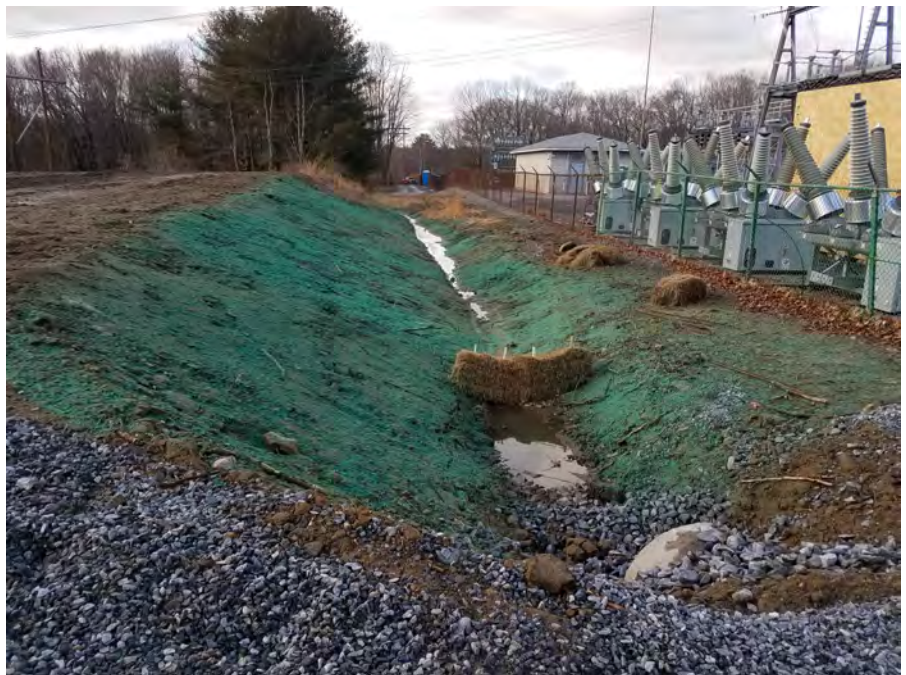
Photo #18:1/19/17, Harwinton: Campville Substation Expansion, drainage swale south side of Substation

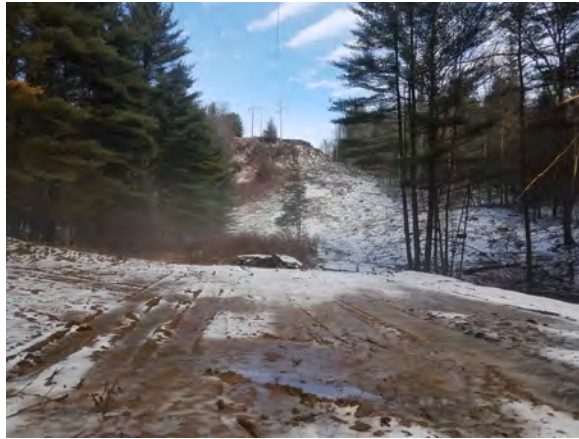
Photo #19:1/26/17, Harwinton- Clearing between Str87 and Str88 completed, standing at Pad Str87 facing north toward Str88 in the distance

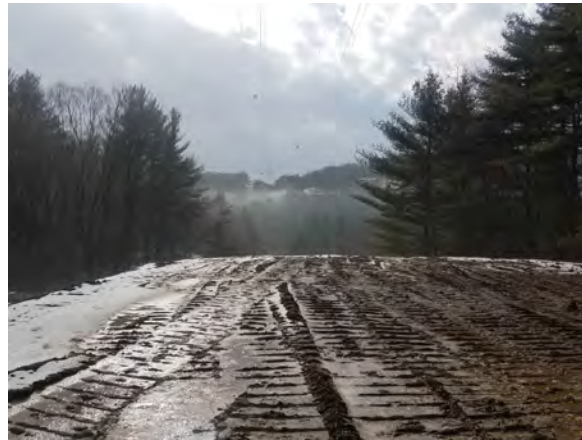
Photo #20:1/26/17, Harwinton- Str3235 and Str3174 pad construction, standing at Str3235 facing south toward Str86 in the far distance

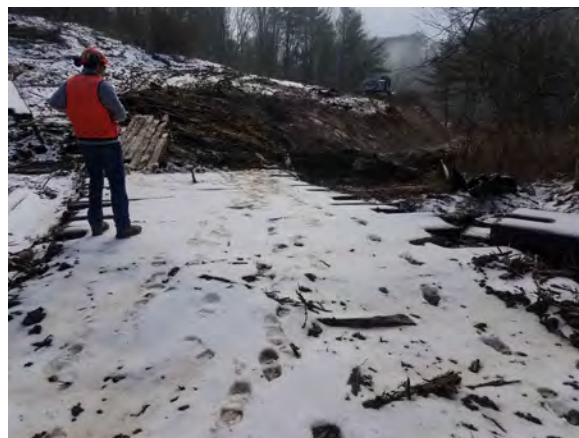
Photo #21:1/26/17, Harwinton- Timber mat crossing at the proposed culvert replacement (watercourse S-F11, Detail Sheet 10) moving approximately 10-feet to the east

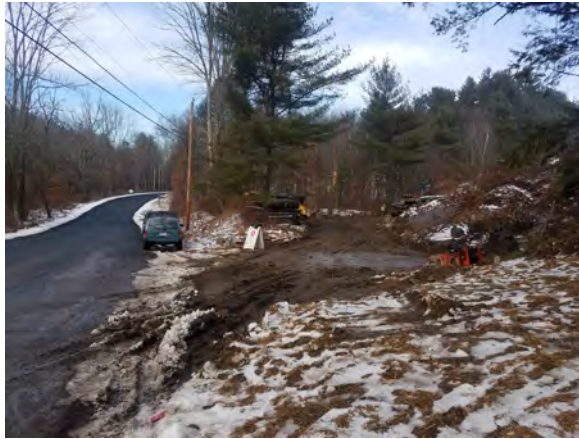
Photo #22:1/26/17, Harwinton- Access road to Str87 at Wildcat Hill Road, stone apron/tracking pad to be constructed

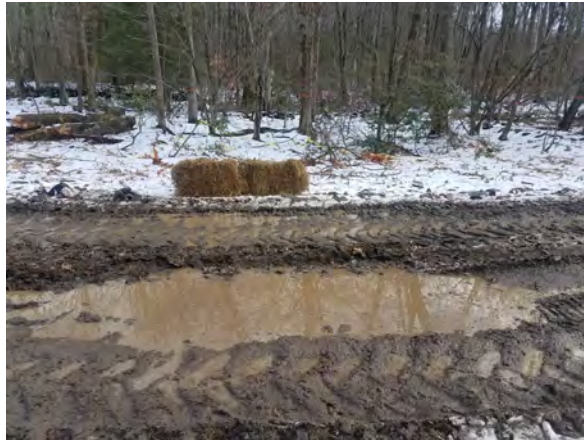
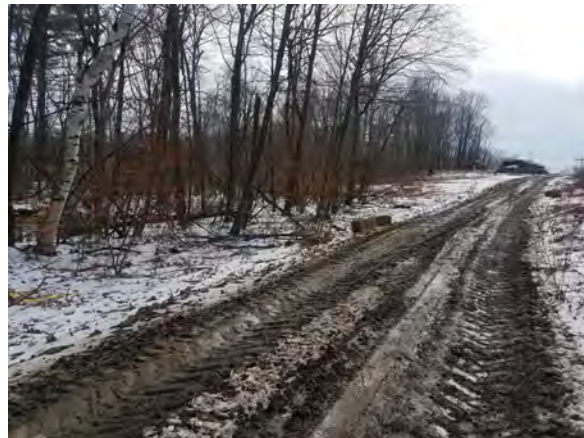
Photo #23:1/26/17, Thomaston- Additional hay bales to be added along the edge of the access road in the area of W-D4/VP D4-1 between Str53 and Str54

Photo #24:1/26/17, Thomaston- Additional hay bales to be added along the edge of the access road in the area of W-D4/VP D4-1 between Str53 and Str54

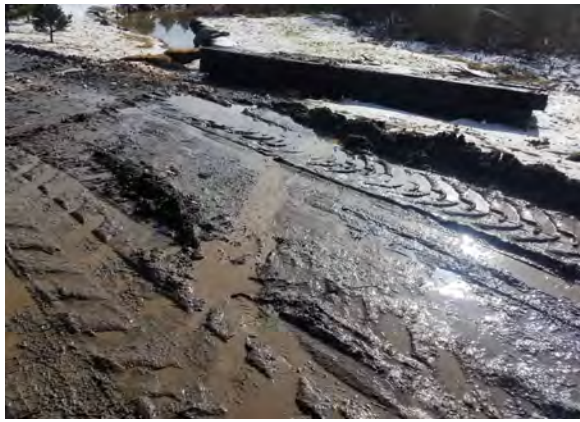
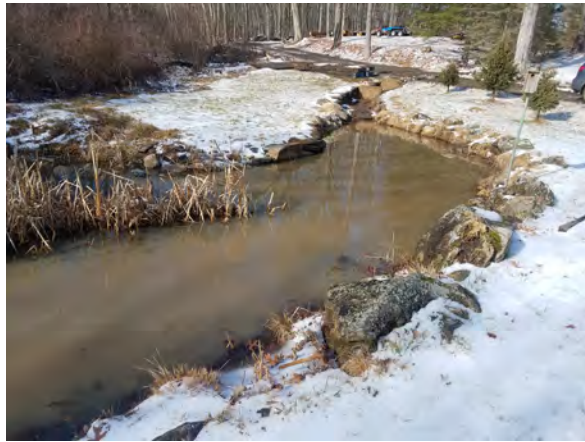
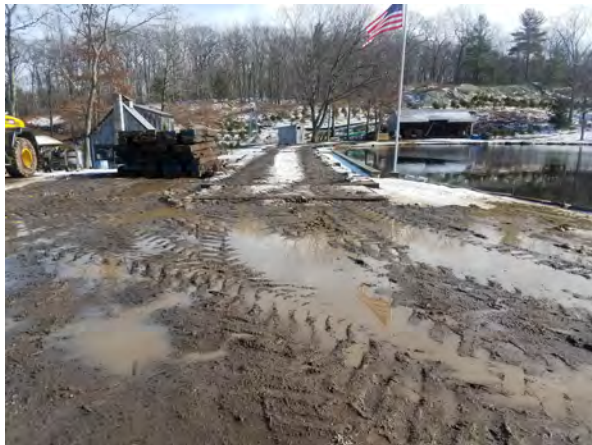
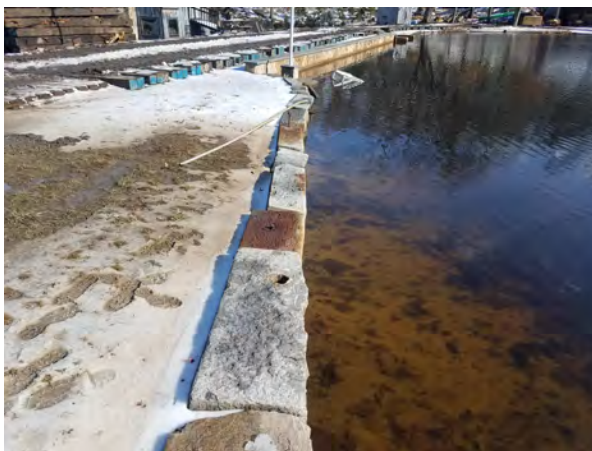
Photo #25:1/26/17, Thomaston- Robert K. & Jean R. Morton Property(41033, Map 21), access road to Str58-Str60, run off to Morton Pond

Photo #26:1/26/17, Thomaston- Robert K. & Jean R. Morton Property(41033, Map 21), access road to Str58-Str60, run off to Morton Pond

Photo #27:1/26/17, Thomaston- Robert K. & Jean R. Morton Property(41033, Map 21), access road to Str58-Str60, run off to Morton Pond

Photo #30:1/26/17, Thomaston- Robert K. & Jean R. Morton Property(41033, Map 21), access road to Str58-Str60, run off to Morton Pond

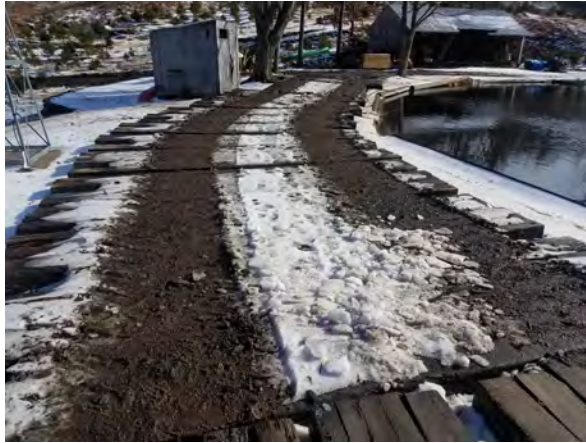
Photo #28:1/26/17, Thomaston- Robert K. & Jean R. Morton Property(41033, Map 21), access road to Str58-Str60, timber mats

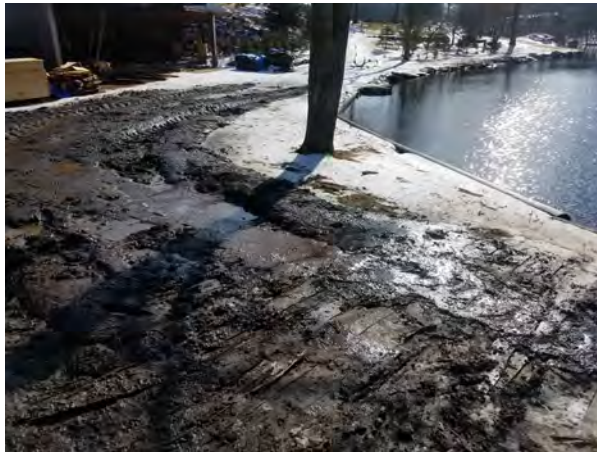
Photo #29:1/26/17, Thomaston- Robert K. & Jean R. Morton Property(41033, Map 21), access road to Str58-Str60, muddy conditions

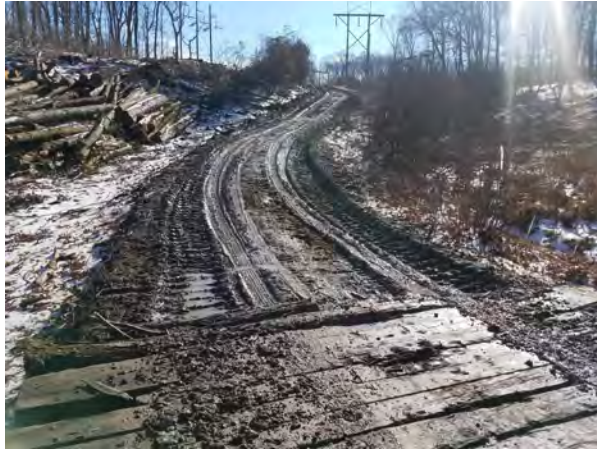
Photo #31:1/26/17, Watertown- Access road to Str24 through Str46, timber mats across W-C1 intermittent watercourse

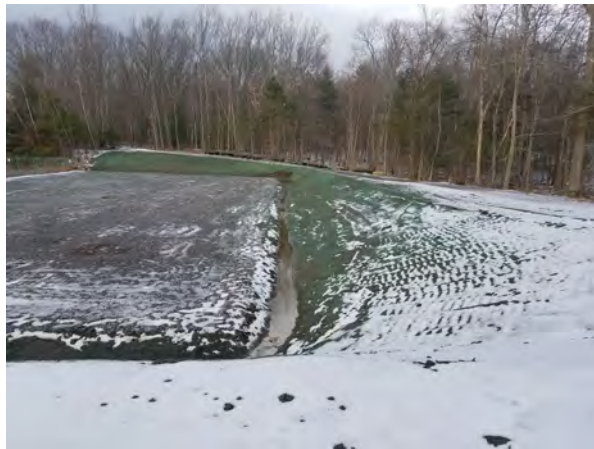
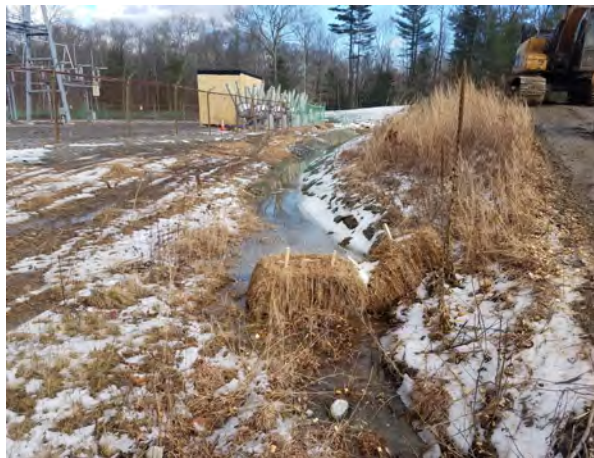
Photo #32:1/26/17, Harwinton- Campville Substation expansion, swale and surface water drainage conditions

Photo #33:1/26/17, Harwinton- Campville Substation expansion, swale and surface water drainage conditions

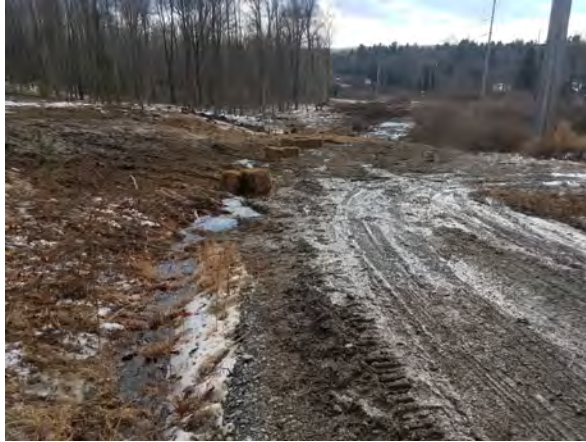
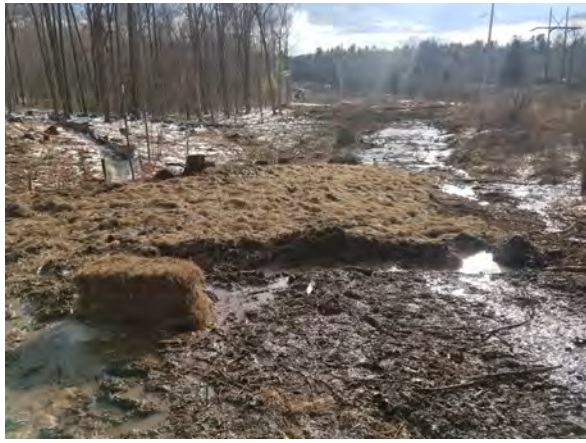
<p style="text-align: center;">Inland Wetland and Watercourse encroachment and mitigation (Continued from previous page)</p>	<p>Bi-Week</p>	<p>Surface water runoff from the Campville Substation drainage was observed flowing down gradient into W-G1(Map Sheet 35). Correctivte actions were already taken. Hay bales were placed to slow the flow of surfrace water runoff and straw was placed over the northwest edge of W-G1 to help stabilize the area.</p>	<p>Continue to monitor and impliment additional E&S controls if neccessary.</p>	<p>Continuing to monitor conditions.</p>
	<p style="text-align: center;">Spills and Material Storage</p>	<p>Interim-Week</p>	<p>None observed</p>	<p>N/A</p>
<p>Bi-Week</p>		<p>Campville Substation a sheen was observed on the access road south of the substation. The sheen was contained to the dirt/gravel road and no impacts were seen on the surrounding grades. There was a slight petroleum (diesel) odor in the area of the release. See attached photos.</p>	<p>Utilize spill pads or absorbent material to contain and capture release. Report release as required.</p>	<p>Spill pads used to recover the release. Spill reported to Eversource and CT DEEP. Spill form completed.</p>

Photo #34:1/26/17, Harwinton- Access road to Str97, surface water runoff to wetland W-G1

Photo #35:1/26/17, Harwinton- Access road to Str97, surface water runoff to wetlands W-G1

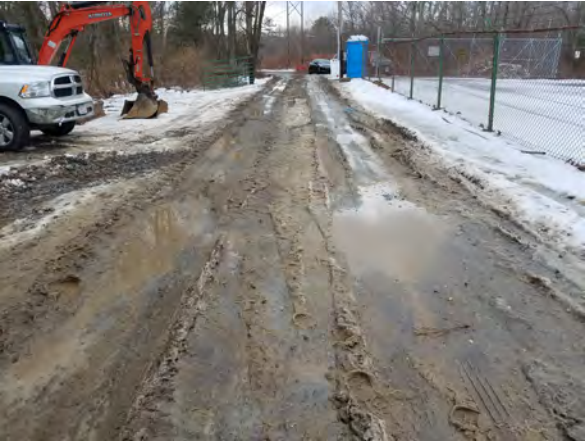
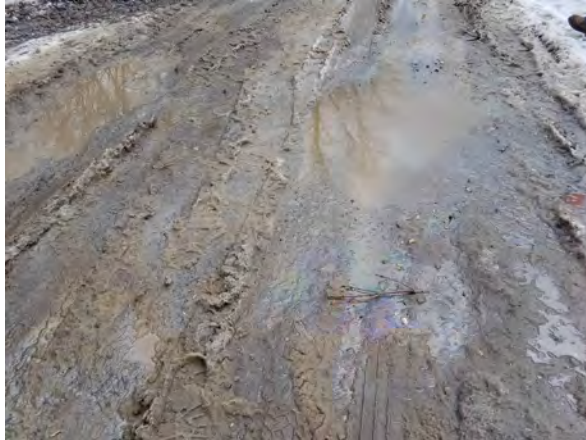
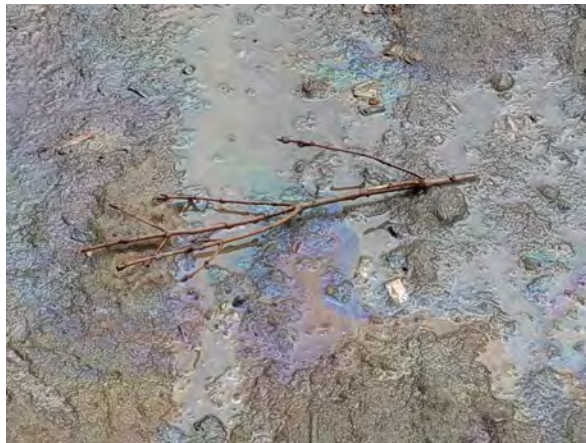
Photo #36:1/26/17, Harwinton- Campville Substation access road, petroleum release to ground

Photo #37:1/26/17, Harwinton- Campville Substation access road, petroleum release to ground

Photo #38:1/26/17, Harwinton- Campville Substation access road, petroleum release to ground
