**Subject: Docket No. 466, Frost Bridge to Campville 115-kV Project  
Decision and Order Condition #5 – Independent Environmental Inspector Report**

Please find enclosed the Biweekly Independent Environmental Inspector Report, Report #5, for the **February 17<sup>th</sup>** and **February 23, 2017**, inspection events for the construction of the Eversource Frost Bridge to Campville 115-kV Project.

**Docket No. 466- Development and Management Plan Inspection**

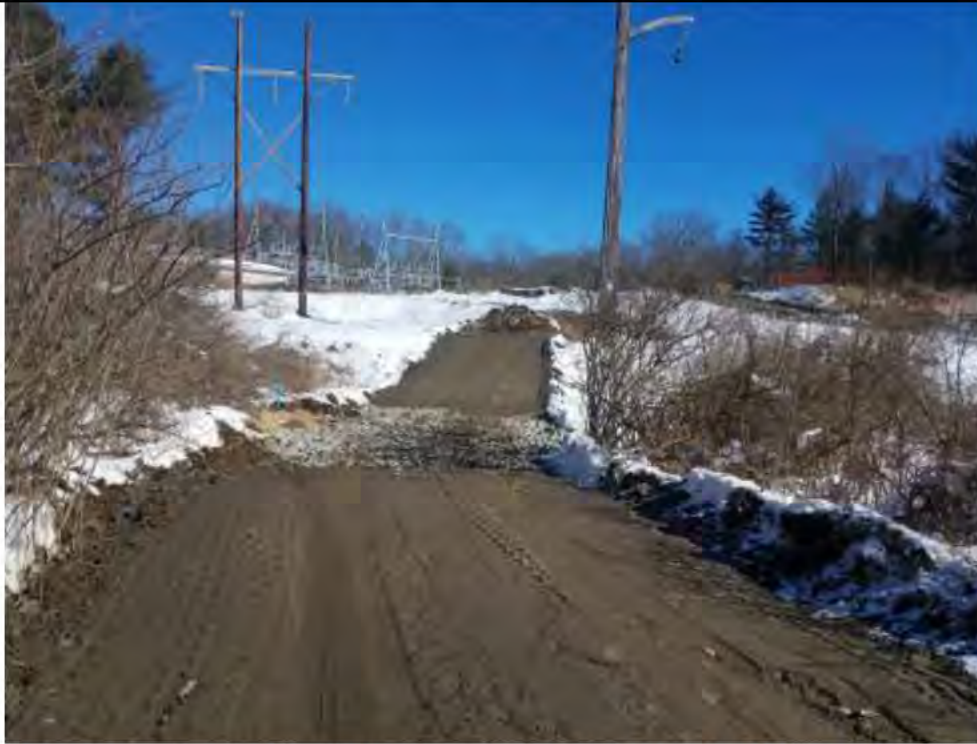
Photo 1: 2/17/2017, Harwinton, Map 35: Hard bottom crossing at S-G3 between Str97 and Str96.

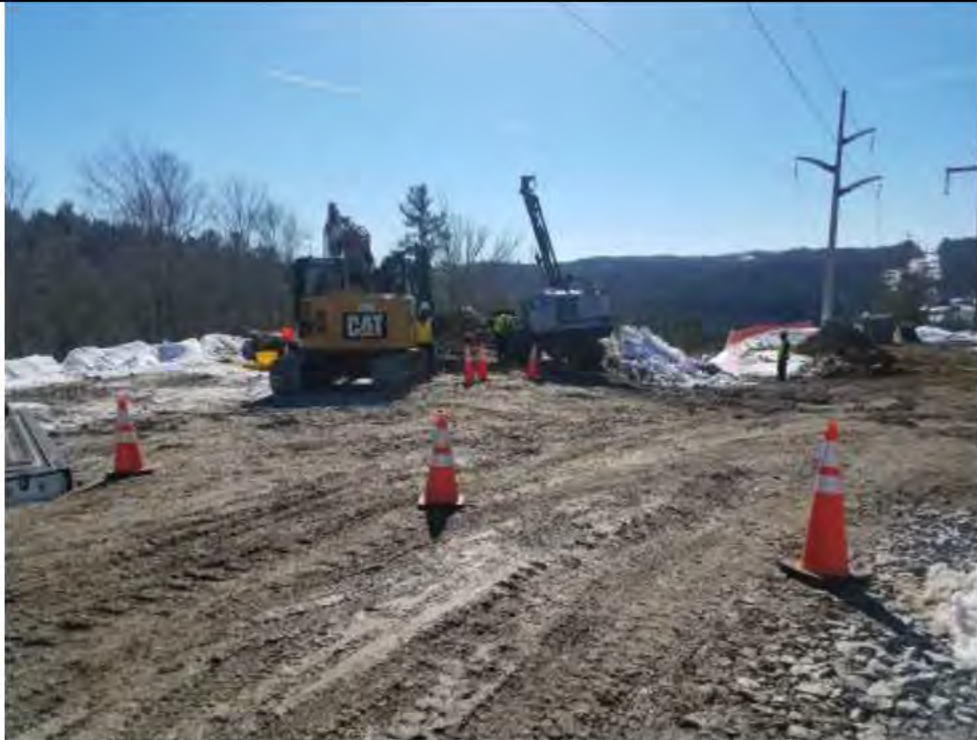
Photo 2: 2/17/2017, Harwinton, Map 32: Construction of temp structures north of Str88, drilling guide anchor holes.

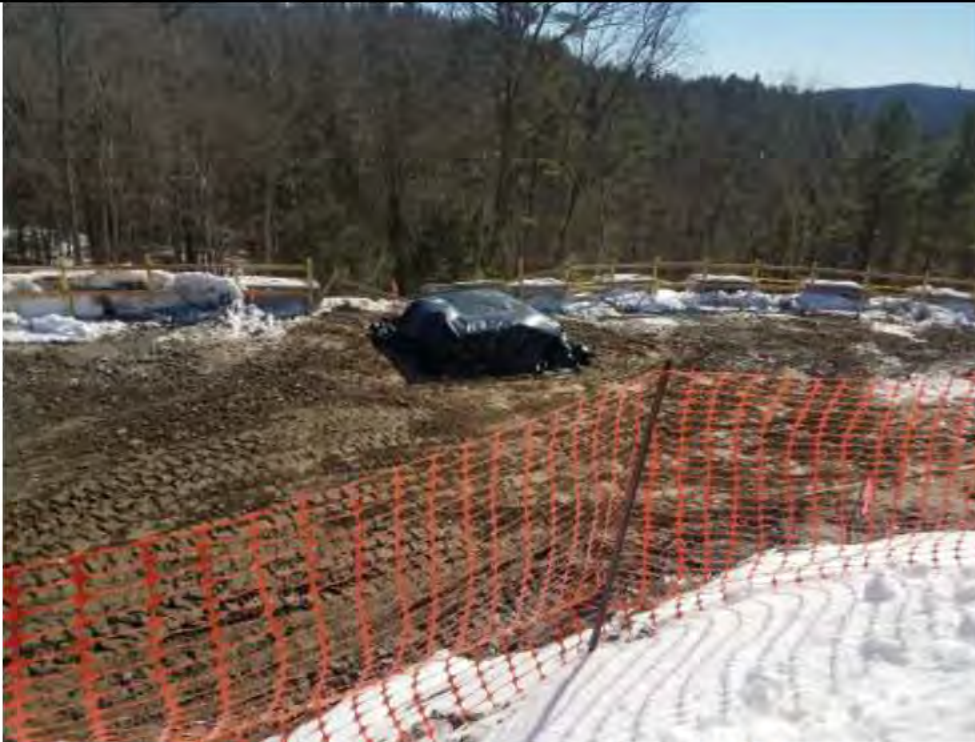
Photo 3: 2/17/2017, Harwinton, Map 32: Construction of Str88, poured concrete foundation.

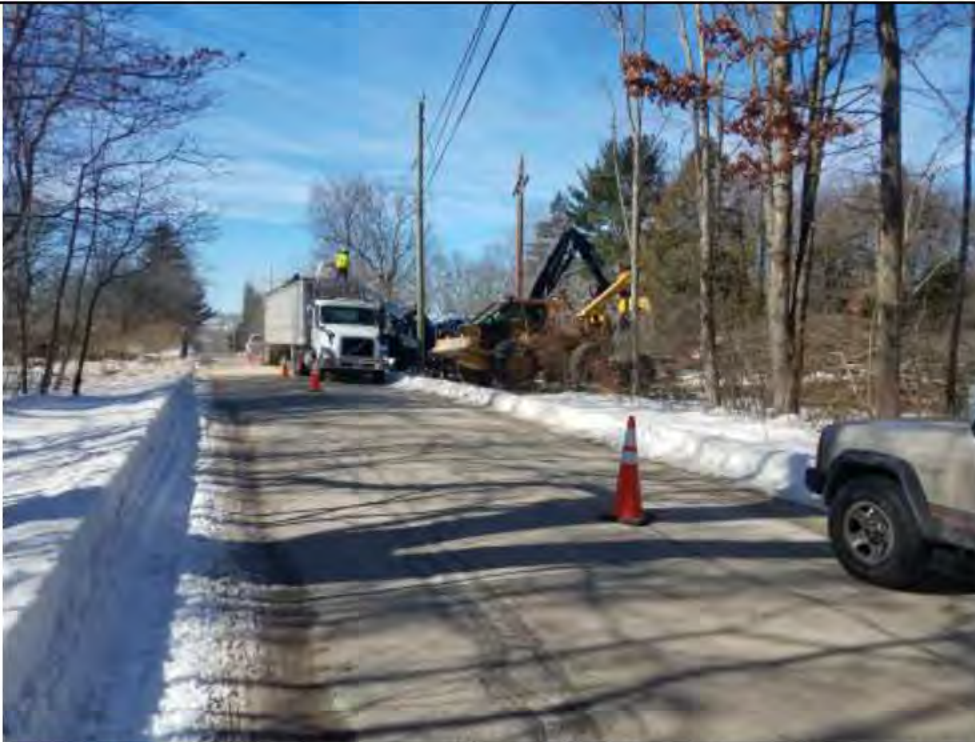
Photo 4: 2/17/2017, Litchfield, Map 26: Wood chipping at area of mechanical clearing between Str74 and Str77.

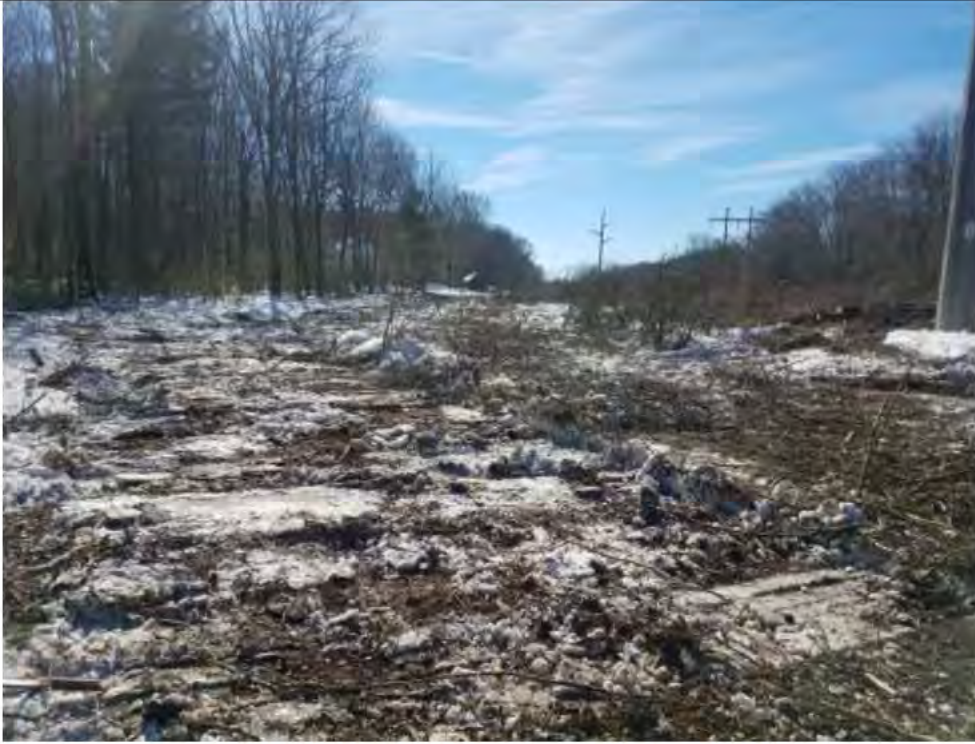
Photo 5: 2/17/2017, Litchfield, Map 26: Mechanical clearing between Str70 and Str73.

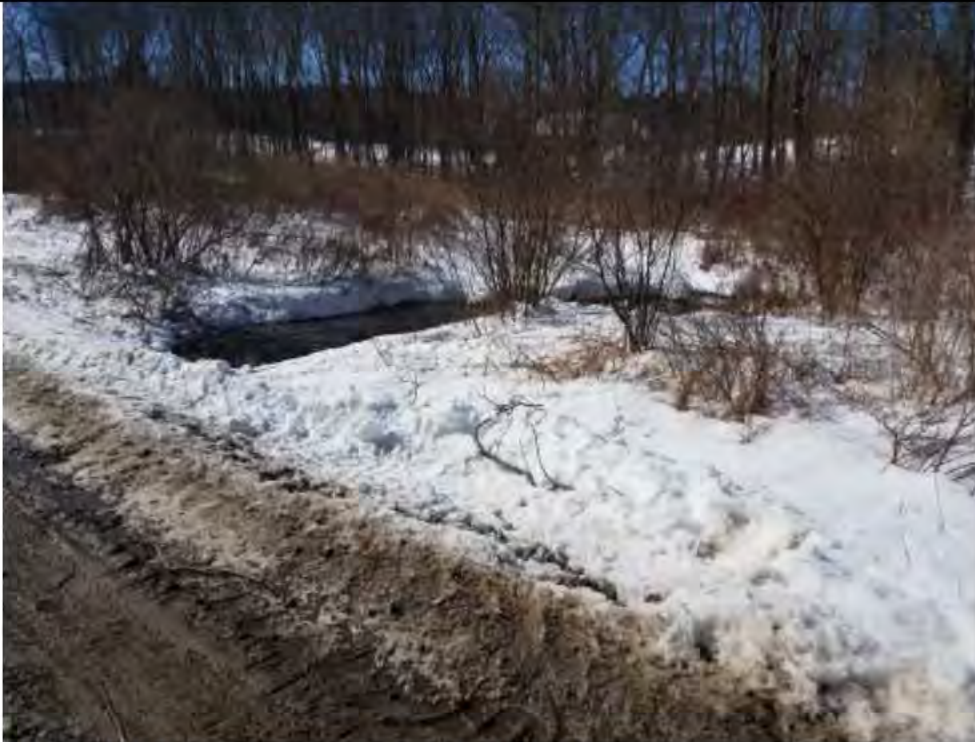
Photo 6: 2/17/2017, Litchfield, Map 26: Decoy vernal pool, DVP E2-1.

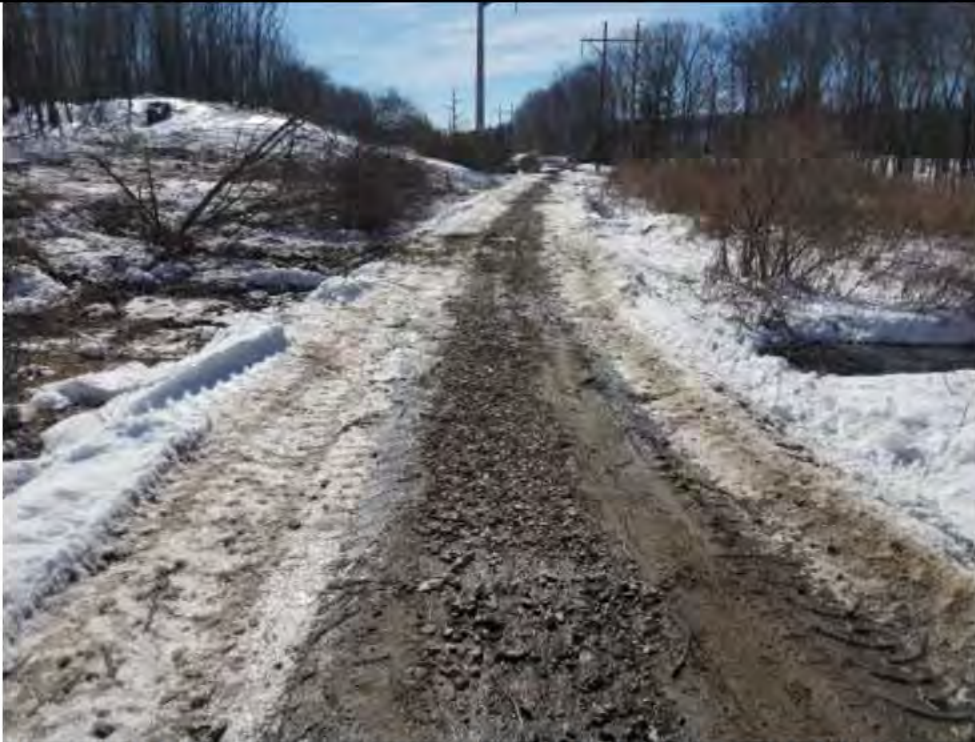
Photo 7: 2/17/2017, Litchfield, Map 26: Decoy vernal pool, DVP E2-1 (Right) and DVP E2-2(left) access road crossing current conditions.

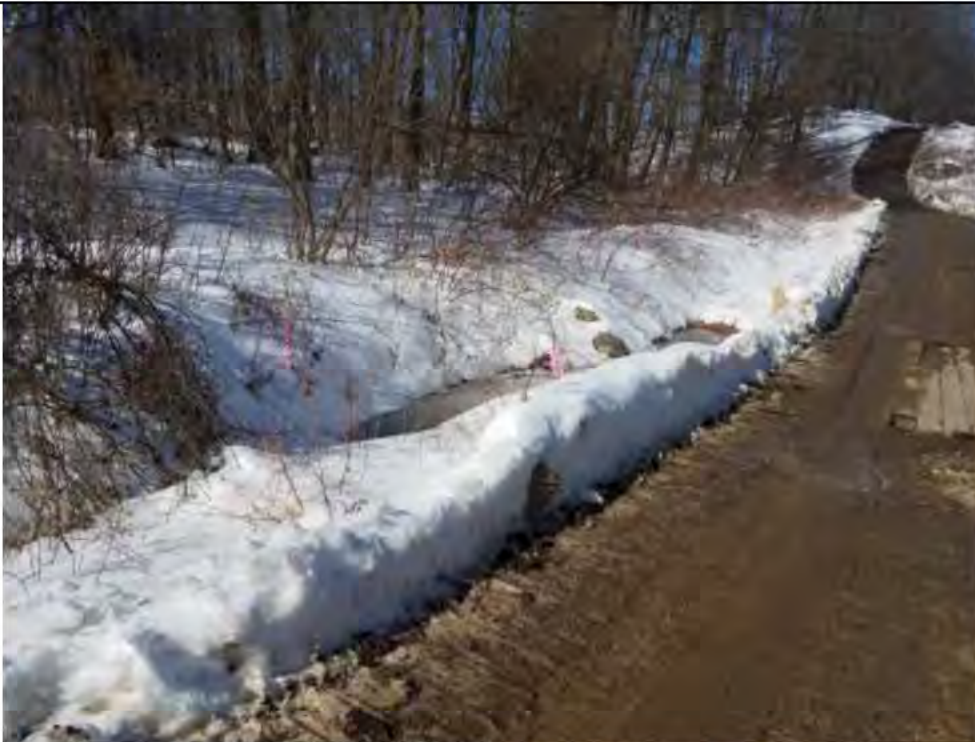
Photo 8: 2/17/2017, Watertown, Map 10: Decoy vernal pool, DVP C4-1 current conditions.

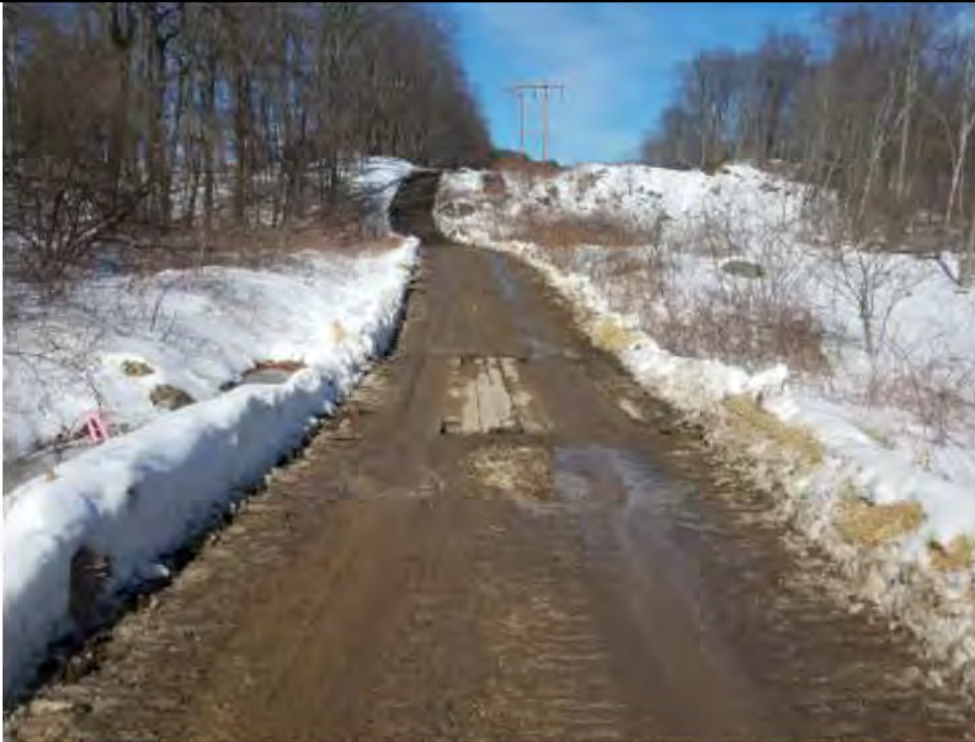
Photo 9: 2/17/2017, Watertown, Map 10: Decoy vernal pool, DVP C4-1 (left), wetland W-C4 (right), access road crossing current conditions.

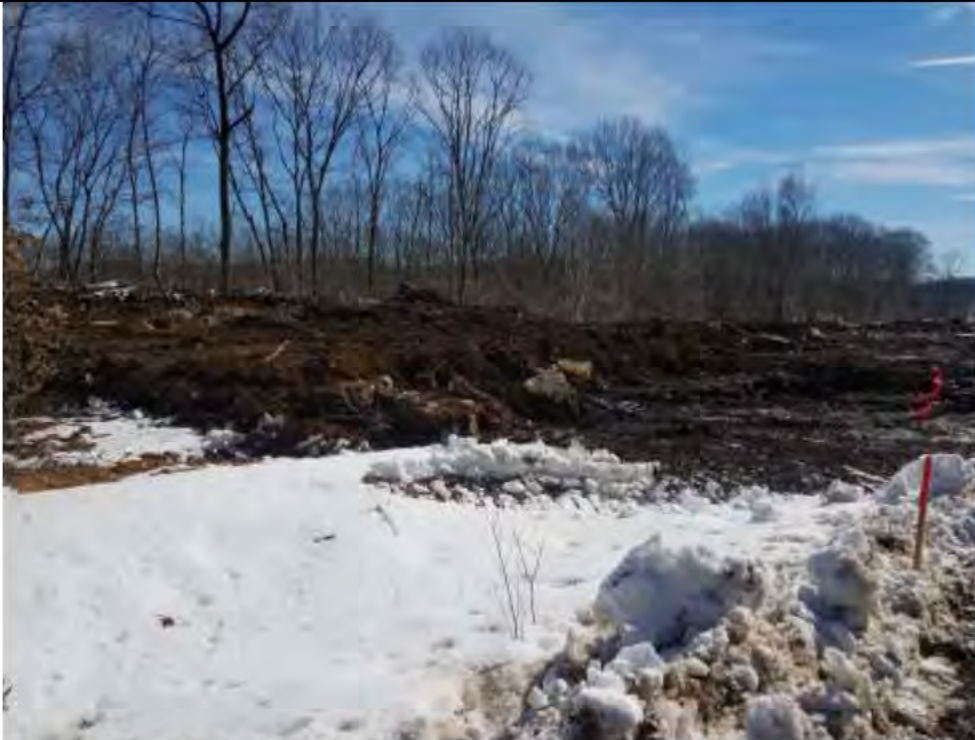
Photo 10: 2/17/2017, Watertown, Map 10: Partial clearing of pad at Str27 and Str28.

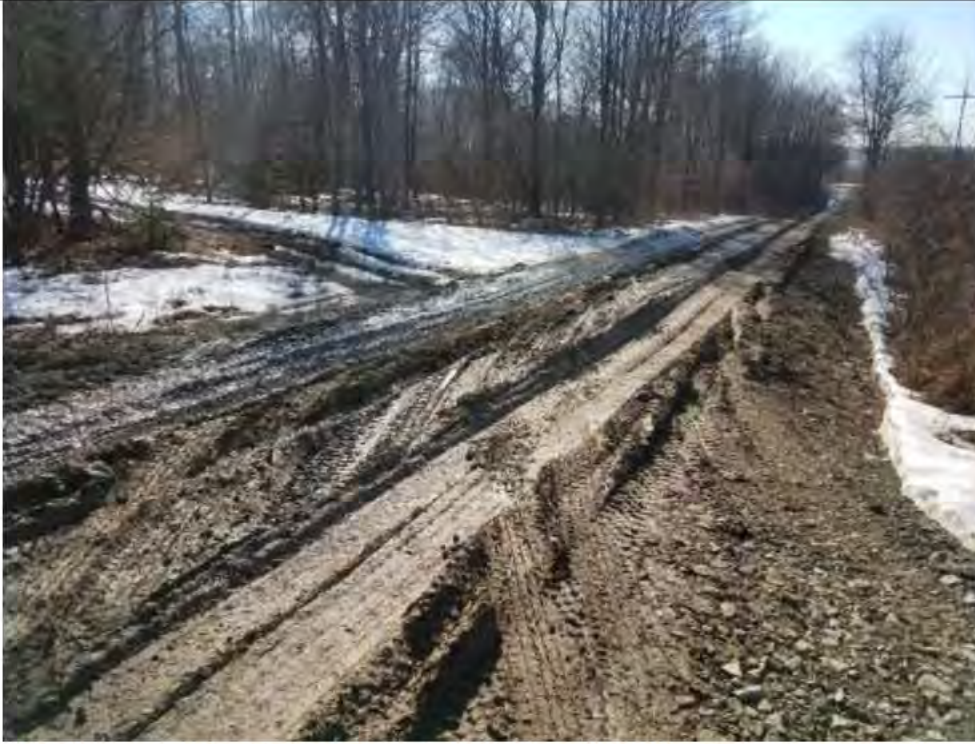
Photo 11: 2/23/2017, Watertown, Map 9A: Soft ground conditions, tire rutting occurring.

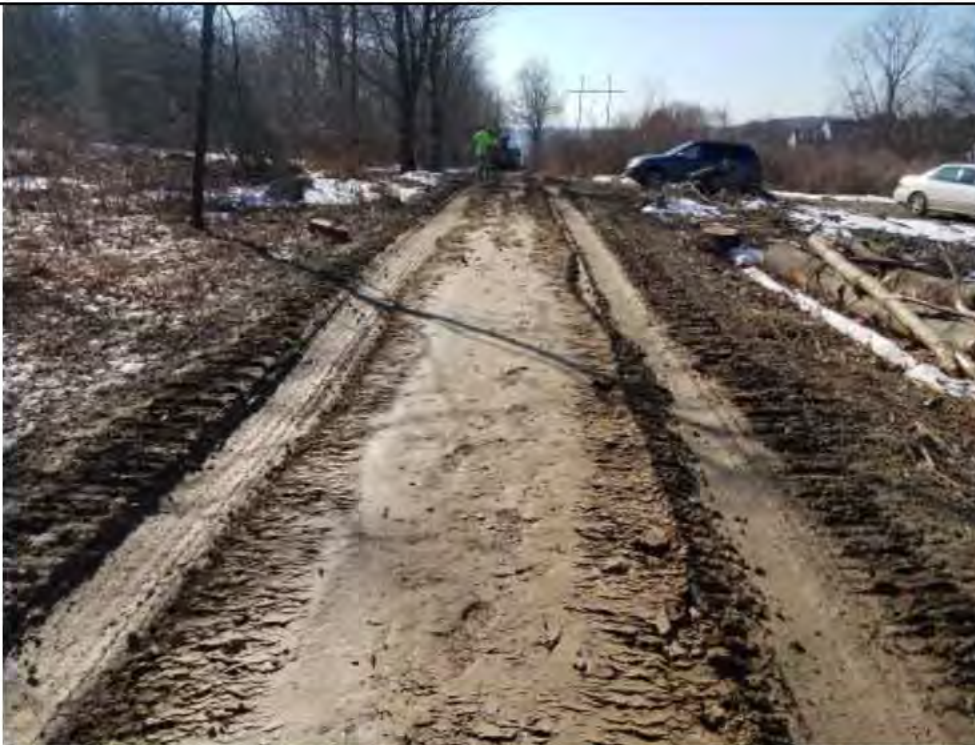
Photo 12: 2/23/2017, Watertown, Map 9A: Soft ground conditions, Northern grading road to remove rutting.

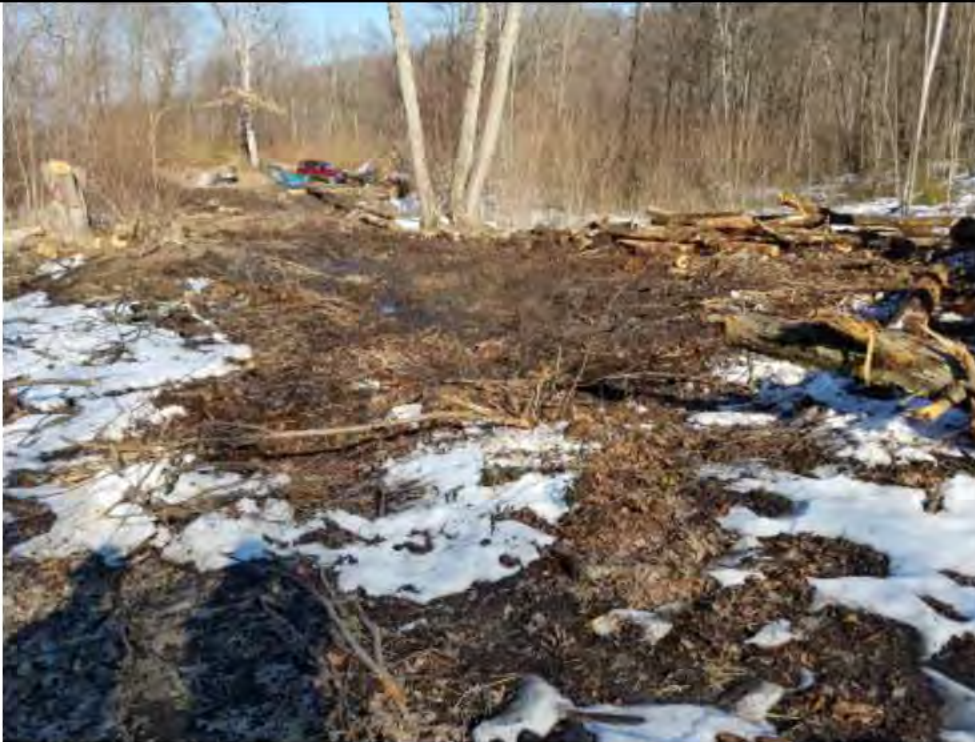
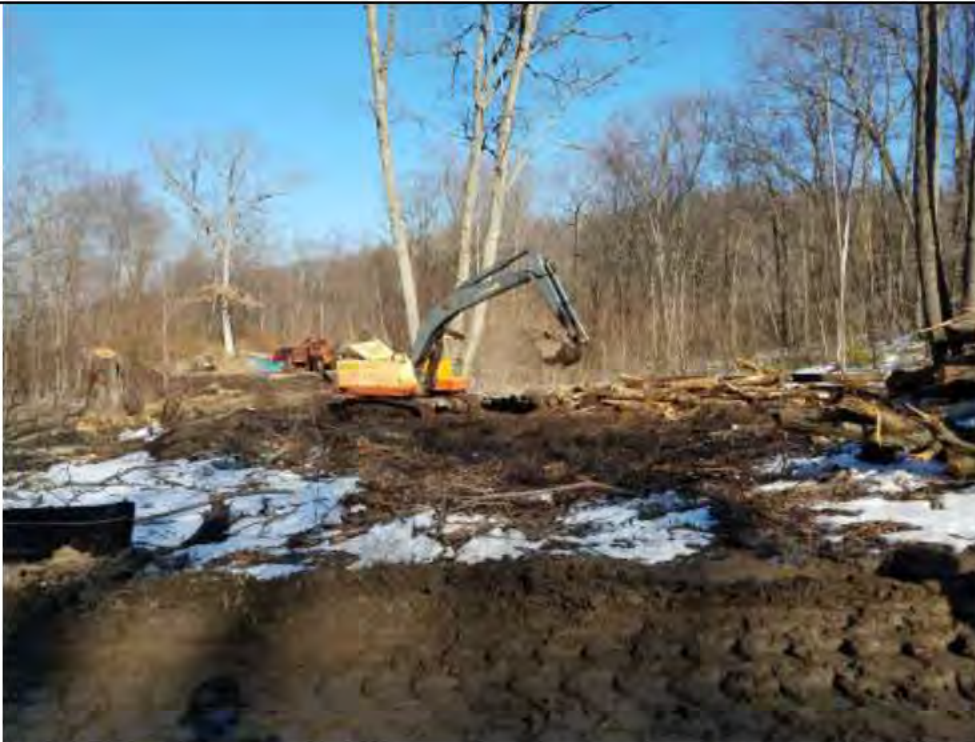
Photo 13: 2/23/2017, Watertown, Map 10: Non project related disturbance to W-C1/S-C1 by abutting landowner

Photo 14: 2/23/2017, Watertown, Map 10: Non project related disturbance to W-C1/S-C1 by abutting landowner

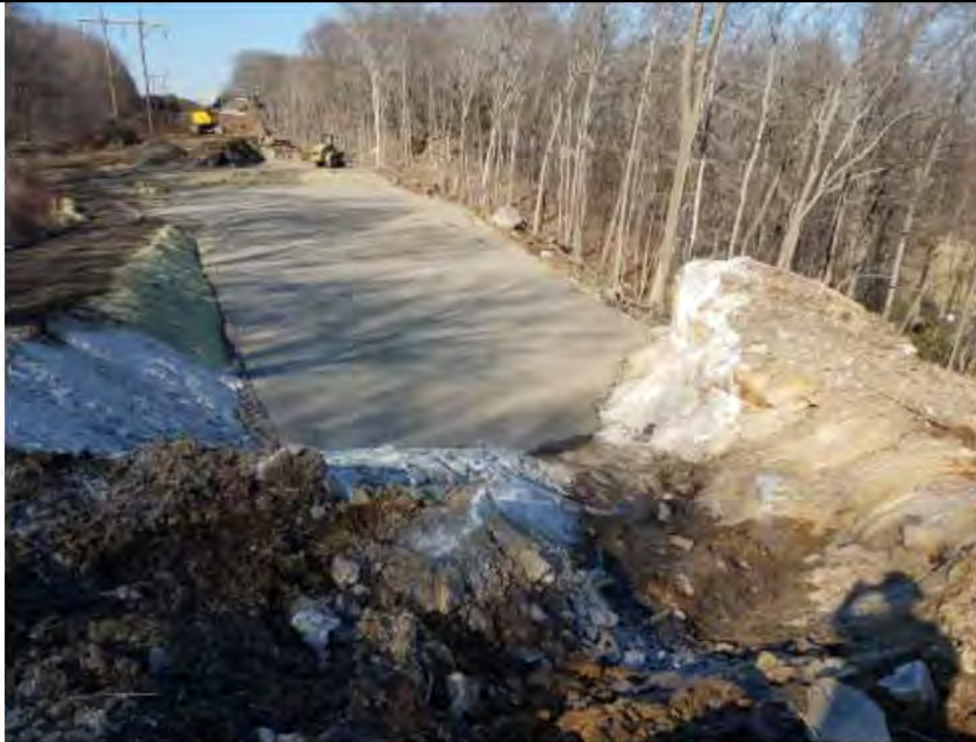
Photo 15: 2/23/2017, Watertown, Map 10: Str27 and Str28 pad construction.

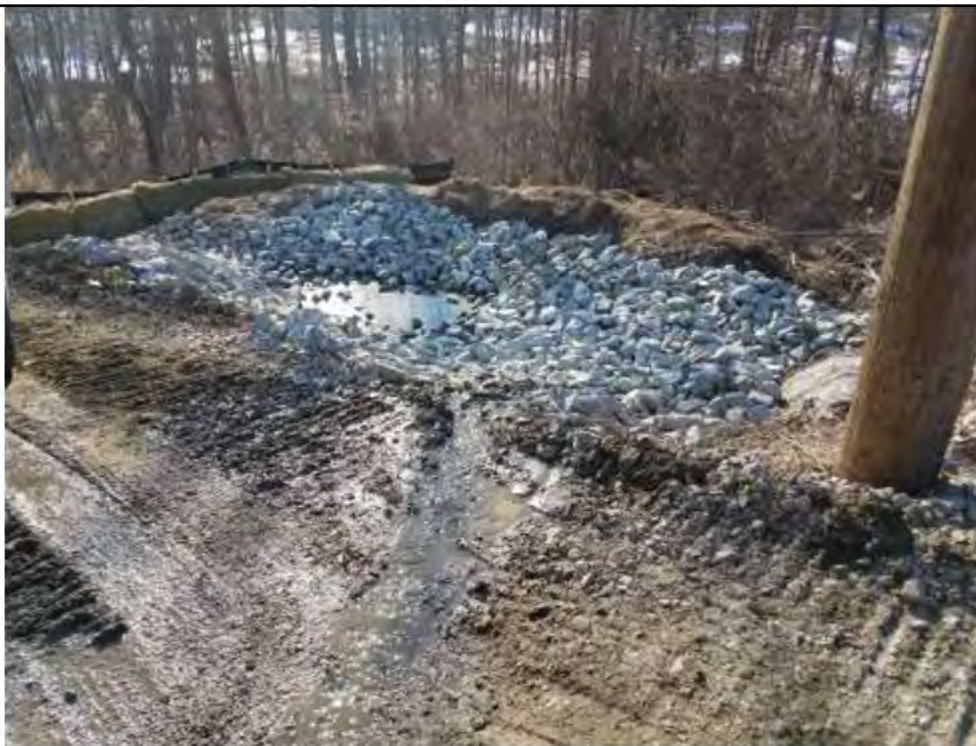
Photo 16: 2/23/2017, Litchfield, Map 26: Water bar and plunge pool upland of W-E2, DVP-E2-1 and DVP-E2-2.

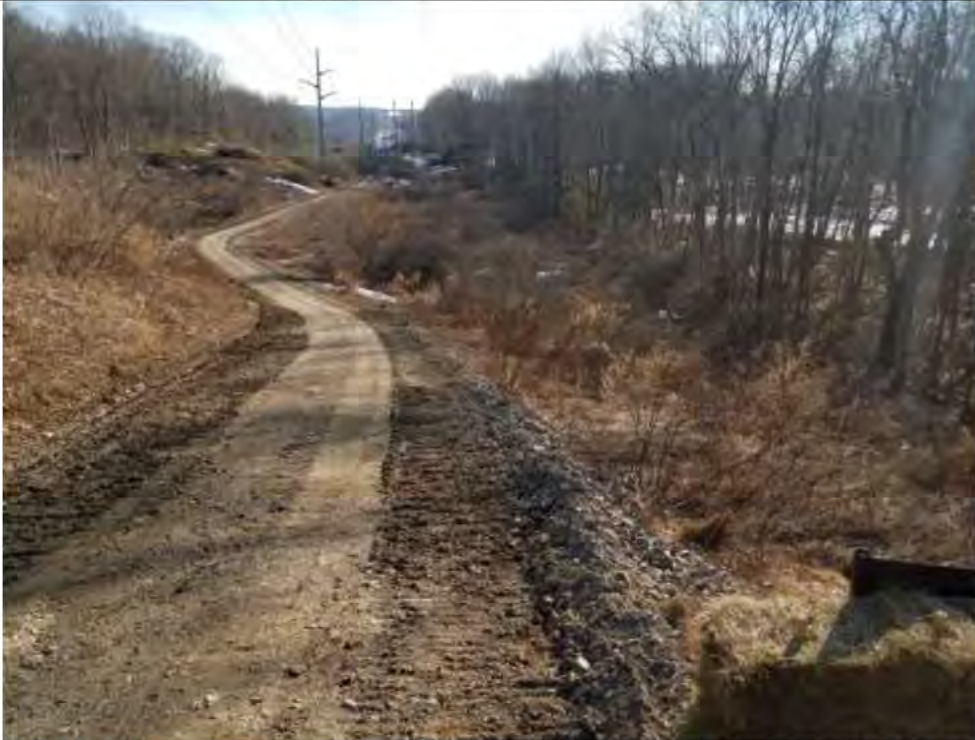
Photo 17: 2/23/2017, Litchfield, Map 26: Access road below water bar and plunge pool upland of W-E2, DVP-E2-1 and DVP-E2-2.

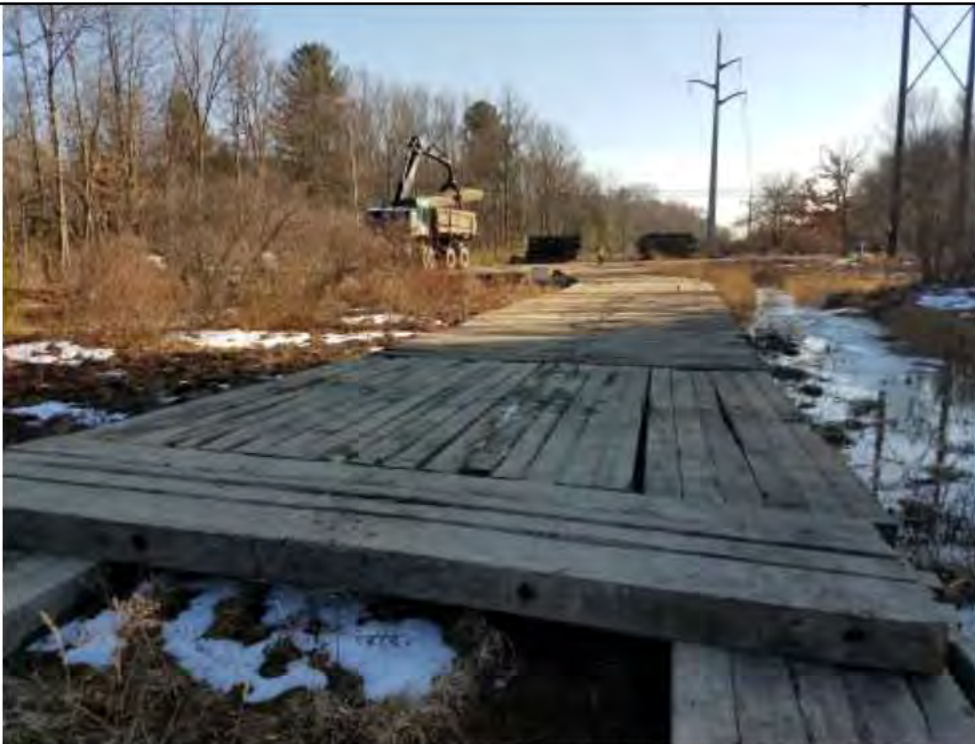
<p><b>Inland Wetland and Watercourse encroachment and mitigation (Continued from previous page)</b></p>	<p><b>Bi-Week</b></p>	<p>Timber mats have been placed at Str78 (Map28) and construction of the timber mat access road to Str79 (Map28) through W-E10 has started. the BMPs (Detail Sheet 3) for an elevated timber mat road for animal crossing were referenced. At the time of this site inspection, the mats were placed with a 50-foot span between each 10' crossing. Northern is changing from the 50-foot span down to a 33' span moving forward with the rest of the timber mat road construction.</p>	<p>N/A</p>	<p>N/A</p>
<p><b>Spills and Material Storage</b></p>	<p><b>Interim-Week</b></p>	<p>None observed or reported.</p>	<p>N/A</p>	<p>N/A</p>
	<p><b>Bi-Week</b></p>	<p>None observed or reported.</p>	<p>N/A</p>	<p>N/A</p>

Photo 18: 2/23/2017, Litchfield, Map 28: Timber mat access road from Str78 to Str79 through W-E10, with 10'+/- animal crossing spaced every 36' along the approximate 500-foot run.

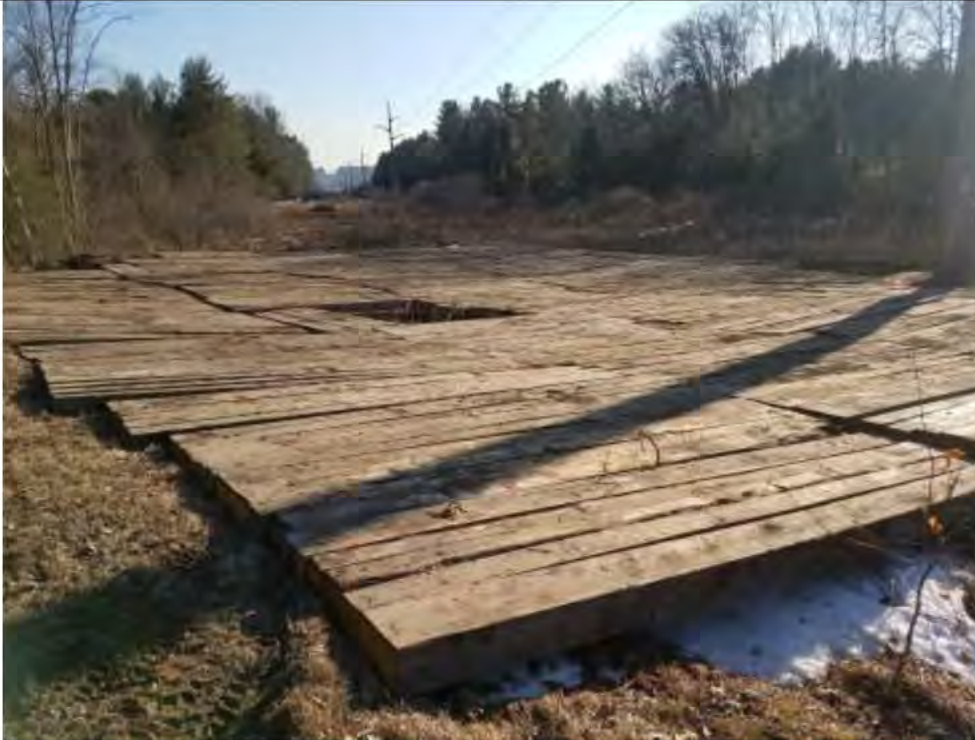
Photo 19: 2/23/2017, Harwinton, Map 35: Str95, matted pad, silt fencing still to be installed around exterior edge of mats to prevent turtle access per BMPs.

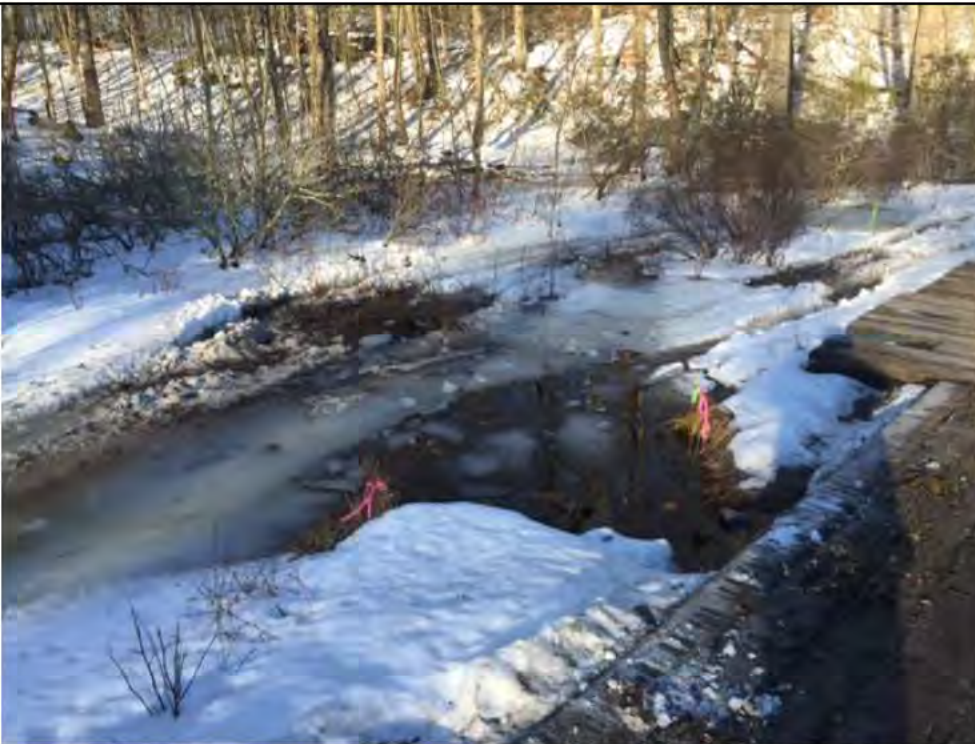
Photo 20: 2/20/2017, Map 11: Non project related disturbance to Vernal pool VP C12-1, ATV tracks .
