**Subject: Docket No. 466, Frost Bridge to Campville 115-kV Project
Decision and Order Condition #4 – Independent Environmental Inspector Report**

Please find the enclosed Biweekly Independent Environmental Inspector Report, Report #9, for the **March 31st** and **April 7th 2017**, inspection events for the construction of the Eversource Frost Bridge to Campville 115-kV Project.

Docket No. 466- Development and Management Plan Inspection

Photograph Log Frost Bridge to Campville 115kV Project

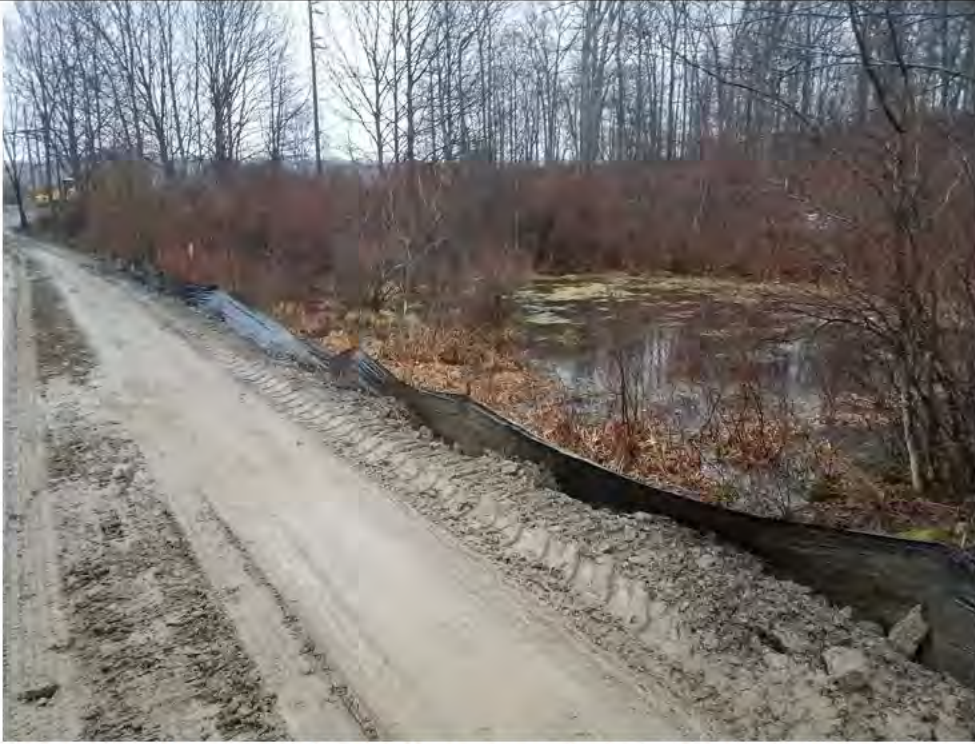
Erosion and Sedimentation Controls	Interim Week	Several areas require immediate maintenance to installed E&S. The access road to Str24 at W-C1A needs silt fencing repairs and excessive sediment removed (See photo #1). Str83 at W-F4 and S-F2 (Map29) requires silt fence repairs and pad slope armament (stone), rills have formed and sediment from the pad has the potential to effect W-F4 (Photos 9, 10, 11).	Repair and maintain E&S to prevent impacts to wetlands/watercourses and to control migration of water flow and sediments within the project ROW.	N/A
	Bi-Week	Northern was in the areas between Str24 & Str36 performing repairs and installing new E&S controls. Inspection of this area will be performed at the next scheduled date. Areas visited on this date (4/7/17) were maintained and functioning as designed with the exception of in the area of Str83 & W-F4. See >	Pad Str83 needs additional attention to construction and material stability. The addition of straw and sections of silt fence have not improved the conditions. Rills are visible, slump and slides are occurring around the south and eastern edges.	Pending

Photo 1: 3/31/2017, Watertown: Map 09A, E&S Maintenance required along access road abutting W-C1A.

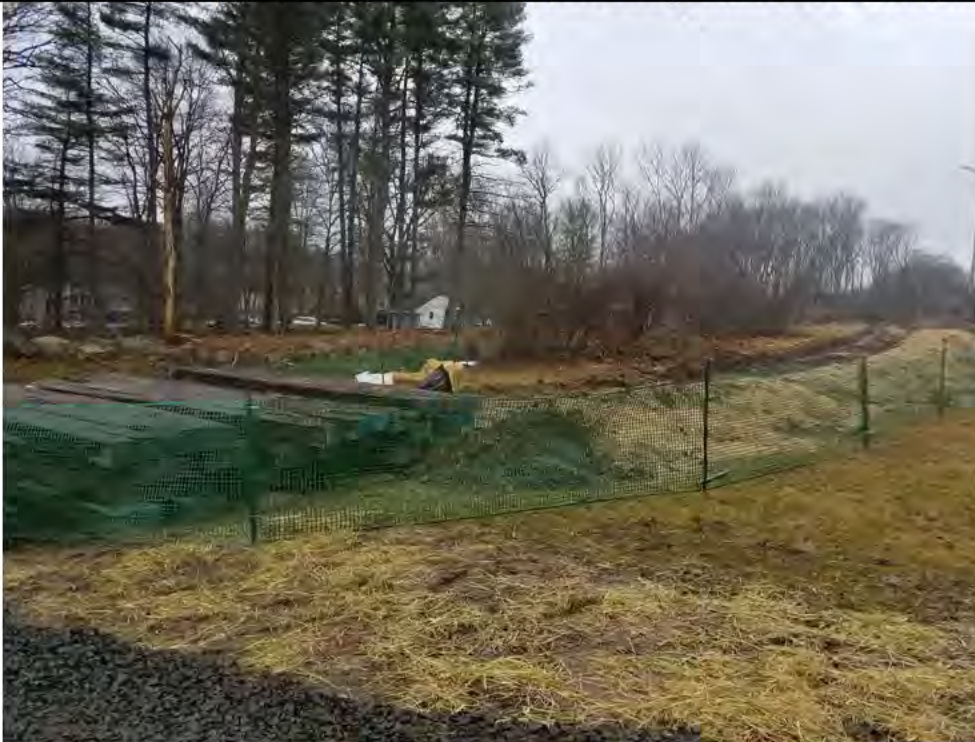
Over the weekend erosion from surface water runoff effected a private driveway at the ROW access road to Str80. E&S was installed to protect wetland W-E11 (Map 28) and in doing so surface water flow went down the private driveway causing significant erosion. See Wetlands Encroachment section below for further details.

Photo 2: 3/31/2017, Litchfield: Maps 28 & 29, access road to Str80 abutting private driveway.

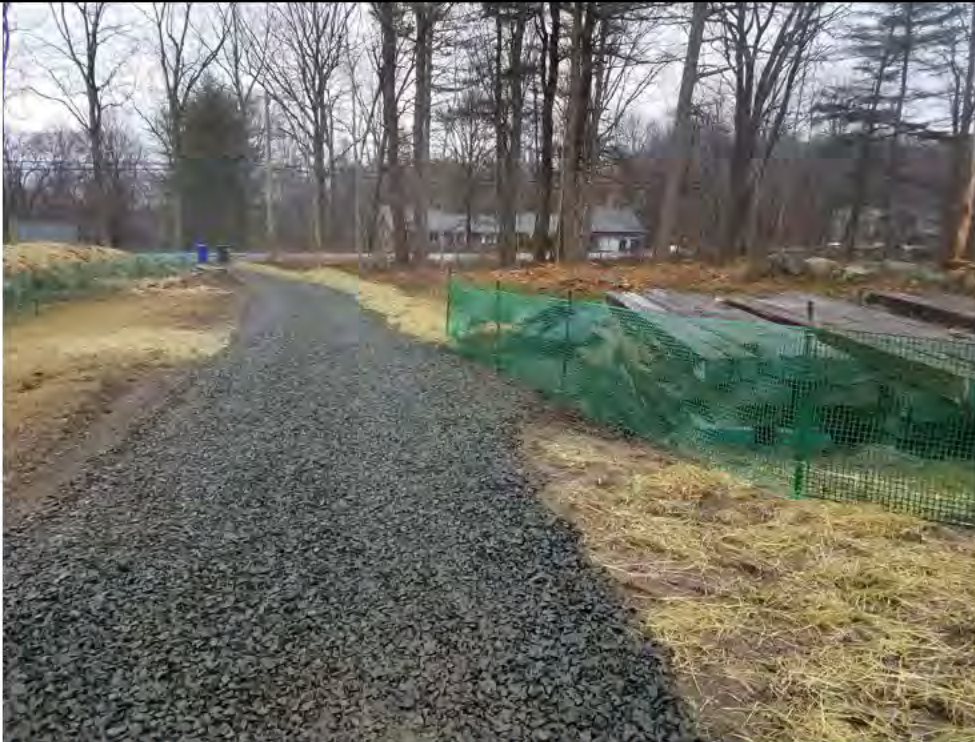
Photo 3: 3/31/2017, Litchfield: Maps 28 & 29, access road to Str80 abutting private driveway, repairs made to driveway after surface water runoff erosion was reported by property owner.

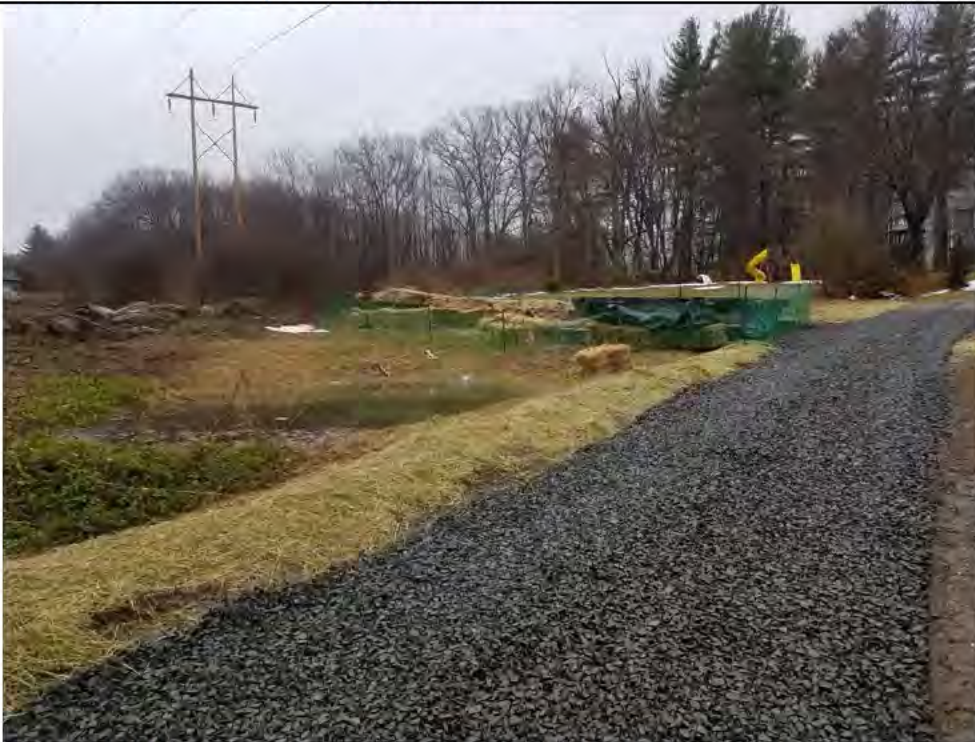
Photo 4: 3/31/2017, Litchfield: Maps 28 & 29, access road to Str80 abutting private driveway, repairs made to driveway after surface water runoff erosion was reported by property owner.

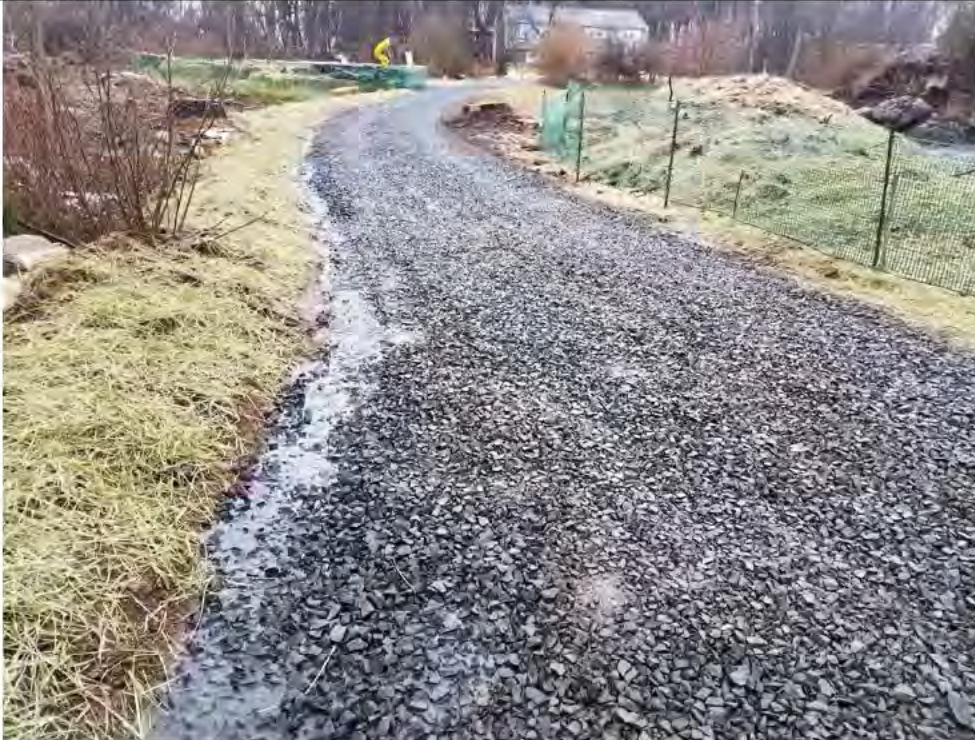
Photo 5: 3/31/2017, Litchfield: Maps 28 & 29, access road to Str80 abutting private driveway, repairs made to driveway after surface water runoff erosion was reported by property owner.

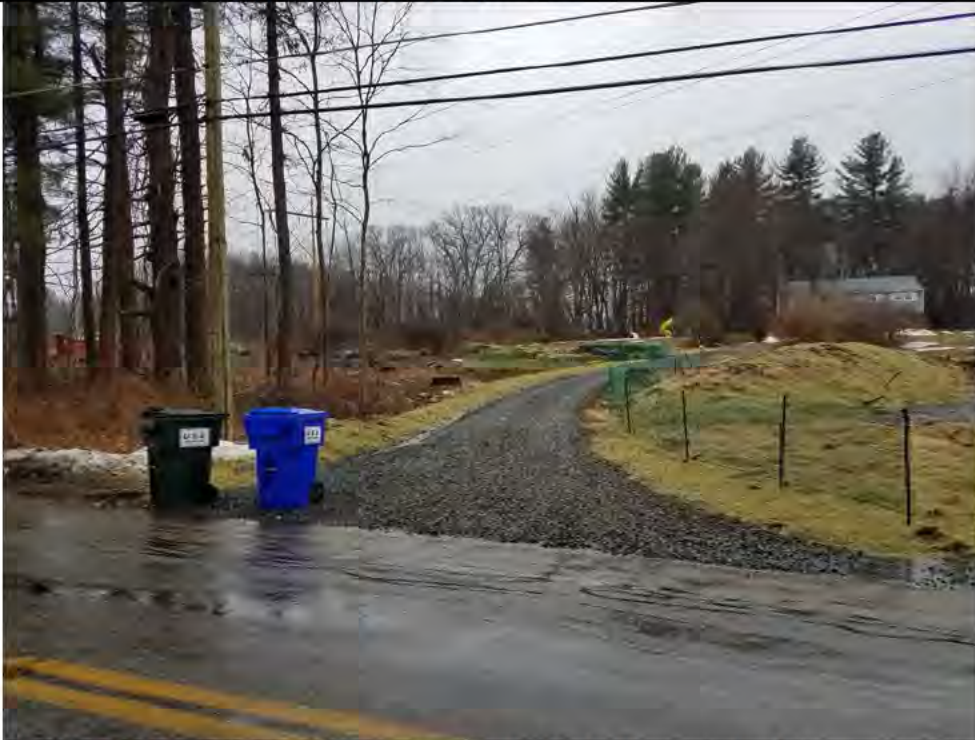
Photo 6: 3/31/2017, Litchfield: Maps 28 & 29, access road to Str80 abutting private driveway, repairs made to driveway after surface water runoff erosion was reported by property owner.

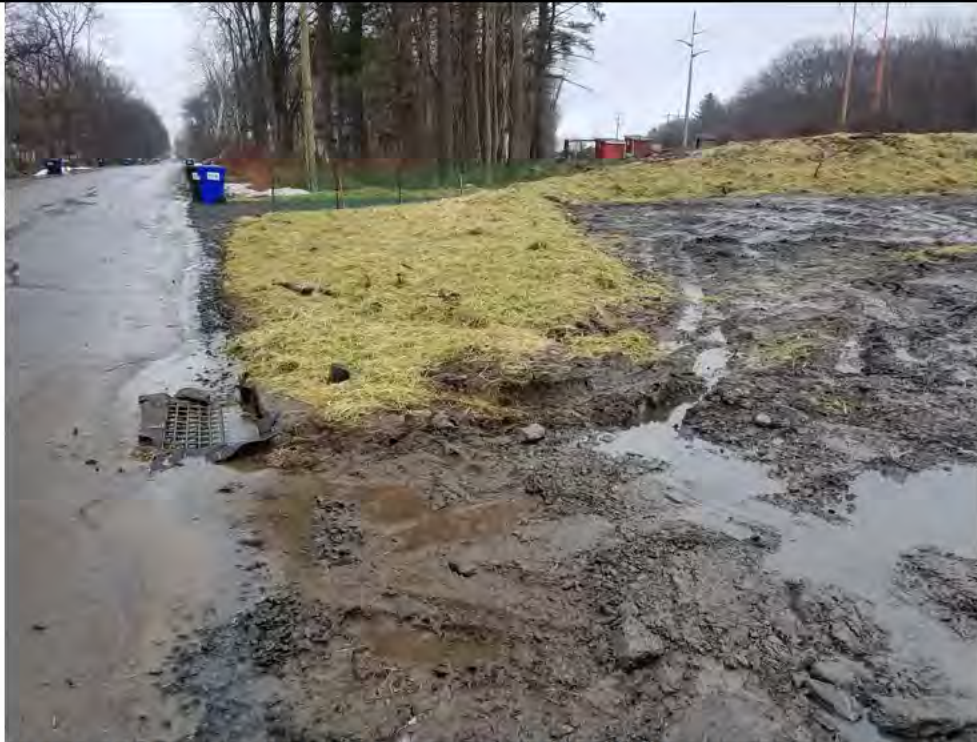
Photo 7: 3/31/2017, Litchfield: Map 29, Str81 abutting Campville Road, E&S, tracking pad, and catch basin protection needed. Corrections were reportedly made on this day after the time of this inspection.

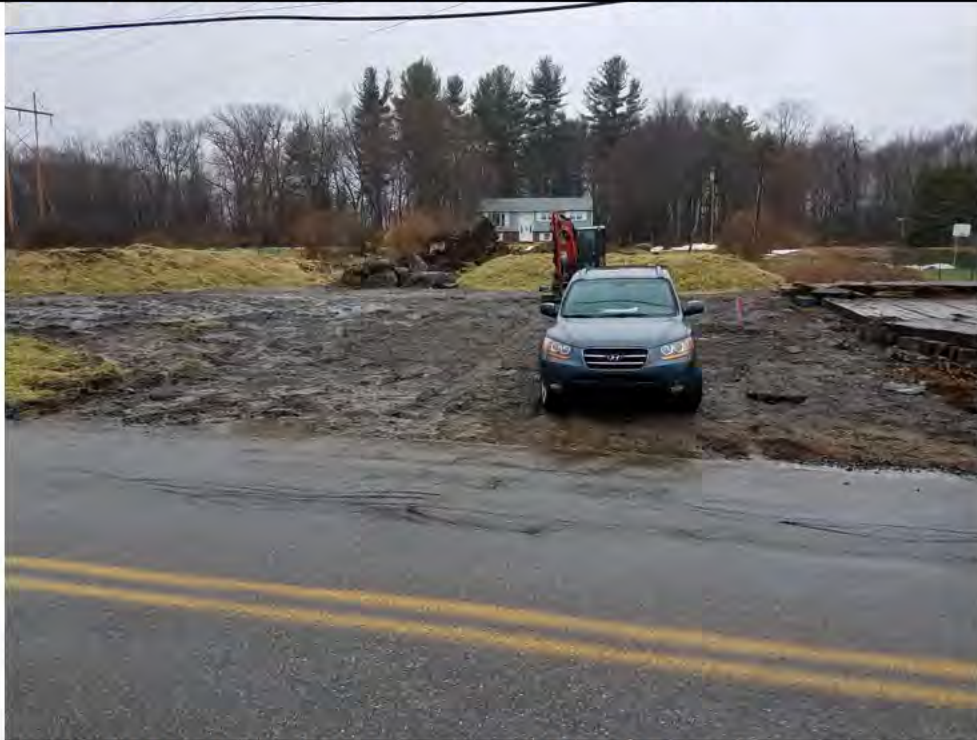
Photo 8: 3/31/2017, Litchfield: Map 29, Str81 abutting Campville Road, E&S, tracking pad, and catch basin protection needed. Corrections were reportedly made on this day after the time of this inspection.

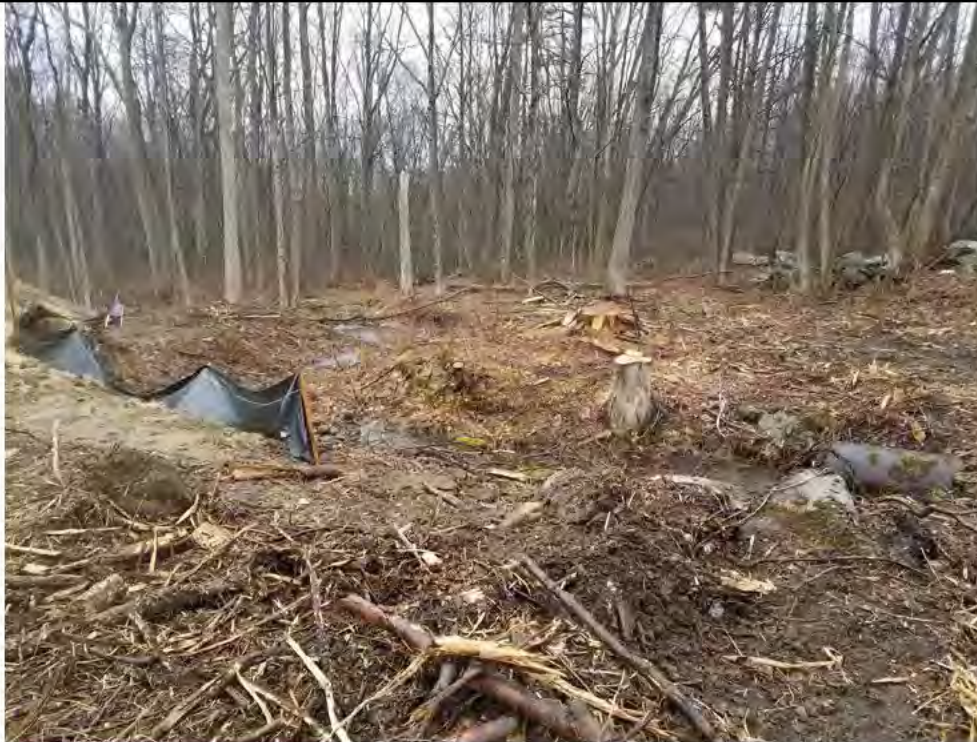
Photo 9: 3/31/2017, Litchfield: Map 29, Str83 abutting W-F4 and S-F2, failing E&S.

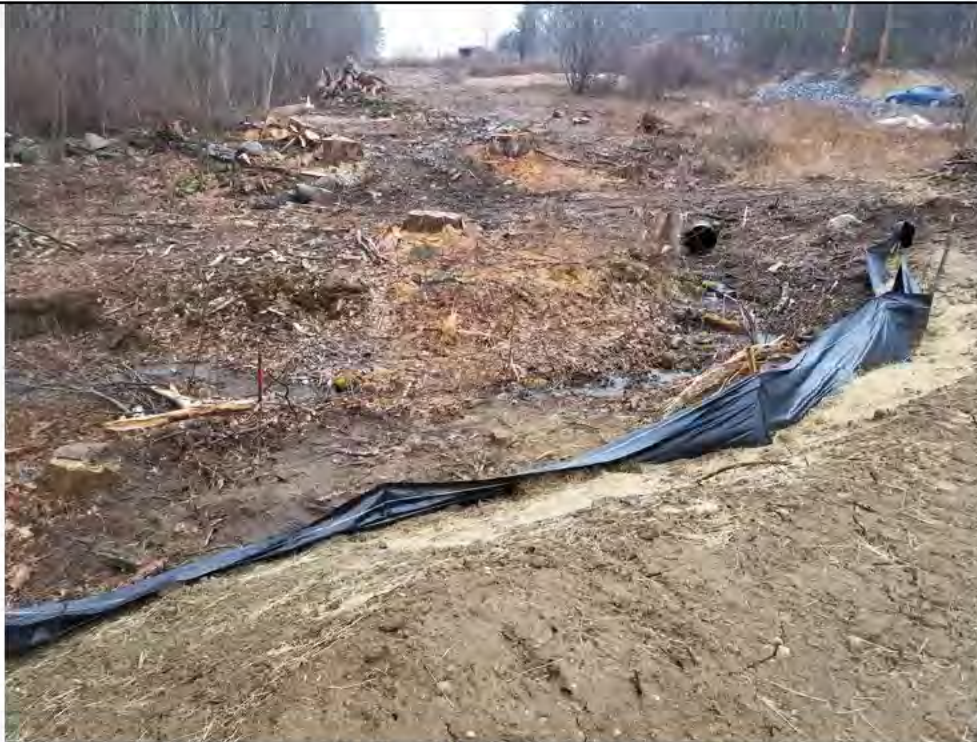
Photo 10: 3/31/2017, Litchfield: Map 29, Str83 abutting W-F4 and S-F2, failing E&S.

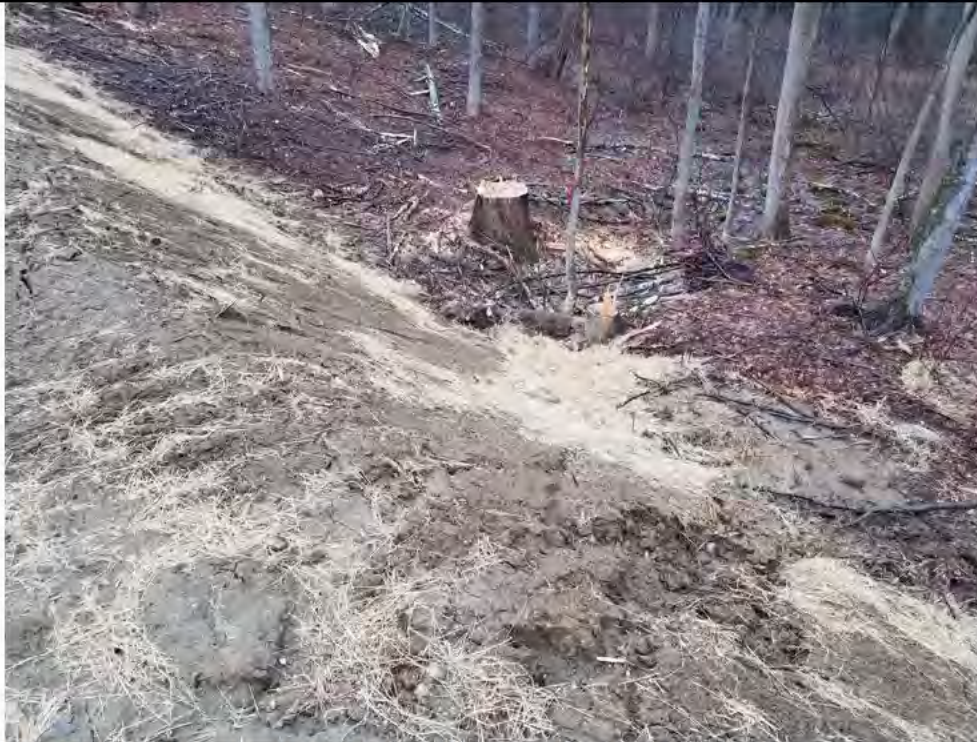
Photo 11: 3/31/2017, Litchfield: Map 29, Str83 abutting W-F4 and S-F2, E&S and pad armament required.

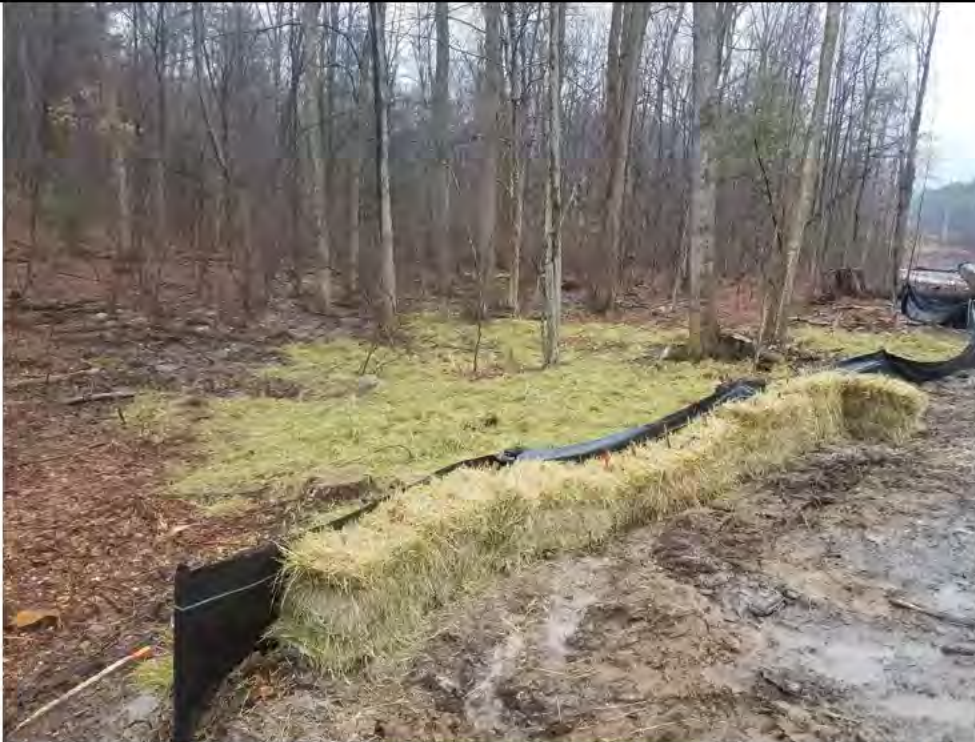
Inland Wetland & Watercourse encroachment & mitigation	Interim Week	Timber mat installations (temporary access roads and temporary structure pads) in wetland areas are in accordance with the BMPs as outlined in the D&M. Cont. from Observations Section- Eversource Outreach and project contractors responded to repair the driveway and install additional E&S to protect the wetlands, private driveway, and public roadway and drainage basins (See Photos 2-6). Additional E&S controls, protection of roadway catch basins, as well as placement of a stone tracking pad was installed at the abutting Str81 later in the day (3/31/17). Before photos are included as Photos 7 & 8.	Cont. from left column- During dewatering activities at Str96 the silt bag ruptured and the surrounding dirt berm washed into a portion of W-G1(Map 35). Wetland restoration was performed, E&S controls were placed between the pad and the wetlands (See Photos 12, 13 & 14). Dewatering at this pad/structure has been completed.	N/A

Photo 13: 3/31/2017, Harwinton: Map 35, Str96 abutting W-G1, restoration and installation of E&S, post wetland impact.

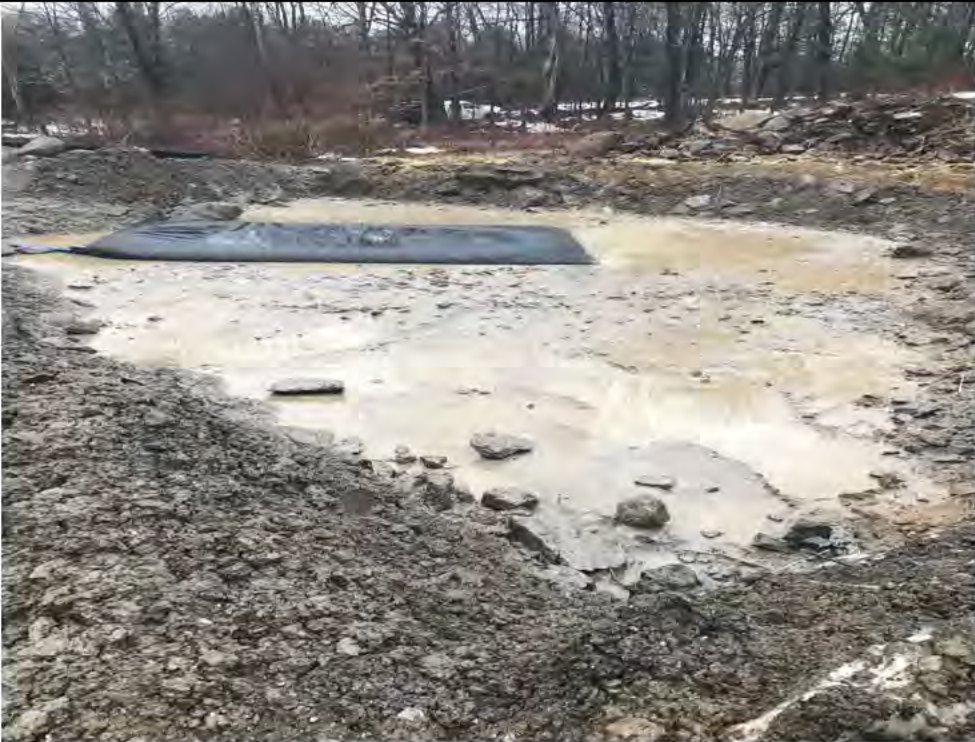
Photo 14: 3/31/2017, Harwinton: Map 35, Str96 abutting W-G1, silt bag and dirt berm, area of release (Photo provided by Matt Davison).

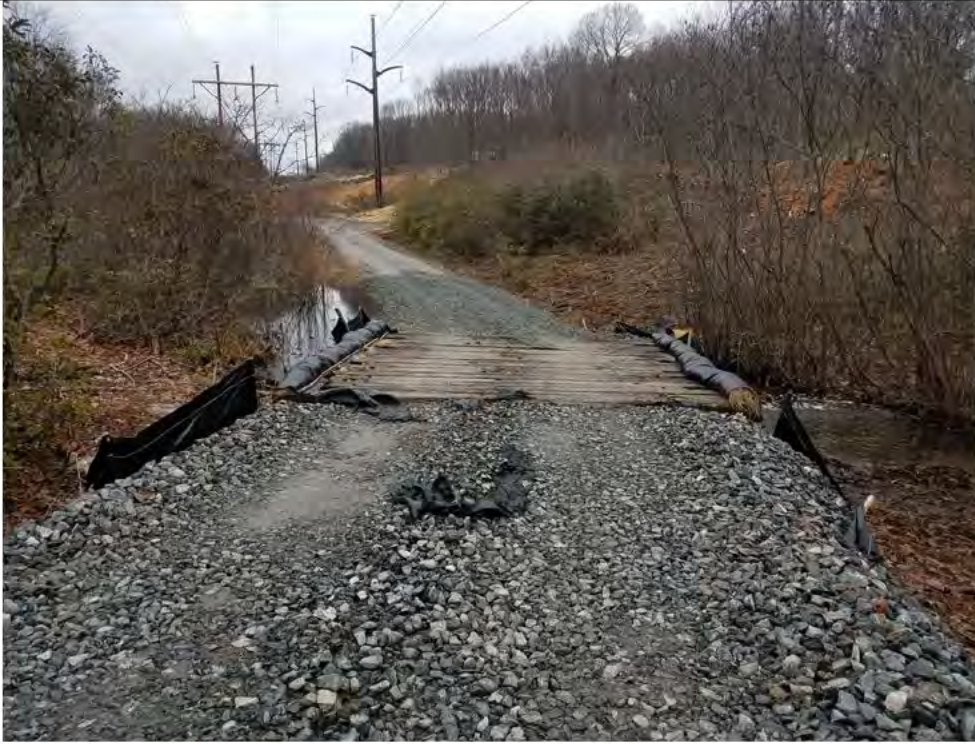
Photo 15: 04/07/2017, Thomaston: Map25, Timber mat crossing at S-E3.

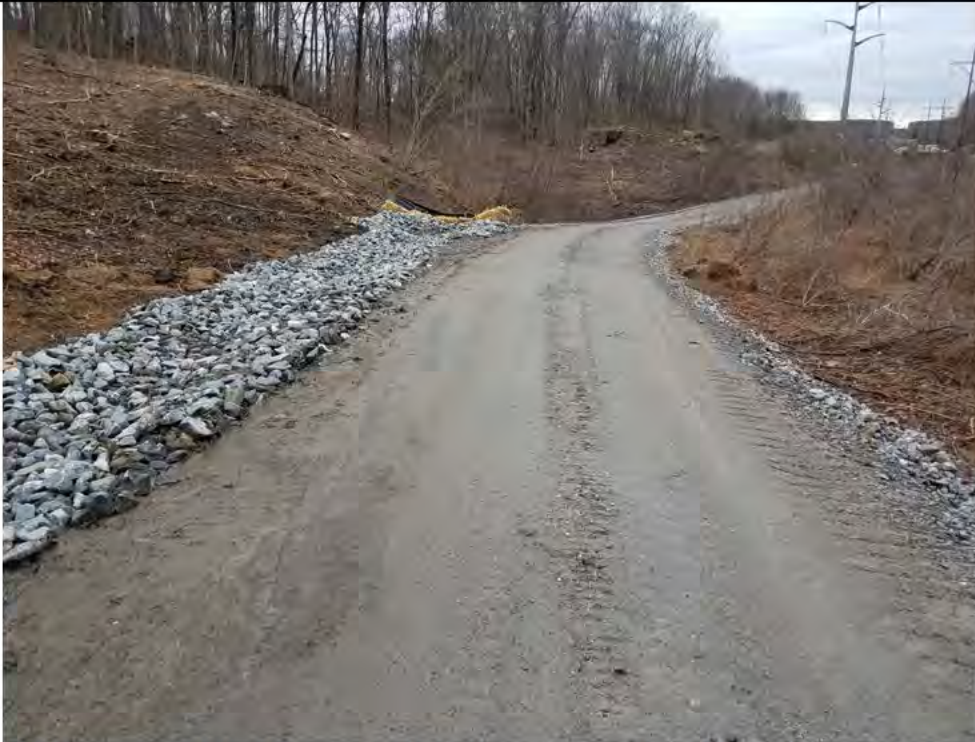
Photo 16: 04/07/2017, Thomaston: Map25, rock swale to temporary sediment basin/trap for surface water diversion.

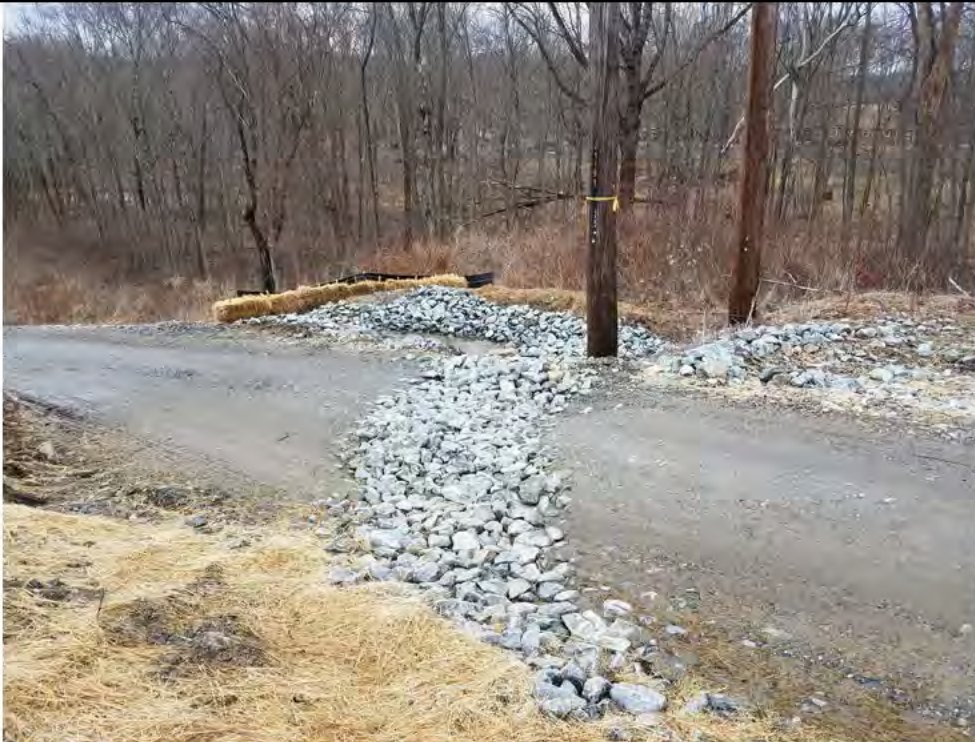
Photo 17: 04/07/2017, Litchfield: Map 26, waterbar to temporary sediment basin/trap.

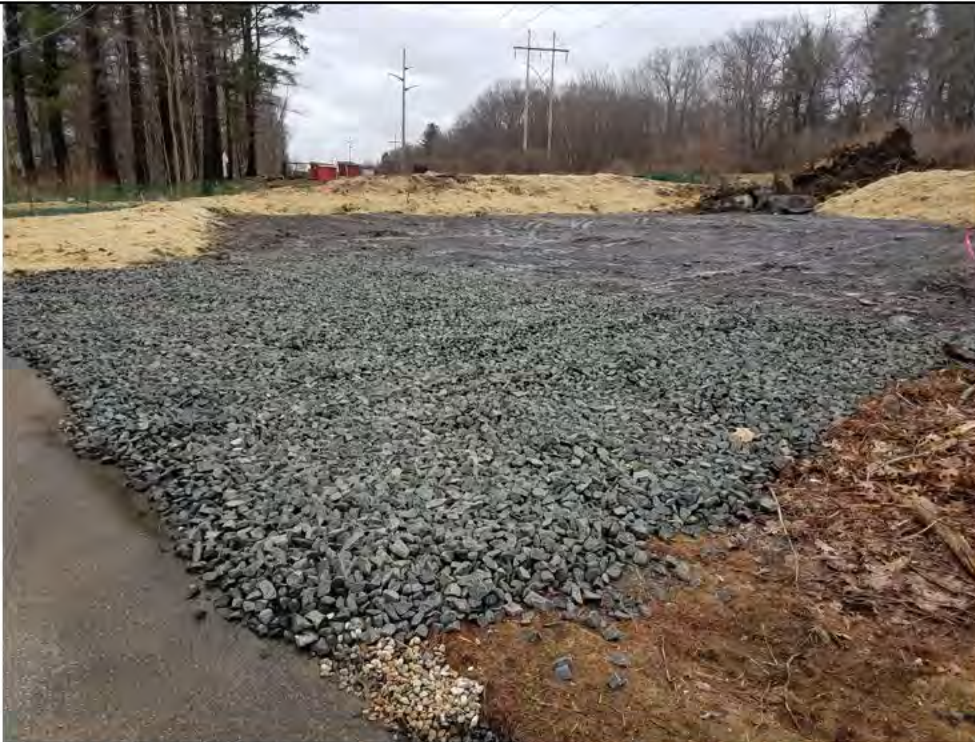
Photo 18: 04/07/2017, Litchfield: Map 29, Stone tracking pad at Str81 and Campville Road.

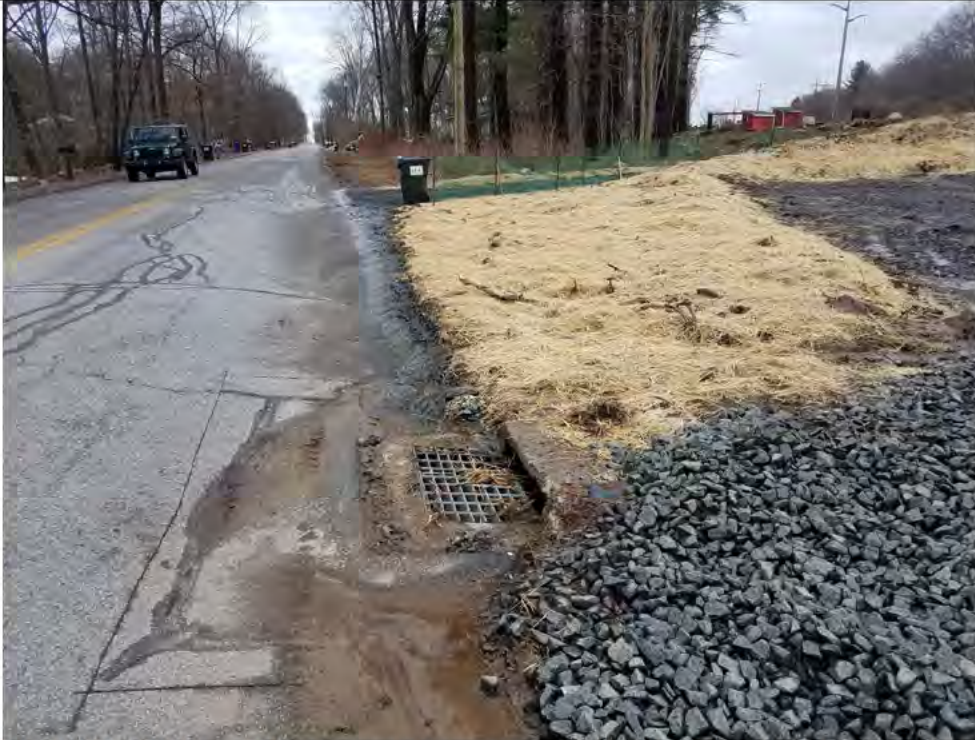
Photo 19: 04/07/2015, Litchfield: Map 29, between ROW access road to Str80 (Southard property) and street access to Str81, E&S controls and catch basin drainage protection measures.

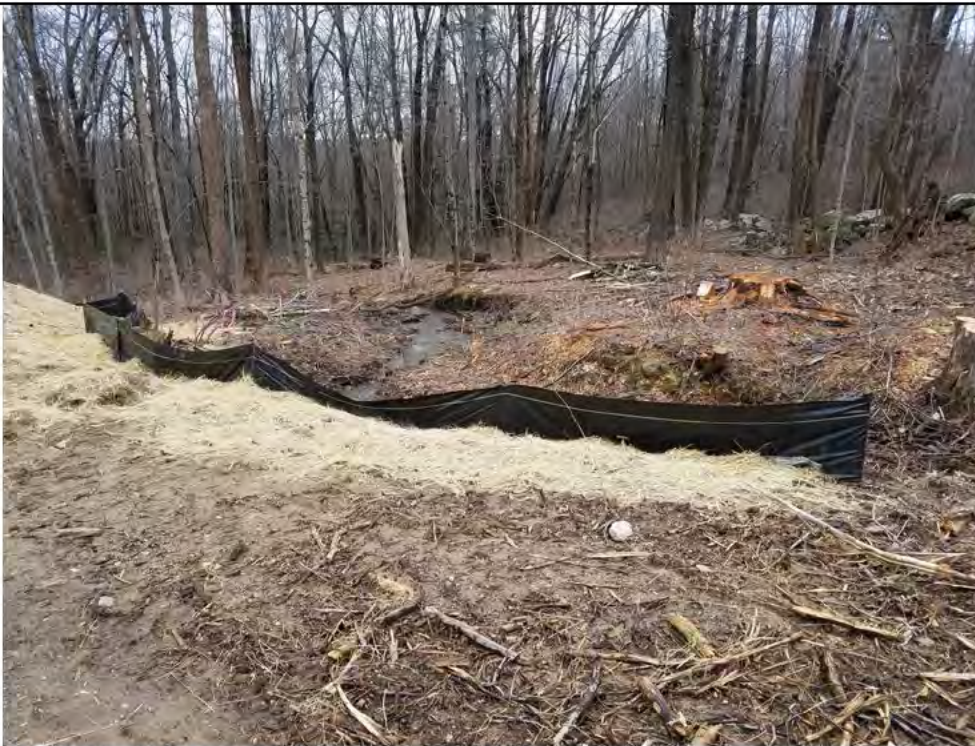
Photo 20: 04/07/2017, Litchfield: Map 29, E&S controls at Str83.

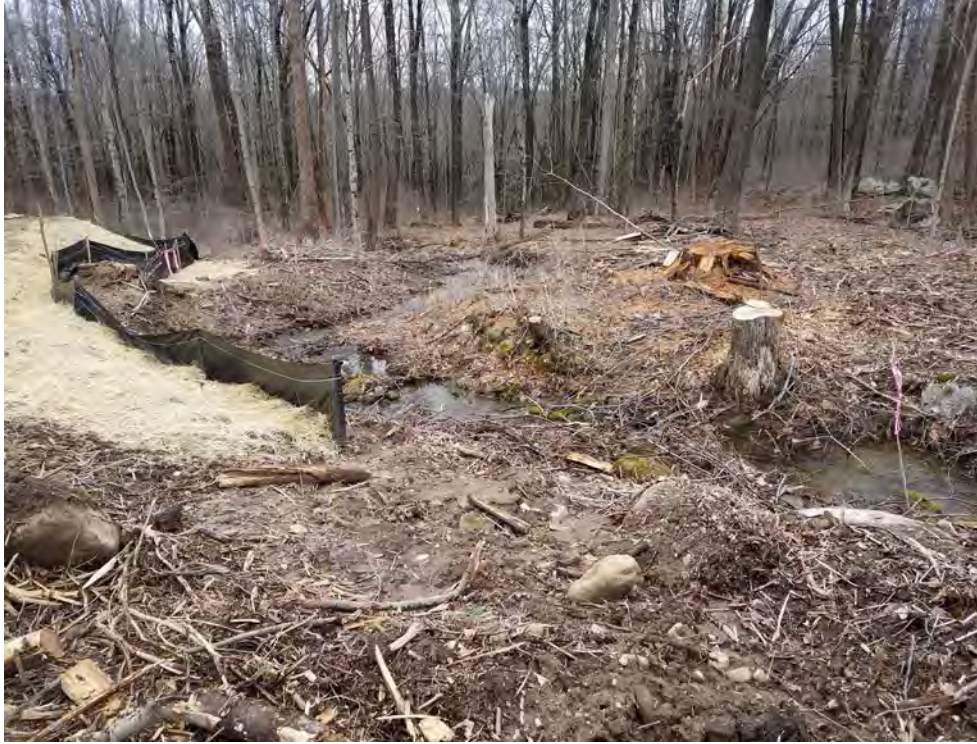
Photo 21: 04/07/2017, Litchfield: Map 29, E&S controls at Str83 and W-F4/S-F2.

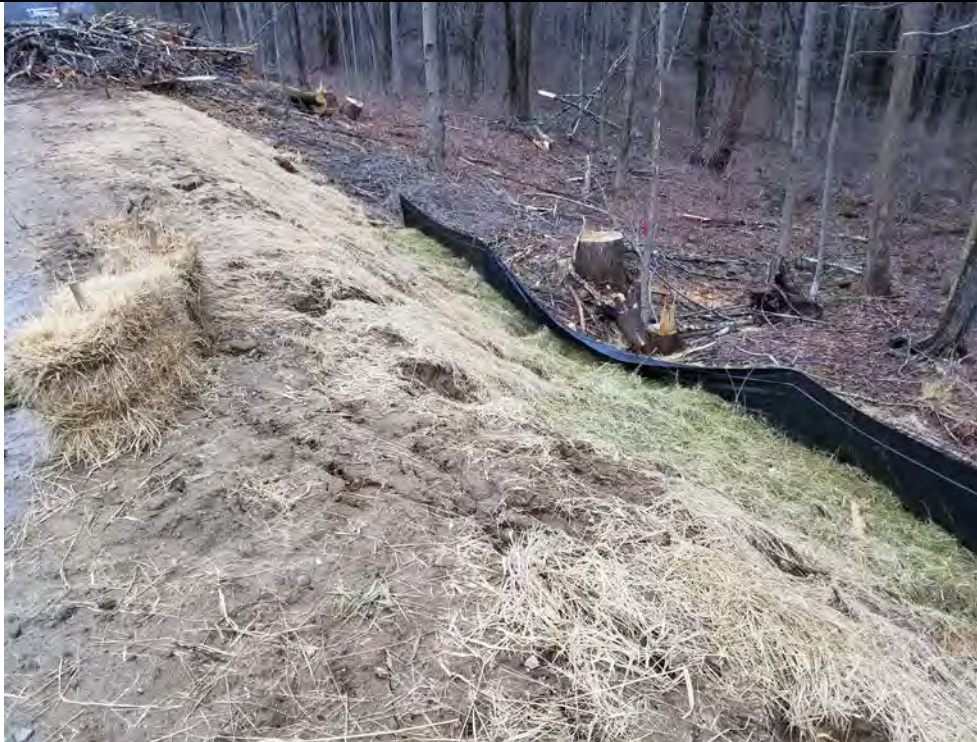
Photo 22: 04/07/2017, Litchfield: Map 29, E&S controls at Str83, erosion of slope material.

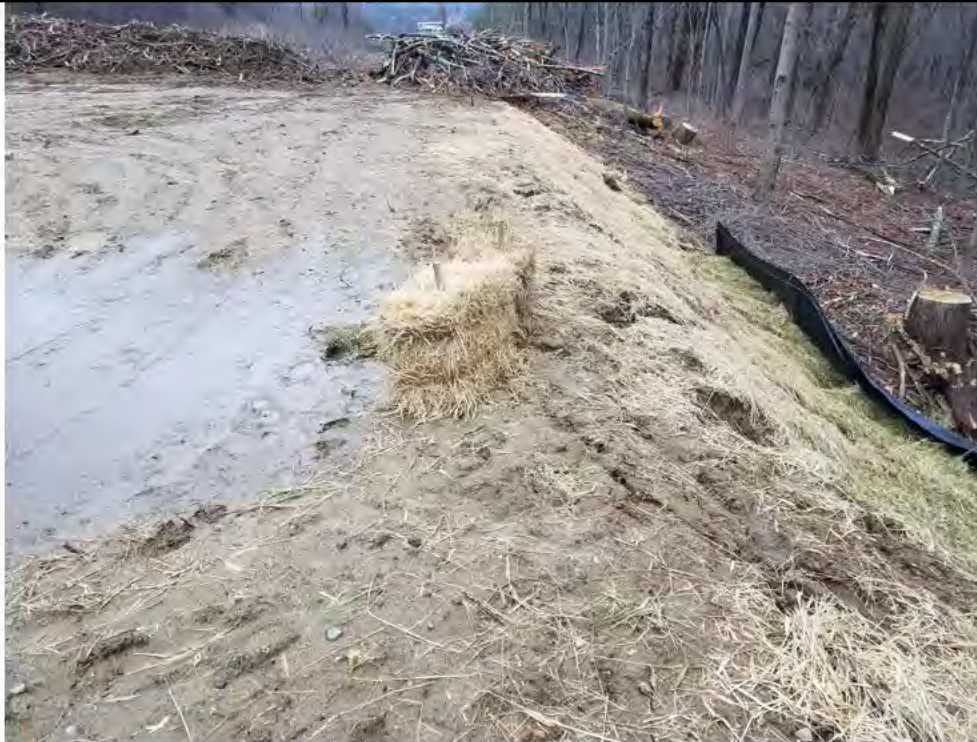
Photo 23: 04/07/2017, Litchfield: Map 29, E&S controls at Str83, ponding on top of pad and runoff causing rills to form.
