**Subject: Docket No. 466, Frost Bridge to Campville 115-kV Project
Decision and Order Condition #4 – Independent Environmental Inspector Report**

Please find enclosed the Biweekly Independent Environmental Inspector Report, Report #11, for the **April 28th** and **May 5th 2017**, inspection events for the construction of the Eversource Frost Bridge to Campville 115-kV Project.

Photograph Log Frost Bridge to Campville 115kV Project

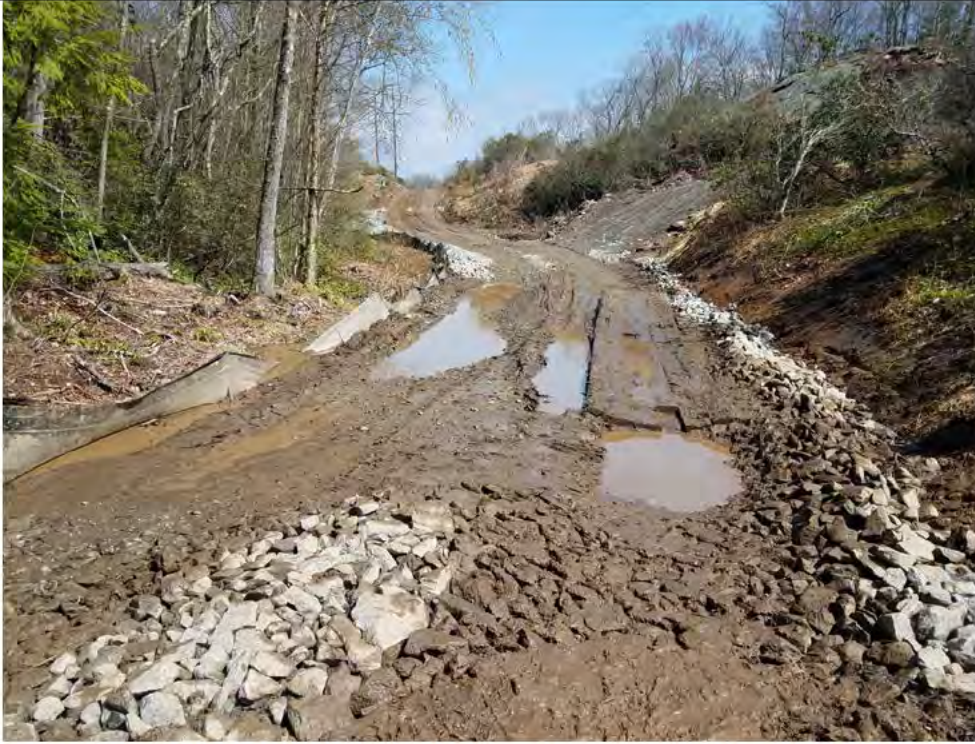
Areas of Inspection		Observation:	Recommended Action/s:	Corrected Action/s:
Access Roads and Adjacent Roadways	Interim Week	In the area of wetland W-C18 (Watertown, Map 13), excessive rutting and ponding was observed, E&S controls required maintenance, and road requires regrading and stone or matting. See photo #1.	Discussed with Matt Davison and Northern crew, the area will be stabilized and matted to prevent further rutting, and E&S controls will be repaired.	Northern stated they would tend to this area immediately.
	Bi-Week	Access and adjacent roadways are clear and maintained. No excessive rutting or ponding of surface water observed. Improvements made in the area of W-C18, performed after the 4/28/17 inspection. See photos #5 & 6.	Continue to monitor and maintain.	N/A
Vegetative Clearing Limits (Including trees to save or danger trees noted.	Interim Week	No out of bounds or excessive clearing observed. Areas currently being cleared are flagged and flagging is updated when needed. ROW photos taken, see photos #2, 3,4.	N/A	N/A

Photo 1: 4/28/2017, Watertown: Map 13, Wetland W-C18 impacts, ponding, rutting, failed E&S controls.

An email was sent to Matt Davison requesting checks of the project E&S controls site wide and specifically within the area of W-C18. Matt will follow up with Northern on the repair of E&S controls within areas discussed in this report. TRC will revisit these areas during the scheduled inspection on 5/12/17 to ensure corrective actions were taken.

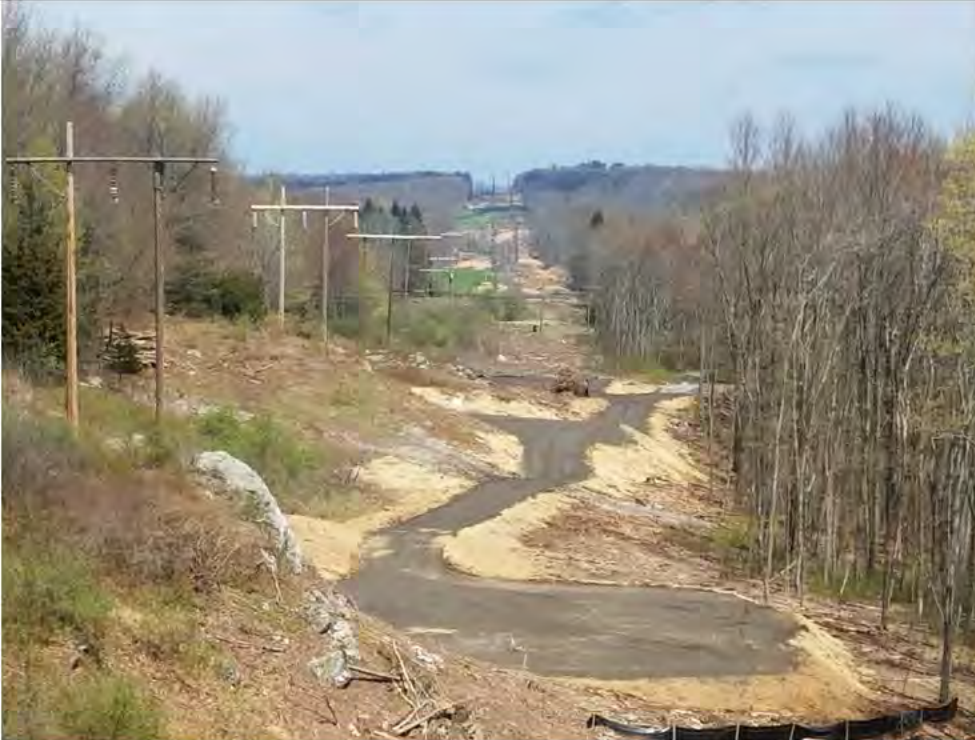
Photo 2: 4/28/2017, Thomaston: Maps 21 & 25, ROW photo, Str60 to Str70 in the far distance at the top of the ridge.

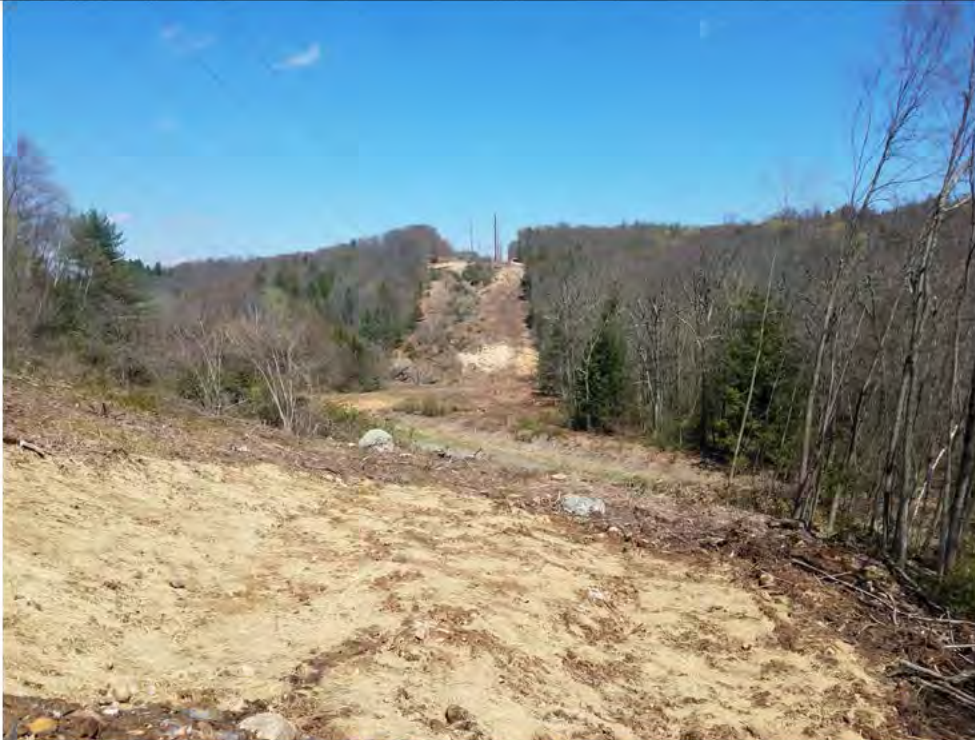
Photo 3: 4/28/2017, Thomaston: Maps 24 & 25, ROW photo, at Str69 to Str70 at the top of the ridge.

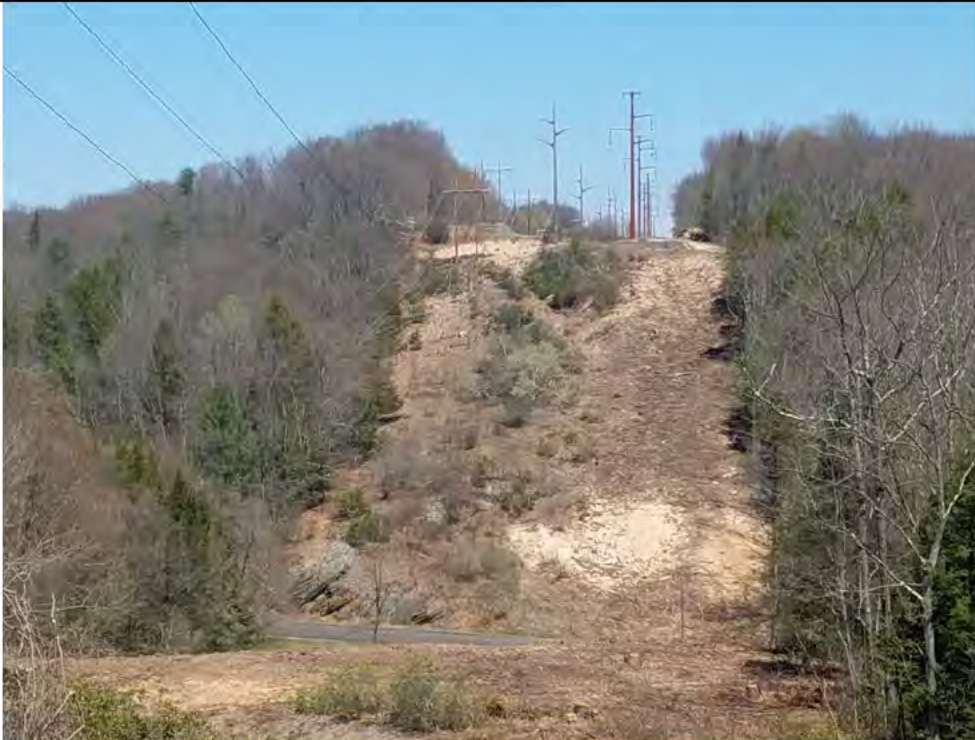
Photo 4: 4/28/2017, Thomaston: Map 25, ROW photo, at Str69 to Str70 at the top of the ridge.

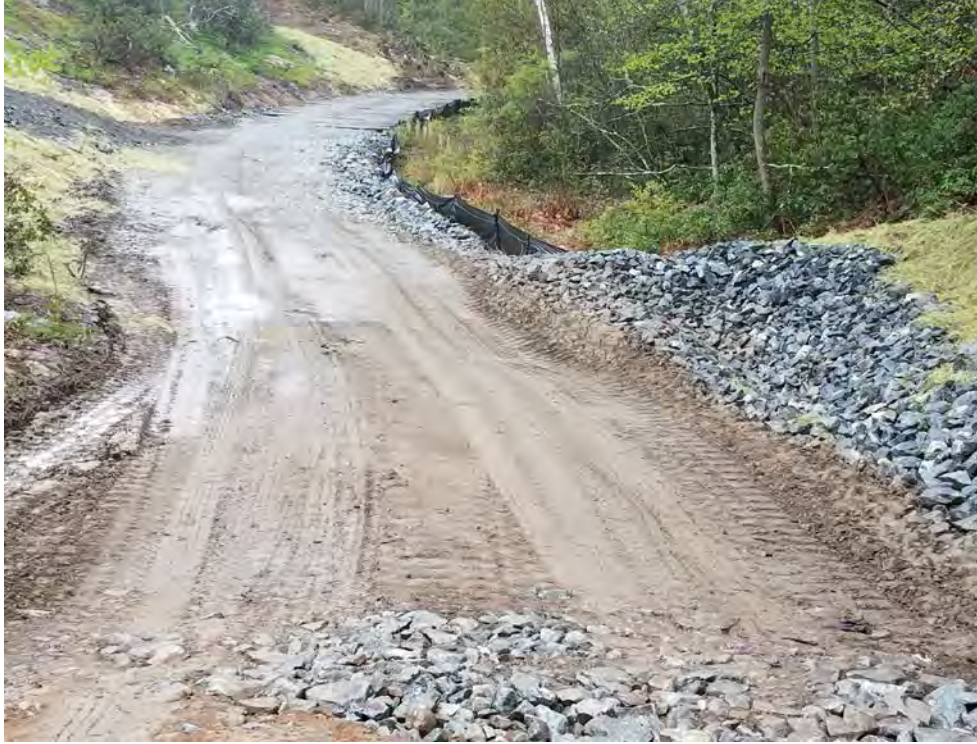
Photo 5: 05/05/2017, Watertown: Map 13, E&S controls and access road improvements in area of wetland W-C18.

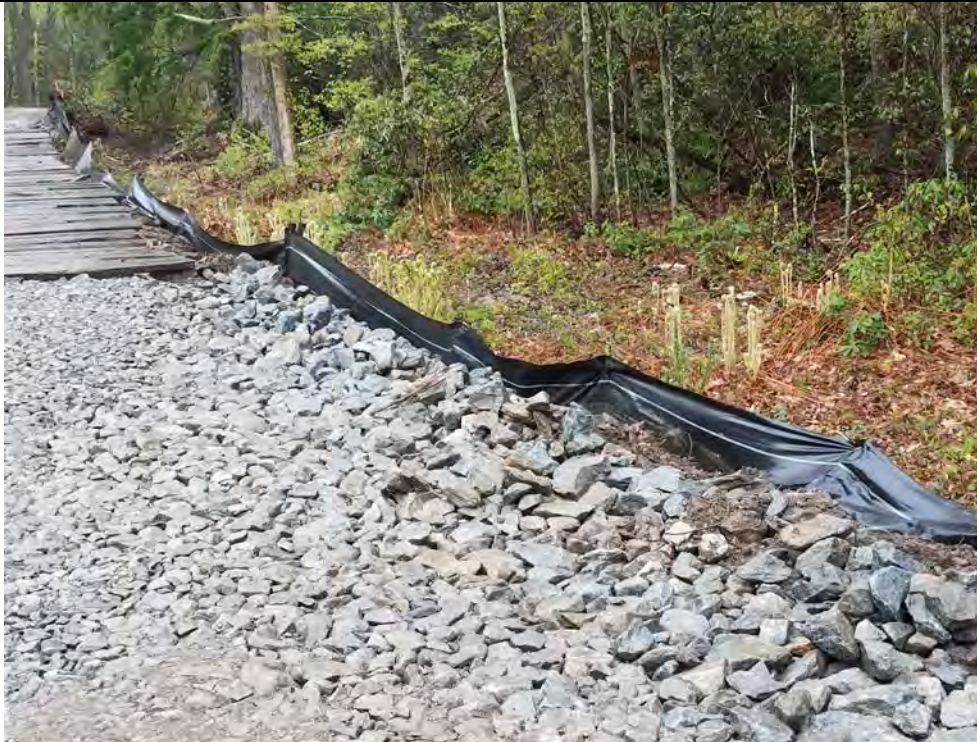
Photo 6: 05/05/2017, Watertown: Map 13, E&S repairs needed in area of wetland W-C18.

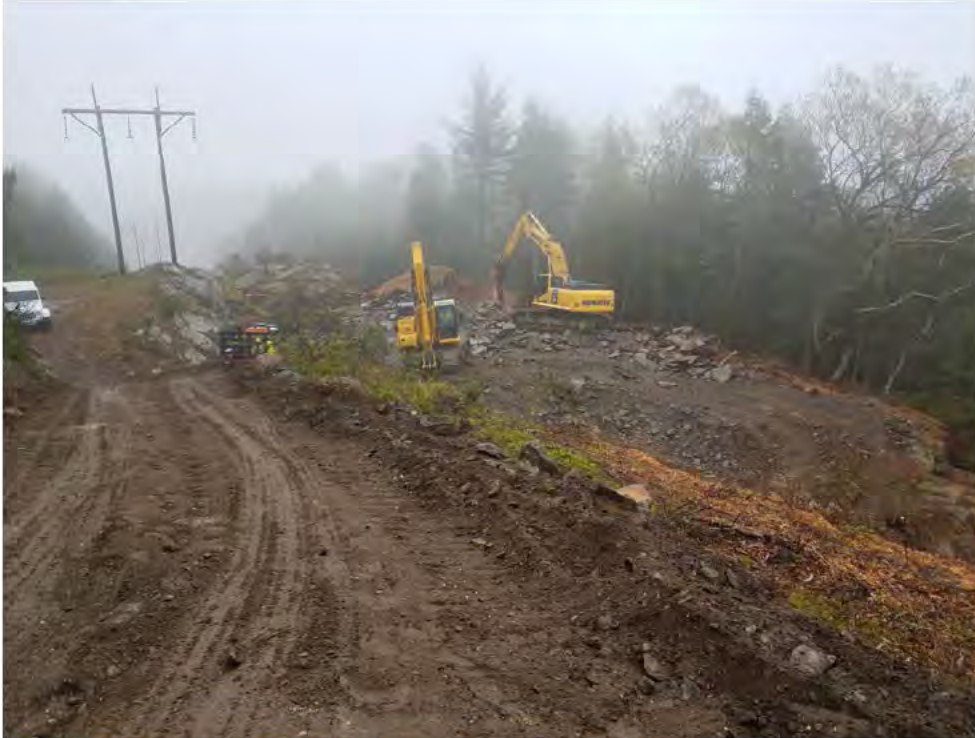
Photo 7: 05/05/2017, Watertown: Map 17, Str49 Pad construction, rock hammering and rough grading.

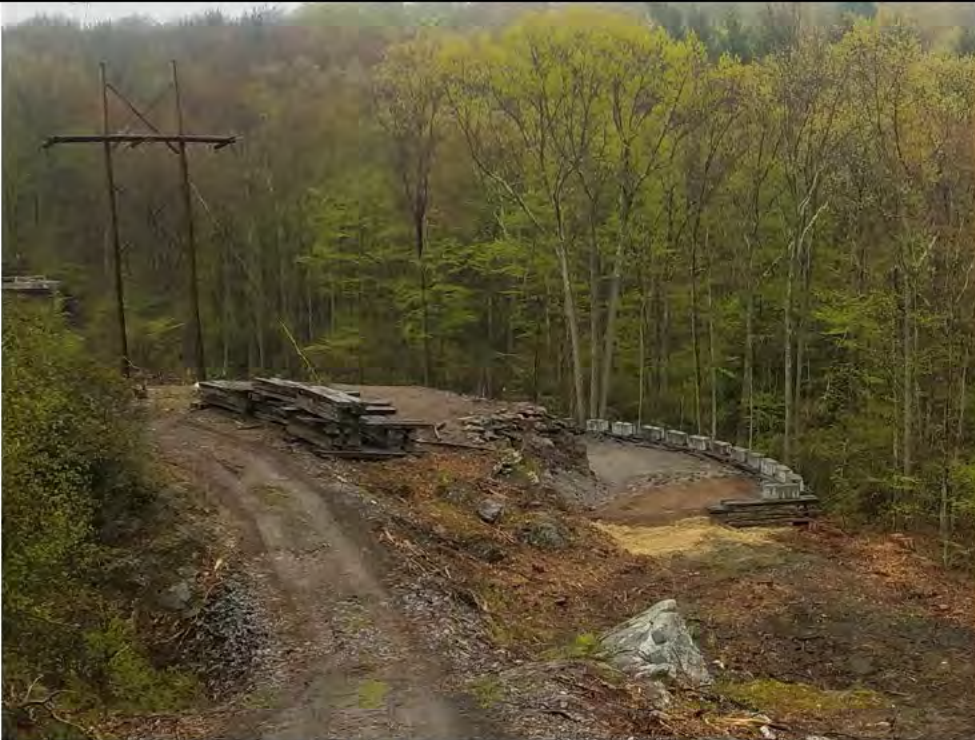
Photo 8: 05/05/2017, Thomaston: Map 18, Str50 pad construction completed.

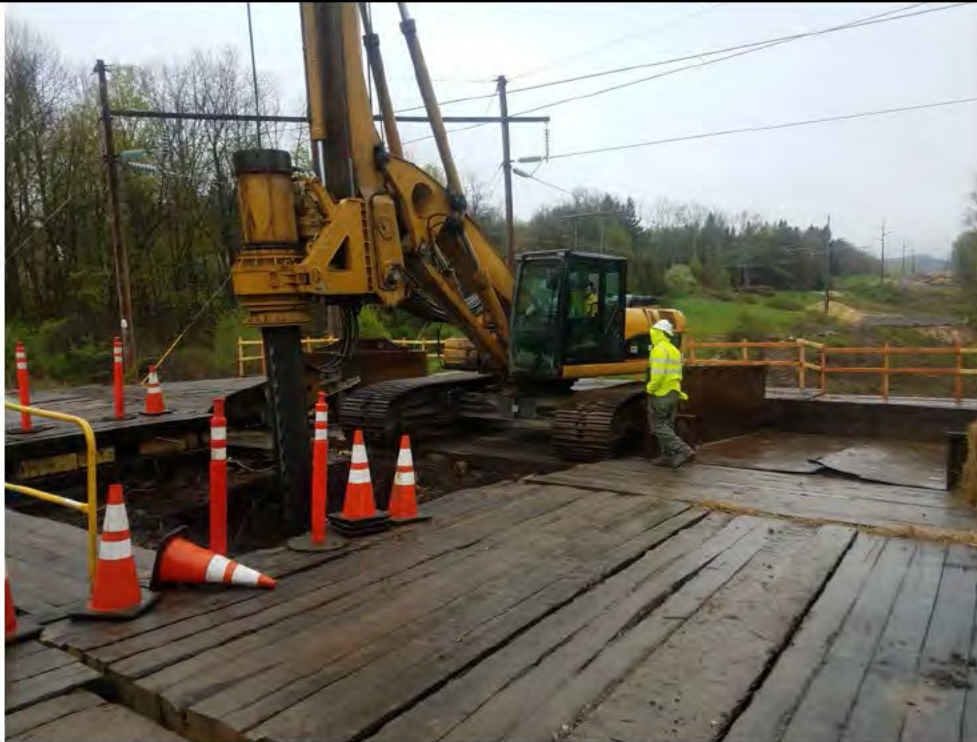
Photo 9: 05/05/2017, Thomaston: Map 22, PAR drilling to install a drilled shaft vertical deadend steel structure.

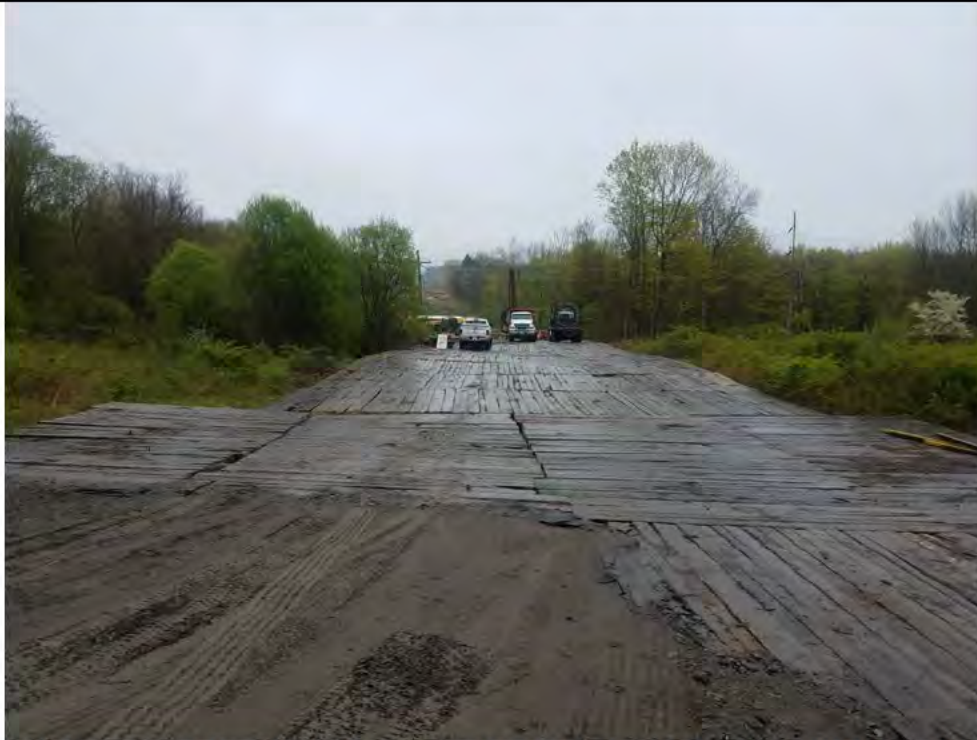
Inland Wetland & Watercourse encroachment & mitigation	Interim Week	Timber mat installations (temporary access roads and temporary structure pads) in wetland areas are in accordance with the BMPs. See photos #9 and 10.	Continue to maintain and clear excessive build up of sediments to prevent the accidental sedimentation into wetlands and watercourses.	N/A

Photo 10: 05/05/2017, Thomaston: Map 22, timber mat pad at Str63-Str64, & wetland W-D12 and vernal pool VP-D12-1.
