**Subject: Docket No. 466, Frost Bridge to Campville 115-kV Project
Decision and Order Condition #4 – Independent Environmental Inspector Report**

Please find enclosed the Biweekly Independent Environmental Inspector Report, Report #16, for the **July 7th** and **July 14th 2017**, inspection events for the construction of the Eversource Frost Bridge to Campville 115-kV Project.

Docket No. 466- Development and Management Plan Inspection

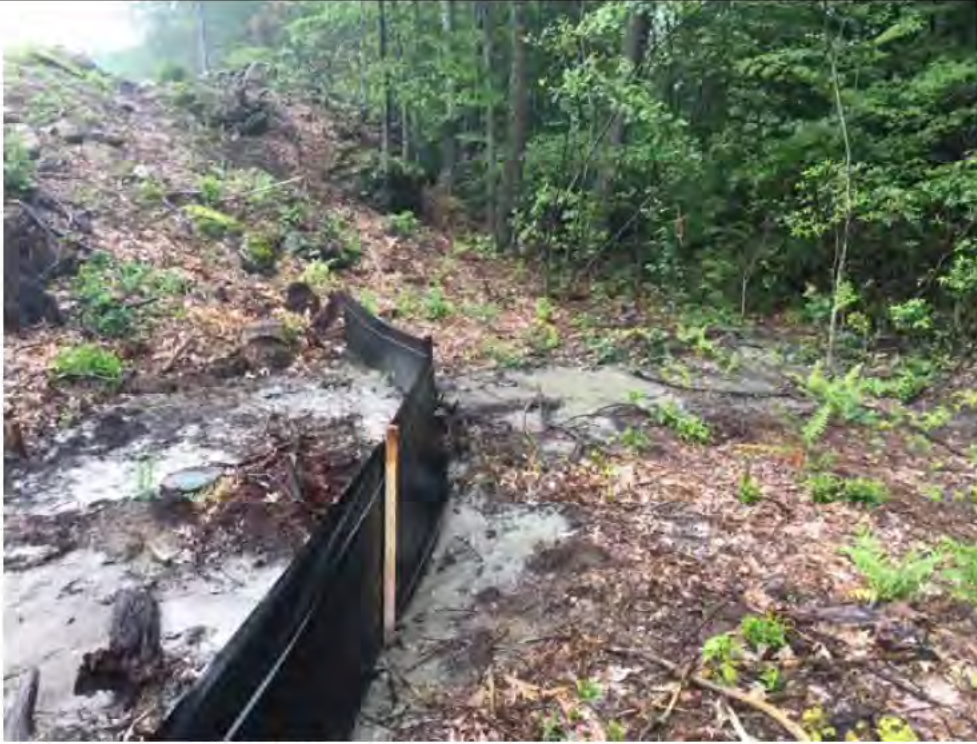
Photo 1: 07/07/2017, Watertown: Area of Str30 at W-C7, silt fence failure.

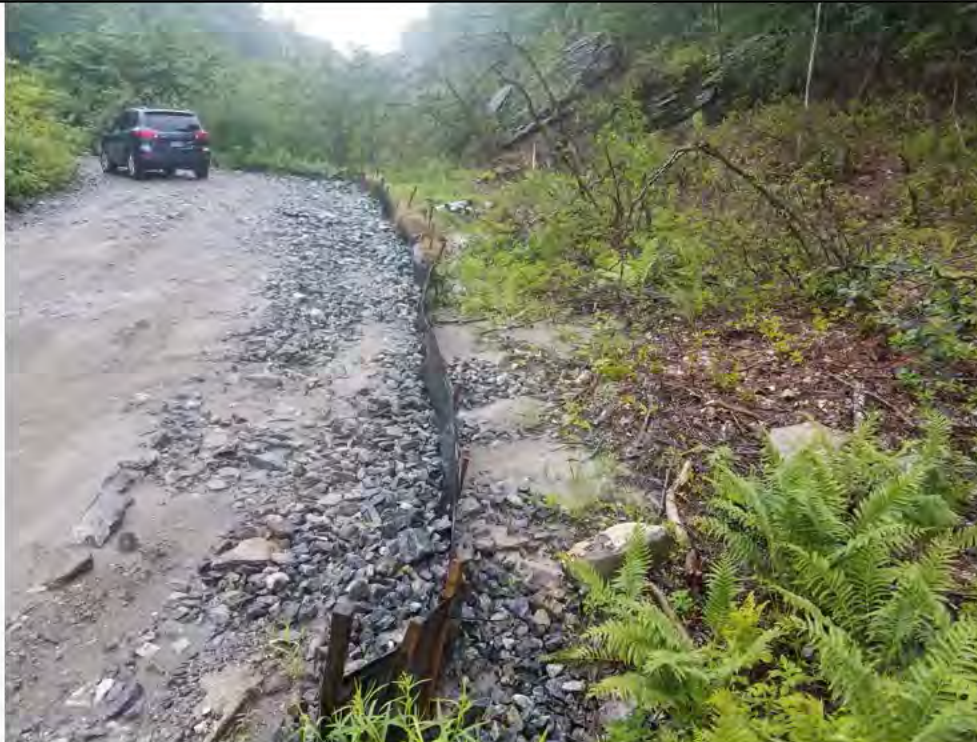
Photo 2: 07/07/2017, Watertown: Area of Str34 at W-C15, silt fence failure.

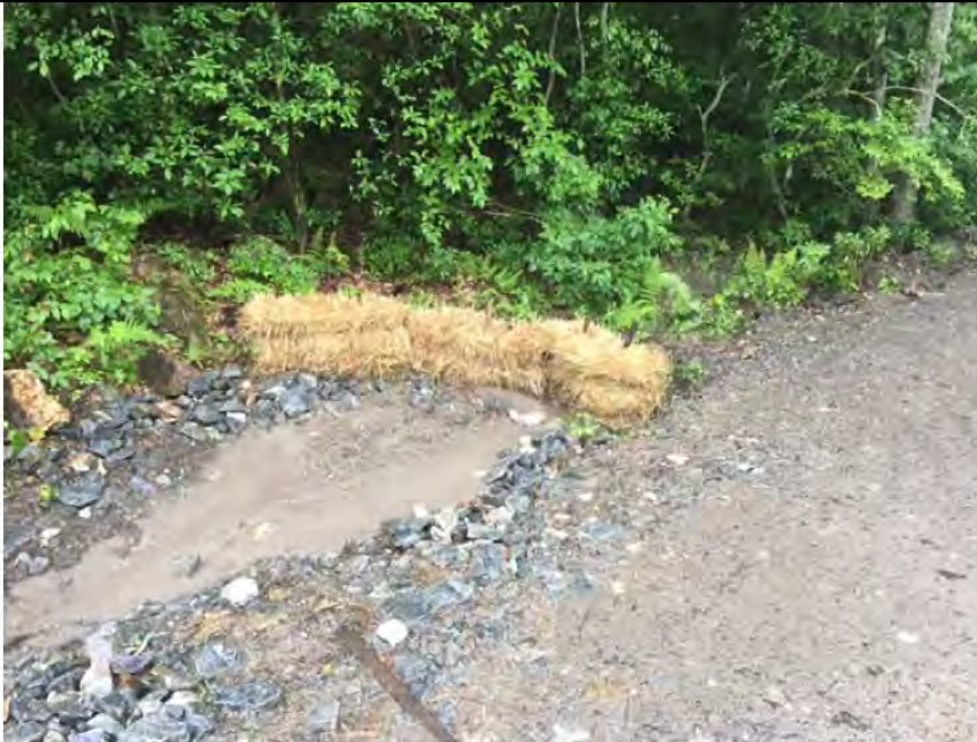
Photo 3: 07/07/2017, Watertown: Area of Str36, temporary sedimentation trap, excess sediment buildup.

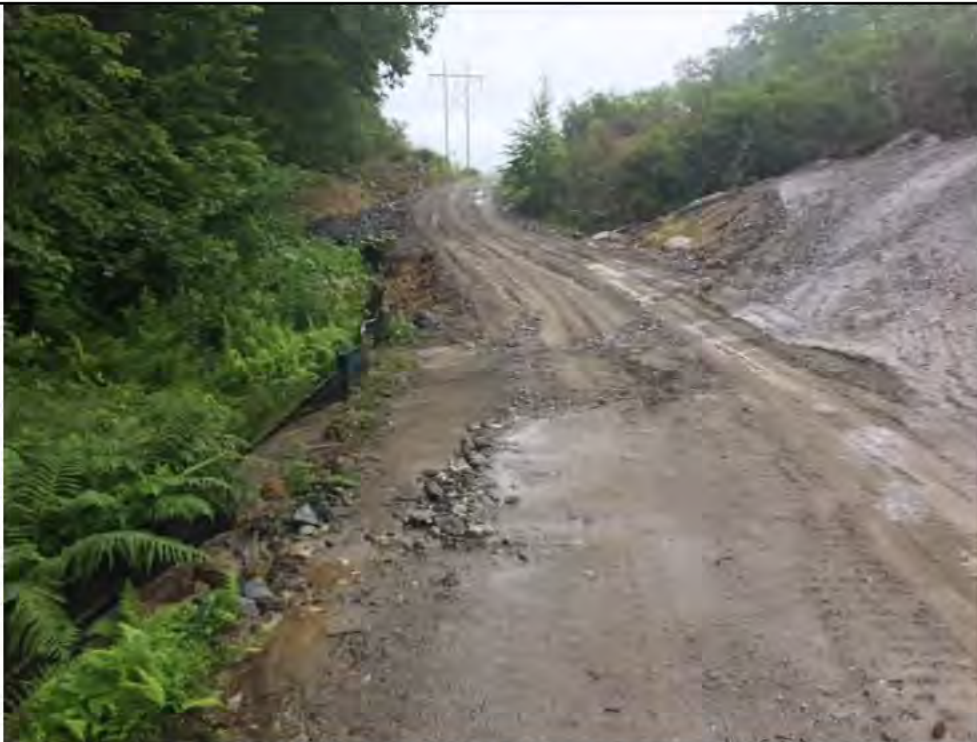
Photo 4: 07/07/2017, Watertown: Area of Str37 at W-C18, silt fence failure, sedimentation into W-C18.

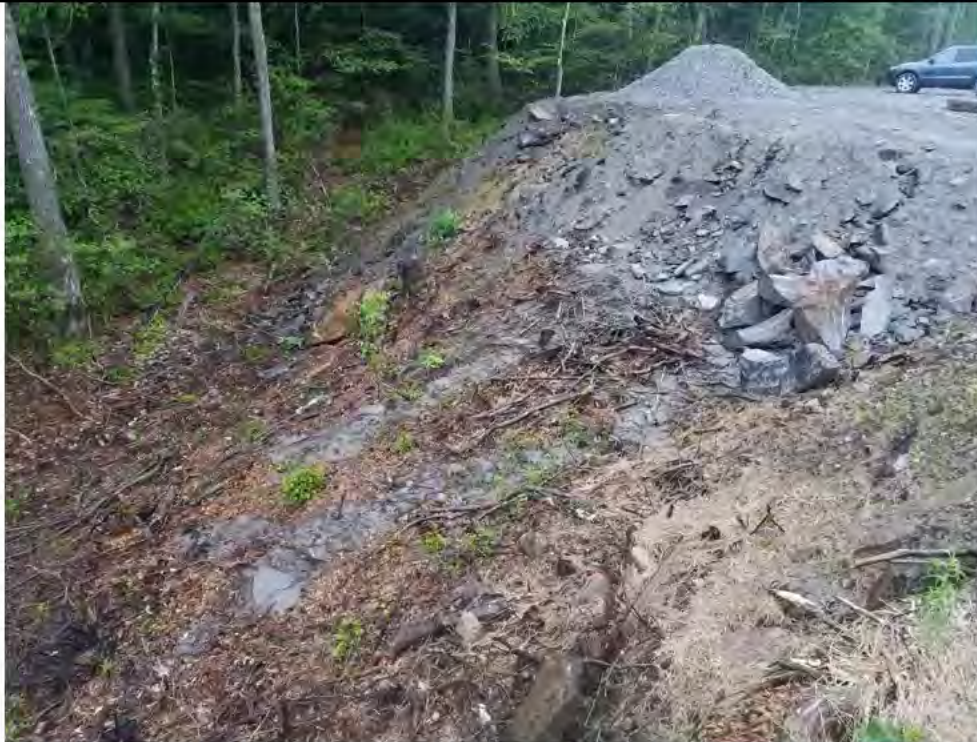
Photo 5: 07/07/2017, Watertown: Northwest corner of Str38 pad, rills and sedimentation off pad slope and visible surface water runoff from access road down slope.

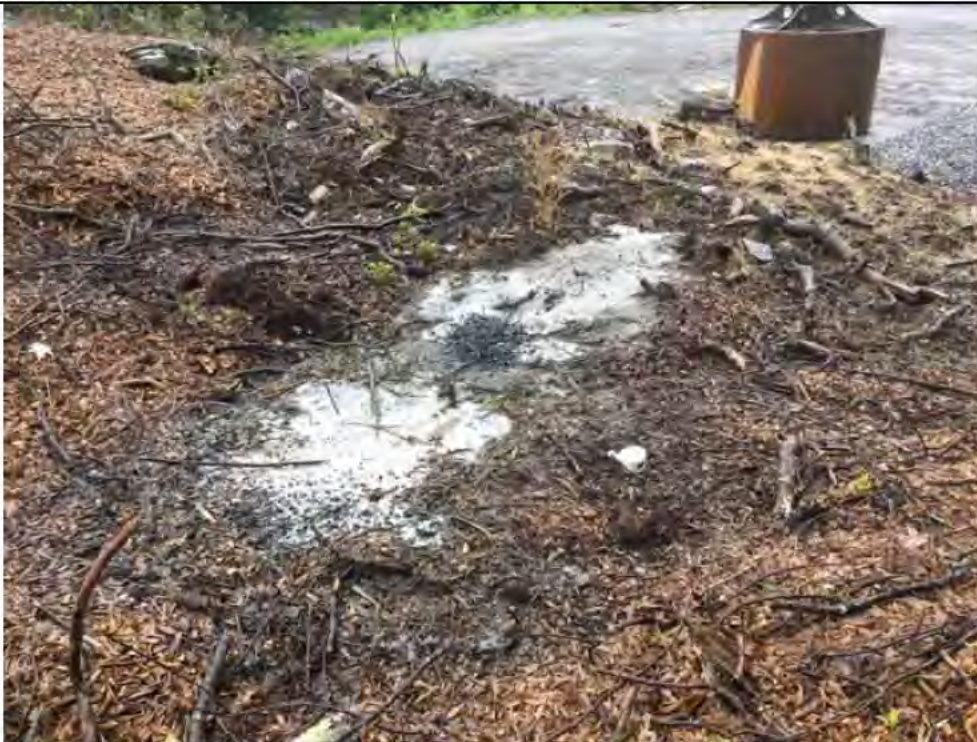
Photo 6: 07/07/2017, Watertown: Upland of Str38 pad, concrete discharge (truck cleanout).

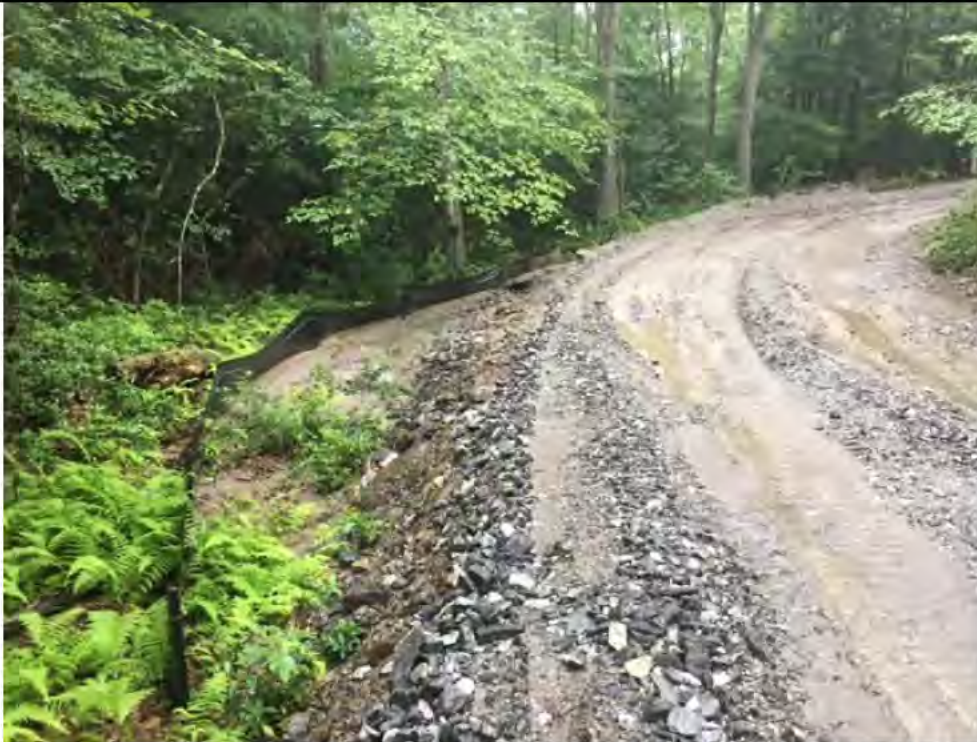
Photo 7: 07/07/2017, Watertown: Access road to Str42, excess sediment buildup and silt fence failure, sedimentation into wooded area.

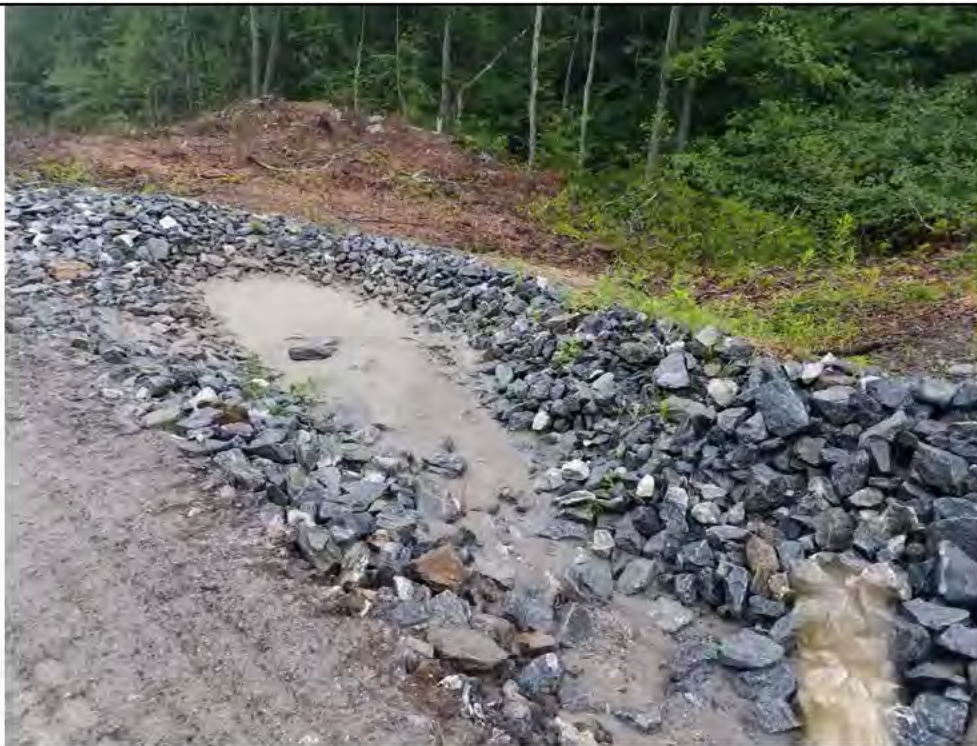
Photo 8: 07/07/2017, Watertown: Access road to Str43, excess sediment buildup in temporary sediment trap.

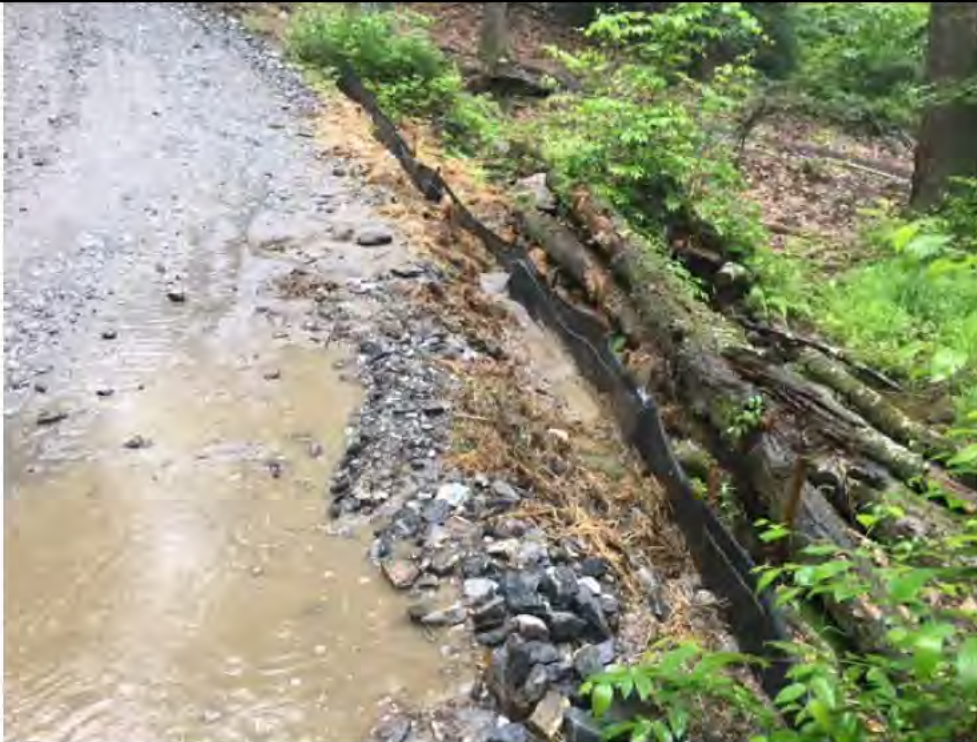
Photo 9: 07/07/2017, Watertown: Access road to Str45, excess sediment buildup and silt fence failure.

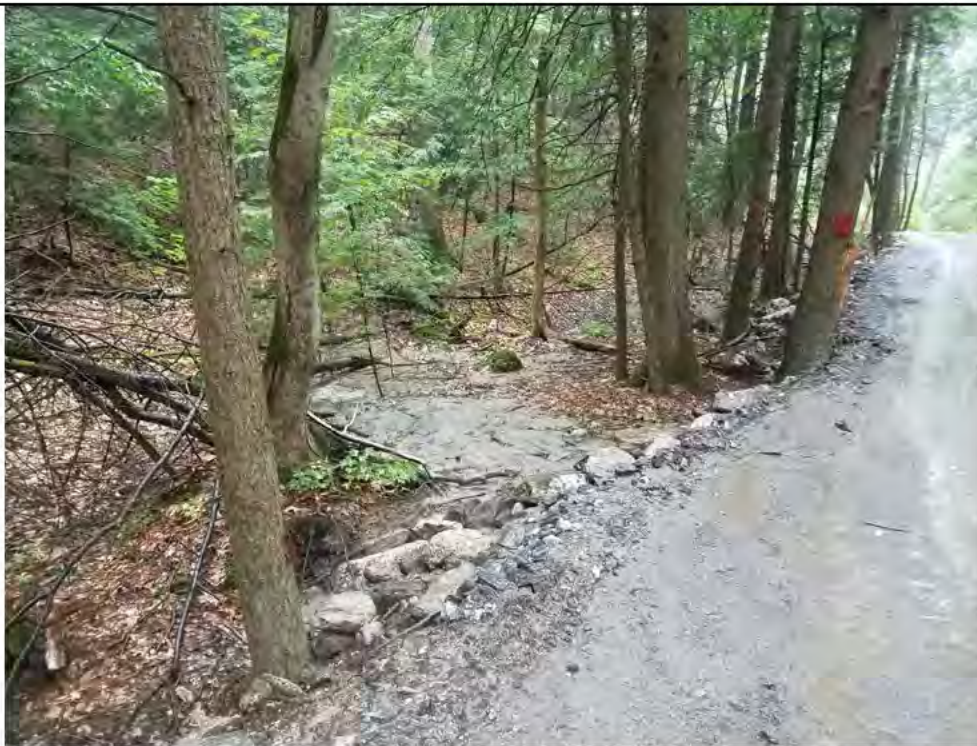
Photo 10: 07/07/2017, Watertown: Access road to Str45, surface water runoff, sedimentation into wooded area.

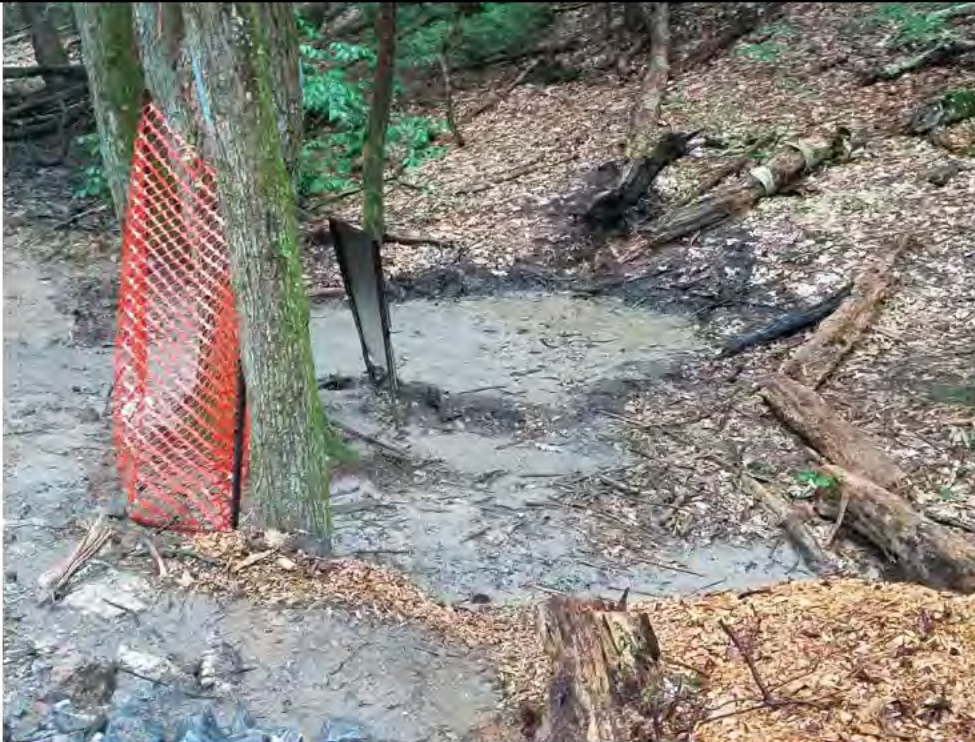
Photo 11: 07/07/2017, Watertown: Access road to Str45, surface water runoff, sedimentation into wooded area and designated CT State hiking trail access point.

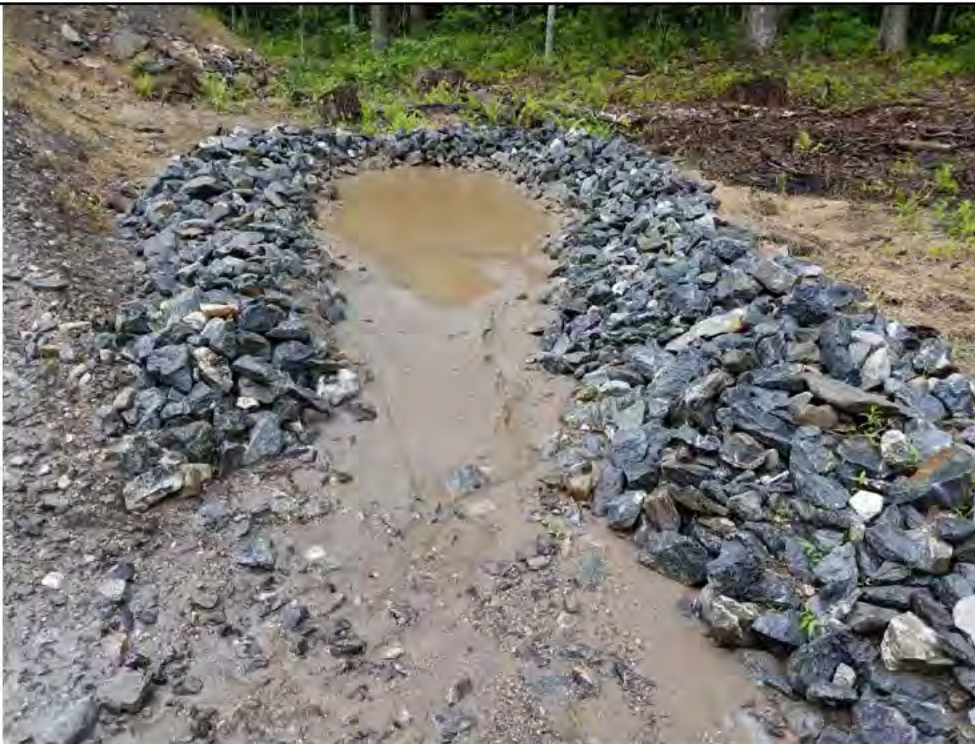
Photo 12: 07/07/2017, Watertown: Access road to Str37 at W-C7, excessive sediment buildup in temporary sediment trap, minor break through and sedimentation, not into W-C7.

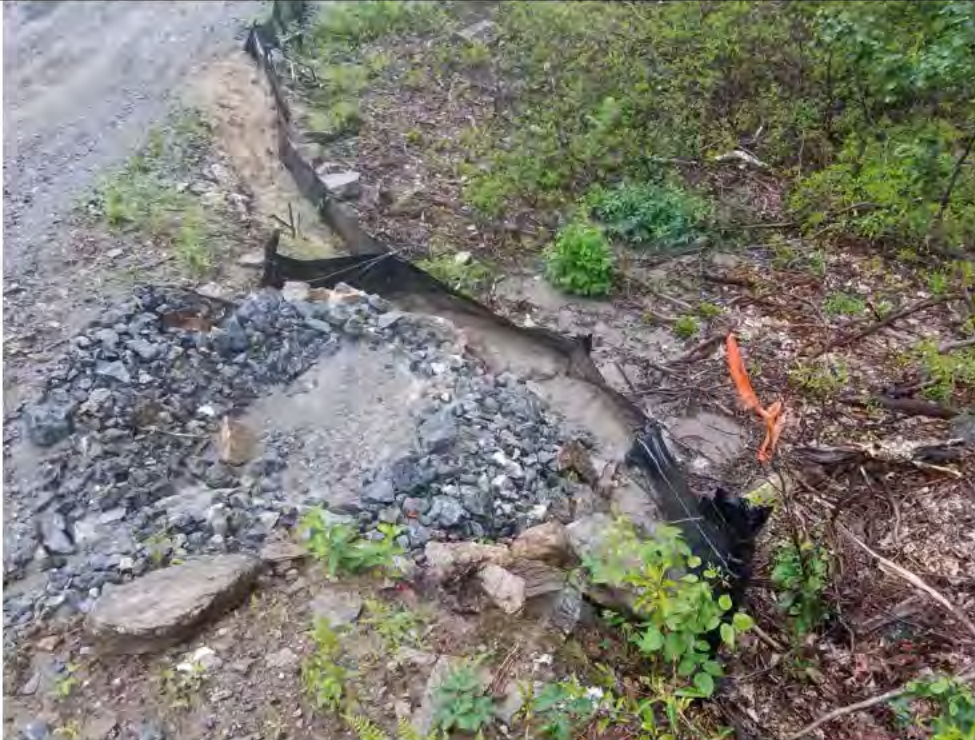
Photo 13: 07/07/2017, Watertown: Access road at W-C15, surface water runoff, improperly sized/constructed sedimentation trap. Silt fence failure, sedimentation into W-C15.

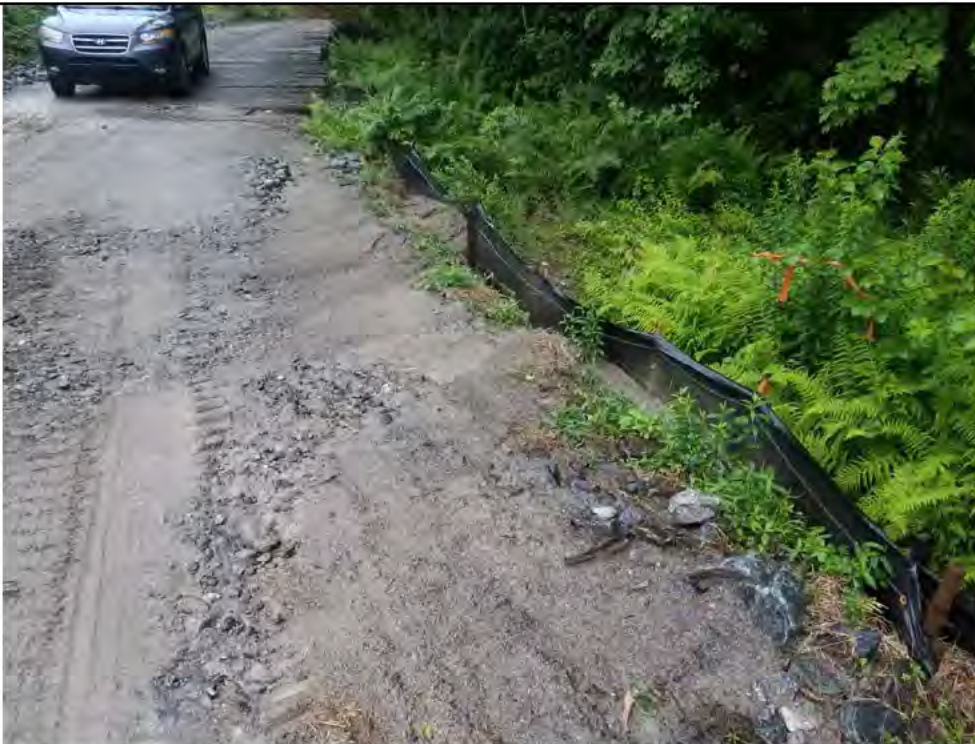
Photo 14: 07/07/2017, Watertown: Access road at W-C18, surface water runoff, excessive sediment buildup on silt fence, silt fence failure, sedimentation into W-C18.

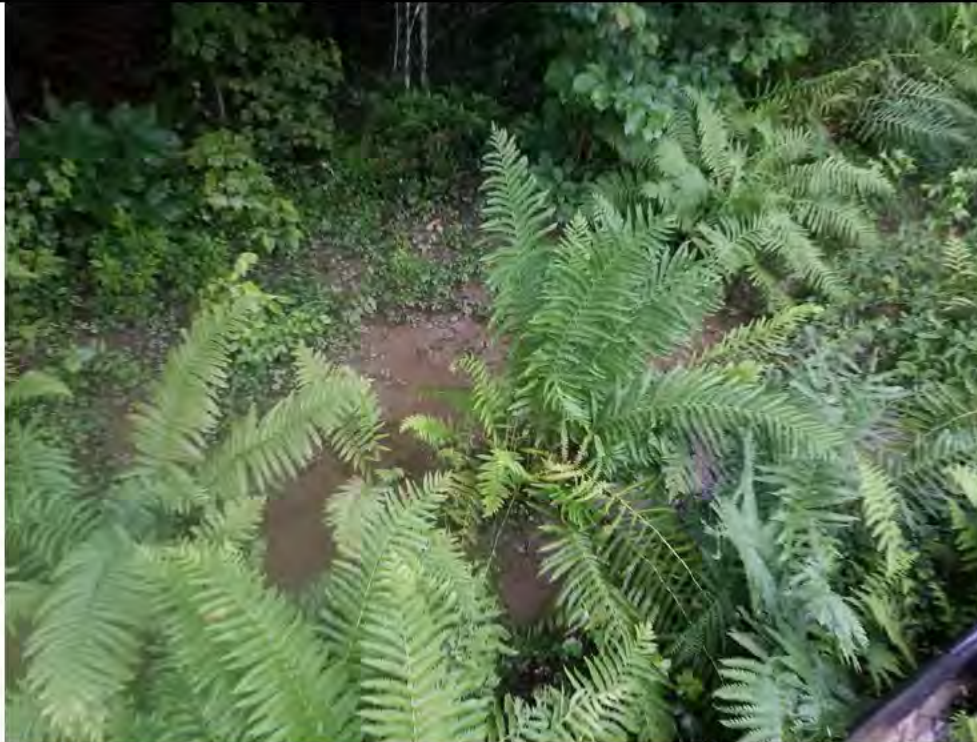
Photo 15: 07/07/2017, Watertown: Access road at W-C18, surface water runoff, excessive sediment buildup on silt fence, silt fence failure, sedimentation into W-C18.

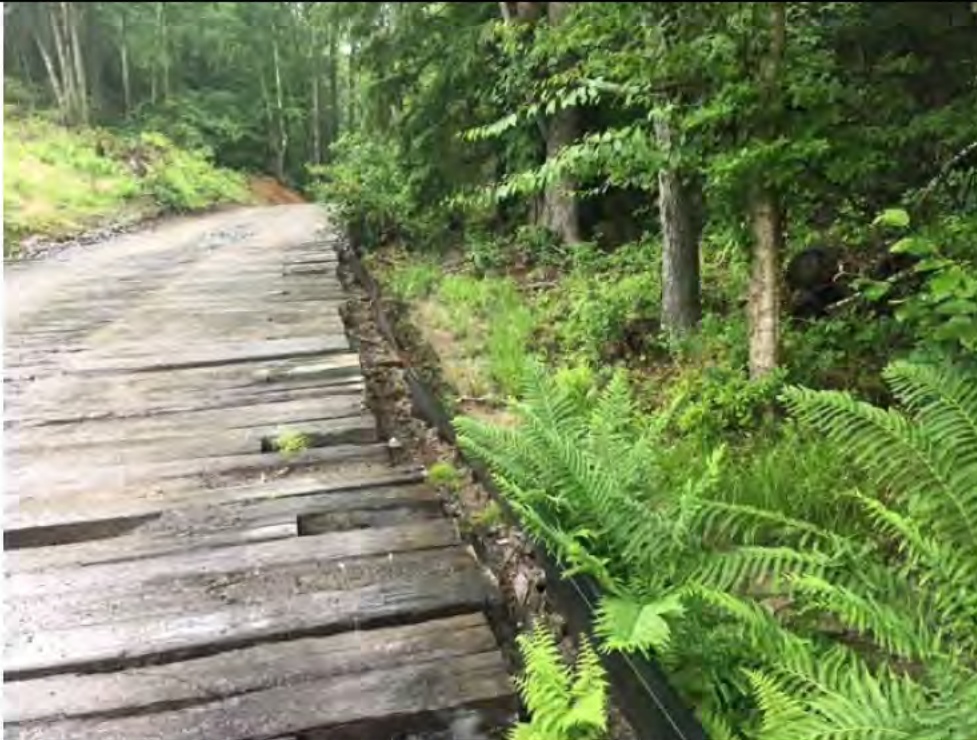
Photo 16: 07/07/2017, Watertown: Access road at W-C18, surface water runoff, excessive sediment buildup on silt fence, silt fence failure, sedimentation into W-C18.

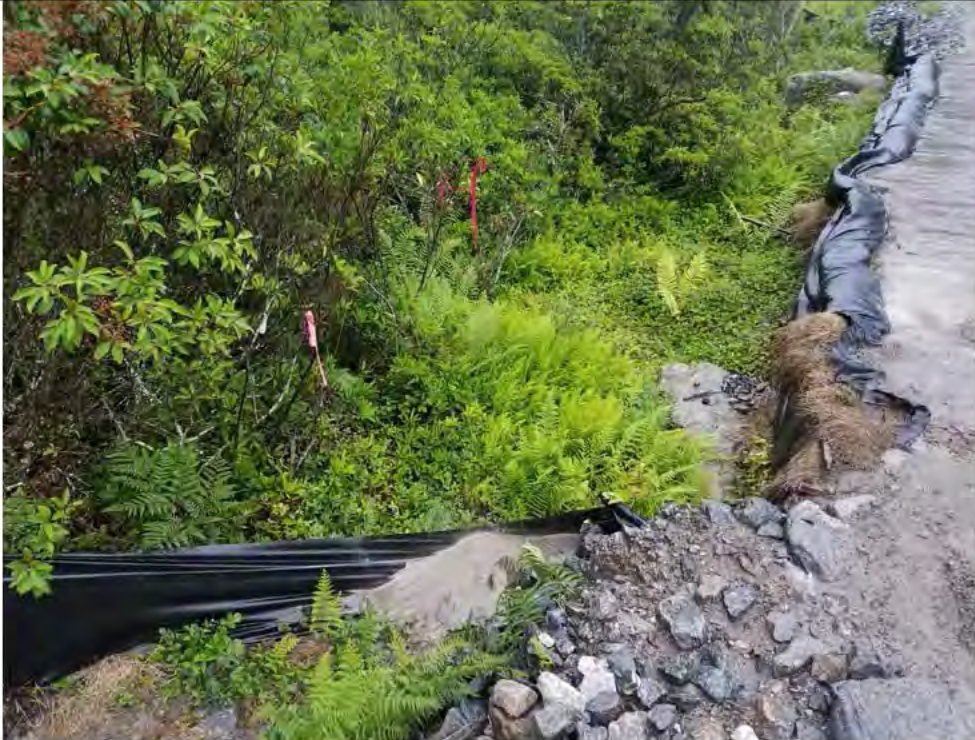
Photo 17: 07/07/2017, Watertown: Access road at W-C20, surface water runoff, excessive sediment buildup on silt fence, silt fence failure, sedimentation into W-C20.

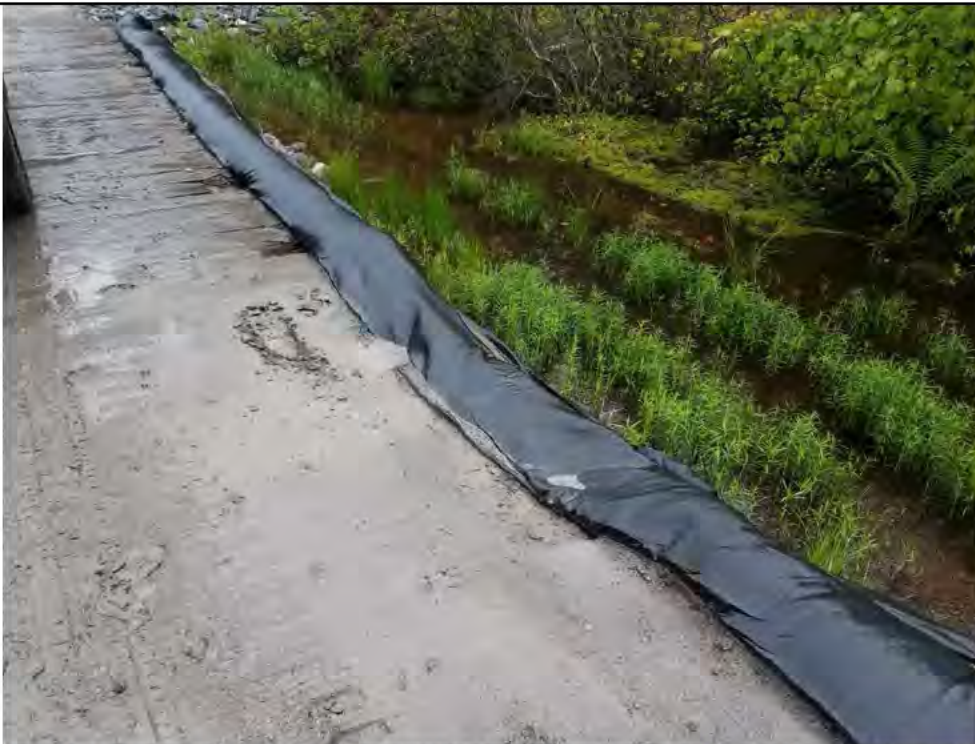
Water Crossings	Interim Week	<p>Timber mat crossing at W-C20/VP-C20-1 has significant sedimentation accumulation. Gaps between timbers are completely filled with sediment and there is approximately 1/4" buildup across the surface. Sedimentation into wetland/Vernal Pool area was observed. See Photos 18 & 19.</p>	Pending
	Bi-Week	<p>The timber mat crossing at W-C20/VP-C20-1 had been cleared but due to recent rainfall events sediments have started to buildup again. Sediment buildup at this time is minimum to moderate. Sedimentation into the wetland/vernal pool area was still present however it did not appear that any additional sedimentation had occurred since the last inspection.</p>	Pending

Photo 18: 07/07/2017, Watertown: Access road at W-C20, surface water runoff, excessive sediment buildup on timber mats, sedimentation into W-C20.

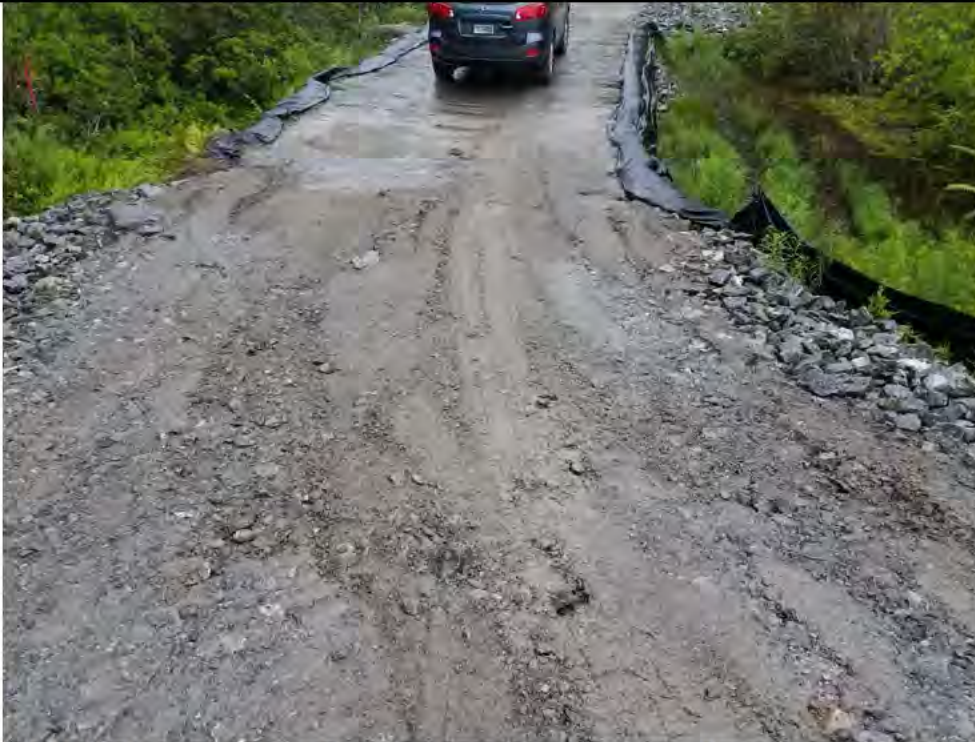
Photo 19: 07/07/2017, Watertown: Access road at W-C20, surface water runoff, excessive sediment buildup on silt fence, silt fence failure, sedimentation into W-C20.
