**Subject: Docket No. 466, Frost Bridge to Campville 115-kV Project
Decision and Order Condition #4 – Independent Environmental Inspector Report**

Please find enclosed the Biweekly Independent Environmental Inspector Report, Report #17, for the **July 21st** and **July 28th, 2017**, inspection events for the construction of the Eversource Frost Bridge to Campville 115-kV Project.

Docket No. 466- Development and Management Plan Inspection

Frost Bridge to Campville 115kV Project

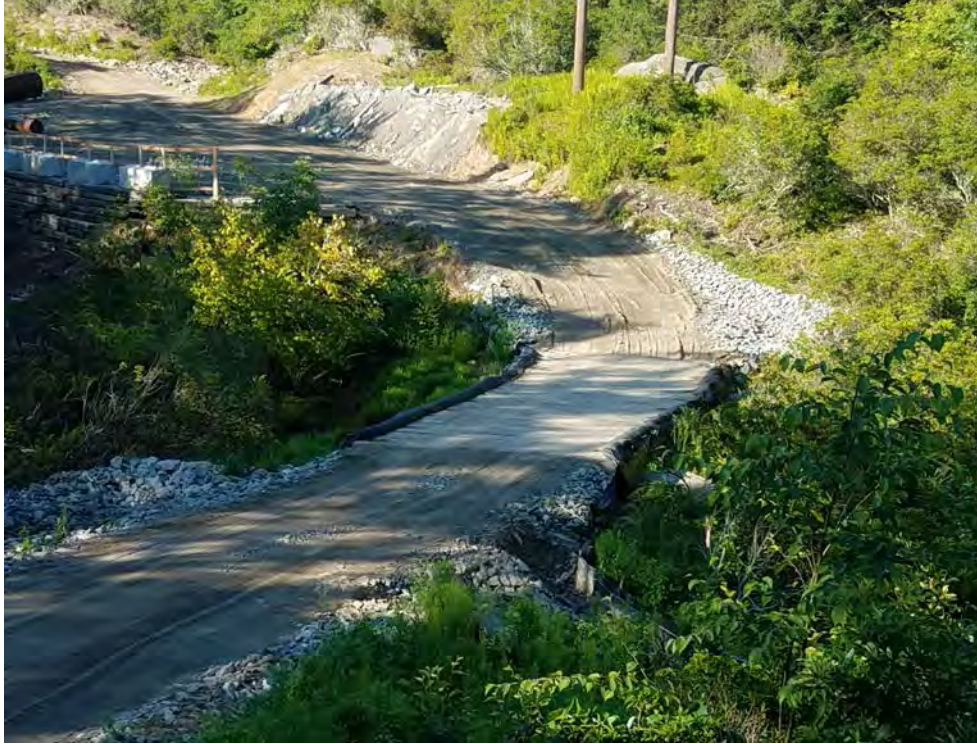
Water Crossings	Interim Week	Some light (very minor) sedimentation buildup on the surface of timber mat crossings (W-C18 and W-C20). Additional sections of silt fence were placed at upland edges of W-C20 to supplement existing silt fence.	Continue to remove buildup of sediments and monitor access road conditions upland of crossing.	On going access road and E&S control maintenance in the areas between Str24 and Str46.
	Bi-Week	Same conditions observed as interim week inspection #17-07.21.2017.	Continue to remove buildup of sediments and monitor access road conditions upland of crossing.	On going access road and E&S control maintenance in the areas between Str34 and Str42

Photo 1: 07/21/2017, Watertown: Map 14, timber mat crossing at W-C20, timber mats cleared and E&S control repairs/improvements, sediment impacts cleared by hand to the waterline.

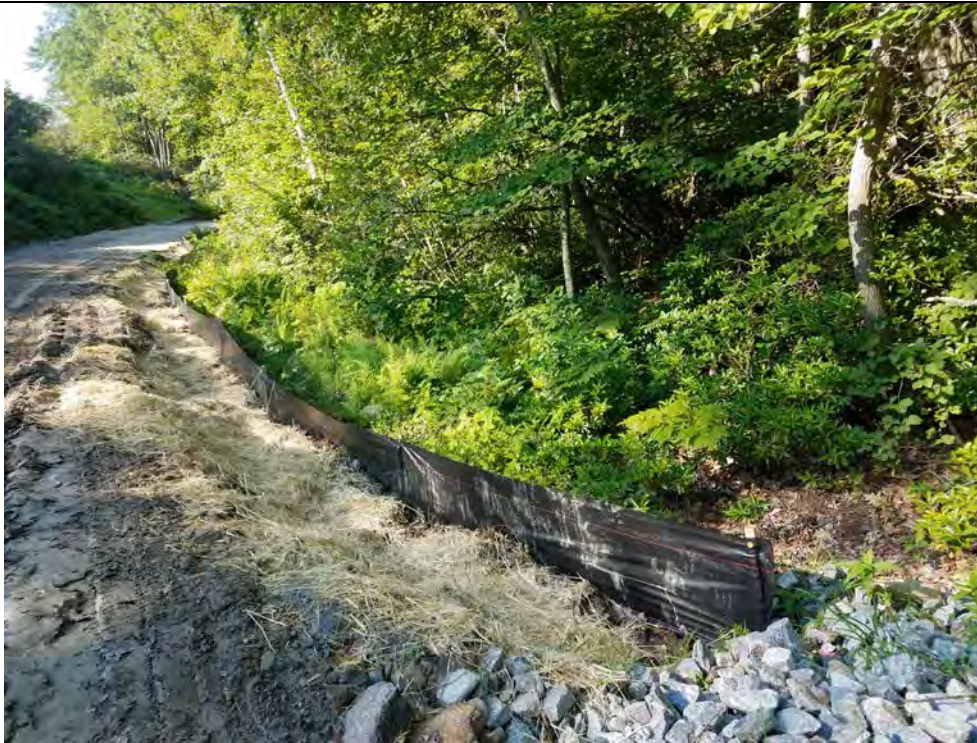
Photo 2: 07/21/2017, Watertown: Map 13, access road at W-C18, E&S control repair.

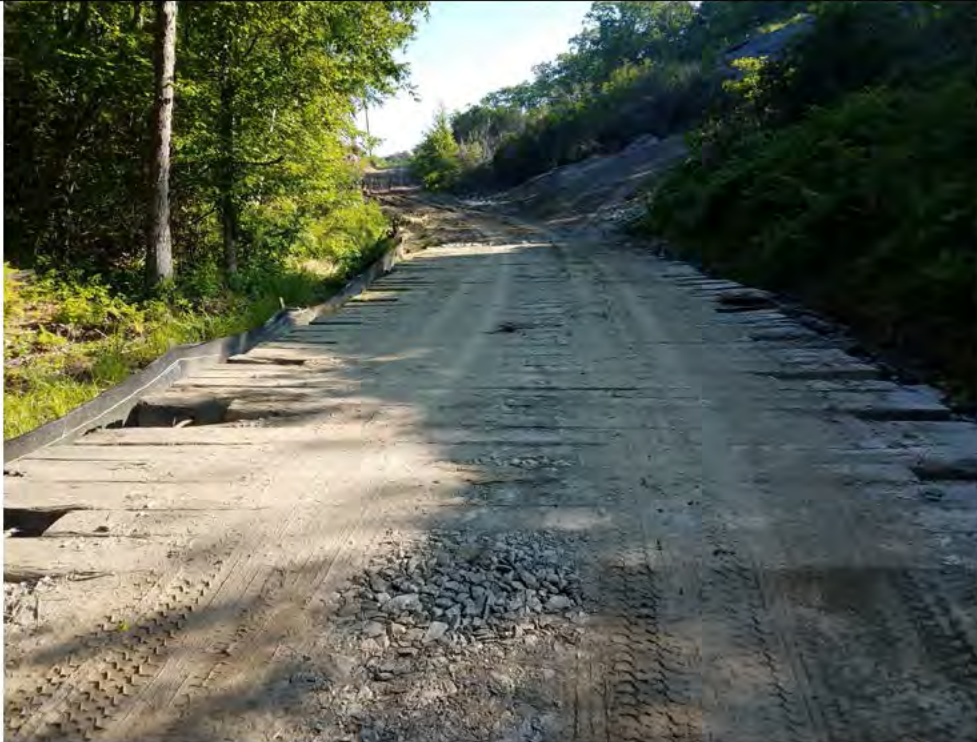
Photo 3: 07/21/2017, Watertown: Map 12, timber mat crossing at W-C15, timber mats cleared, E&S control repairs.

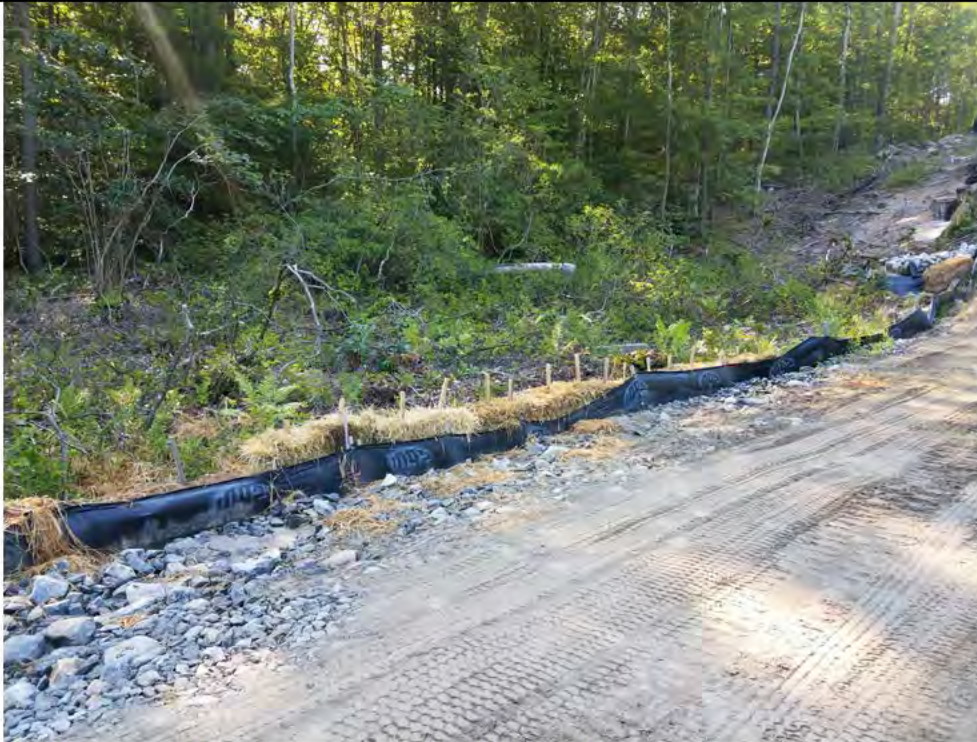
Photo 4: 07/21/2017, Watertown: Map 11, access road at W-C12, E&S repairs.

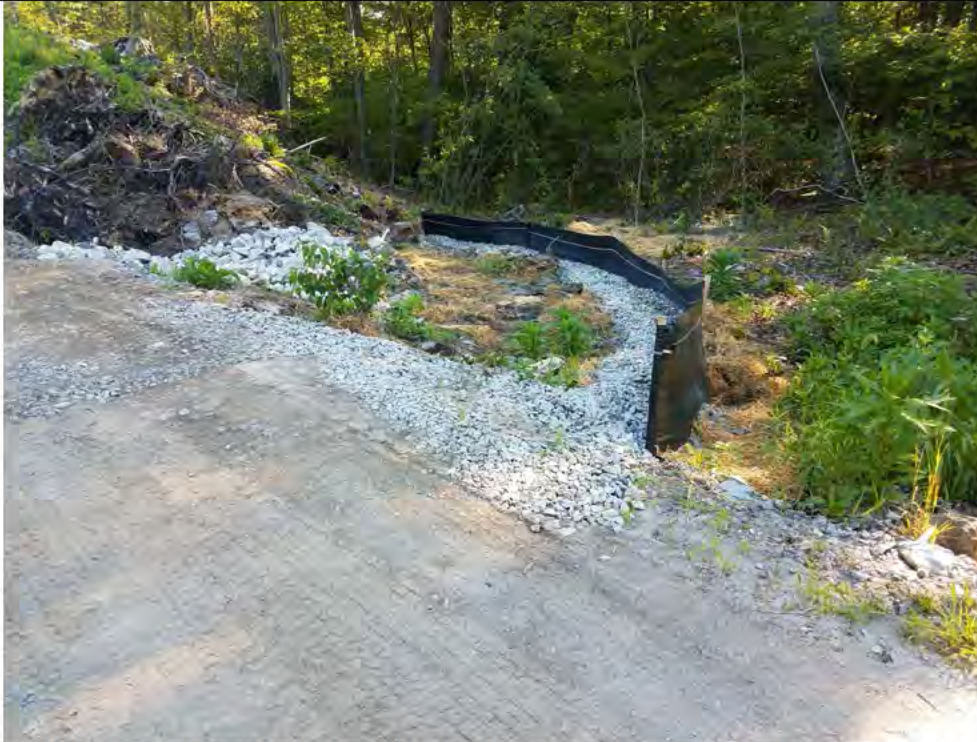
Photo 5: 07/21/2017, Watertown: Map 11, area of Str30 at W-C7, access road at Str30, repairs to E&S controls.

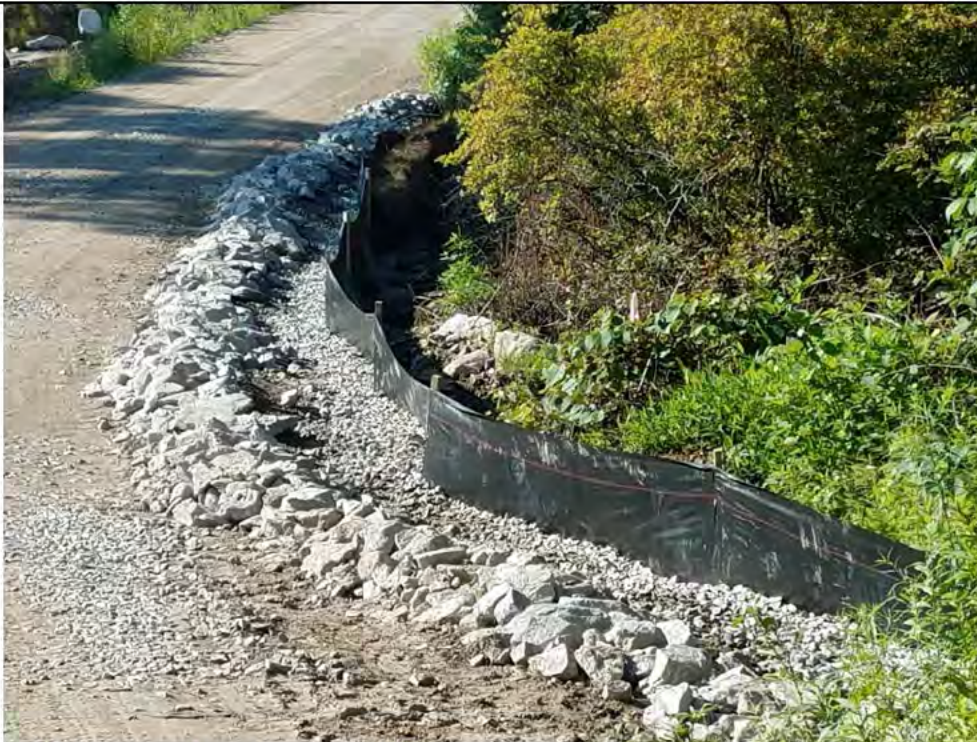
Photo 6: 07/21/2017, Watertown: Map 10, area of W-C3, access road at Str27, E&S control repair/improvements.
