**Subject: Docket No. 466, Frost Bridge to Campville 115-kV Project
Decision and Order Condition #4 – Independent Environmental Inspector Report**

Please find enclosed the Biweekly Independent Environmental Inspector Report, Report #23, for the **October 13th** and **October 20th, 2017**, inspection events for the construction of the Eversource Frost Bridge to Campville 115-kV Project.

Docket No. 466- Development and Management Plan Inspection

Frost Bridge to Campville 115kV Project

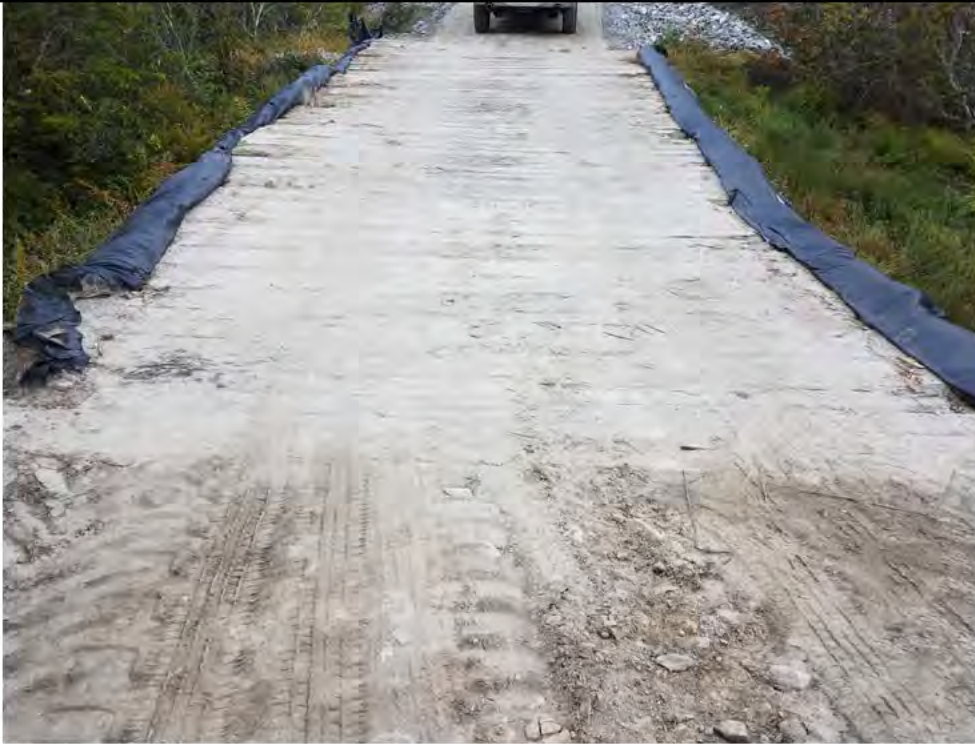
Photo 1: **10/06/17**, Watertown: Map 14, Wetland W-C20 timber mat crossing, sediment buildup on mats. Photo taken from Biweekly Report #22 showing existing sediment buildup and dry conditions.

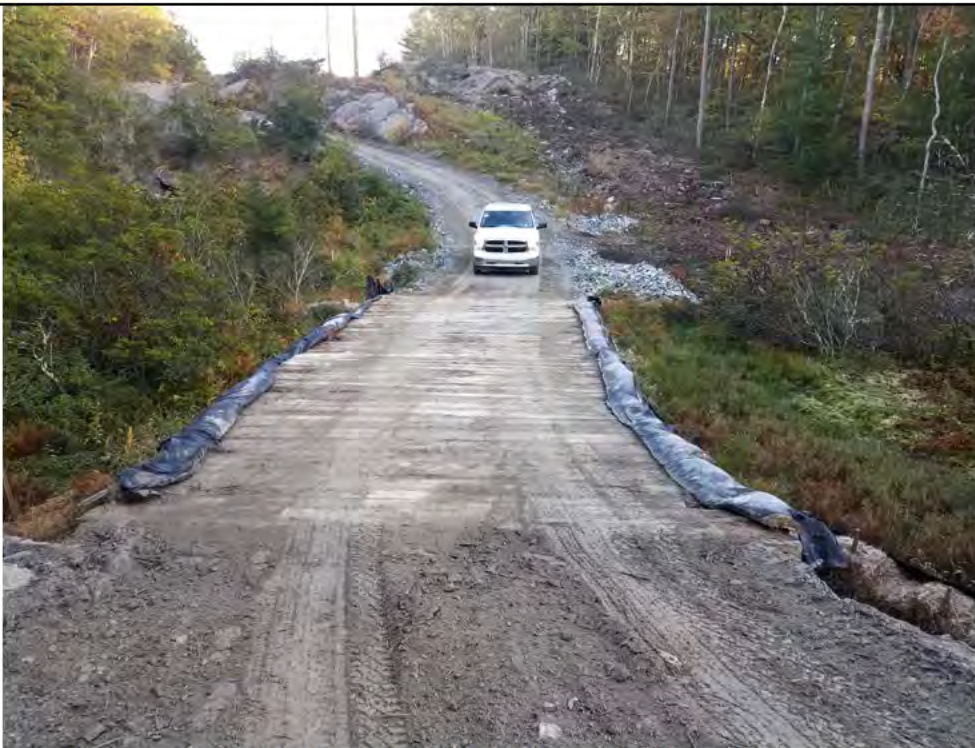
Water Crossings	Interim Week	<p>Corrective actions were completed by BluRoc at W-C20. The timber mats were cleared of excess sediments (See photo #1).</p> <p>Timber mat crossings and hard bottom crossings are functioning as designed and appear to be clean of excess buildup of sediments and structurally maintained.</p>	N/A	
	Bi-Week	<p>Timber mats and hard bottom crossings appear to be in good condition and maintained.</p>	N/A	N/A

Photo 1-1: **10/13/17**, Watertown: Map 14, **CORRECTIVE ACTION**-Wetland W-C20 timber mat crossing, sediment buildup cleared, some recent minor buildup however hard-packed into the crevices of the timbers.

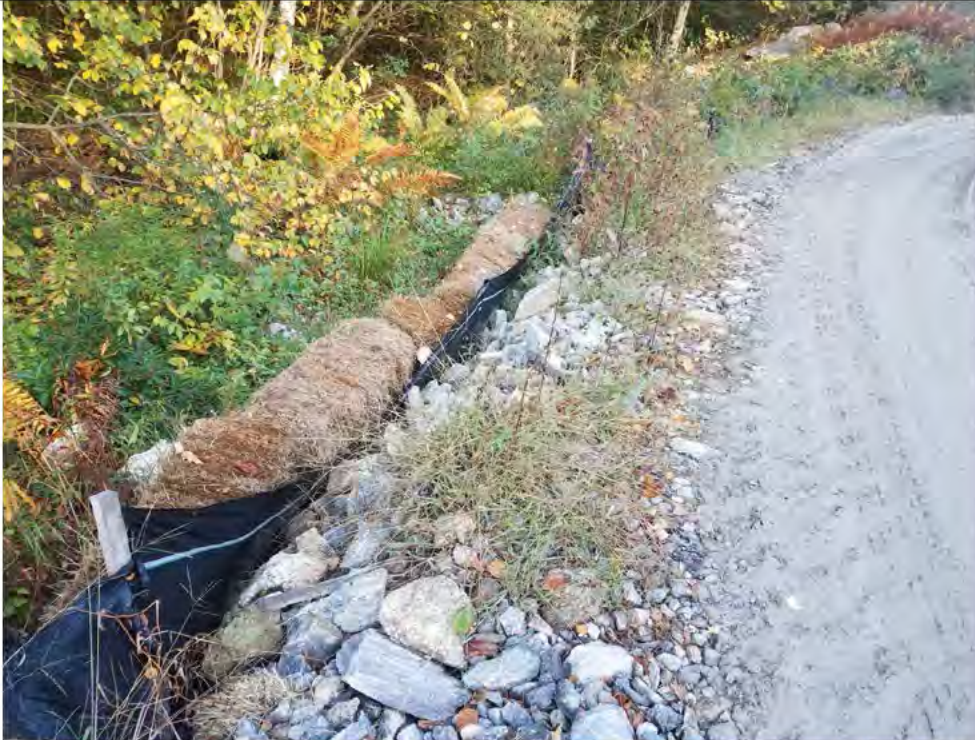
Erosion and Sedimentation Controls	Interim Week	Northern continues maintenance of existing E&S controls throughout the project ROW. Many sections of silt fence and straw bales will need to be replaced at the time of restoration and access road final grading. Many are at their limits functionally and structurally (See Photo #2 and 3).	Continue to maintain existing E&S controls until veg establishment and stabilization is achieved following restoration activities.	In Progress
	Bi-Week	Restoration has begun and discussions were had with BluRoc about replacing and/or restoring existing E&S controls to ensure E&S control effectiveness throughout the winter and vegetation establishment.	N/A	In Progress
Inland Wetland & Watercourse encroachment & mitigation	Interim Week	Restoration and upland stabilization of disturbed areas has begun site wide.	N/A	In Progress

Photo 2: 10/13/17, Watertown: General conditions of many sections of silt fence and straw bales alongside of access roads of the ROW. Road base stone and riprap have pushed outward overloading the structural integrity of the E&S controls and many times tearing the fabric and allowing sediments to pass through.

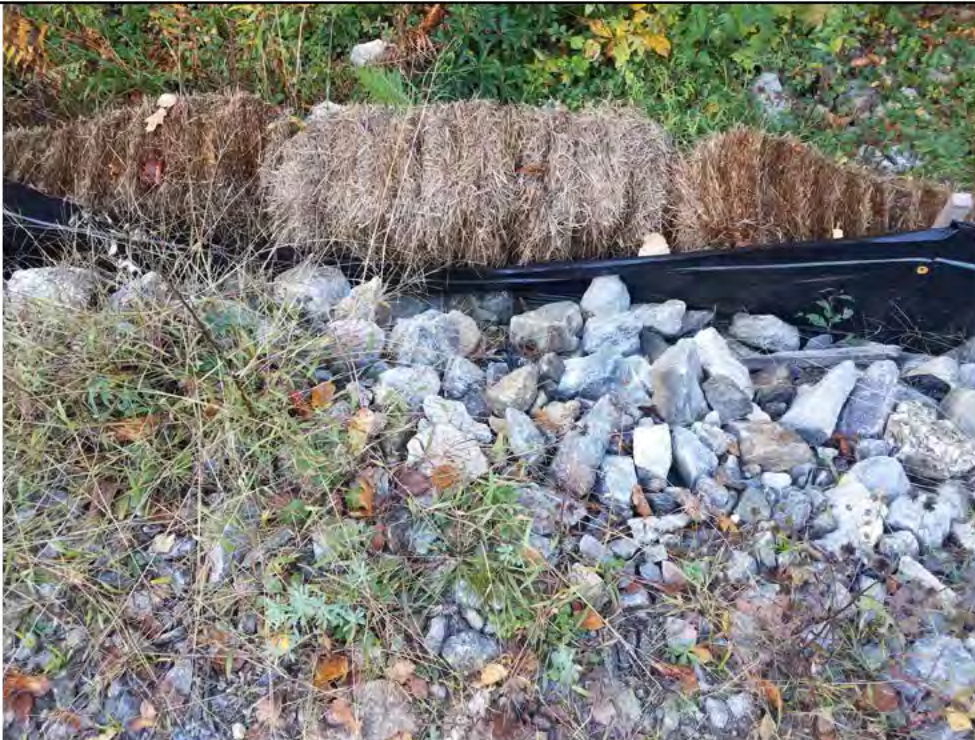
Photo 3: 10/13/17, Watertown: General conditions of many sections of silt fence and straw bales alongside of access roads of the ROW. Road base stone and riprap have pushed outward overloading the structural integrity of the E&S controls and many times tearing the fabric and allowing sediments to pass through.

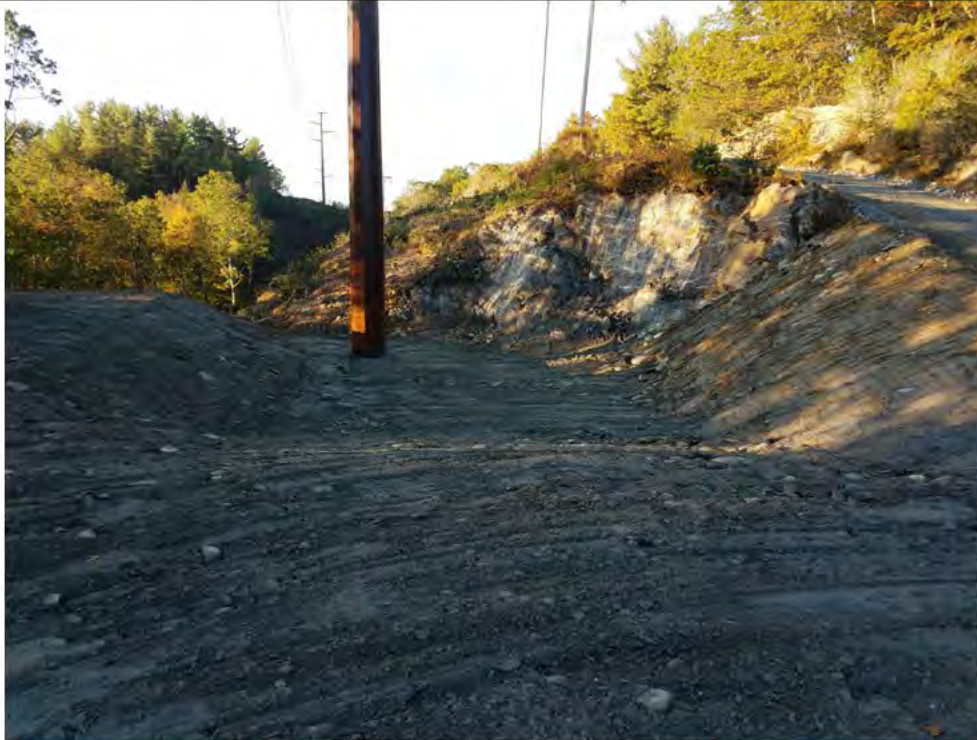
Photo 4: 10/13/17, Watertown: Map 15, Str42 partial restoration, grading and preparing for seeding and slope stabilization.

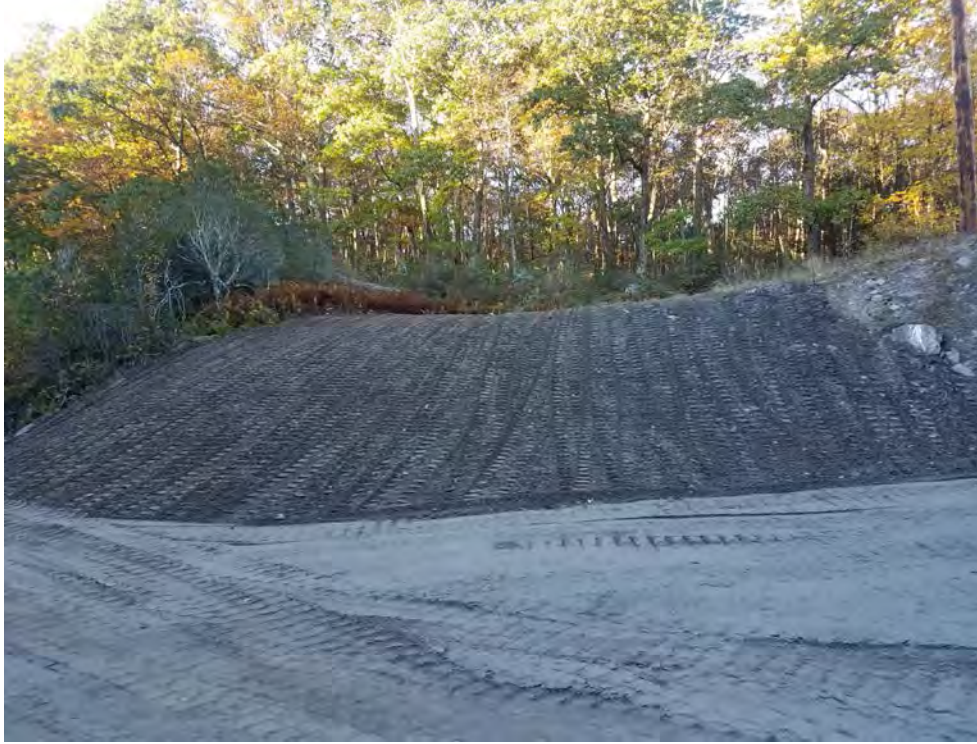
BluRoc was observed on site in the area of Str24 to Str46 continuing restoration activities (See Photo #5) and a crew of 3 was observed starting the culvert replacement at W-F11/S-F10 (Map 32, Harwinton), southwest of Str87 (See Photos #6 and #7).

Photo 5: 10/20/17, Watertown: Maps 09-16, Str24-Str46, upland slope grading and preparing for seeding for restoration.

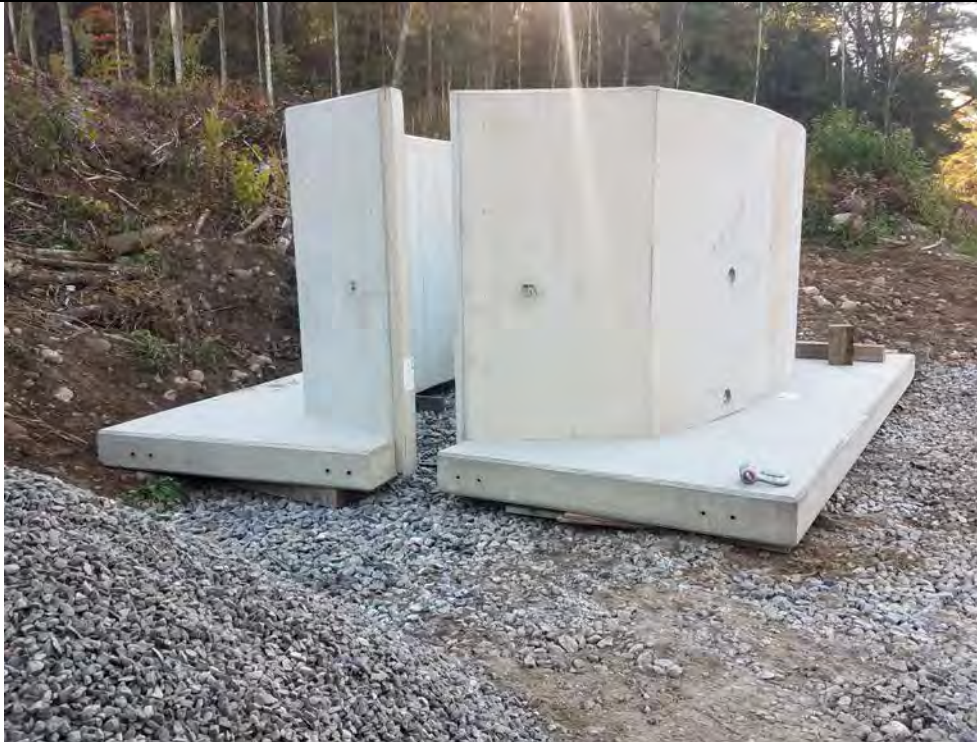
Photo 6: 10/20/2017, Harwinton: Map 32, culvert replacement at W-F11/S-F10, culvert halves pictured.

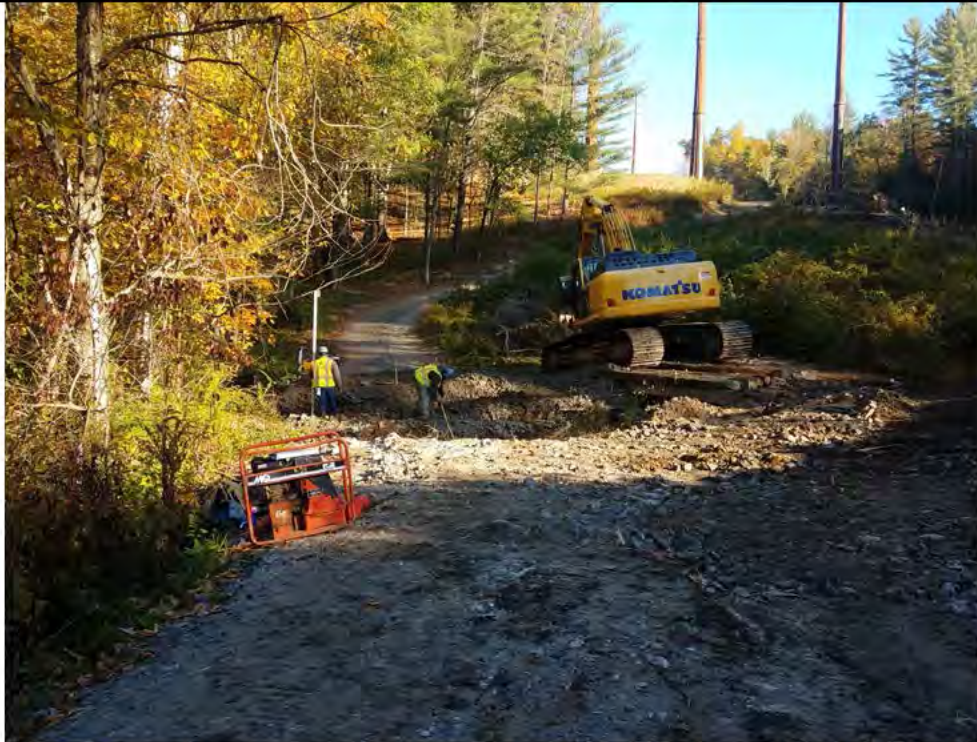
Photo 7: 10/20/2017, Harwinton: Map 32, culvert replacement at W-F11/S-F10, southwest of Str87.
