**Docket No. 466- Development and Management Plan Inspection**

**ROW/SUBSTATIONS**

### Frost Bridge to Campville 115kV Project

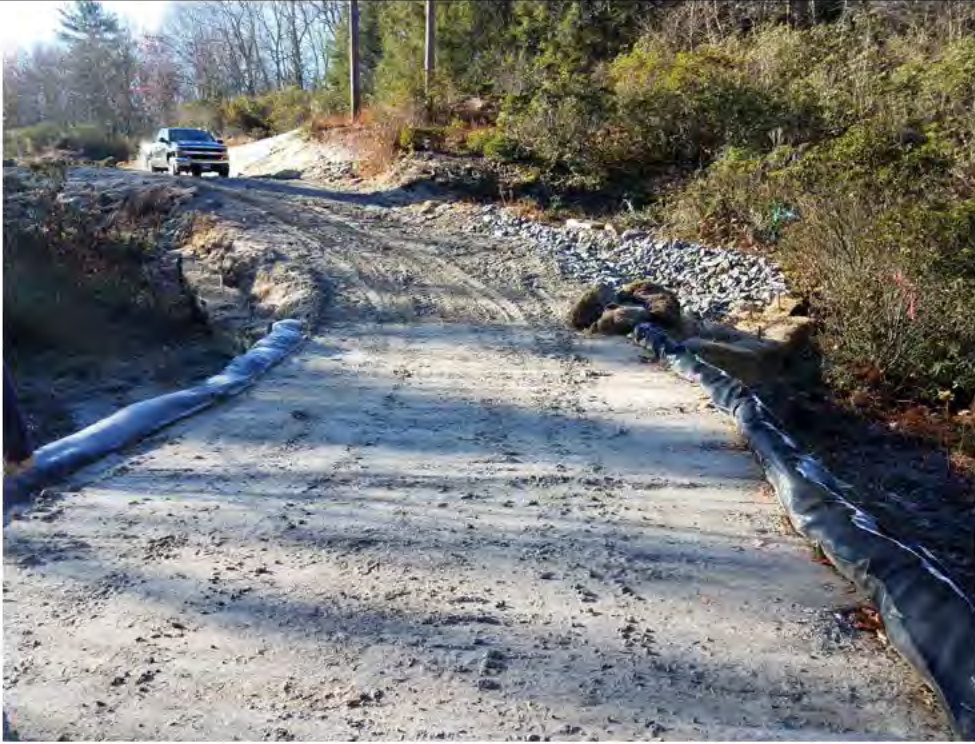
<b>Water Crossings</b>	<b>Interim Week</b>	<p>Timber mat crossing conditions have improved however the timber mats at W-C20 (see Photo 1) have a build up of sediments at this time and should be monitored closely to prevent additional impacts to the surrounding area and wetland W-C20.</p>		
	<b>Bi-Week</b>	<p>Timber mats at W-C20 have been cleared of excess sediments.</p> <p>Restoration has yet to be performed within W-C20. Sediment impacts are still present.</p>	N/A	<p>Restoration activities are in progress site wide.</p>

Photo 1: 11/24/17, Watertown: Map 14, timber mat crossing conditions at W-C20, buildup of sediments on timber mats.

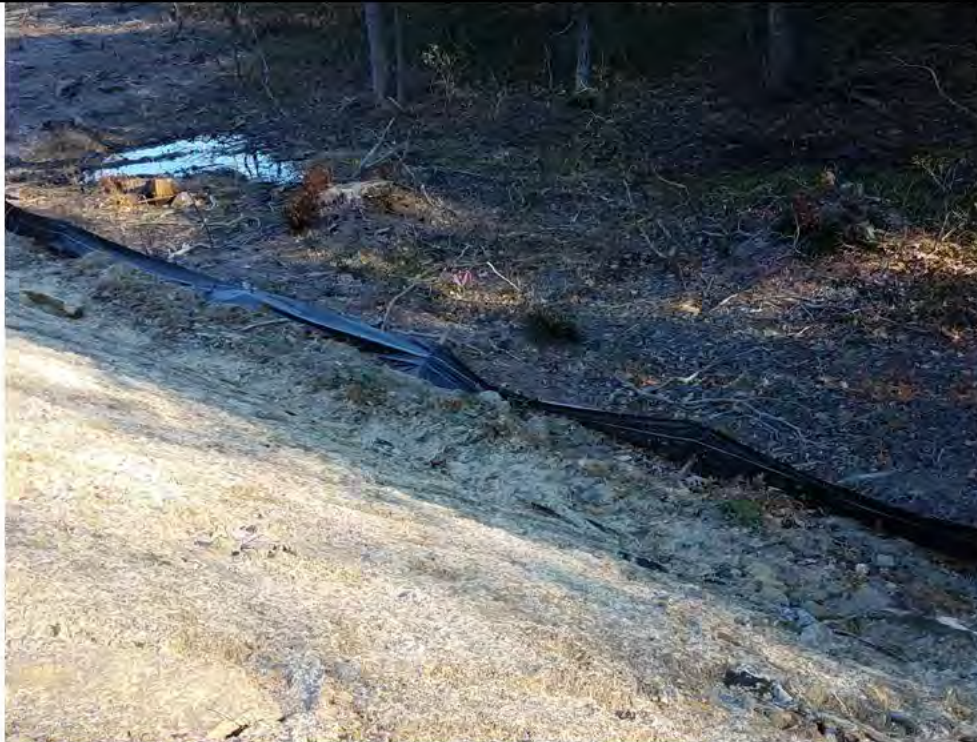
<b>Erosion and Sedimentation Controls</b>	<b>Interim Week</b>	<ul style="list-style-type: none"> <li>-Remove and reset silt fence at W-C14 (see Photo 2).</li> <li>-Silt fence at the toe of slope at pad Str39 needs repairs (see Photo 3).</li> <li>-Silt fence at Str62 needs repairs (see Photo 4).</li> <li>-Silt fence at Str69 blown out from heavy sedimentation buildup (see Photo 5), sedimentation observed approximately 20' past silt fence.</li> </ul>	Continue to maintain/repair/replace existing E&S controls until veg establishment and stabilization is achieved following restoration activities.	In Progress
	<b>Bi-Week</b>	<ul style="list-style-type: none"> <li>-Remove and reset silt fence at W-C14 (previously reported).</li> <li>-Silt fence at the toe of slope at pad Str39 needs repairs (previously reported).</li> <li>-Silt fence between Str30 and Str31 has excess sediment buildup.</li> <li>-Silt fence at Str23 needs repairs. Continued</li> </ul>	<ul style="list-style-type: none"> <li>-Straw cover (blown) on several pads between Str3 and Str7 have been blown off by winds, grass seed no longer in place and slopes not stabilized (see Photo 10).</li> <li>-Water bars between Str27 and Str38 need full or minor regrading (flattened out).</li> </ul>	Restoration activities are in progress site wide.

Photo 3: 11/24/17, Watertown: Map 14, Str39 at W-C20/VP-20-1, silt fence repairs required.

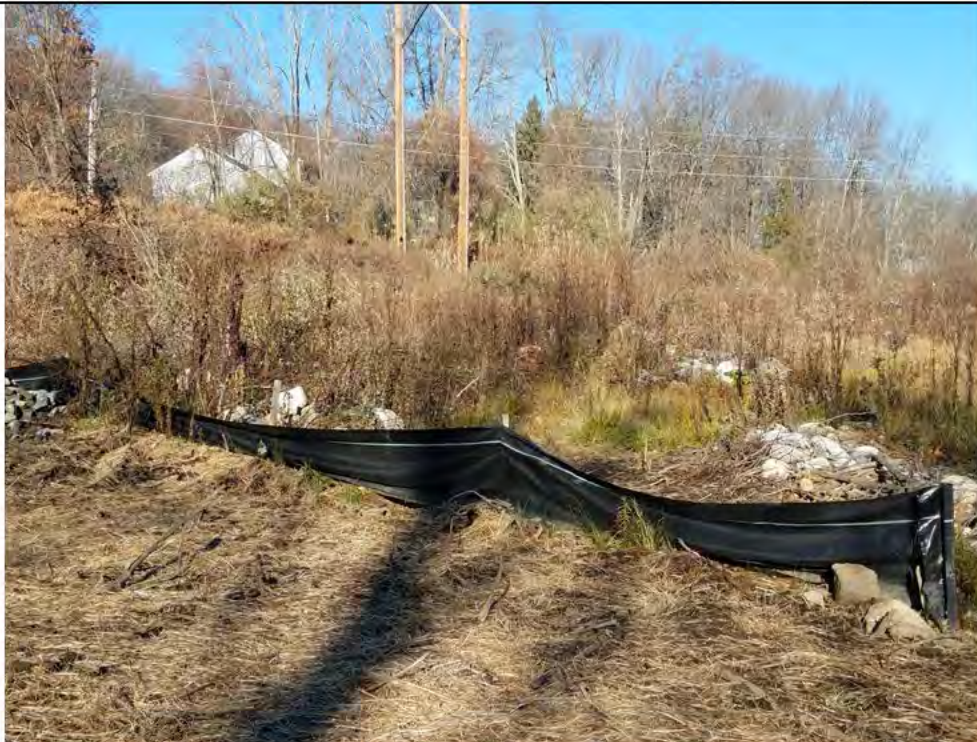
Photo 4: 11/24/17, Thomaston: Map 22, Str62 at W-D10, silt fence repairs required.

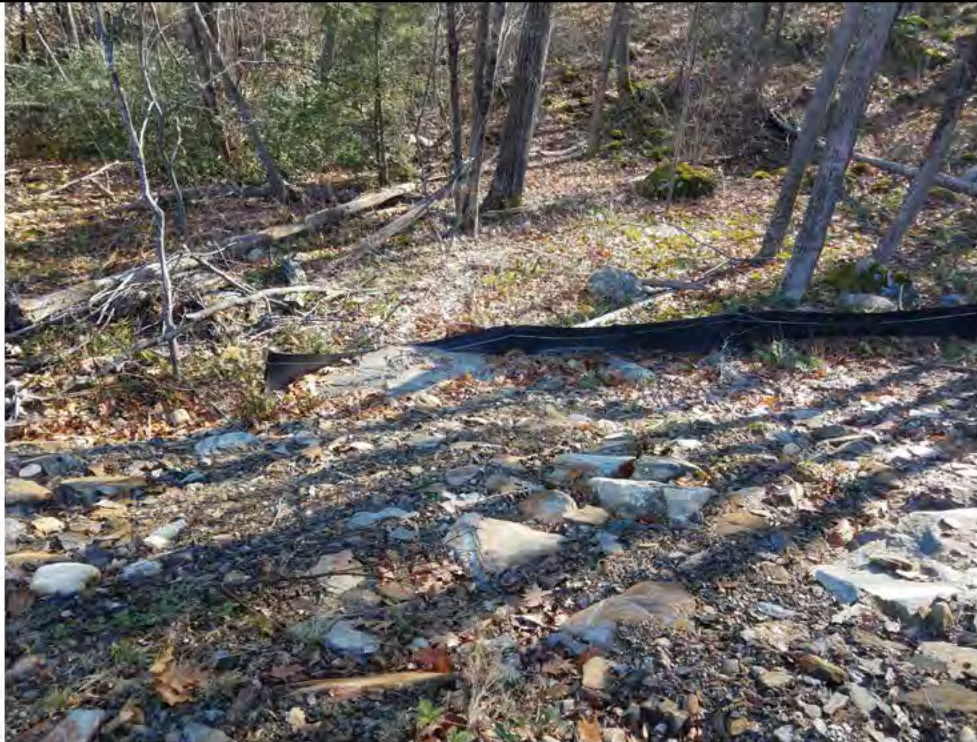
Photo 5: 11/24/17, Thomaston: Map 22, Str69 at the toe of the east slope, silt fence repairs required.

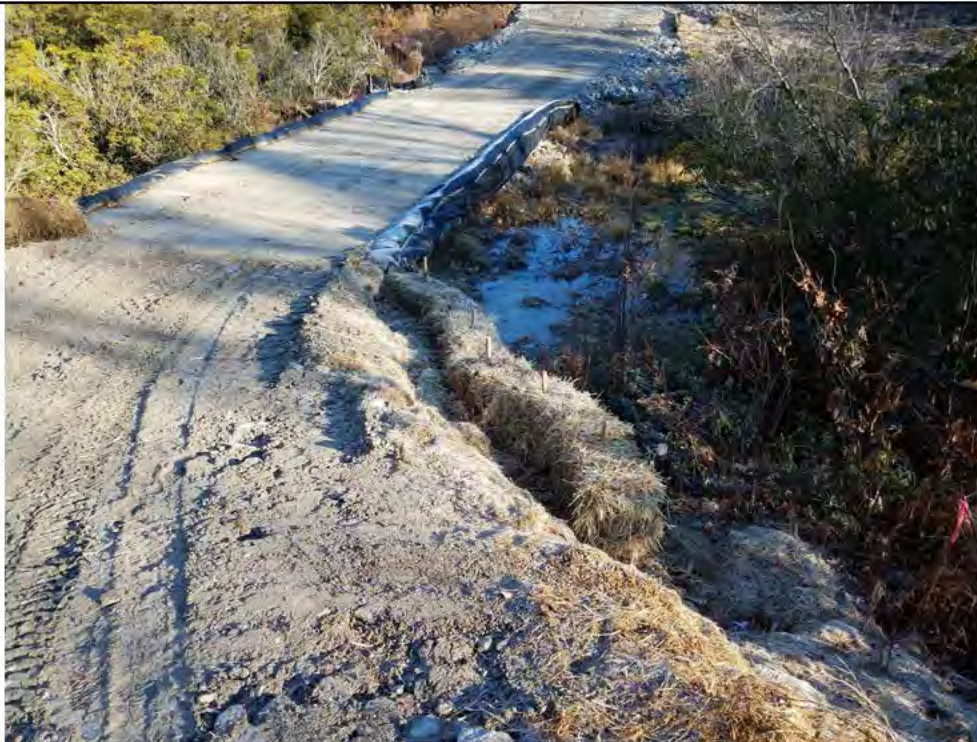
Photo 6: 11/24/17, Watertown: Map 14, CORRECTIVE ACTION-New hay bales and blown hay at W-C20.

<b>Inland Wetland &amp; Watercourse encroachment &amp; mitigation</b>	<b>Interim Week</b>	Corrective actions at W-C20 (sedimentation impacts) are in progress at this time pending area restoration activities. Water bar construction and road grading upland of W-C20 has been completed. New hay bales and blown hay have been placed at the upland edge of the wetland to stabilize the sediments as well (see Photos 6 and 7).	N/A	In Progress

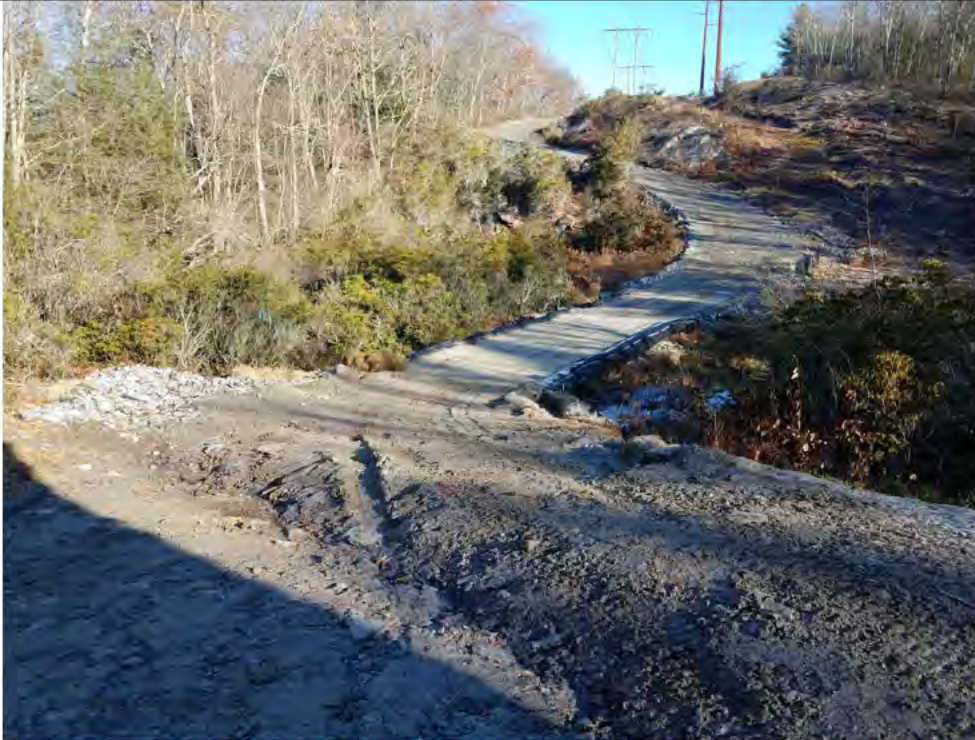
Photo 7: 11/24/17, Watertown: Map 14, CORRECTIVE ACTION-Formed water bar upland of W-C20.

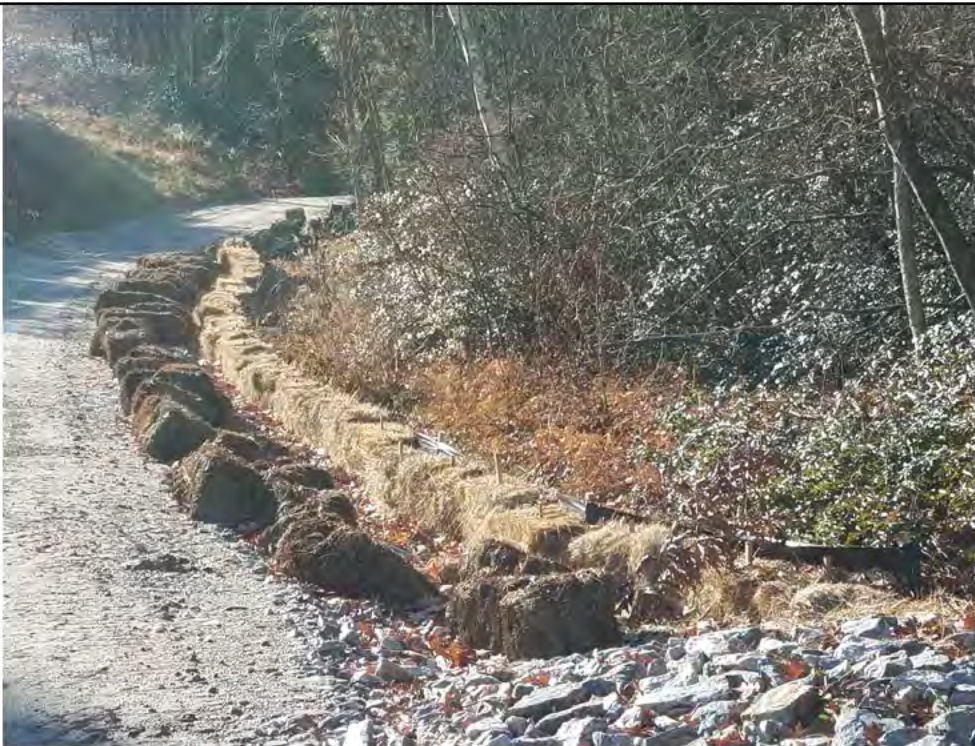
Photo 8: 11/24/17, Watertown: Maps 09-14, CORRECTIVE ACTION-Replaced hay bales at many locations throughout the ROW.

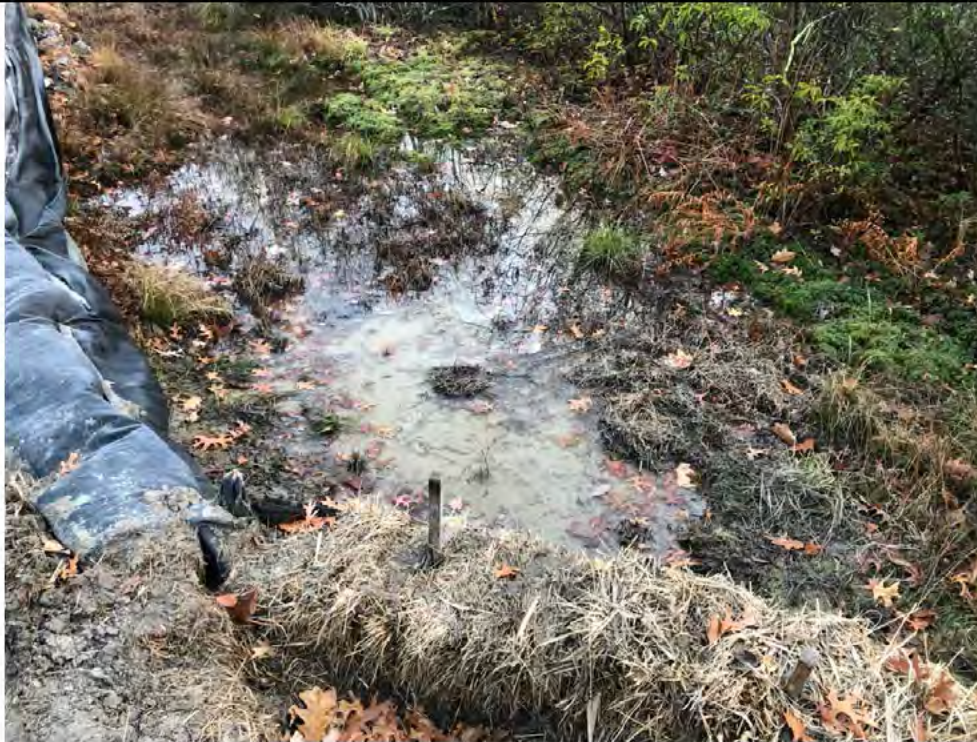
<p><b>Inland Wetland and Watercourse encroachment and mitigation (Continued from previous page)</b></p>	<p><b>Bi-Week</b></p>	<p>No further changes in conditions at W-C20 (see Photo 9).</p>	<p>Stabilize erosion conditions and restore W-C20.</p>	<p>Restoration activities are in progress site wide.</p>
<p><b>Spills and Material Storage</b></p>	<p><b>Interim-Week</b></p>	<p>None observed, none reported.</p>	<p>N/A</p>	<p>N/A</p>
	<p><b>Bi-Week</b></p>	<p>None observed, none reported.</p>	<p>N/A</p>	<p>N/A</p>

Photo 9: 12/01/17, Watertown: Map 14, sediment impacts to W-C20 awaiting restoration.

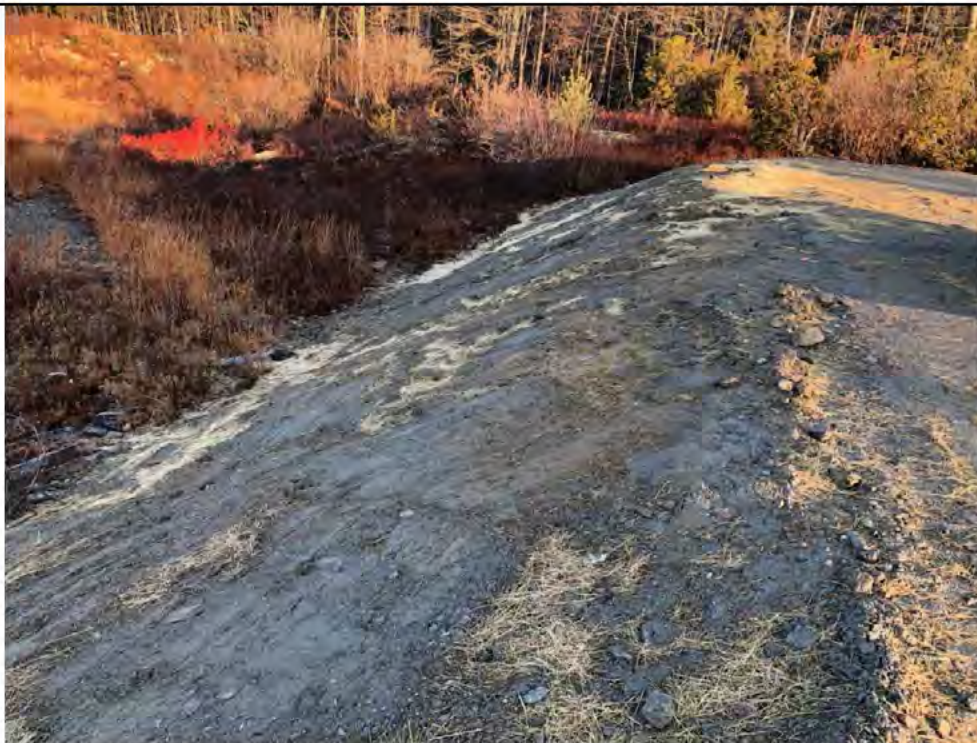
Photo 10: 12/01/17, Watertown: Maps 3-4, various areas of pads between Str3 and Str9, straw and grass seed blown off by wind conditions.
