**Subject: Docket No. 468, Plumtree Substation to Brookfield Junction 115-kV Project
Decision and Order Condition #4 – Independent Environmental Inspector Report**

Please find enclosed the Biweekly Independent Environmental Inspector Report, Report #2, for the **October 19th** and **October 26th 2017** inspection events for the construction of the Eversource Plumtree Substation to Brookfield Junction 115-kV Project.

Docket No. 468– Development and Management Plan Inspection

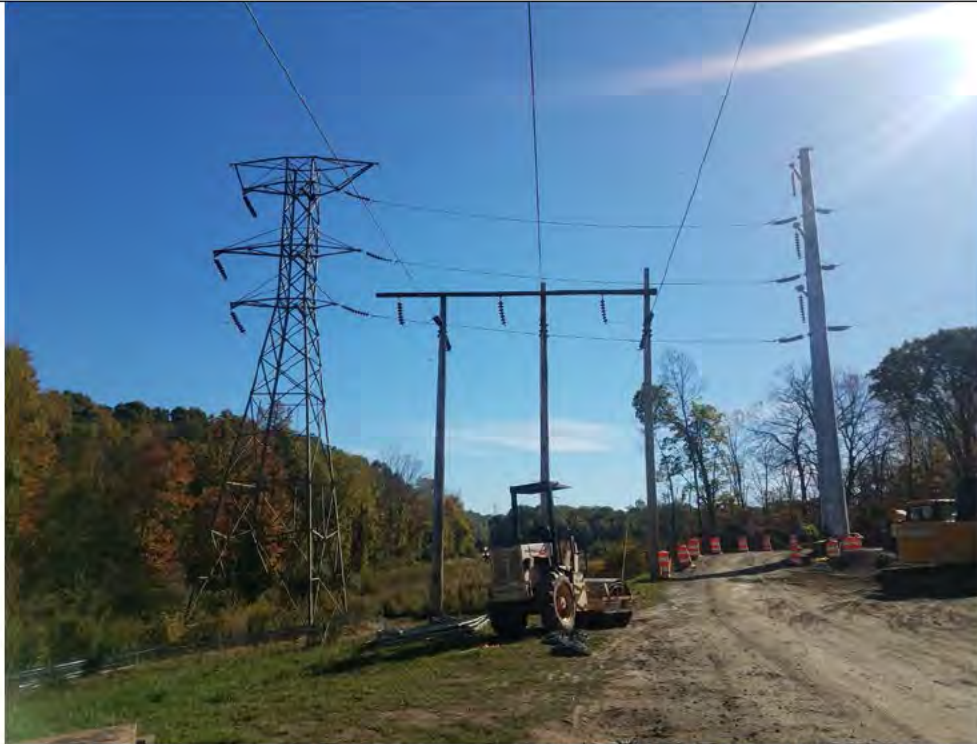
Structure 4647A erected and lines pulled (see Photos 1 and 2) as part of the 1485 line modification. No active work observed today on structure 4647A or the immediate surrounding area.

Photo 1: 10/19/17, Stony Hill Substation, Str4647A structures and lines, photo taken facing east.

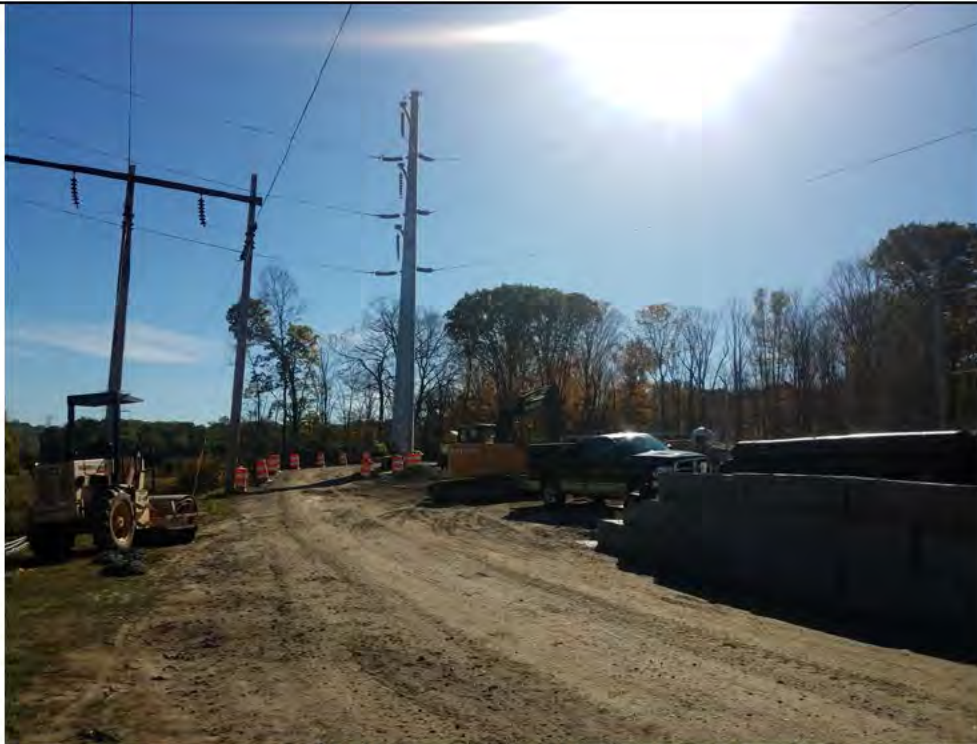
Photo 2: 10/19/17, Stony Hill Substation, Str4647A structures and lines, photo taken facing east.

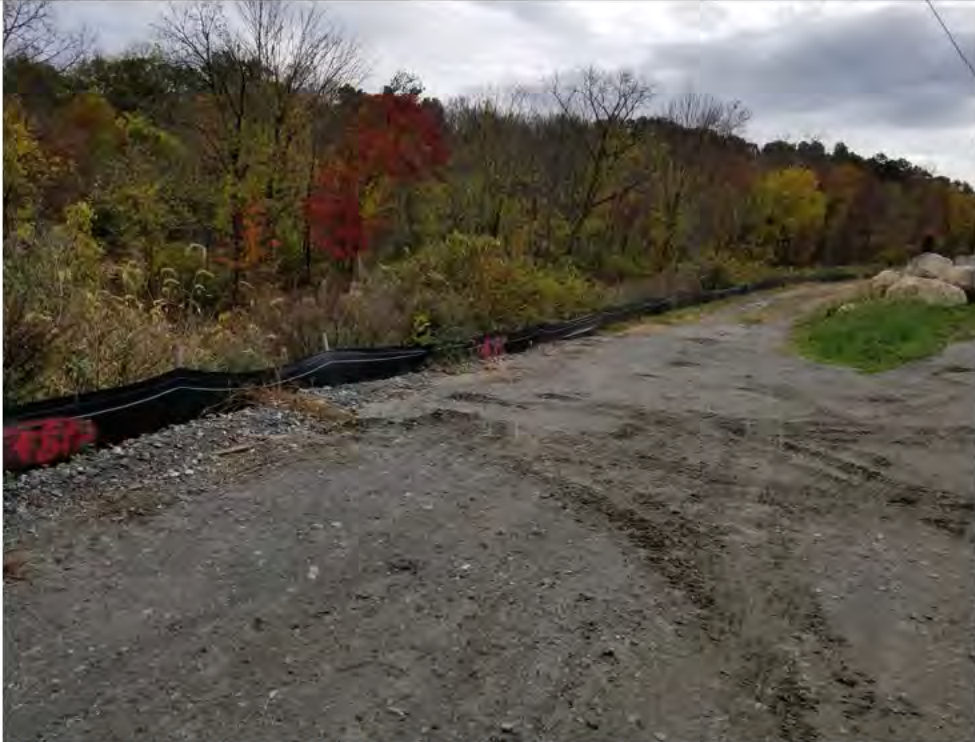
Structure 4647A erected and lines pulled. No active work observed today on structure 4647A or the immediate surrounding area. Work area E&S controls and access road conditions following rainfall events (intermittent rainfall between 10/24 - 10/26) were inspected today. Perimeter E&S controls (silt fencing) commences approximately 100-feet west of structure 4648 and runs parallel with the road to the east and then turns south following the approved limits of disturbance. The silt fence appears to be installed according to the approved limits of disturbance and no excess clearing or out of bounds activities were observed. No E&S deficiencies were observed (see Photos 3-6) and the single road drainage swale was functioning properly (see Photos 7 & 8).

Erosion and Sedimentation Controls	Interim Week	Silt fencing installed along the limits of disturbance installed according to BMP's and maintained.	N/A	
	Bi-Week	Silt fencing installed along the limits of disturbance installed according to BMP's and maintained (see Photos 3-6). A stone filled swale running perpendicular off the access road was clear of excess sediments and no uncontrolled flow observed (see Photo 7 & 8).	N/A	
Inland Wetland & Watercourse encroachment & mitigation	Interim Week	N/A	N/A

Photo 3: 10/26/17: Stony Hill Substation, Str4647A and substation work area perimeter silt fencing, photo taken facing east.

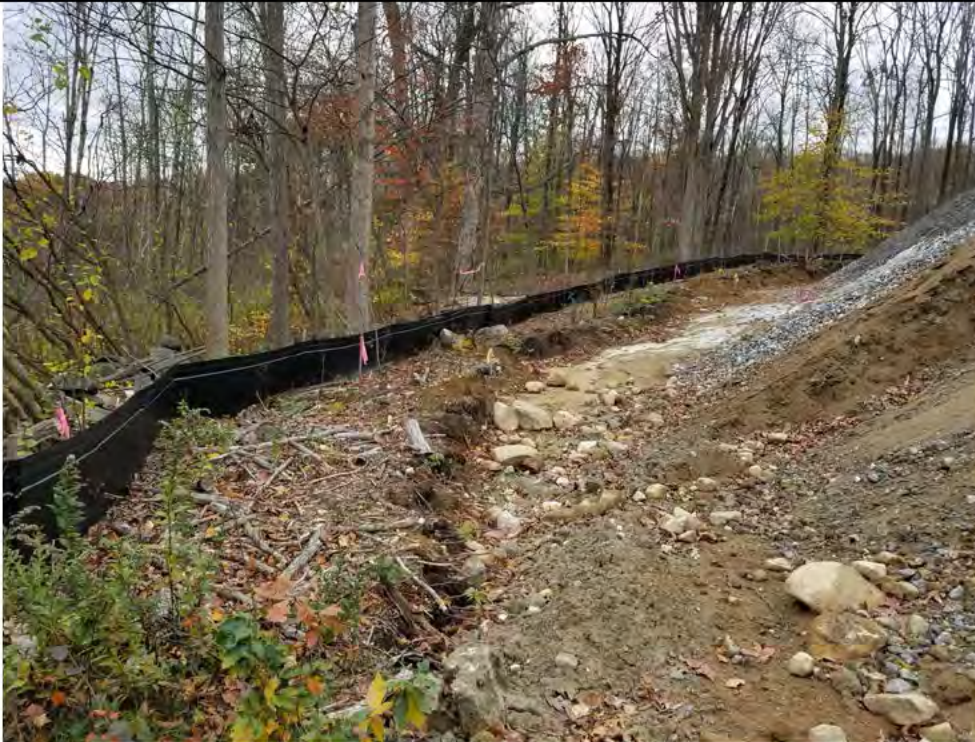
Photo 4: 10/26/17: Stony Hill Substation, Str4647A and substation work area perimeter silt fencing, photo taken facing south.

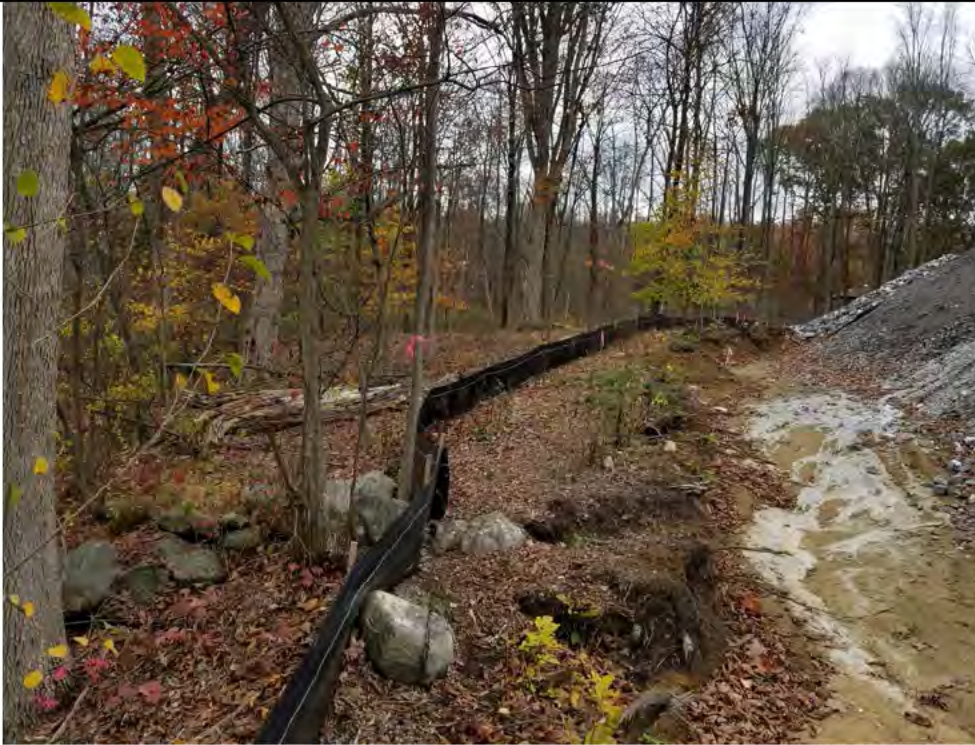
Photo 5:10/26/17: Stony Hill Substation, Str4647A and substation work area perimeter silt fencing, photo taken facing south.

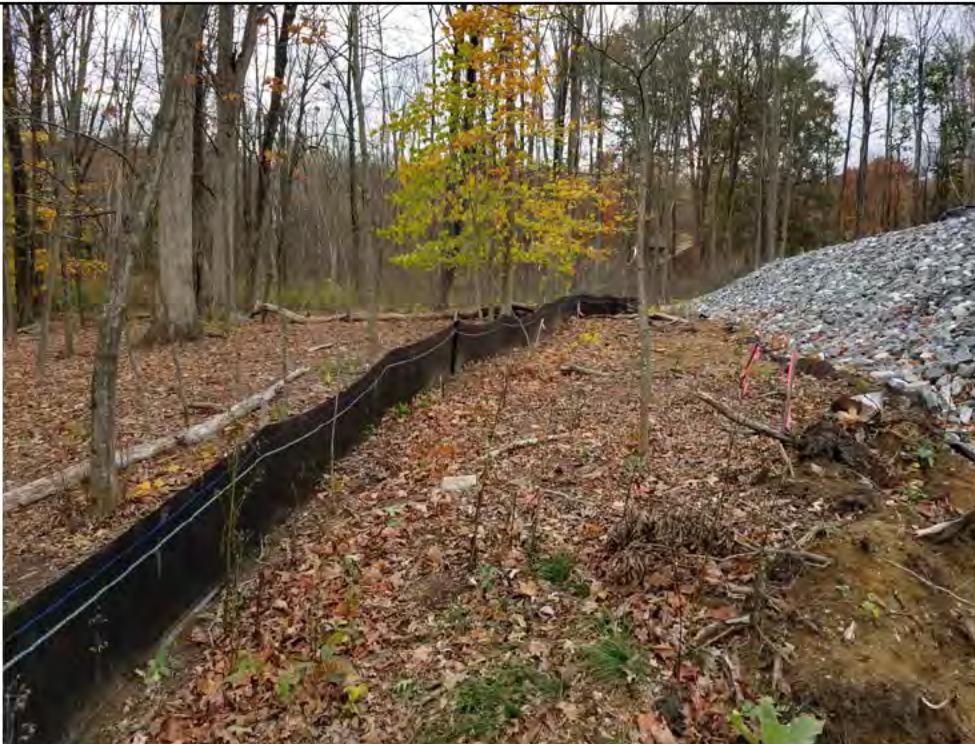
Photo 6:10/26/17: Stony Hill Substation, Str4647A and substation work area perimeter silt fencing, photo taken facing south.

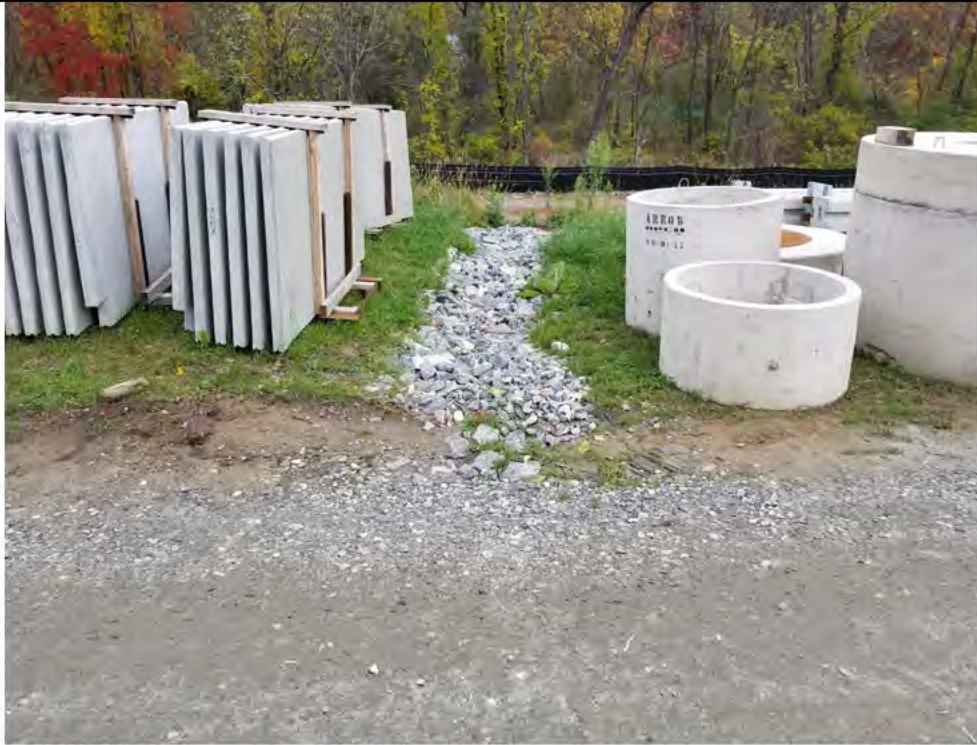
Photo 7:10/26/17: Stony Hill Substation, Str4647A and substation access road drainage, photo taken facing north.

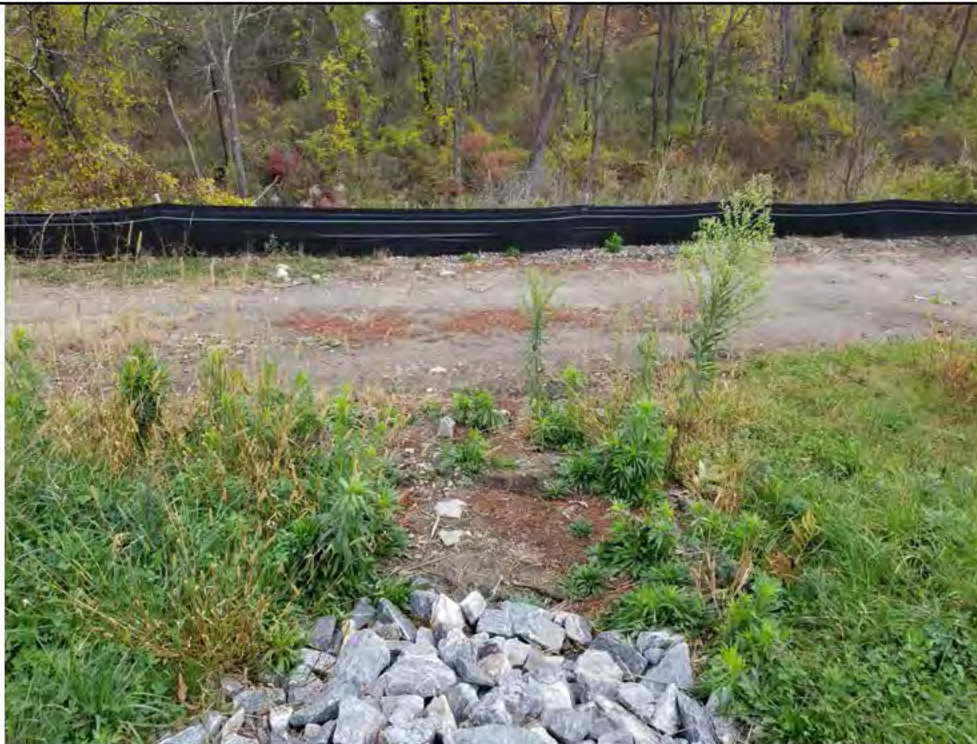
Photo 8:10/26/17: Stony Hill Substation, Str4647A and substation access road drainage, photo taken facing north.
