**Subject: Docket No. 468, Plumtree Substation to Brookfield Junction 115-kV Project  
Decision and Order Condition #4 – Independent Environmental Inspector Report**

Please find enclosed the Biweekly Independent Environmental Inspector Report, Report #4, for the **November 16<sup>th</sup>** and **November 22<sup>nd</sup>, 2017** inspection events for the construction of the Eversource Plumtree Substation to Brookfield Junction 115-kV Project.

**Docket No. 468– Development and Management Plan Inspection**

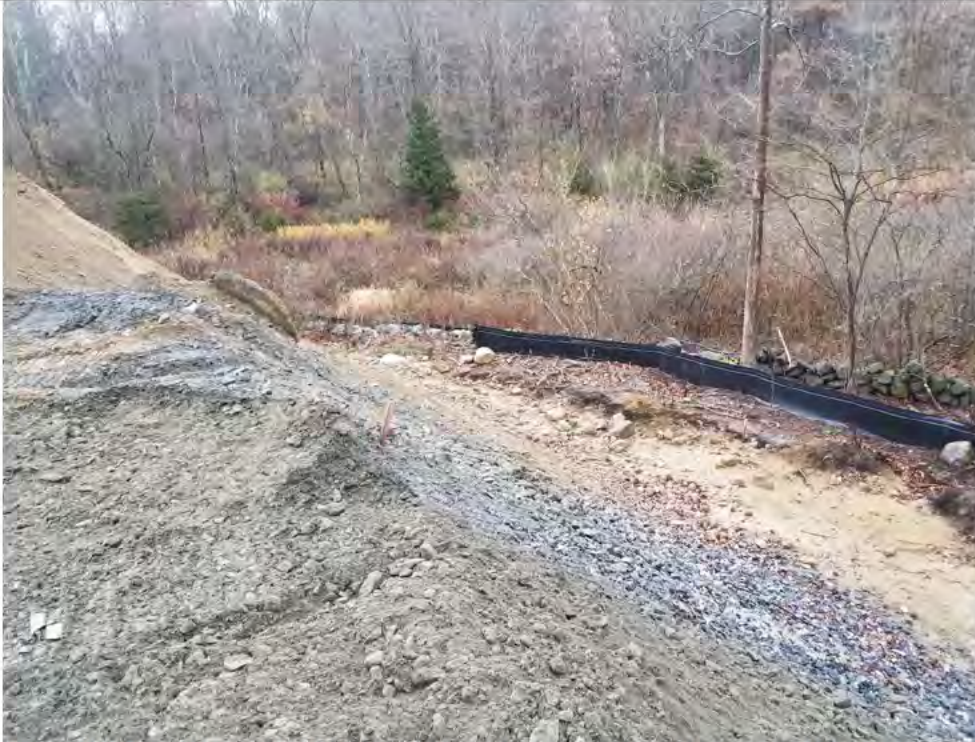
<b>Erosion and Sedimentation Controls</b>	<b>Interim Week</b>	Silt fencing installed along the limits of disturbance is installed according to BMP's, functioning as designed, and maintained. See Photo 1.	N/A	
	<b>Bi-Week</b>	Silt fencing installed along the limits of disturbance is installed according to BMP's, functioning as designed, and maintained as needed. See Photos 2 and 3.	N/A	
<b>Inland Wetland &amp; Watercourse encroachment &amp; mitigation</b>	<b>Interim Week</b>	None observed.	N/A

Photo 1: 11/16/17, Stony Hill Substation, Str4647A, silt fence line in northeast corner, W-7 north and east in this photo, photo taken facing north.

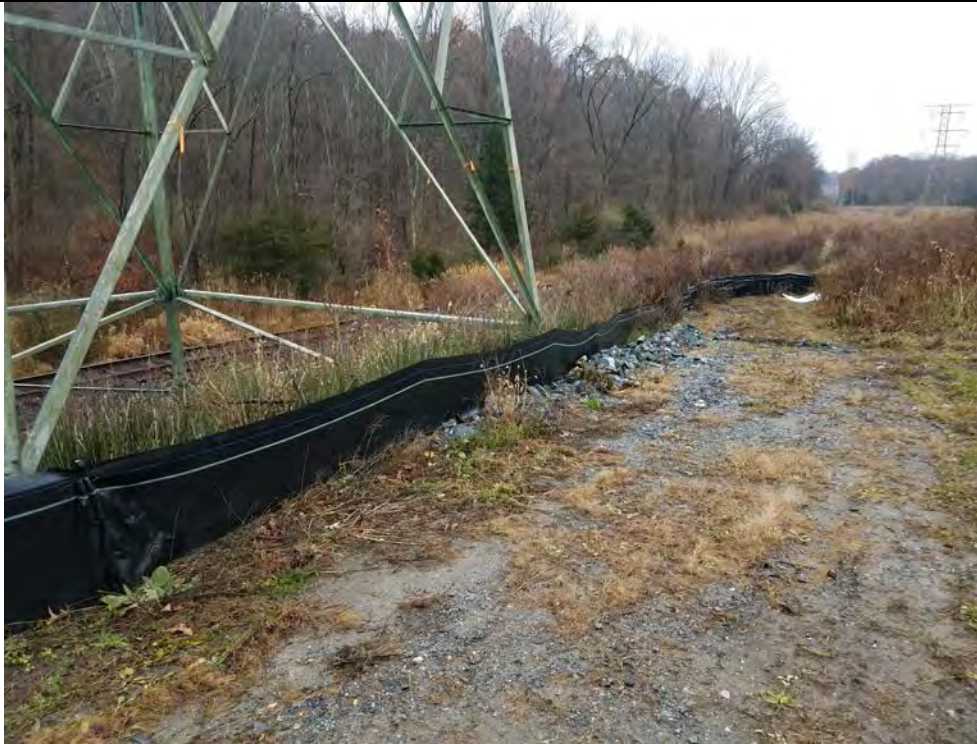
Photo 2: 11/22/17, Stony Hill Substation, Str4647A, silt fence line, north boundary, photo taken facing east.

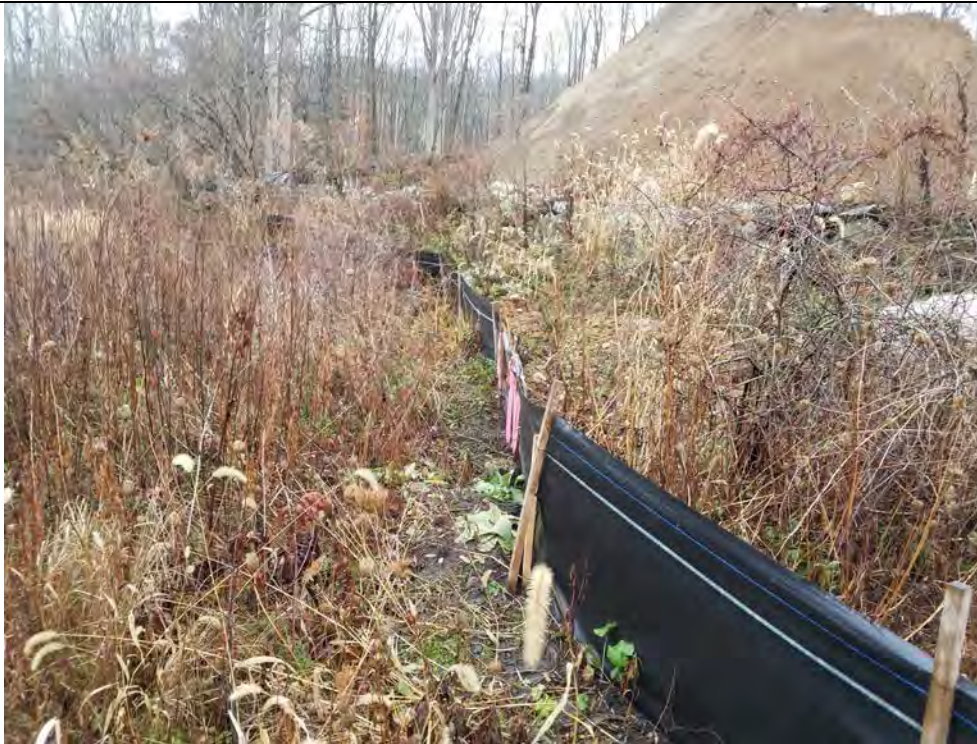
Photo 3: 11/22/17, Stony Hill Substation, Str4647A, silt fence line, east boundary, photo taken facing south. from the NE corner.
