**Subject: Docket No. 468, Plumtree Substation to Brookfield Junction 115-kV Project  
Decision and Order Condition #4 – Independent Environmental Inspector Report**

**Docket No. 468– Development and Management Plan Inspection**

**Photograph Log**  
**Southwest Connecticut Reliability Project**  
**Plumtree Substation to Stony Hill Substation**

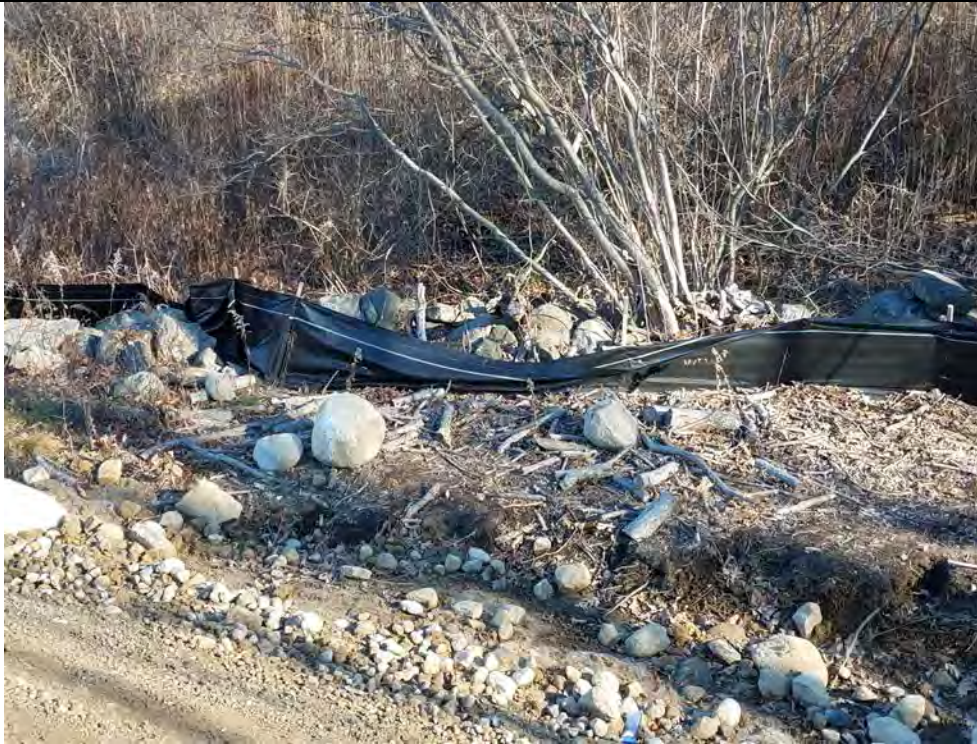
<b>Erosion and Sedimentation Controls</b>	<b>Interim Week</b>	Silt fencing installed along the limits of disturbance is installed according to BMP's, functioning as designed, and maintained.	N/A	N/A
	<b>Bi-Week</b>	Minor repairs needed to a 10-foot section of the silt fence in the northeast corner. Fabric detached along the upper edge of the stakes and needs to be reattached with staples. Under the current conditions the functionality of the silt fence is not compromised.	Spoke with the Eversource project/construction inspector and the silt fence will be repaired by the end of the day.	Silt fence will be repaired and maintained as needed. Currently E&S controls are checked regularly for compliance with BMPs.
<b>Inland Wetland &amp; Watercourse encroachment &amp; mitigation</b>	<b>Interim Week</b>	None observed	N/A

Photo 1: 12/07/17, Str4647A, northeast corner silt fence line, photo taken facing east.
