Subject: Docket No. 468, Plumtree Substation to Brookfield Junction 115-kV Project Decision and Order Condition #4 – Independent Environmental Inspector Report

Please find enclosed the Biweekly Independent Environmental Inspector Report, Report #7, for the **December 28th, 2017** and **January 4th, 2018** inspection events for the construction of the Eversource Plumtree Substation to Brookfield Junction 115-kV Project.

Docket No. 468- Development and Management Plan Inspection

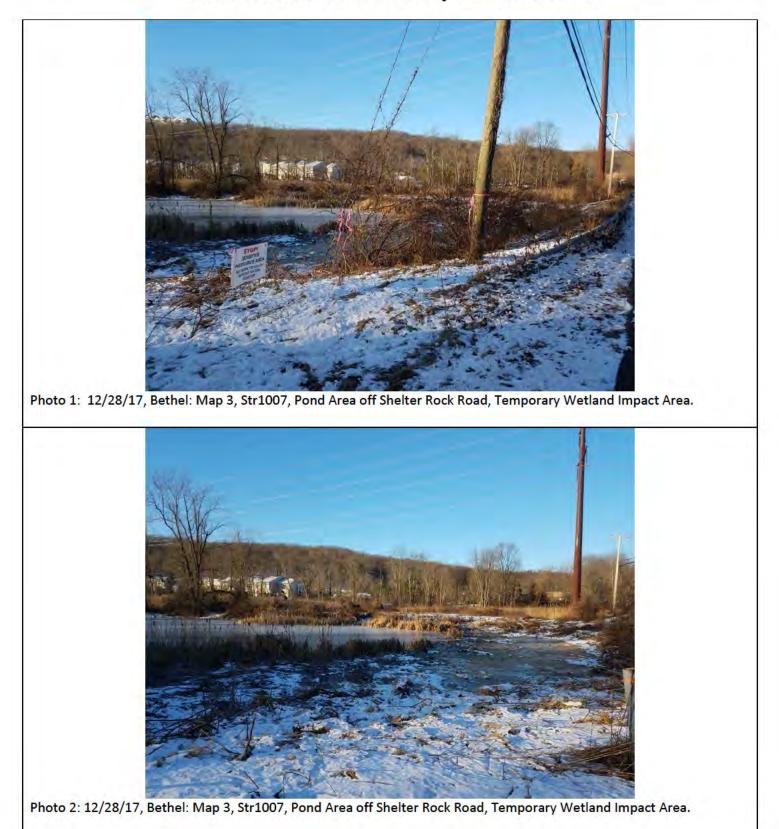
S	Interim Week	No water crossing was observed in the areas inspected. Vegetation and tree clearing was was completed at wetland W1, Pond Area (Bethel, Map 3) see Photo 1 and Photo 2.	N/A	
Water Crossings	Bi-Week	No inspection performed due to weather.	N/A	
	Ш

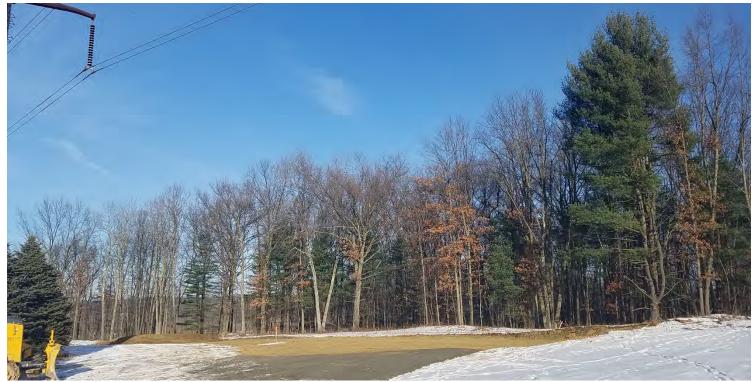
Photo #1: 1/3 – Structure 1025 north of Park Ridge Road – Grading of workpad for Structure 1025. Facing northeast.

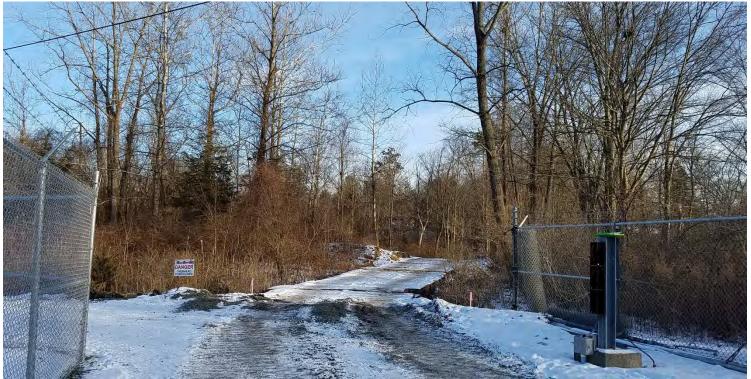
Photo #2: 1/3 – Between Plumtree Substation driveway and Plumtree Substation yard – Access route between the driveway and substation is cleared of trees. Uplands graded to a level surface and wetland crossing matted for tree clearing access. *Facing southeast*.

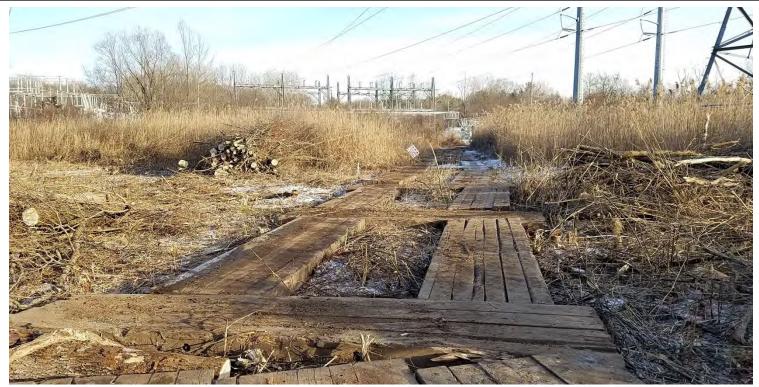
Photo #3: 1/3 – Near Structure 1003 west of Plumtree Substation – Temporary tree clearing access. Cleared brush and timber is temporarily stages within the permitted matted workpad footprints within Wetland W1. Staked locations of the limits of clearing were flagged with orange glow flagging prior the start of tree clearing in this area. *Facing southeast*.

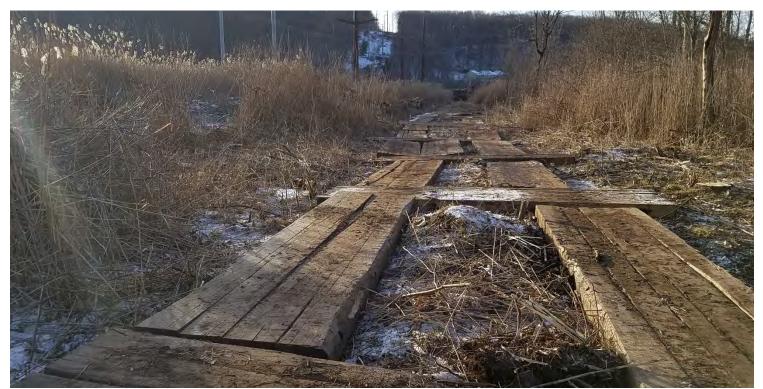
Photo #4: 1/3 – Near Structure 1003 west of Plumtree Substation – Alternate view of the location shown in Photo #3. *Facing west*.
