**Subject: Docket No. 468, Plumtree Substation to Brookfield Junction 115-kV Project
Decision and Order Condition #4 – Independent Environmental Inspector Report**

Please find enclosed the Biweekly Independent Environmental Inspector Report, Report #8, for the **January 11th** and **January 18th, 2018** inspection events for the construction of the Eversource Plumtree Substation to Brookfield Junction 115-kV Project.

Docket No. 468– Development and Management Plan Inspection

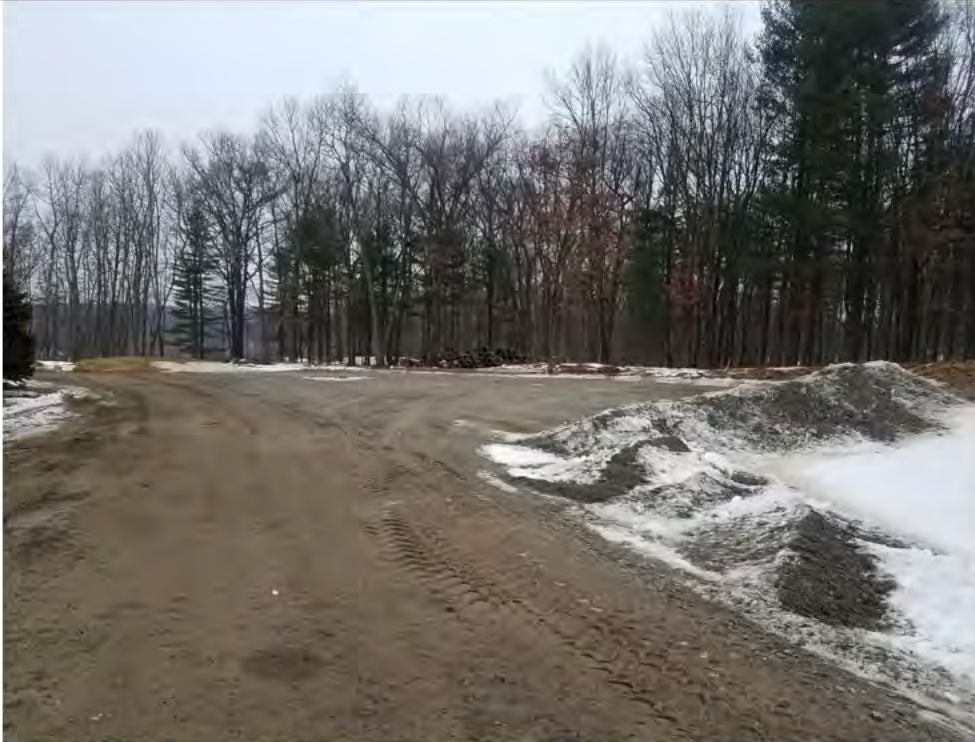
Pad construction for Str1025 was near completion and appeared to be waiting on top course of material and final compaction (Brookfield, Map 13, see Photo 1). Supreme was actively transporting in and placing timber mats in Wetland W1 to construct one continuous pad for structures Str1000 through Str1003 (Bethel, Map 02, see Photo 2).

Photo 1: 01/11/18, Brookfield: Map 13, Str1025 pad construction in progress, awaiting placement of top course.

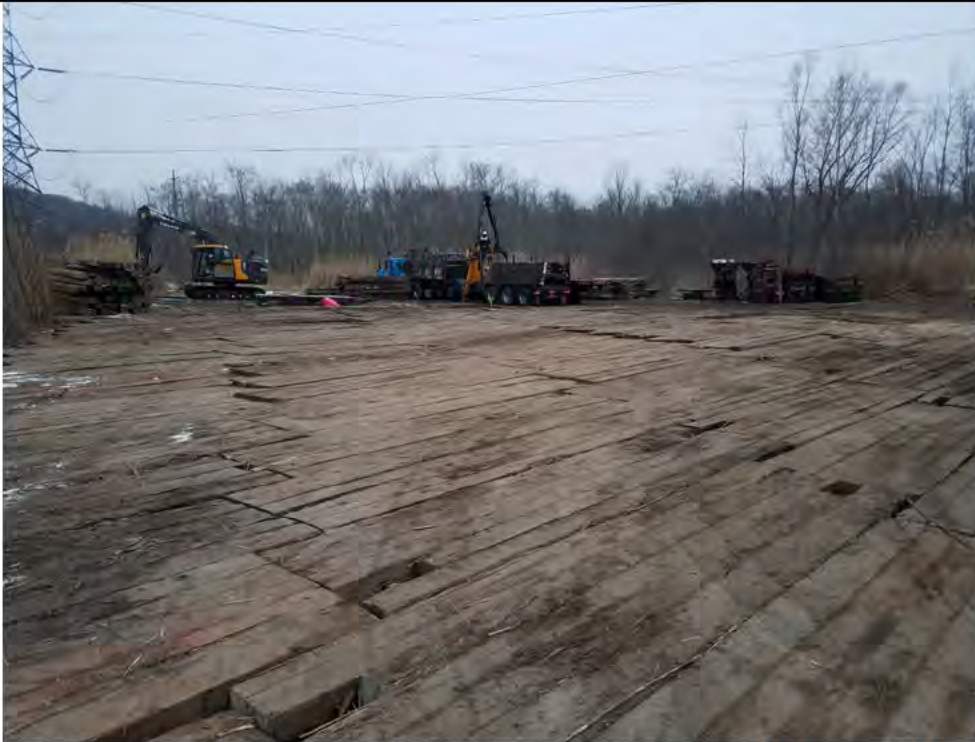
Photo 2: 01/11/2018, Bethel: Map 02, timber mat placement for structure pads 1000 through 1003. Working in Wetland W1.

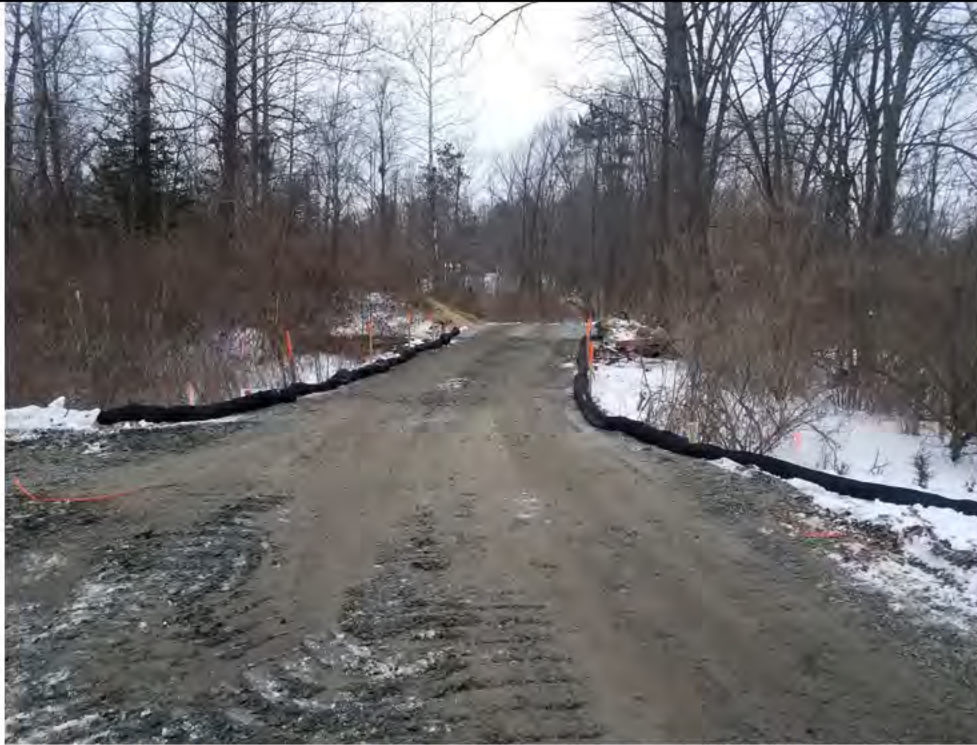
Water Crossings	Interim Week	<p>Supreme placed timber mats along a section of the access road to the Plumtree Substation and the access point to Str1000-Str1003 (Wetland W1). No tracking pad/s were observed at the approaches (from the southeast or the northwest) to the crossing (see Photo 3) and tracking of sediments was observed. Some moderate sediment buildup was observed on the timber mats. The contractor was already notified and aware of the conditions at the time of this inspection and has been cleaning the mats as buildup occurs.</p>	<p>Sediment buildup is being monitored and maintenance is being performed as needed to help prevent sedimentation into the wetland. Crushed aggregate tracking pads at this location would help in controlling sediment tracking issues. At the time of this inspection frost was observed however above freezing temperatures and/or rainfall will likely cause heavy sedimentation in this area. This is the main point of access to the Plumtree Substation and the four structures (Str1000 to Str1003). Heavy equipment and project vehicle tracking through this area may be significant.</p>

Photo 3: 01/11/2018, Bethel: Map 02, access road and timber mat crossing to Plumtree Substation and structures Str1000 through Str1003 and Wetland W1.

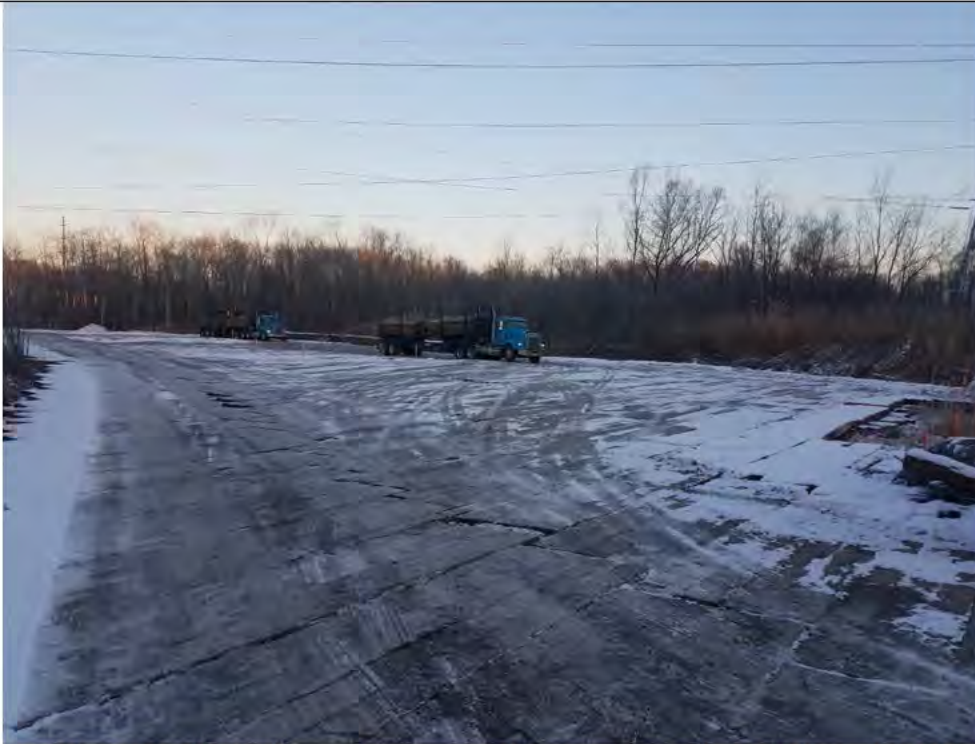
Supreme continues transporting in and placing timber mats in Wetland W1 to construct pads for structures Str1000 through Str1005 (Bethel, Map 02, see Photos 4 and 5). Snow and ice cover observed site wide.

Bi-Week	<p>Area discussed above was at the time of this inspection snow and ice covered (see photos 4-6). No change in conditions with respect to the timber mat crossing on the access road at the SE corner of Plumtree Substation (sliver of Wetland W1).</p>	N/A

Photo 4: 01/18/2018, Bethel: Map 02, timber mat placement for structure pads 1000 through 1003. Working in Wetland W1.

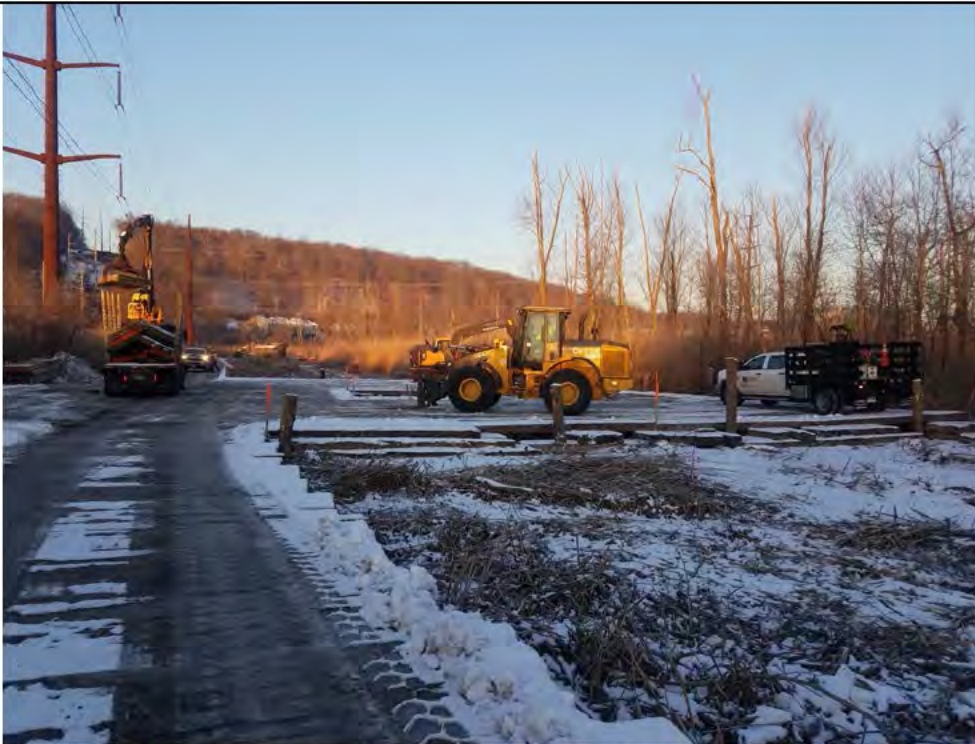
Photo 5: 01/18/2018, Bethel: Map 02, timber mat placement for structure pads 1004 through 1005. Working in Wetland W1.

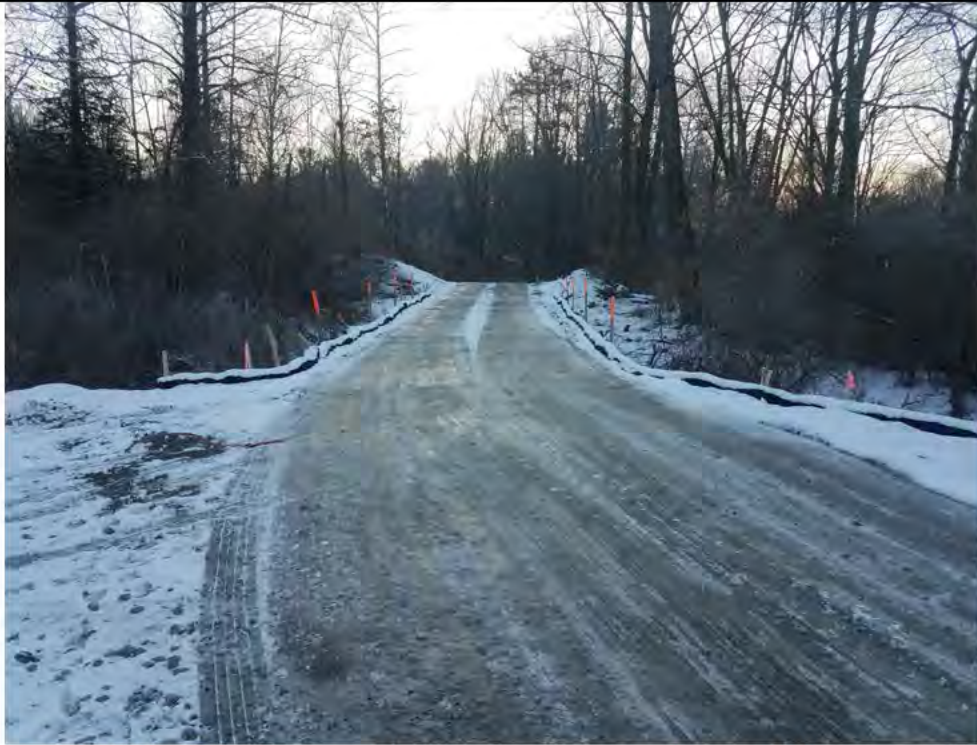
Photo 6: 01/18/2018, Bethel: Map 02, access road timber mat crossing to Plumtree Substation and structure pads 1000 through 1005 in Wetland W1.
