**Subject: Docket No. 468, Plumtree Substation to Brookfield Junction 115-kV Project  
Decision and Order Condition #4 – Independent Environmental Inspector Report**

Please find enclosed the Biweekly Independent Environmental Inspector Report, Report #10, for the **February 8<sup>th</sup>**, and **February 15<sup>th</sup>, 2018** inspection events for the construction of the Eversource Plumtree Substation to Brookfield Junction 115-kV Project.

**Docket No. 468– Development and Management Plan Inspection**

## Southwest Connecticut Reliability Project

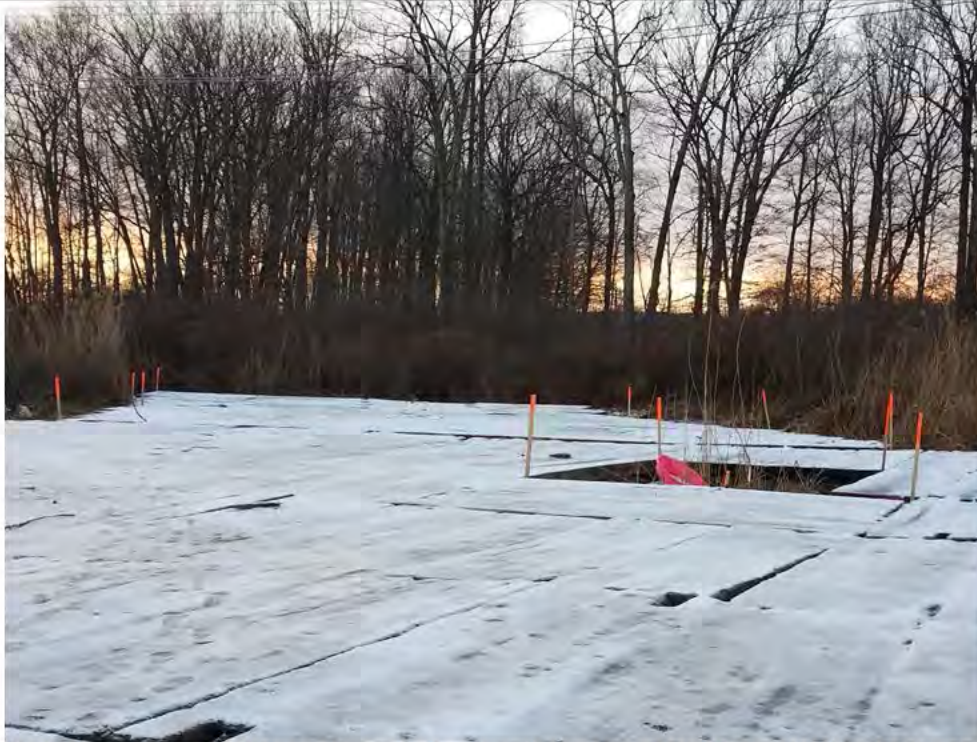
Photo 1: 02/08/2018, Bethel: Maps 01-02, south end of pull pad abutting Str1005 in Wetland W1, photo taken facing south.

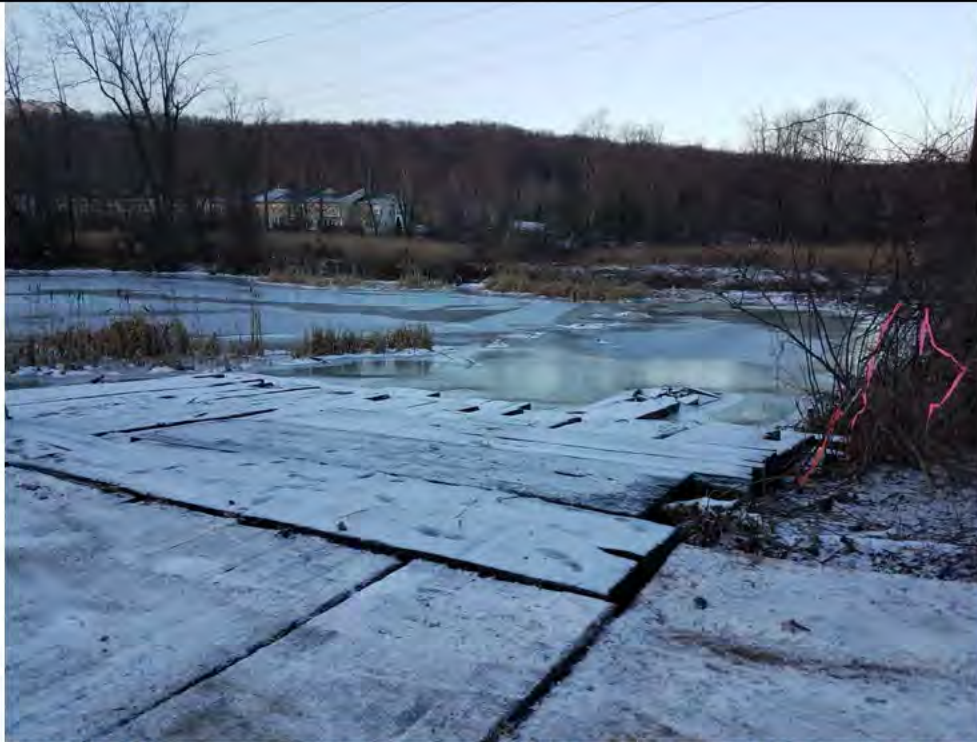
Photo 2: 02/08/2018, Bethel: Map 03, start of timber mat installation in Wetland W1 to access Str1007 to the west, photo facing west from the east access point off Shelter Rock Road.

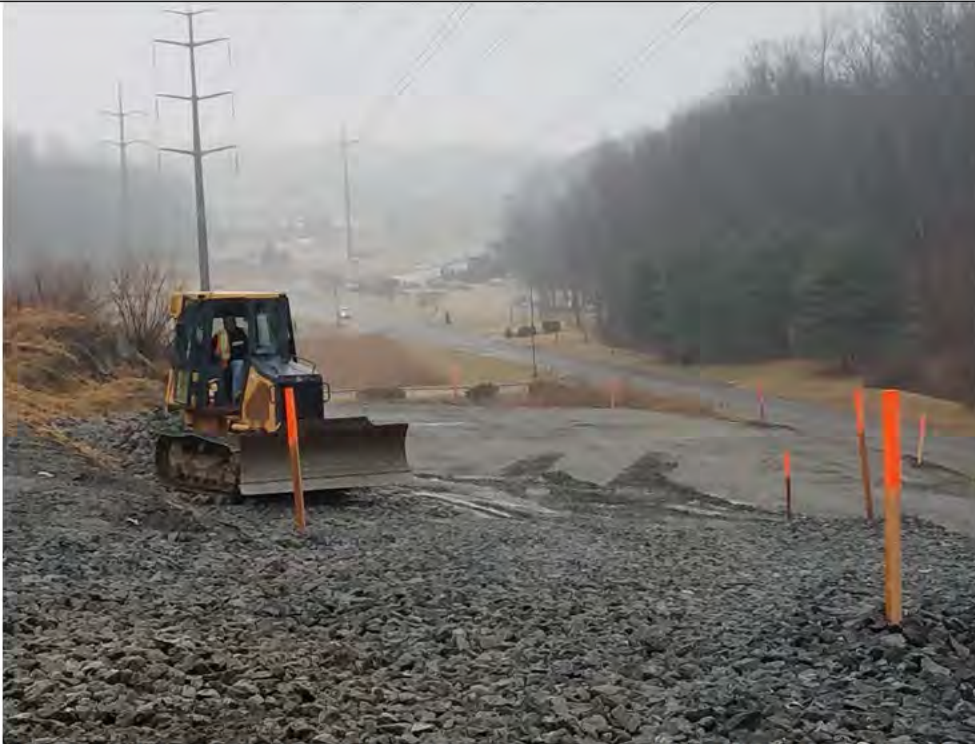
Supreme was actively grading the stone course at Str1023 (Bethel/Brookfield, Map 12, see Photo 1), and cutting rough grade at Str1009(Danbury, Map 05, see Photo 2). Timber mat placement at Str1007(Bethel, Map 03) is completed(see Photo 3) and timber mat placement is in progress at Str1008(Danbury, Map 04).

Photo 1: 02/15/2018, Bethel/Brookfield: Map 12, grading stone course at Str1023, photo taken facing south.

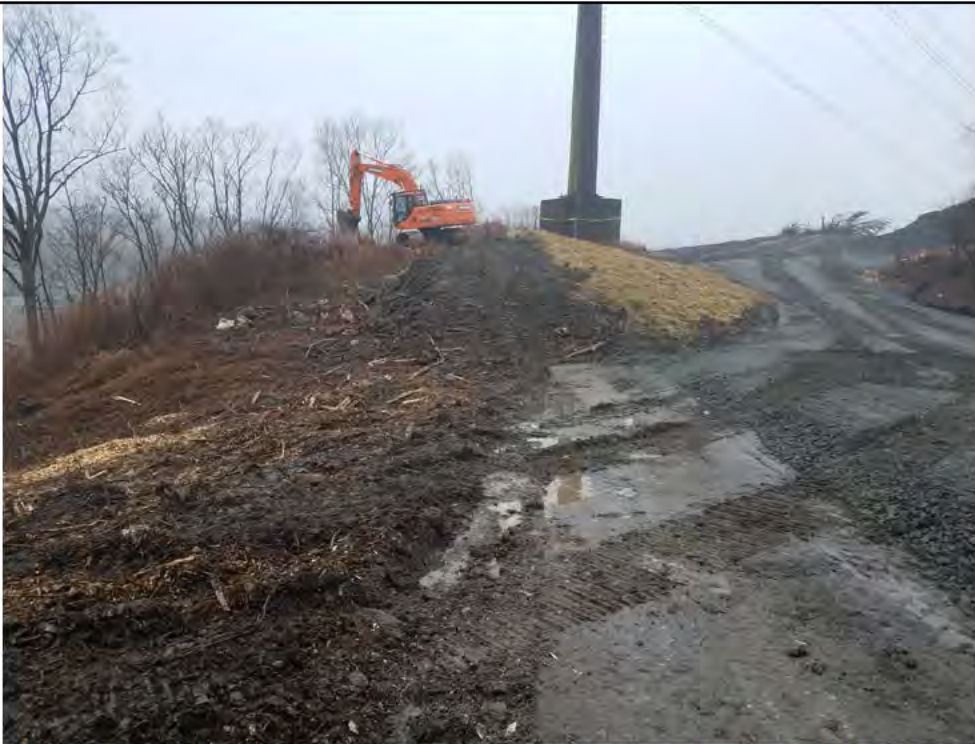
Photo 2: 02/15/2018, Danbury: Map 09, cutting grade and rough grading of pad at Str1009, photo taken facing southeast.

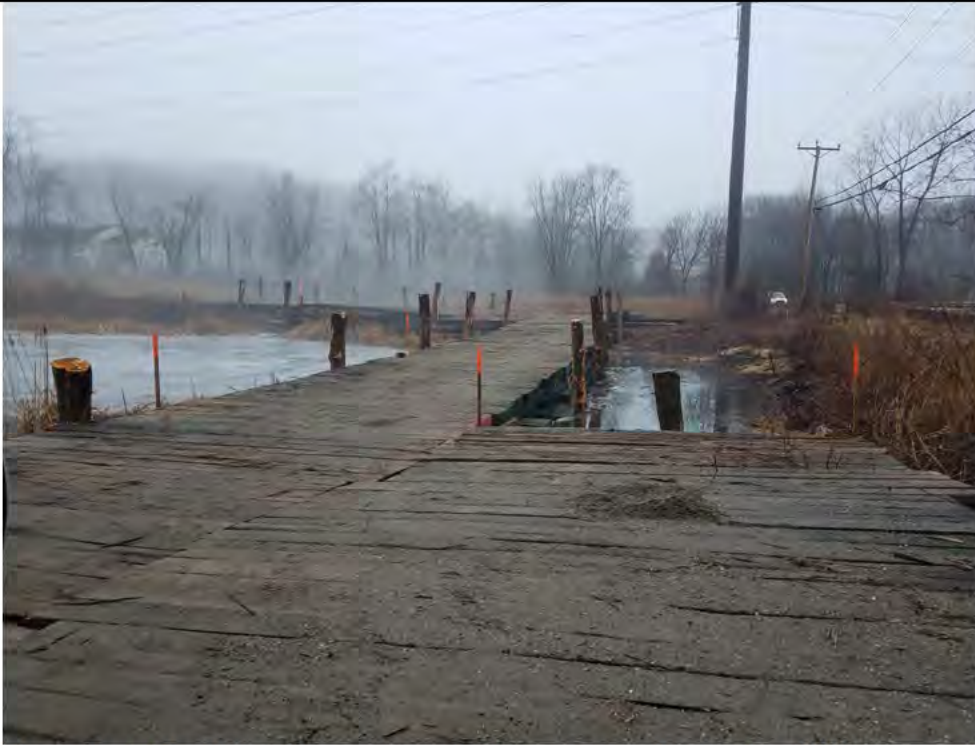
Photo 3: 02/15/2018, Bethel: Map 03, timber mat installation completed in Wetland W1 to access Str1007 to the west, photo facing west from the east access point off Shelter Rock Road.

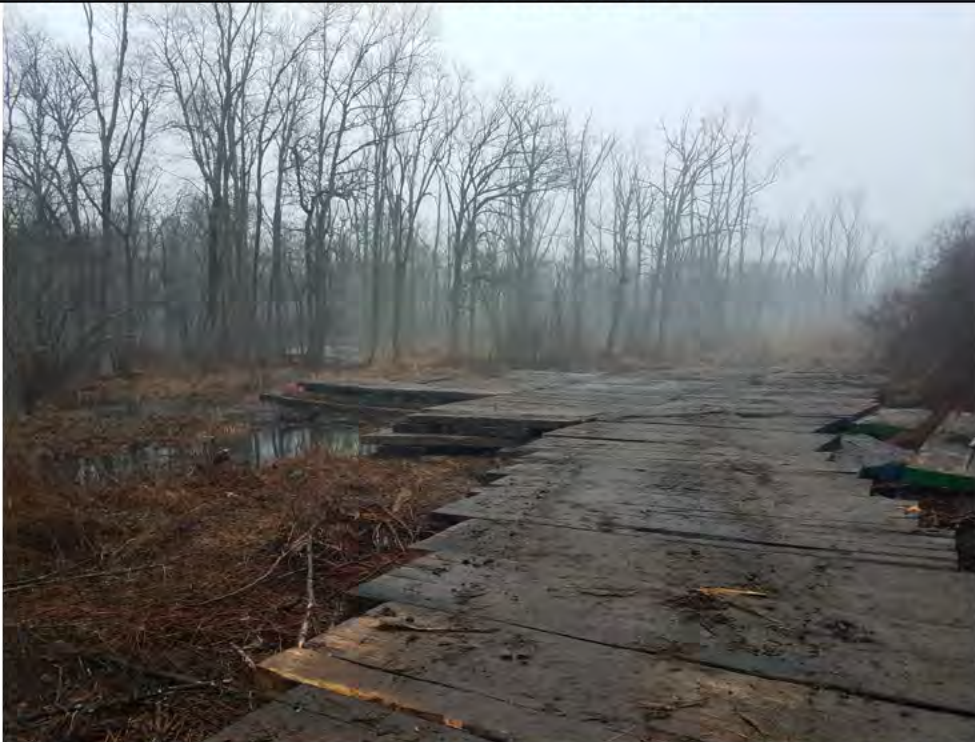
Photo 4: 02/15/2018, Danbury: Map 04, timber mat installation in progress in Wetland W1 at Str1008, Photo taken facing south toward Str1008.
